*Date:* October 15, 2007  
*Refer To:* EP2007-0635

**Subject: Submittal of Certification of Culvert Repair behind the SM-30 Warehouse, in the Vicinity of Solid Waste Management Units 03-010(a) and 03-001(e)**

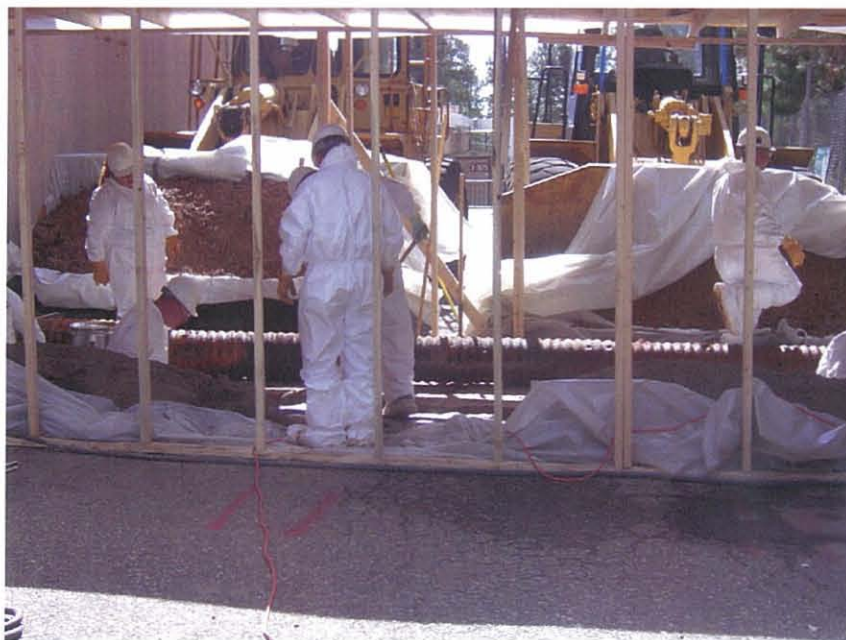
Photo 1. Removal of old culvert.

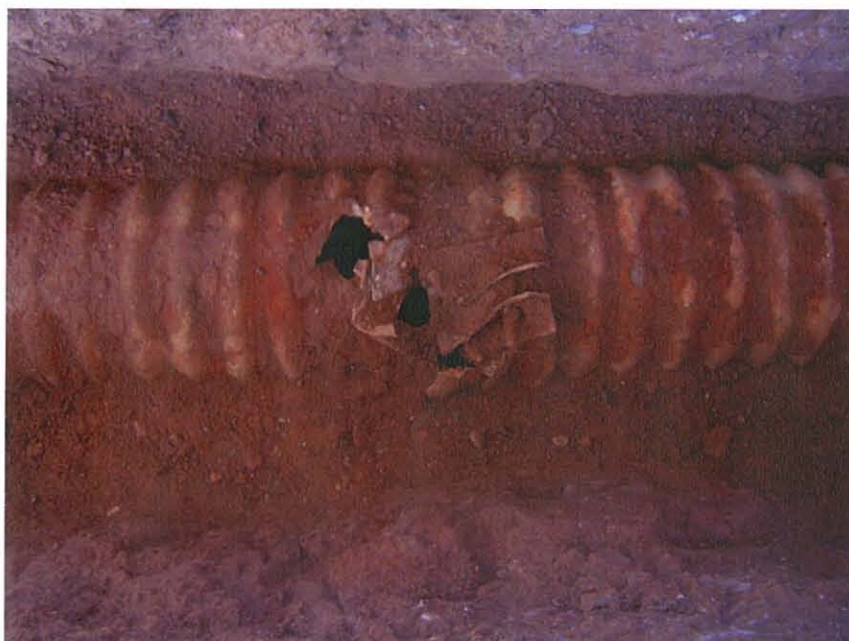
Excavation of the culvert began on October 4, 2007, following construction of a sheltered frame over the line to eliminate potential stormwater impacts. The entire line was hand-excavated to avoid damaging the existing utilities that cross the culvert. The original culvert was found to be damaged near the junction with the building foundation, as the camera logging showed. In addition, the bottom of the culvert was found to be significantly deteriorated. On October 5, 2007, the new CMP was installed in the original trench. All joints of the new CMP were connected with couplings, sealed with mastic, and encased in concrete. The photographs included with this letter document the culvert repair.

Photo 2. Break in old culvert.

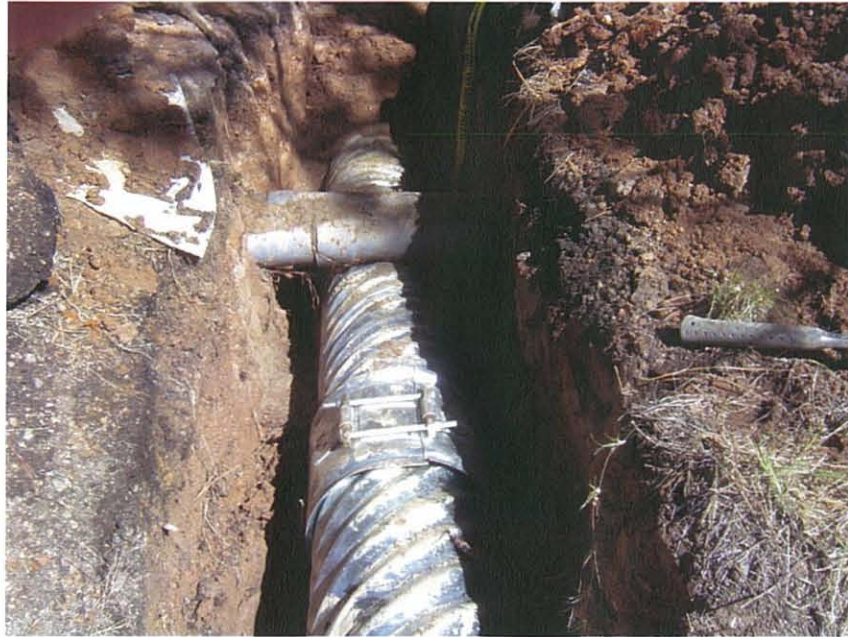
Photo 3. New CMP and existing utility line.

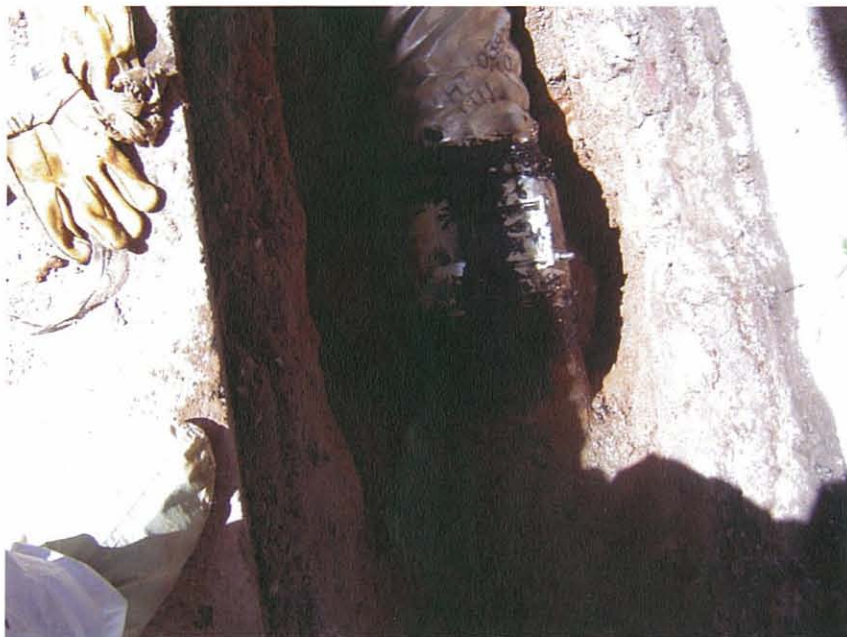
Photo 4. Mastic sealing of coupling.

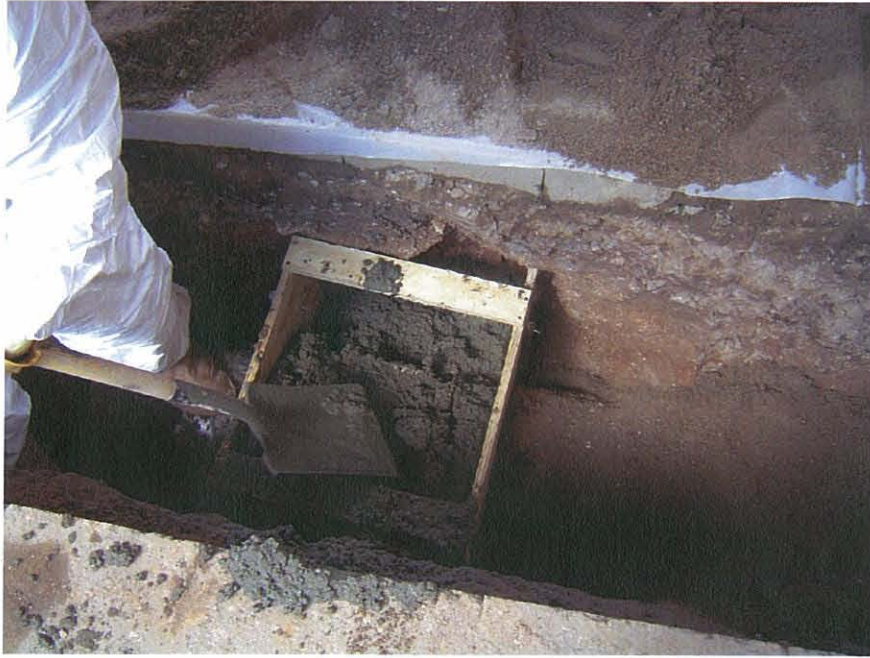
Photo 5. Encasing the coupling in concrete.
