Date: DEC 1 8 2009 Refer To: EP2009-0662

Subject: Erosion Controls Associated with Fishladder Canyon [Solid Waste Management

Unit 16-003(o)]

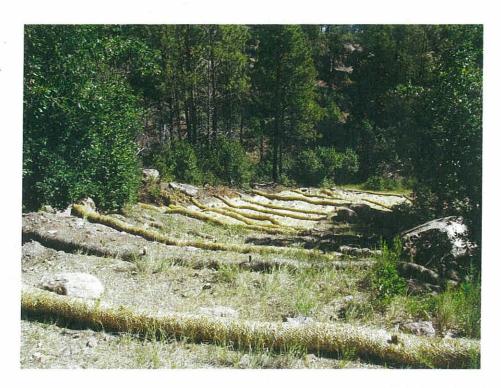
Figure 1. View looking downslope from mesa top into Fishladder Canyon

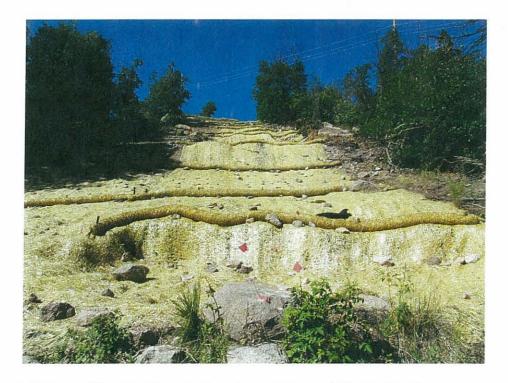
Figure 2. View looking upslope from bottom of Fishladder Canyon

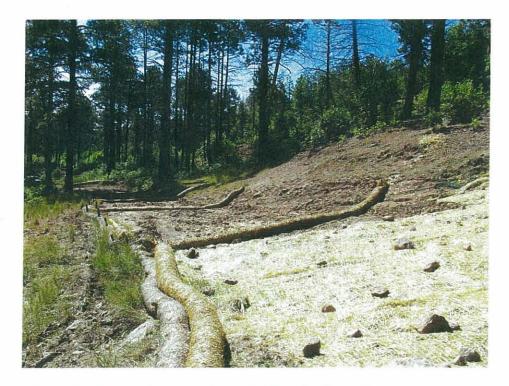
Figure 3. View looking east down Fishladder Canyon
