LA-UR-11-4793
September 2011
EP2011-0280

Las Conchas Wildfire Effects and Mitigation Actions in Affected Canyons

Prepared by the Environmental Programs Directorate

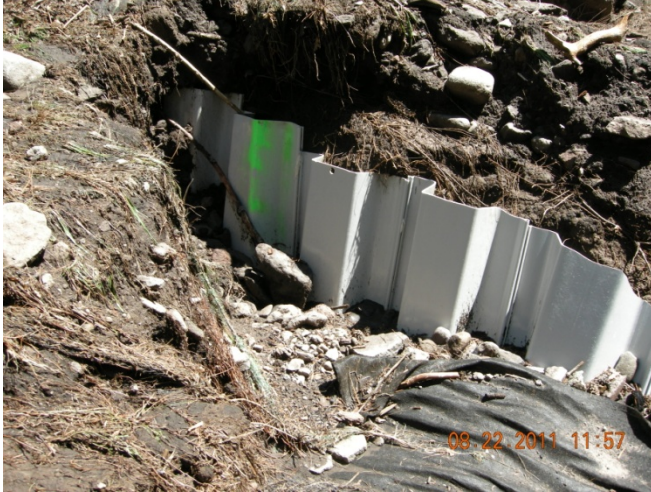
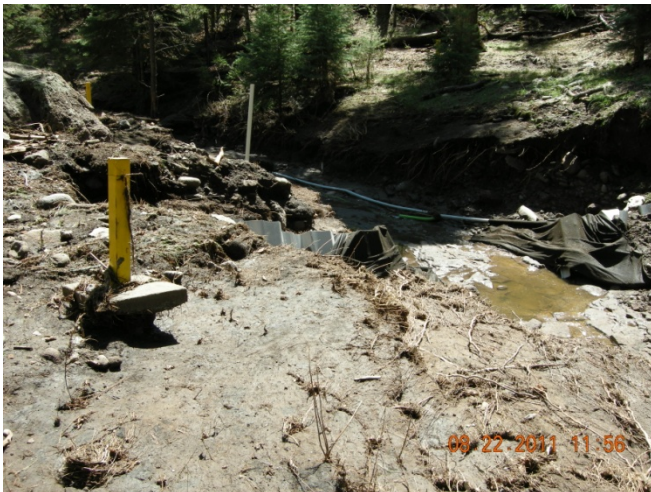
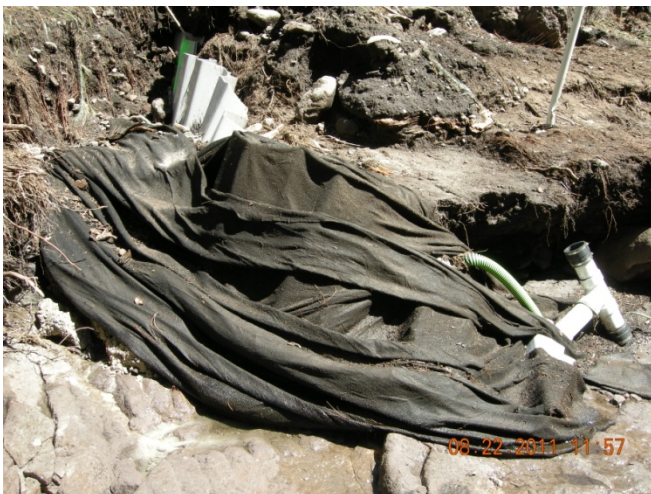
On August 21, 2011, an even larger rain event occurred over the recent burn scar in the upper Cañon de Valle watershed. Runoff from the storm flooded NM 501 as well as the area upstream from the PRB with debris. The site was inspected on August 26, 2011. Additional changes to the channel and damage to equipment following the August 21, 2011, flooding event included the following:

- The flood incised through the PRB cutoff wall down to bedrock about 10 ft wide and about 5 ft deep.
- The cutoff wall was broken and splayed open downstream.

- Sediment was eroded from the channel bed and adjacent stream banks and sediment and rocks as large as 2 to 3 ft in diameter were deposited on top of the PRB vessel and throughout the canyon.

- All monitoring tubes and plumbing around the vessel were either transported downstream or buried.
- The tube connecting the cutoff wall to the vessel was ripped out of the vessel and the cutoff wall.

- Wells at locations CDV-16-611919, CDV-16-611934, CDV-16-611936, and CDV-16-611938 were washed away by flood waters, and the surface completion and well housing at location CDV-16-611931 was stripped away, leaving only PVC well casing.

- The piezometers at each of the cutoff wall's discharge points were broken off as well at locations CDV-16-611929 and CDV-16-611930.
- Debris from the PRB was found up to 1 mi downstream.

Damage occurred at the Permeable Reactive Barrier (PRB) in Upper Water Canyon from storm events on August 3 and August 21

As described in section 2.1, the PRB in Cañon de Valle and several associated monitoring wells were damaged by flooding that occurred in August. Continued operation of the barrier and associated groundwater monitoring is not possible. As described in the 2010/2011 Monitoring Summary Report for the Technical Area 16 Permeable Reactive Barrier and Associated Corrective Measures Implementation Projects, which will be submitted to NMED on September 30, 2011, a flood recovery plan will be prepared

that will identify action to be taken in response to the damage that occurred to the PRB and associated wells.

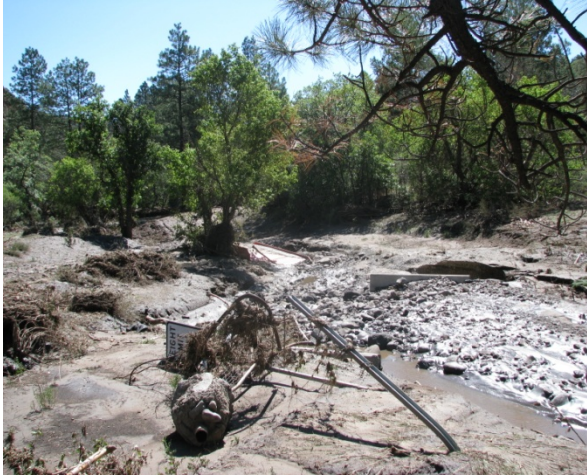
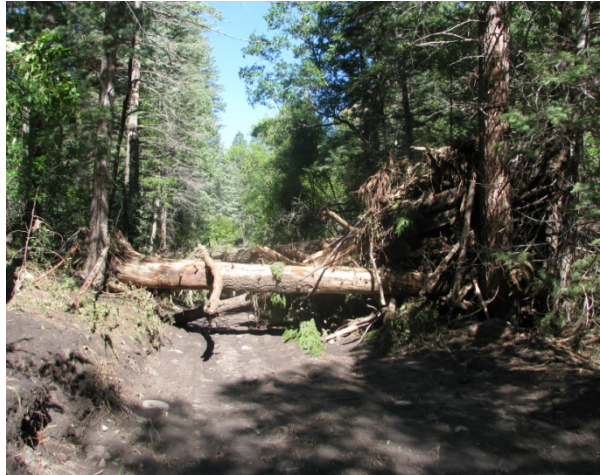
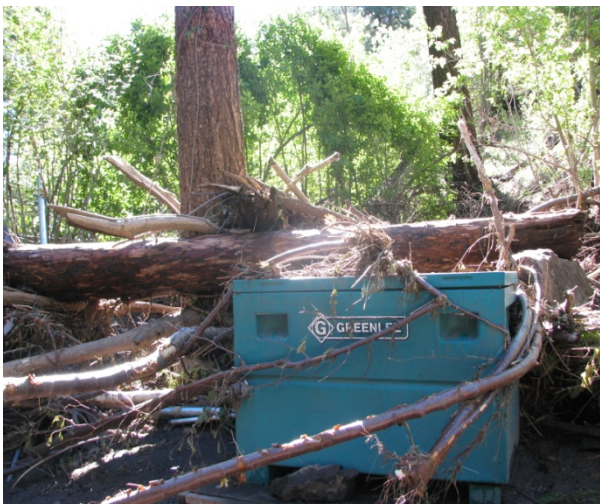
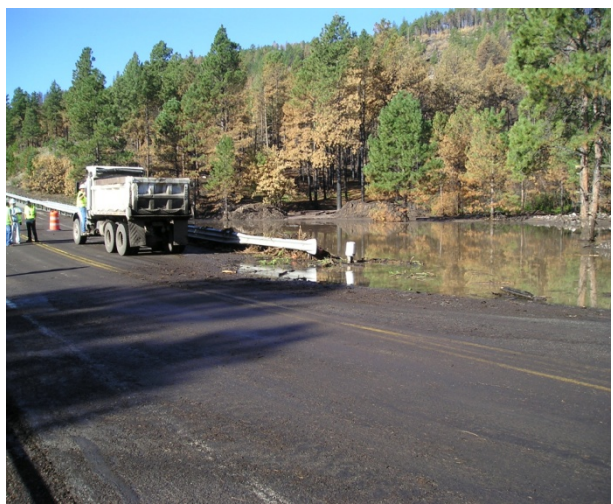
Storm event on August 21st produced significant runoff that damaged many gage stations within the Water Canyon watershed. Peak flows were estimated to be between 4950 cfs and 6190 cfs

Repairs at E026, completed on August 24, 2011, included removing log and flood debris from the channel, clearing sediment and debris from the stilling well, and redirecting the stream channel back to the gage. Repairs at E252 and E253, completed on September 12, included clearing debris from the stilling wells, redirecting the stream channel back to the gage, and replacing damaged sampling and data-logging equipment. At E265, an automated sampler, triggered by an actuator, was installed September 12.

As described in section 2.2, 10 gage stations were damaged by flooding on August 21 and August 22, 2011. Stations E026, E252, and E253 have been repaired, but stream channels are continuing to shift, periodically isolating the gages from stormwater flow or burying sampling lines and stilling wells in sediment. These changing stream conditions are contributing to increased uncertainty in gage measurements and the decreased likelihood of sample collection. Sampling functionality has been reestablished at E265, but at this time rainfall and stream stage measurements are not functioning. Repairs at E243, E244, E252.5, E256, and E262, will be made following road repairs. No further stormwater sampling or stage measurements will be made at E243, E244, E252.5, E256, and E262 in 2011.

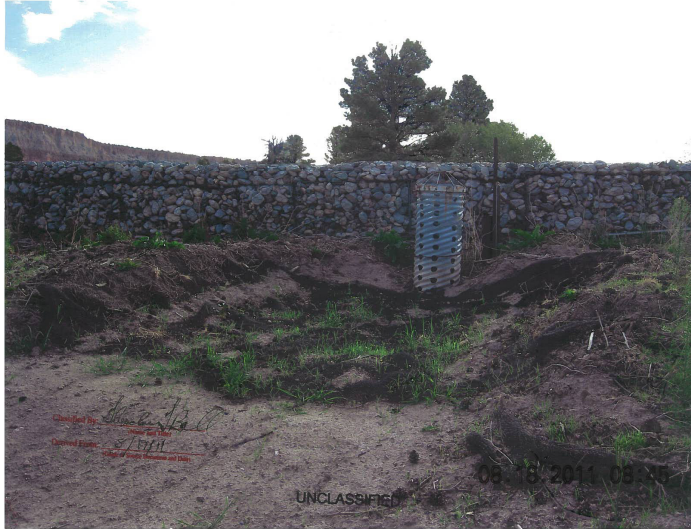
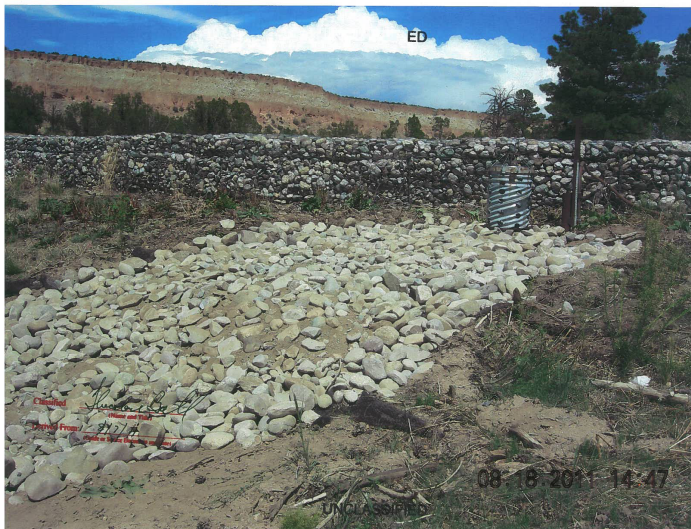
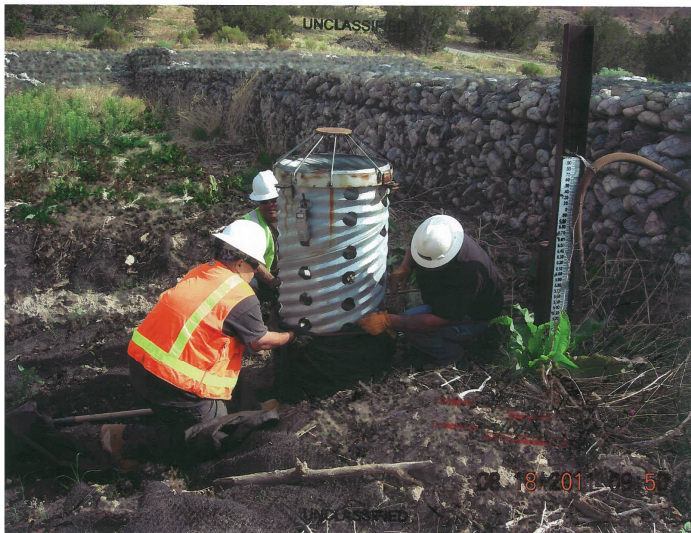
To prevent potential overtopping of the LA weir by floodwaters, more of the discharge standpipe at the base of the weir was exposed to increase the flow rate through the weir. At the request of the NMED, the standpipe was returned to its original configuration on August 18, 2011

To prevent potential overtopping of the weir by floodwaters, more of the discharge standpipe at the base of the weir was exposed to increase the flow rate through the weir. This activity was performed in conjunction with the sediment-removal activities described above. At NMED's request, the standpipe was returned to its original configuration and wrapped with filter fabric on August 18, 2011. Photographs of the restored standpipe were provided to NMED on August 18, 2011, and are also included in Appendix A.

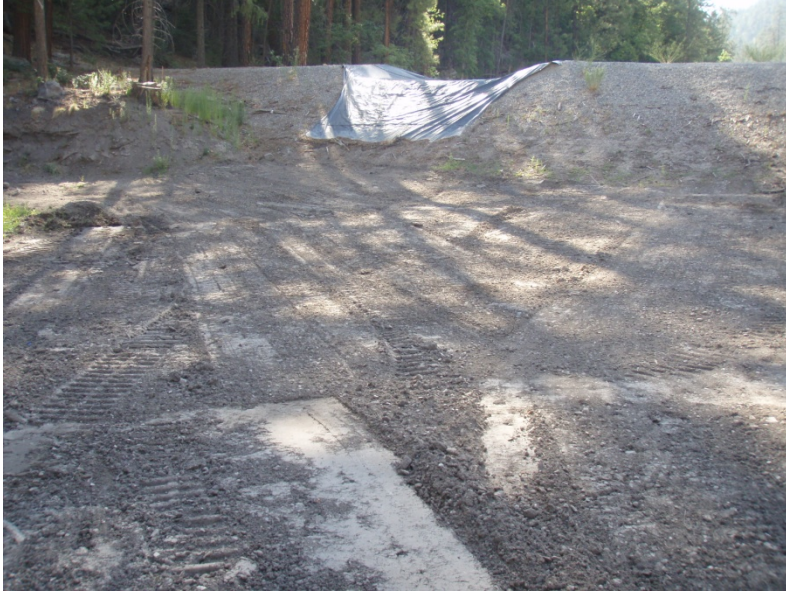
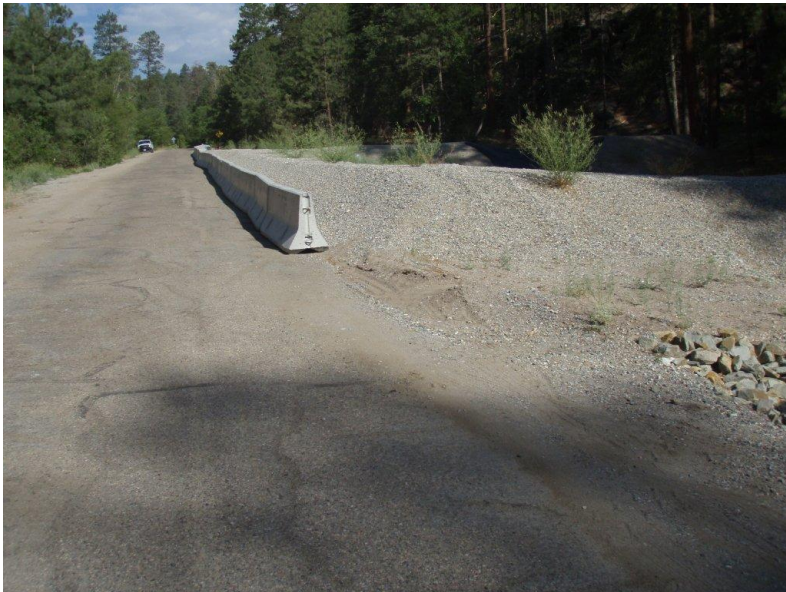
To prevent possible release of PCB-contaminated sediments, the sediments accumulated in the basins were removed (+/- 25 Cu/Yd).

The retention basins were armored to prevent possible damage from flooding. Concrete barriers were placed around the basins to provide armoring.

Two sediment retention basins were constructed in Los Alamos Canyon as part of the interim measure for Solid Waste Management Unit (SWMU) 01-001(f). These basins were constructed to capture sediments contaminated with polychlorinated biphenyls (PCBs). Because the retention basins are located in the canyon bottom, the berms that form the basins could potentially be damaged by flooding. To prevent possible transport of PCB-contaminated sediments, the sediments that had accumulated in the basins were removed. Approximately 25 yd³ of sediment was excavated from the basins, placed into rolloff bins, and removed from the site for off-site disposal. In addition to removing the sediments, the retention basins were protected to reduce the potential for damage from flooding. Concrete Jersey barriers were placed in the canyon floor in a configuration that should divert flood water around the basins. Photographs of the basins following sediment removal and armoring are included in Appendix A. Sediment removal and armoring was performed from July 8 to 11, 2011.

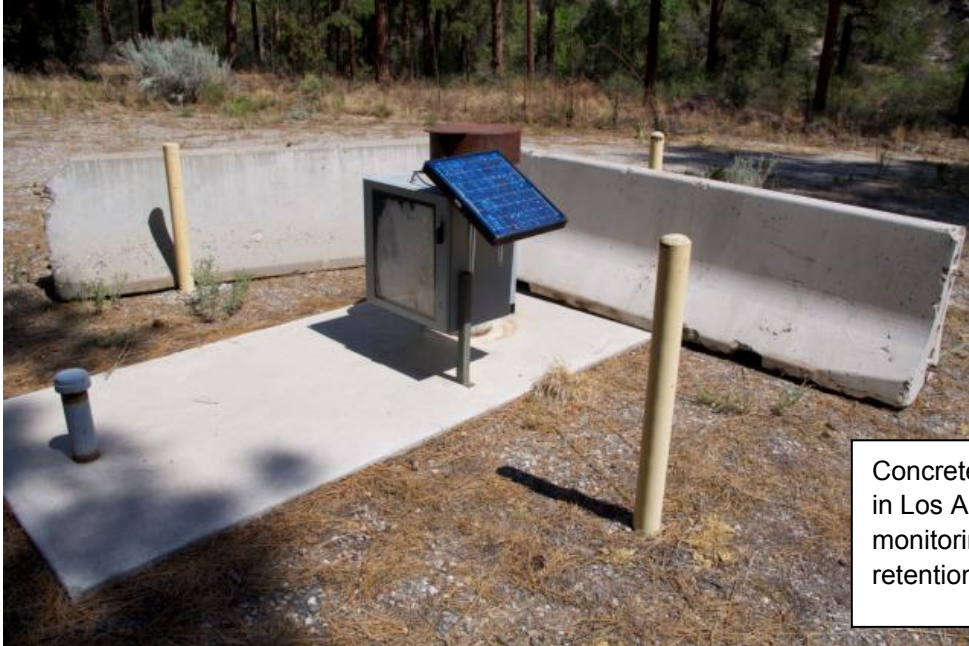
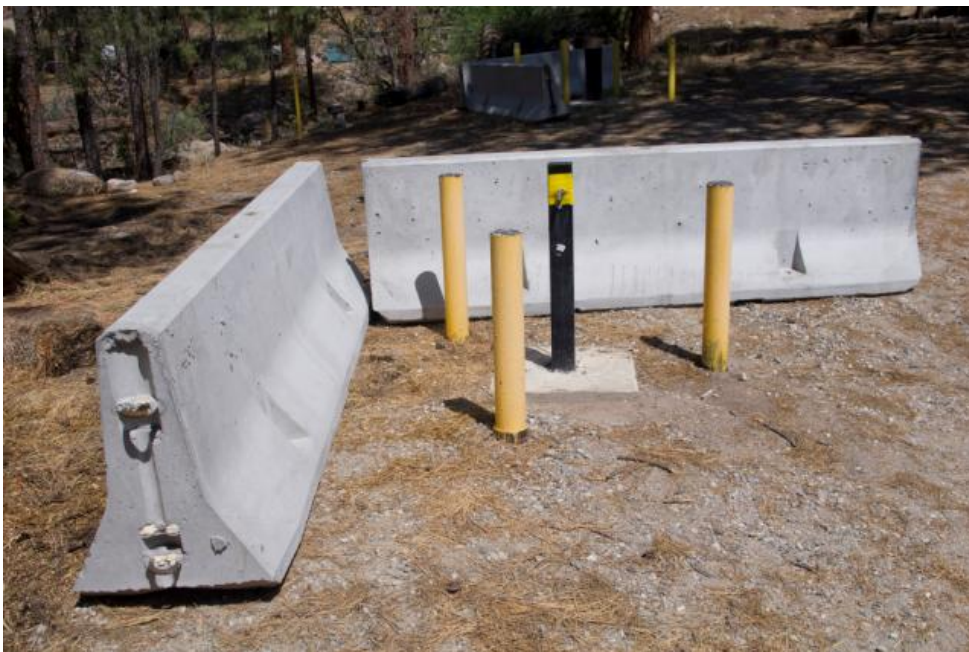
Concrete barriers were installed in Los Alamos Canyon to protect monitoring wells and sediment retention ponds.

Wells located in canyons are also subject to potential physical damage from water and debris during flooding. To provide protection from such damage, concrete Jersey barriers were placed upstream of

monitoring and water supply wells to divert floodwaters. Well armoring was performed from July 8 to 11, 2011.

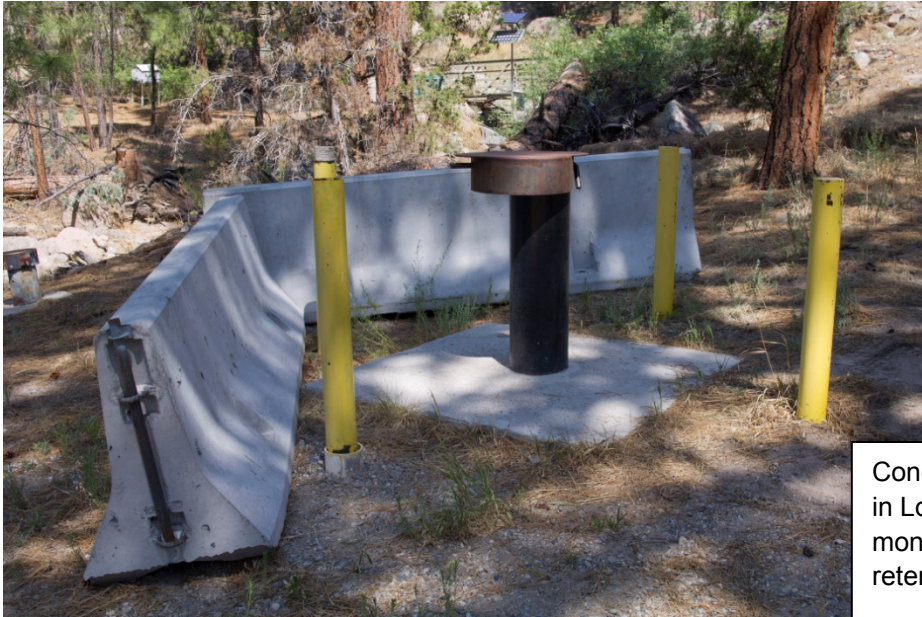
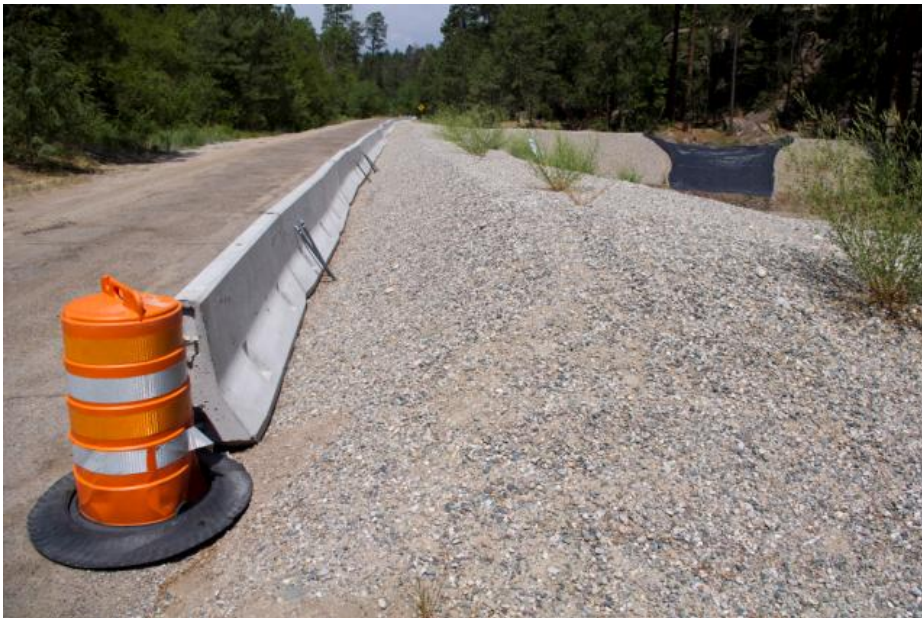
Concrete barriers were installed in Los Alamos Canyon to protect monitoring wells and sediment retention ponds.
