Symbol: ADESH-14-135

LAUR: 14-29098

Subject: Submittal of the Inspection and Maintenance of Erosion Controls Associated with Fishladder Canyon [Solid Waste Management Unit 16-003(o)]

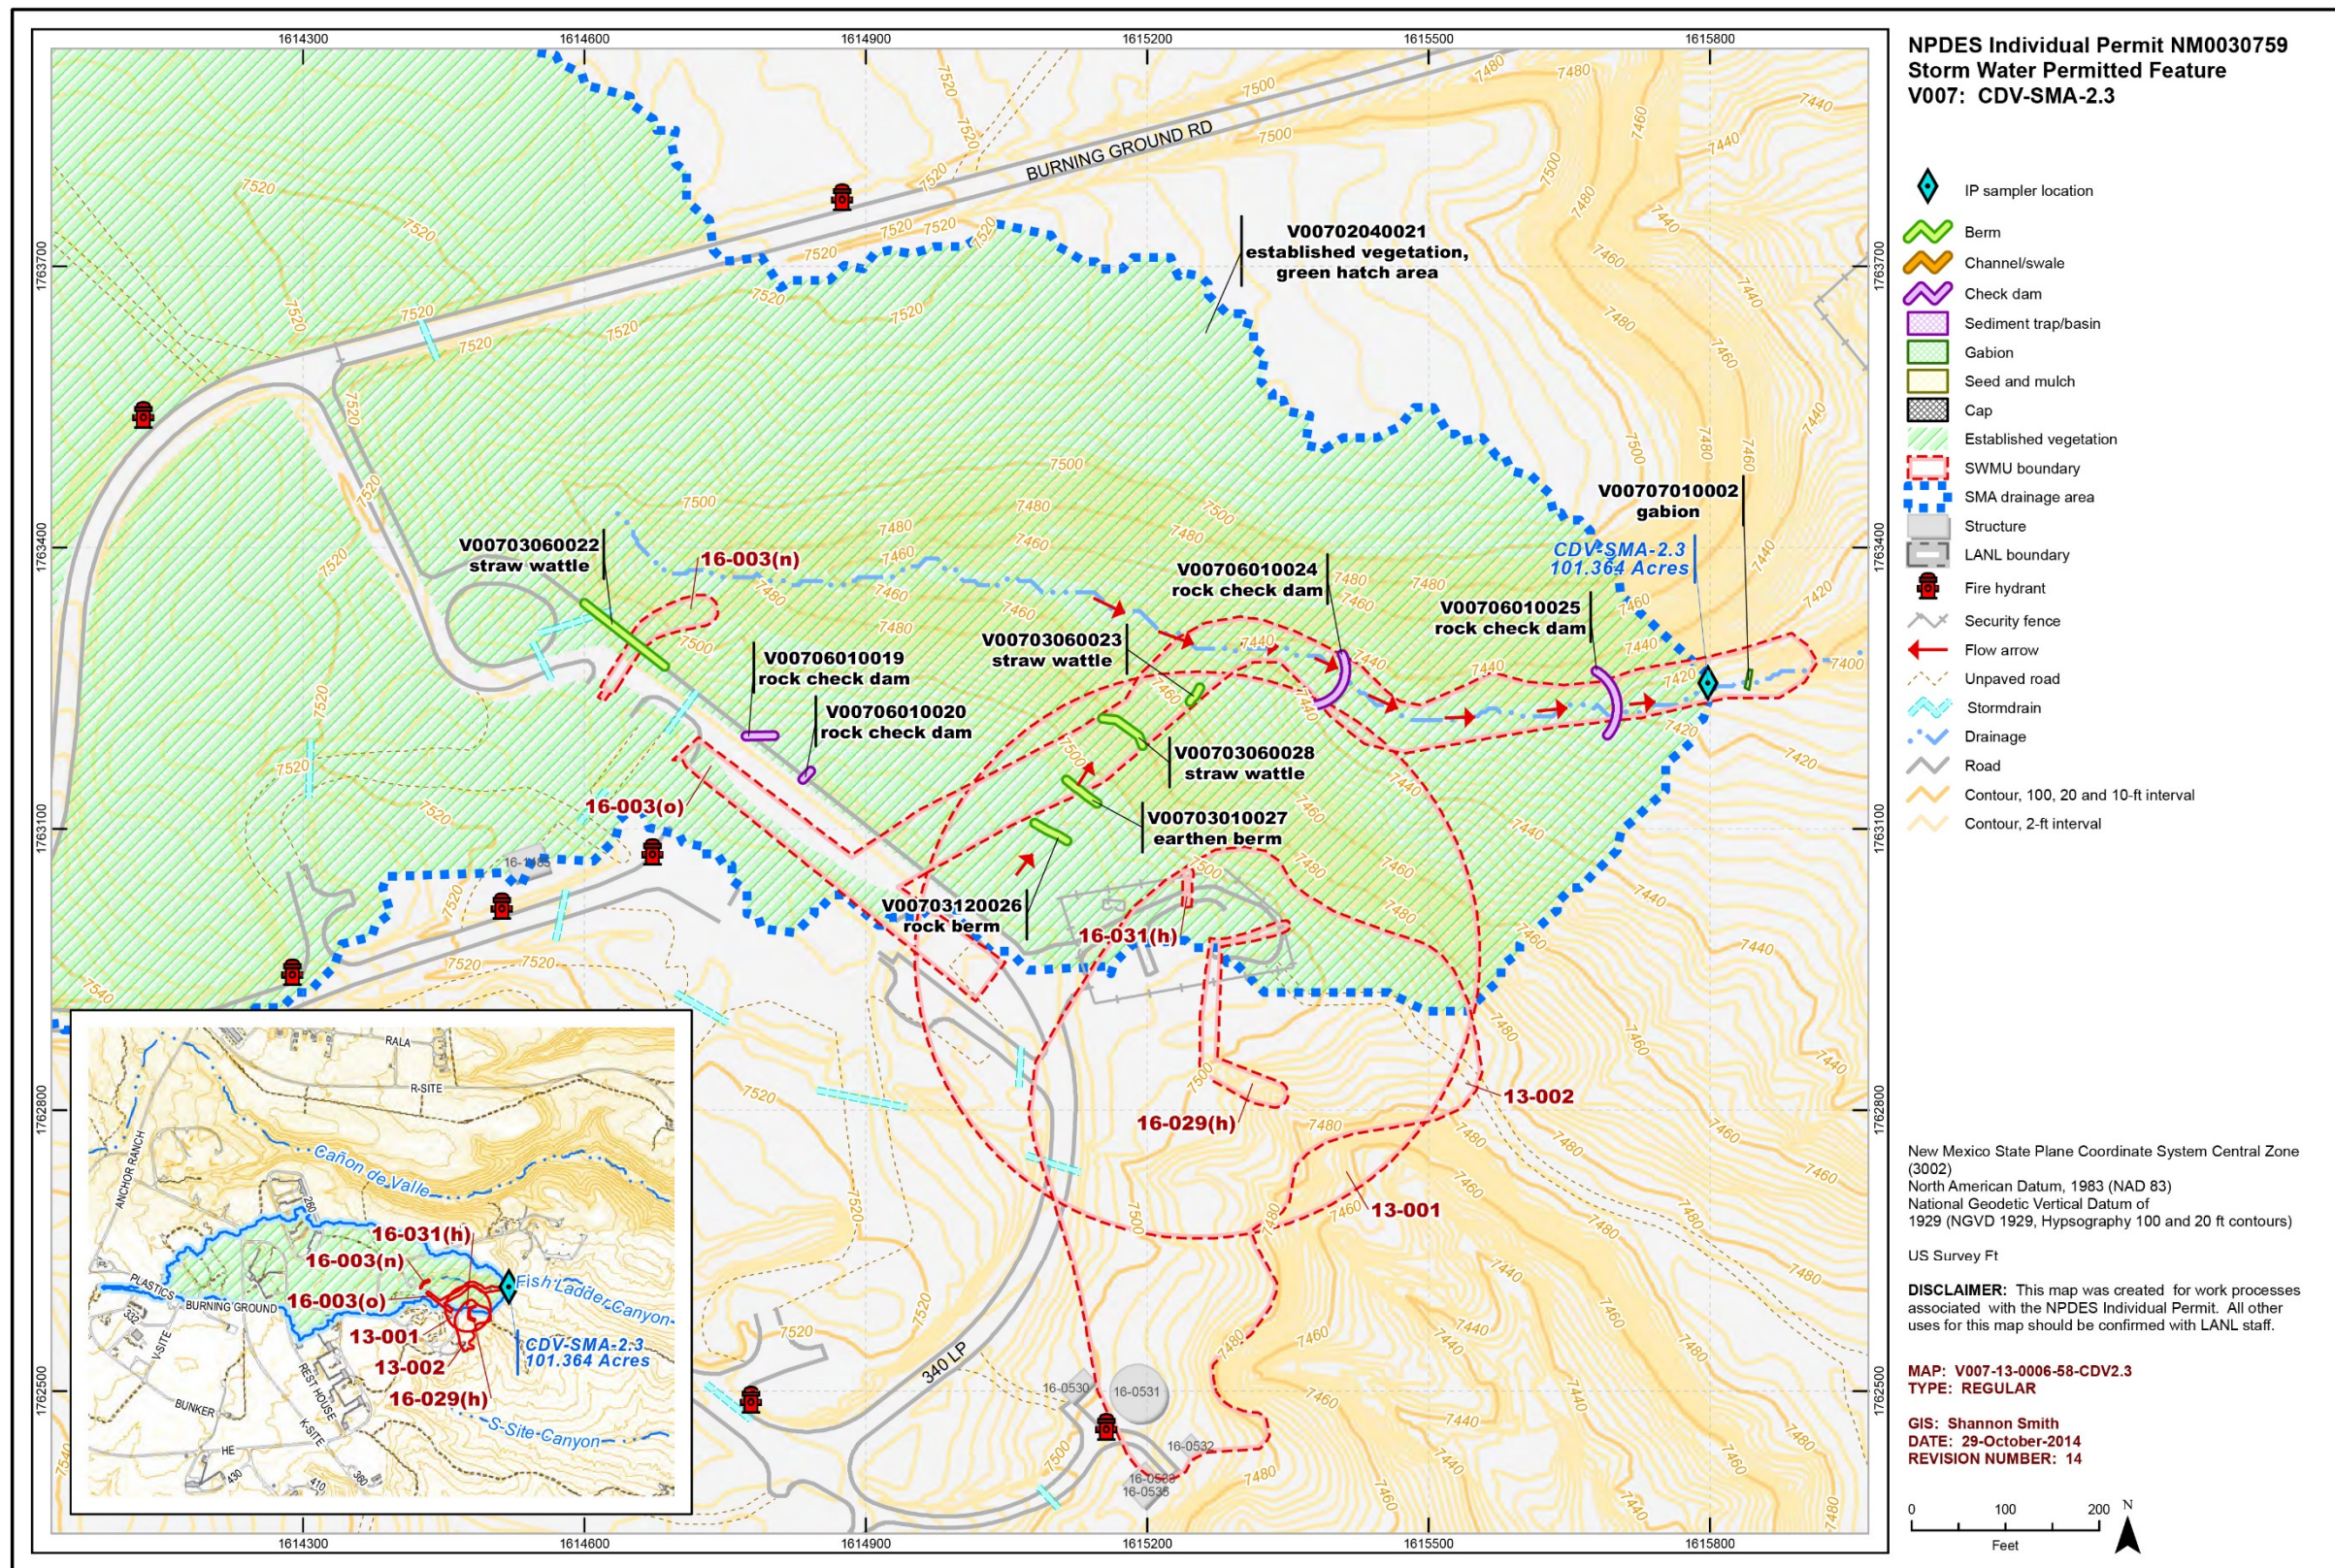
have been installed per IP requirements at SWMU 16-003(o) and are shown in Figure 1. Figure 1 is an IP site monitoring area (SMA) map showing the IP sampler location, IP storm water controls, and SWMUs associated with the SMA. Storm water controls associated with Fishladder Canyon [SWMU 16-003(o)] consist of a gabion (-0002), two rock check dams (-0024 and -0025), one rock berm (-0026), one earthen berm (-0027), and two straw wattles (-0023 and -0028), as shown in Figures 2 through 6. Figures 7 and 8 show the hill slope into Fishladder Canyon, and Figure 9 shows the former access road. Other storm water controls in this SMA are not associated with SWMU 16-003(o) and are not discussed in this report.

Figure 1 Locations of the IP sampler, IP storm water controls, and SWMUs associated with the IP site monitoring area

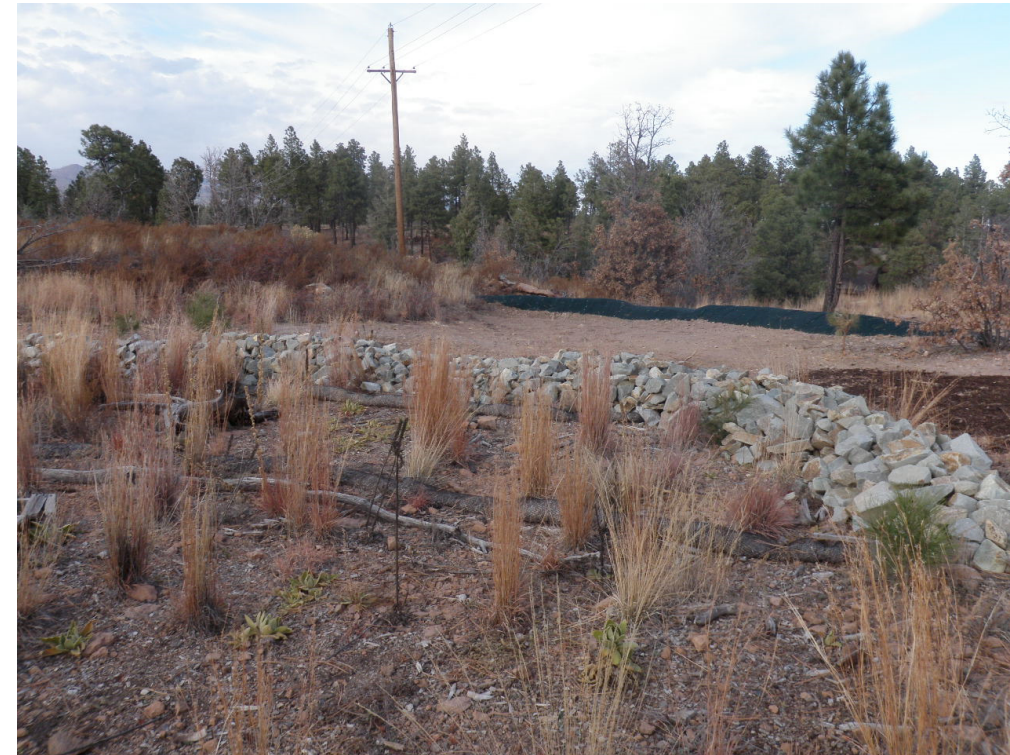
Figure 2 2014 Installation - Rock berm (V00703120026) and earth berm (V00703010027) at the top of drainage into Fishladder Canyon (11/14/2014)

5. The IP annual erosion evaluation was completed on October 9, 2014. Inspection findings recommended installing an earth berm (-0027) and a rock berm (-0026) to replace existing straw wattles acting as runoff/sediment controls and installing an additional straw wattle (-0028) as a runoff/sediment control. These maintenance items were completed on October 24, 2014.

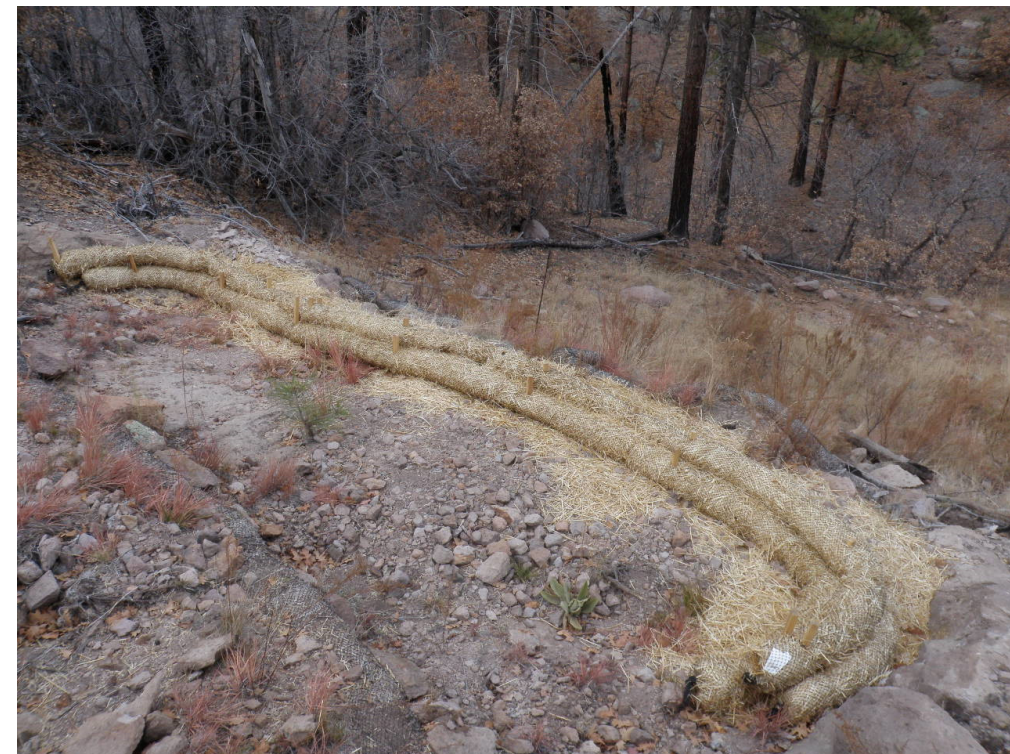
Figure 3 2014 Installation – Straw wattle (V00703060028) on the slope into Fishladder Canyon (11/14/2014)

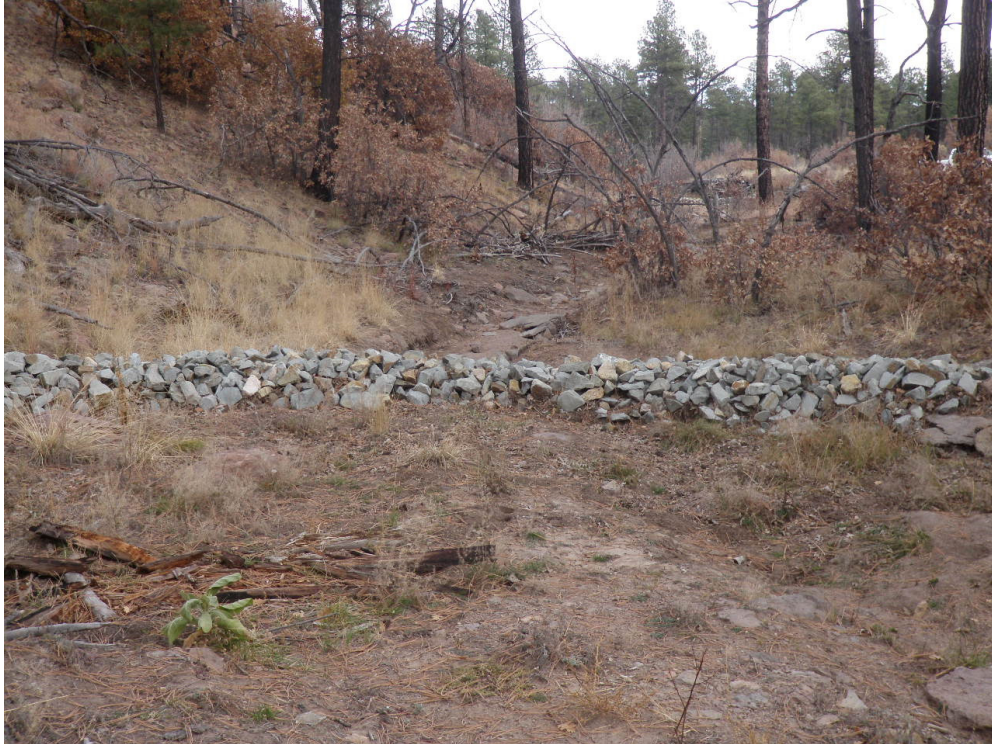
Figure 4 2014 Installation - Rock check dam (V00706010024) in the bottom of Fishladder Canyon (11/114/2014)

1. An inspection was completed on June 3, 2014, for the rain event occurring on May 23, 2014. Inspection findings recommended installing a new rock check dam (-0025) to replace an existing rock check dam (-0016) acting as a runoff/sediment control, installing another rock check dam (-0024) as an additional runoff/sediment control, and replacing or modifying the existing gabion (-0002) acting as a runoff/sediment control. Straw wattles were installed during the inspection directly upslope of rock check dam (-0016) and directly upslope of gabion (-0002) as temporary backup control measures. After conducting a site visit on June 4, 2014, project personnel determined maintenance on the gabion (-0002) was not necessary at this time. The rock check dams were installed on June 25, 2014.

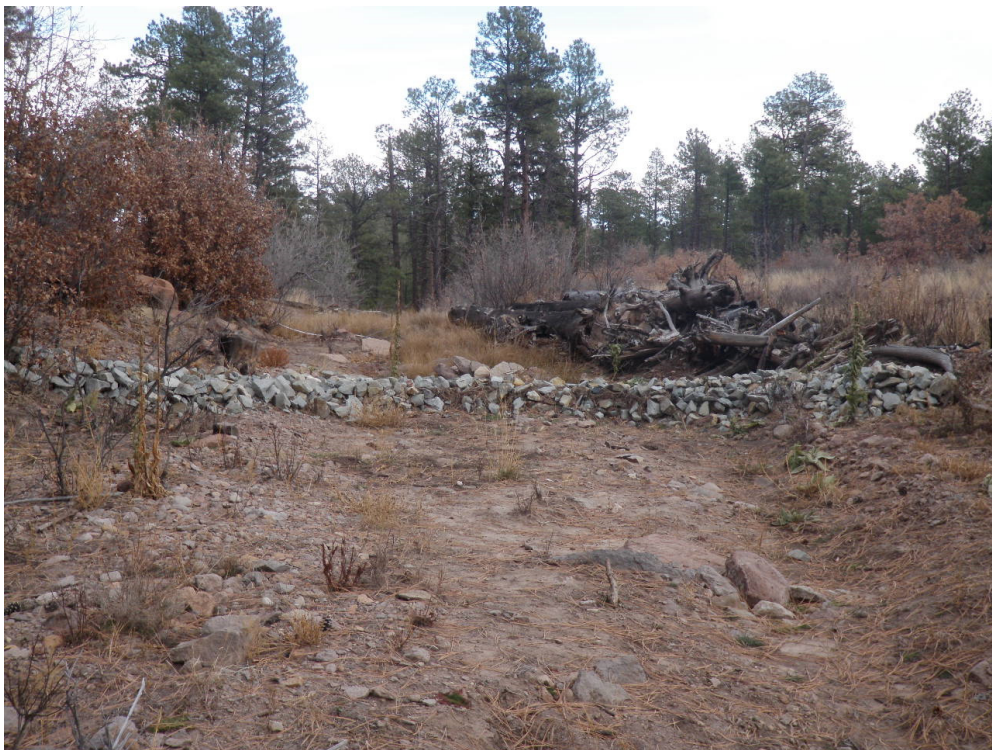
Figure 5 2014 Installation - Rock check dam (V00706010025) in the bottom of Fishladder Canyon (11/14/2014)

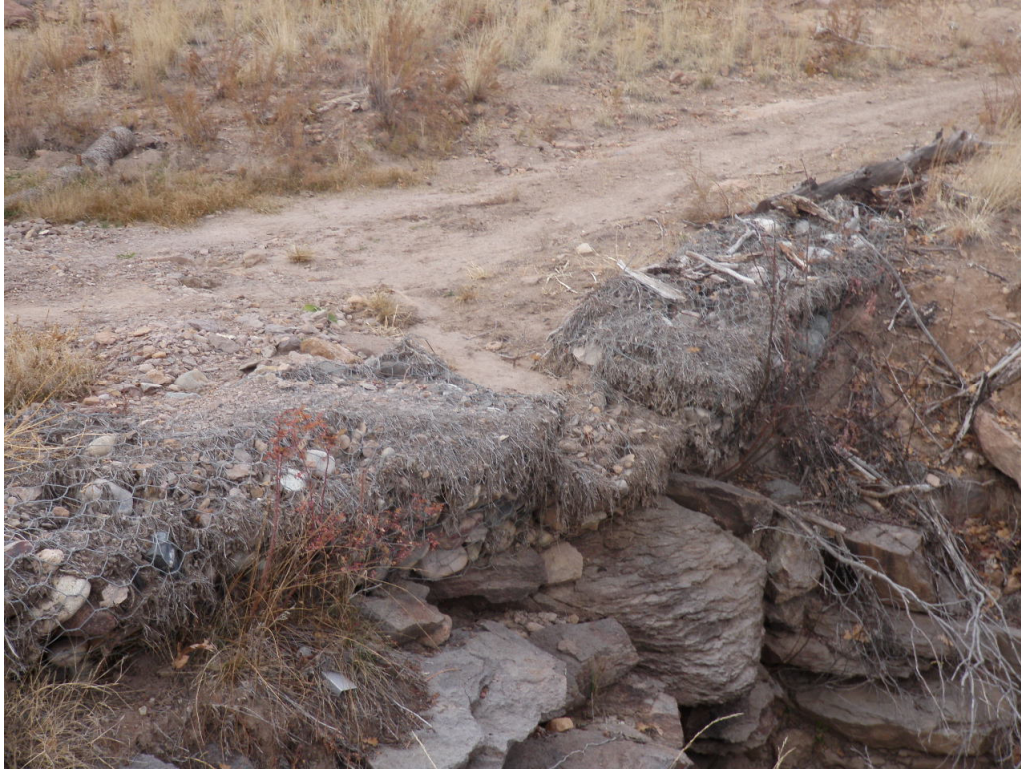
Figure 6 Gabion (V00707010002) at the crossing of the access road in Fishladder Canyon (11/14/2014)

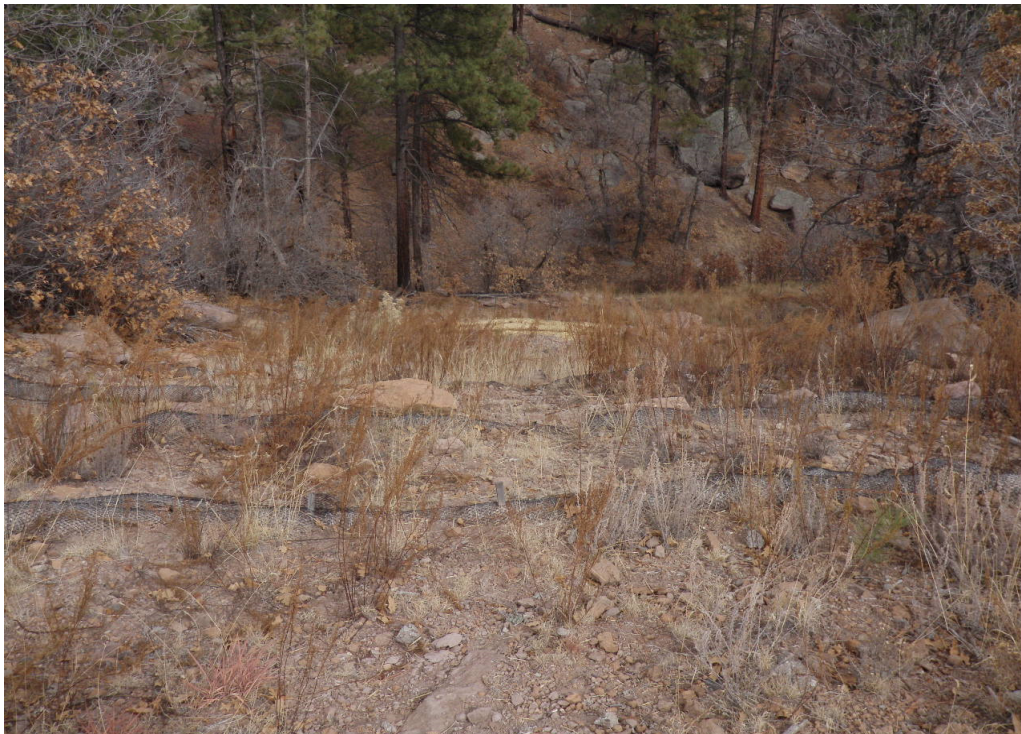
Figure 7 View looking downslope from mesa top into Fishladder Canyon (11/14/2014). Straw wattle (V00707010028) and retired Phase II straw wattles are visible.

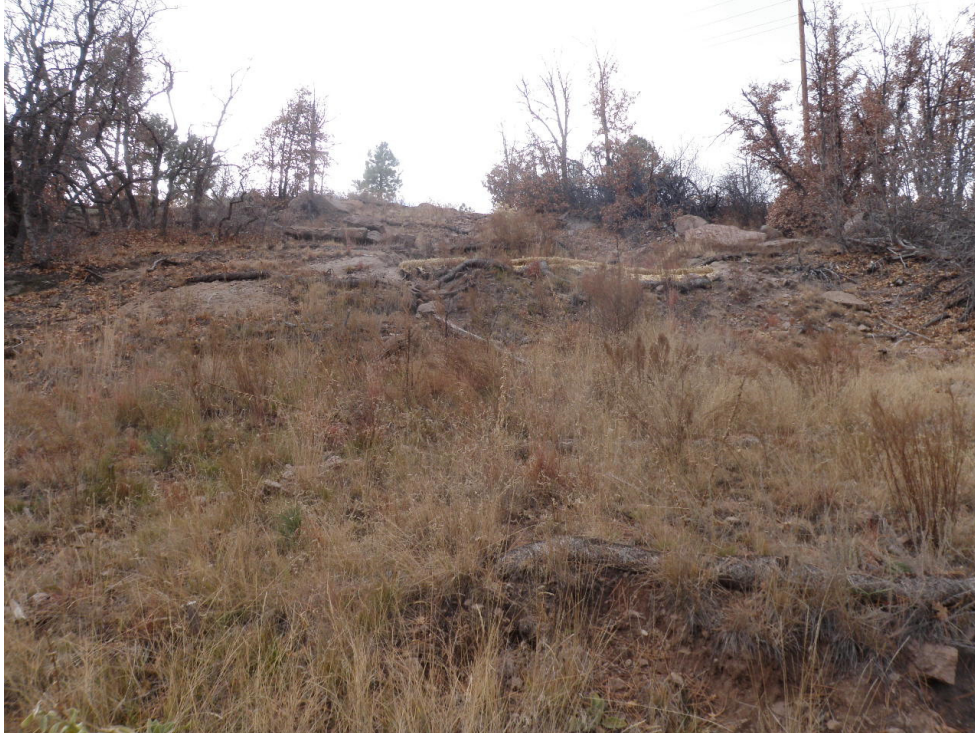
Figure 8 View looking upslope out of Fishladder Canyon (11/14/2014). Straw wattle (V007030600028) is visible in middle of photo, and straw wattles retired in 2013 are visible.

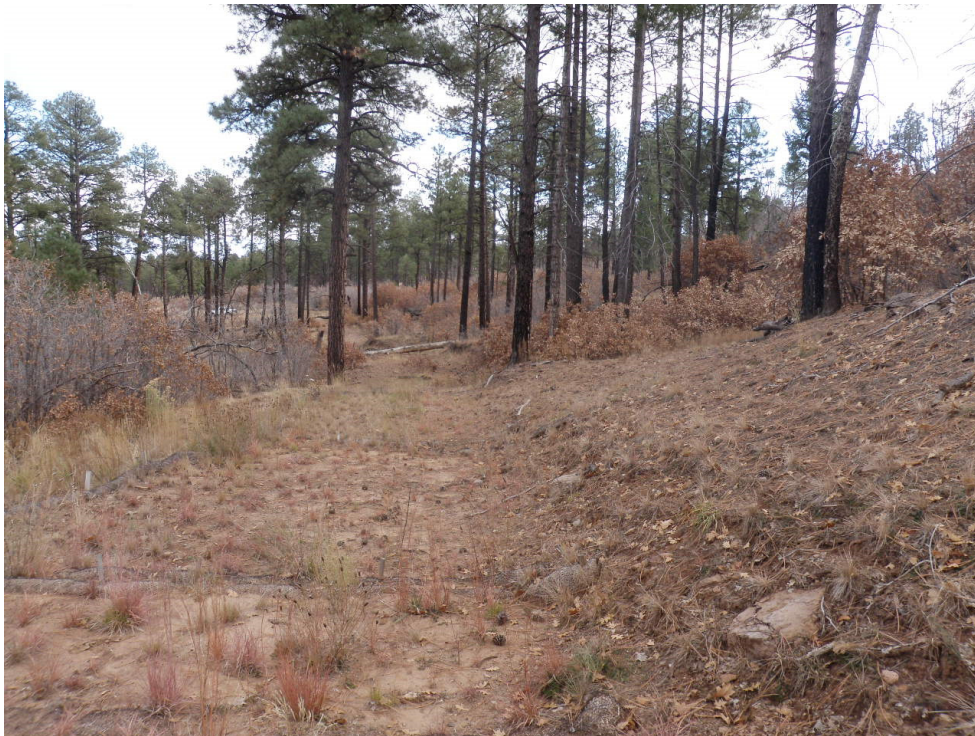
Figure 9 View east on access road into Fishladder Canyon (11/14/2014). Retired Phase II wattles are visible in photo.
