Date: NOV 16 2016

Refer To: ADEM-16-5326

Subject: Inspection and Maintenance of Erosion Controls in Drainages to the 90s Line Pond at Technical Area 16

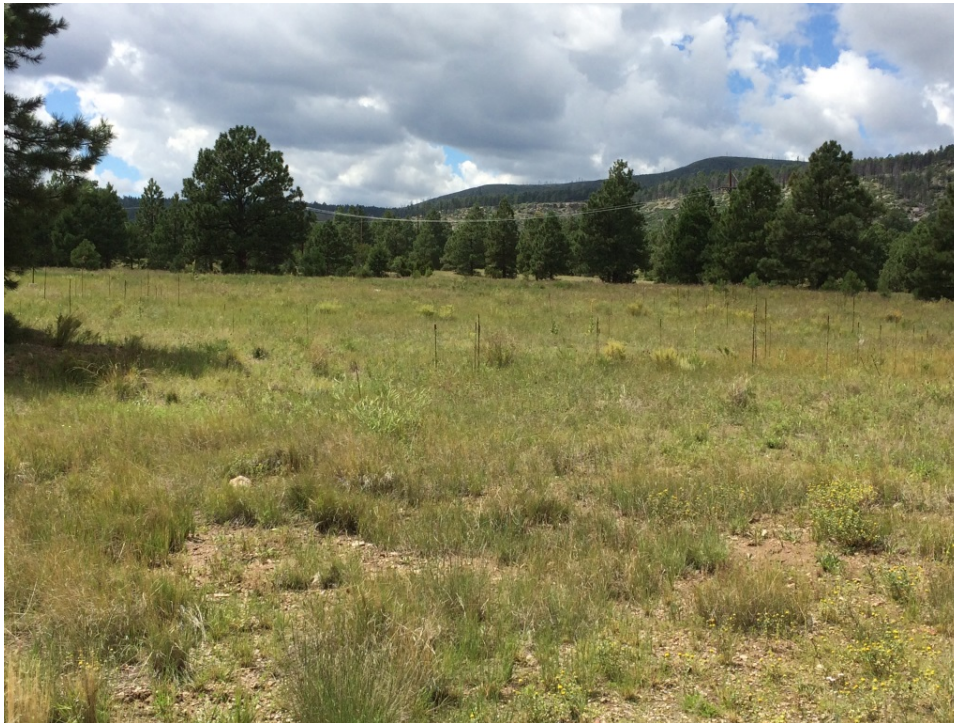
Figure 1 Vegetated Consolidated Unit 16-008(a)-99 draining to 90s Line Pond, September 2016.

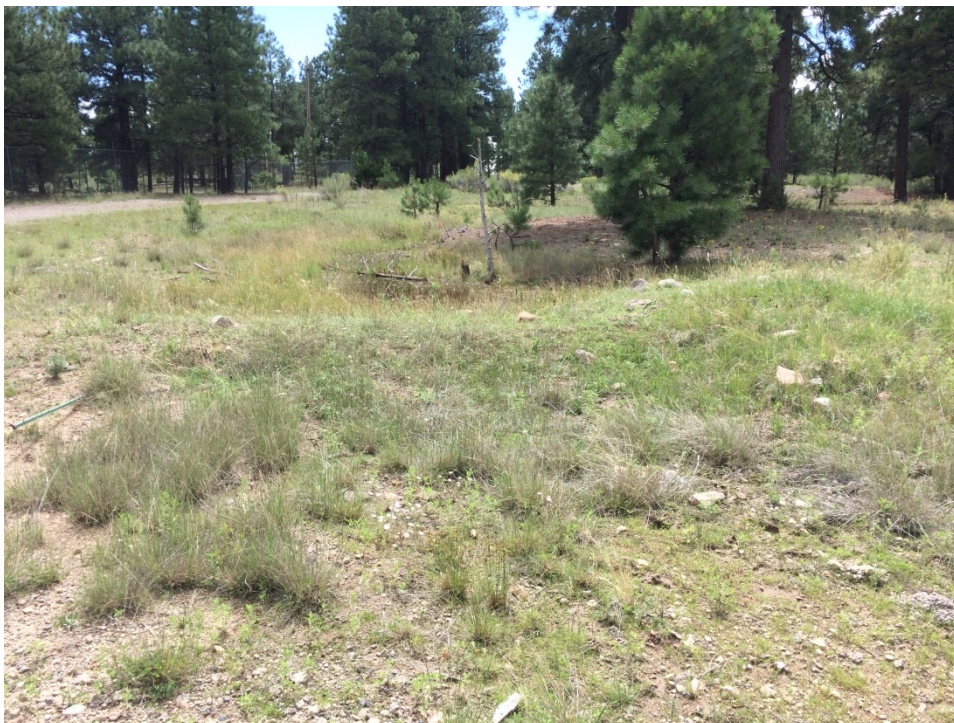
Figure 2 Run-on control earthen berm in the vegetated area draining to 90s Line Pond, September 2016.

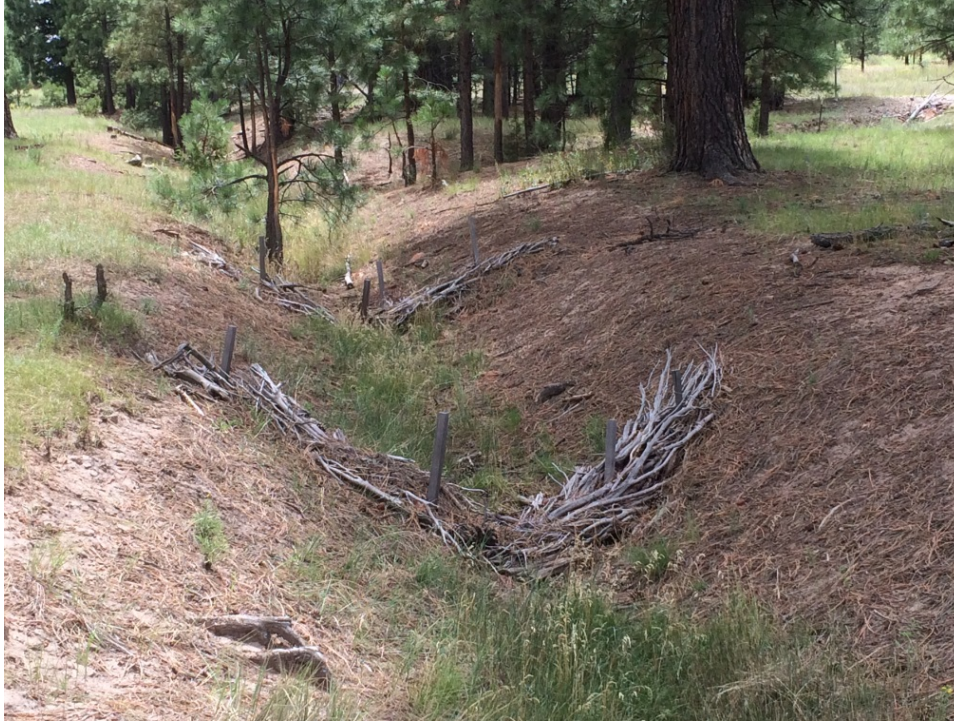
Figure 3 Juniper bale check dams located in drainage channel to 90s Line Pond, September 2016. Note needle cast and vegetation in channel.

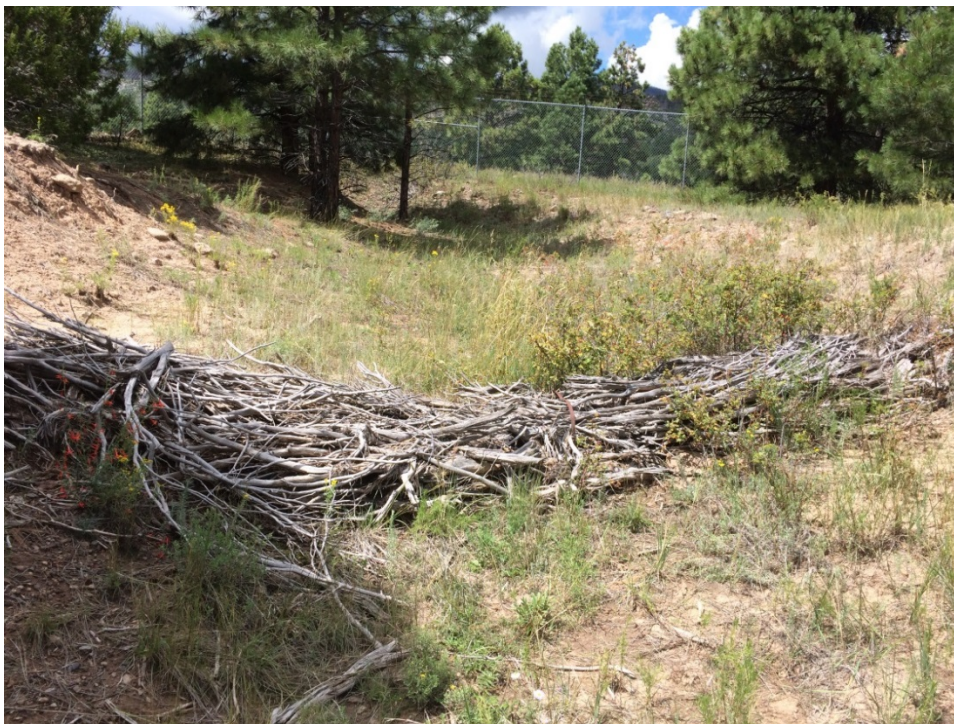
Figure 4 Juniper bale check dam located in drainage channel to 90s Line Pond, September 2016. Note vegetation in channel.

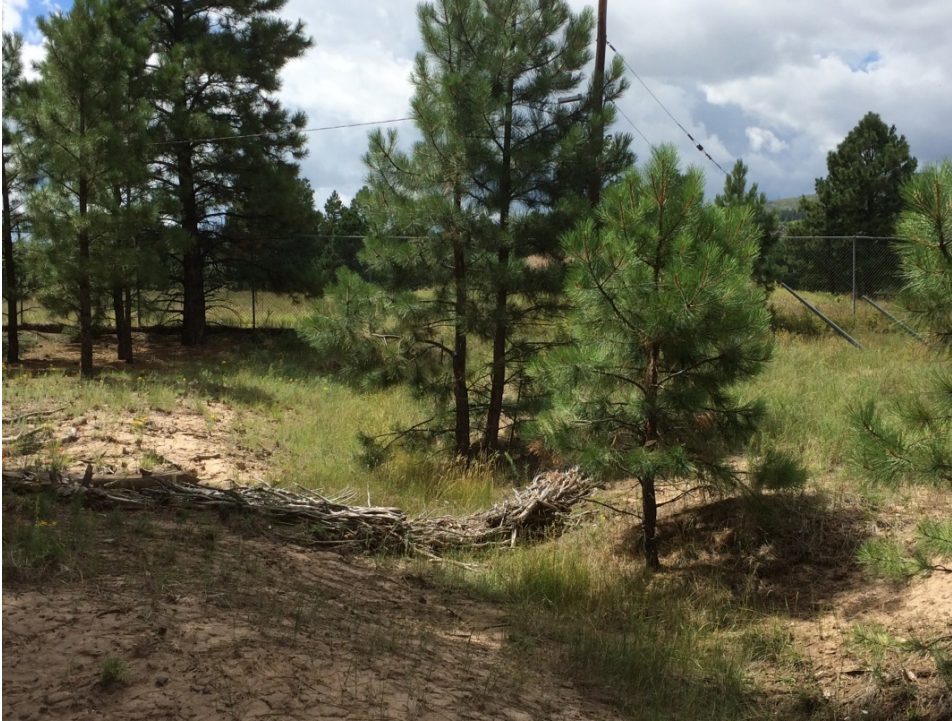
Figure 5 Juniper bale check dam located in drainage channel to 90s Line Pond, September 2016. Note vegetation in channel.

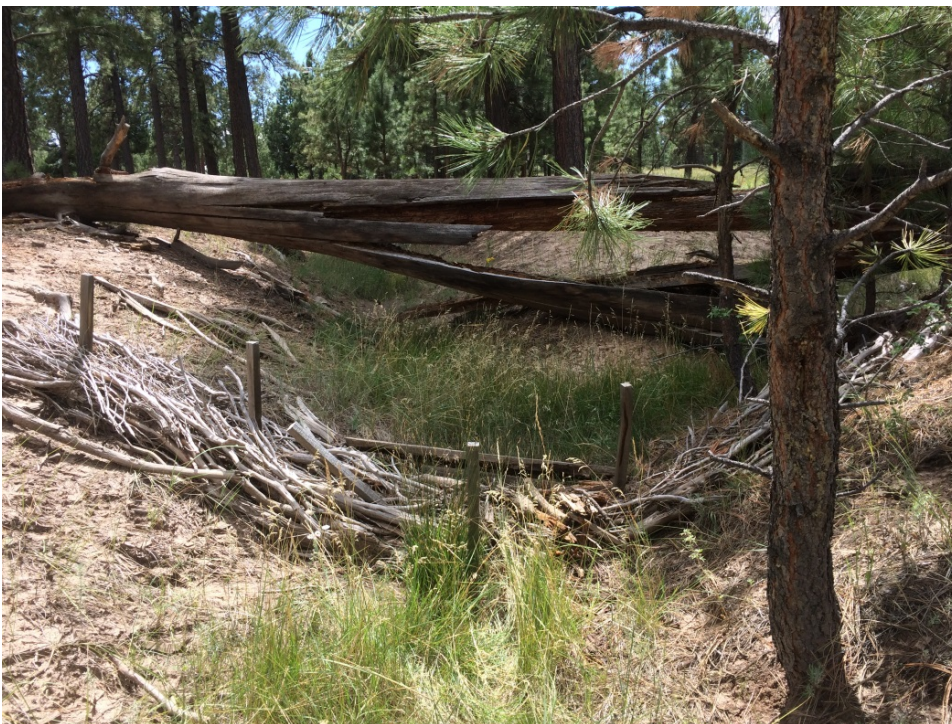
Figure 6 Juniper bale check dam located in drainage channel to 90s Line Pond, September 2016. Note vegetation in channel.

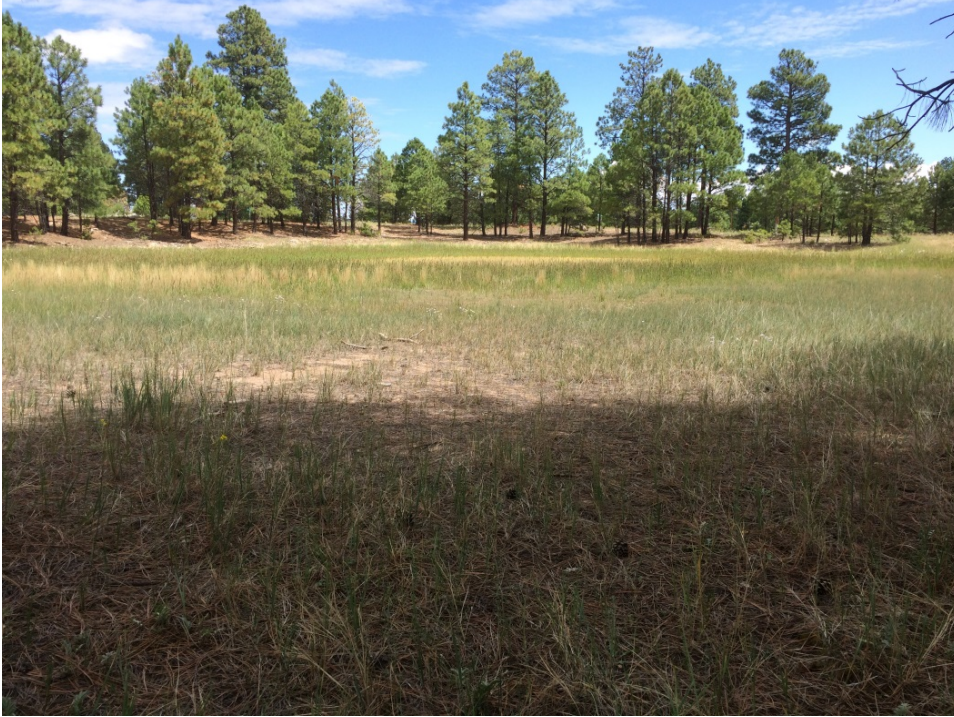
Figure 7 90s Line Pond, September 2016
