Subject: Inspection and Maintenance of Erosion Controls Associated with Solid Waste Management Unit 16-003(o) within Fishladder Canyon

This letter documents the annual inspection and maintenance of erosion controls associated with Solid Waste Management Unit (SWMU) 16-003(o) within Fishladder Canyon. This letter is required as part of the New Mexico Environment Department's (NMED's) approval with modifications for the Phase II investigation report for the Technical Area 16 (TA-16) 340 Complex, Revision 1, dated February 9, 2009.

Attachment: Inspection and Maintenance of Erosion Controls Associated with Fishladder Canyon
[Solid Waste Management Unit 16-003(o)] (EP2016-0153)

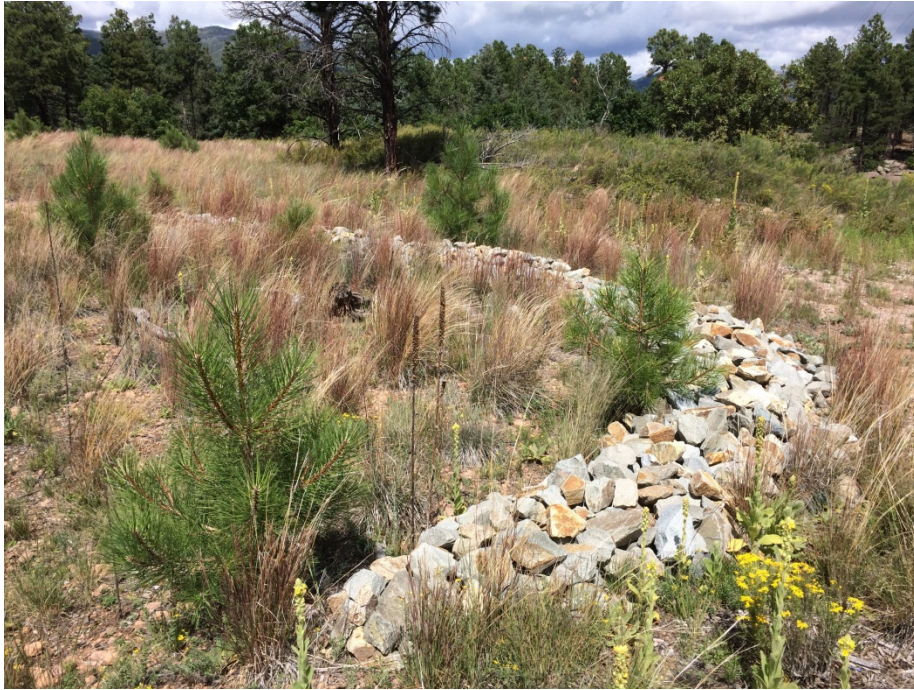
Figure 2 Rock berm (V00703120026—center of photo) at the top of drainage leading into Fishladder Canyon (September 2016). Note established vegetation. Condition of control: excellent.

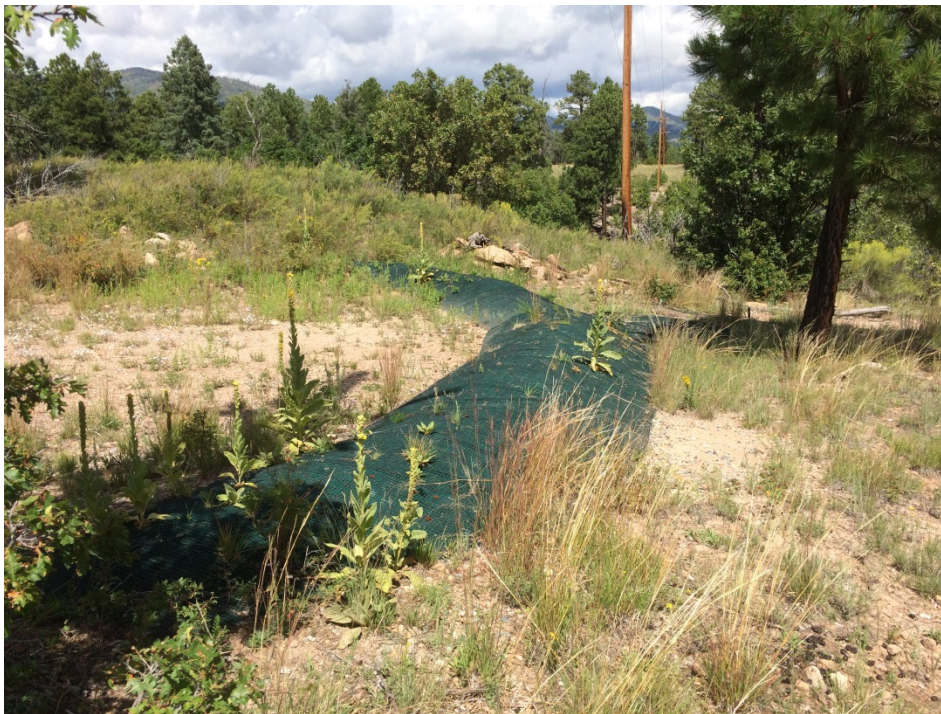
Figure 3 Earthen berm (V00703010027—center of photo) at the top of drainage leading into Fishladder Canyon (September 2016). Note established vegetation. Condition of control: excellent.

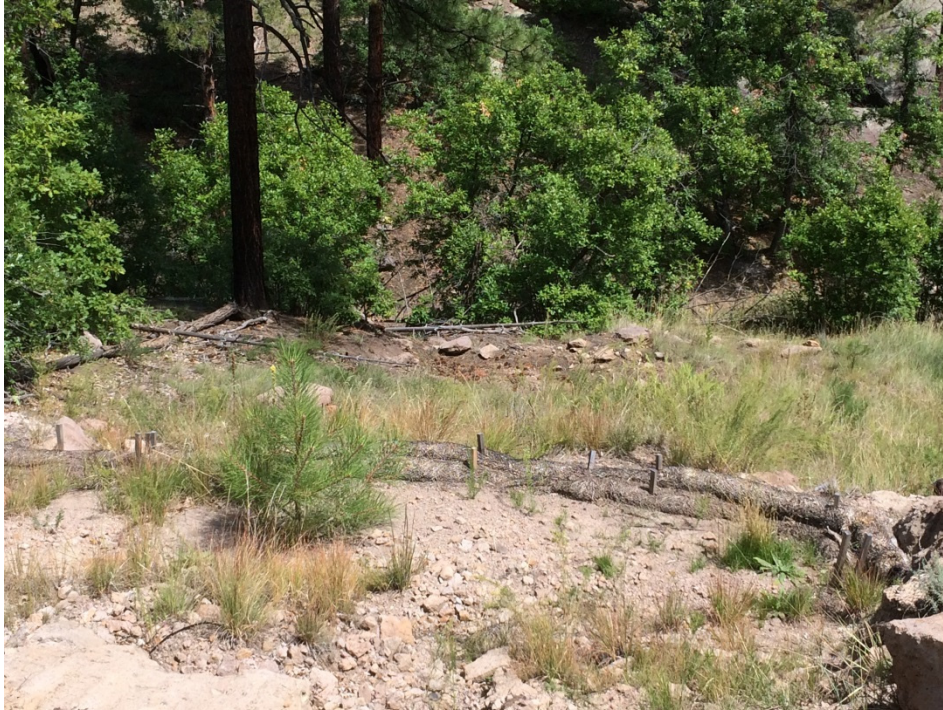
Figure 4 View downslope of the former fishladder location (September 2016). Note established vegetation above and below straw wattle (V007030600028–center of photo). Condition of control: good.

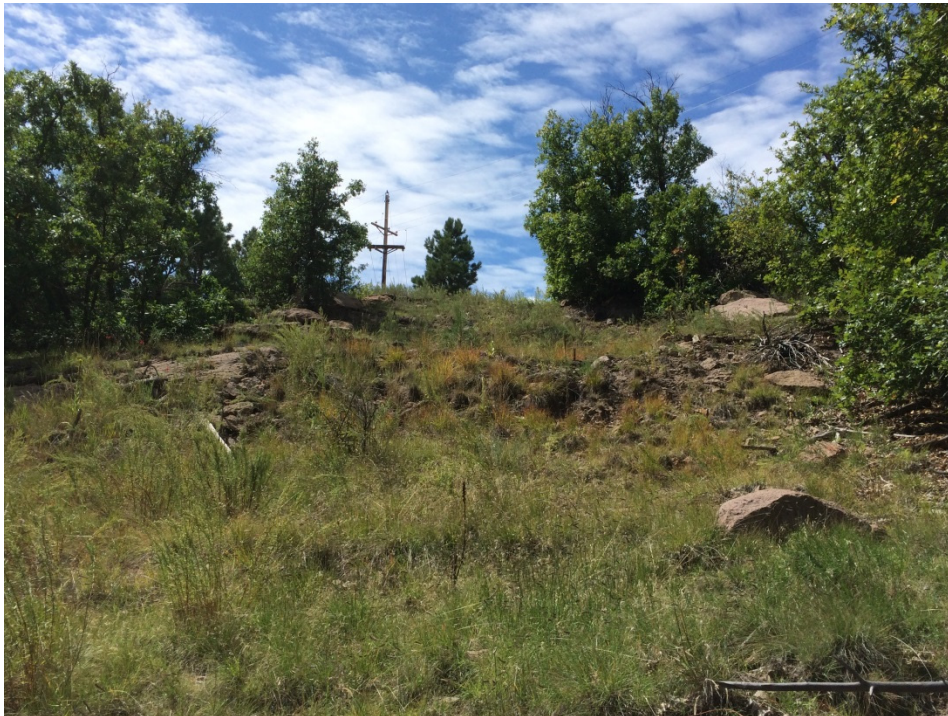
Figure 5 View upslope of the former fishladder location from the canyon bottom (September 2016). Note established vegetative cover and lack of erosional features. Control not visible in photo.

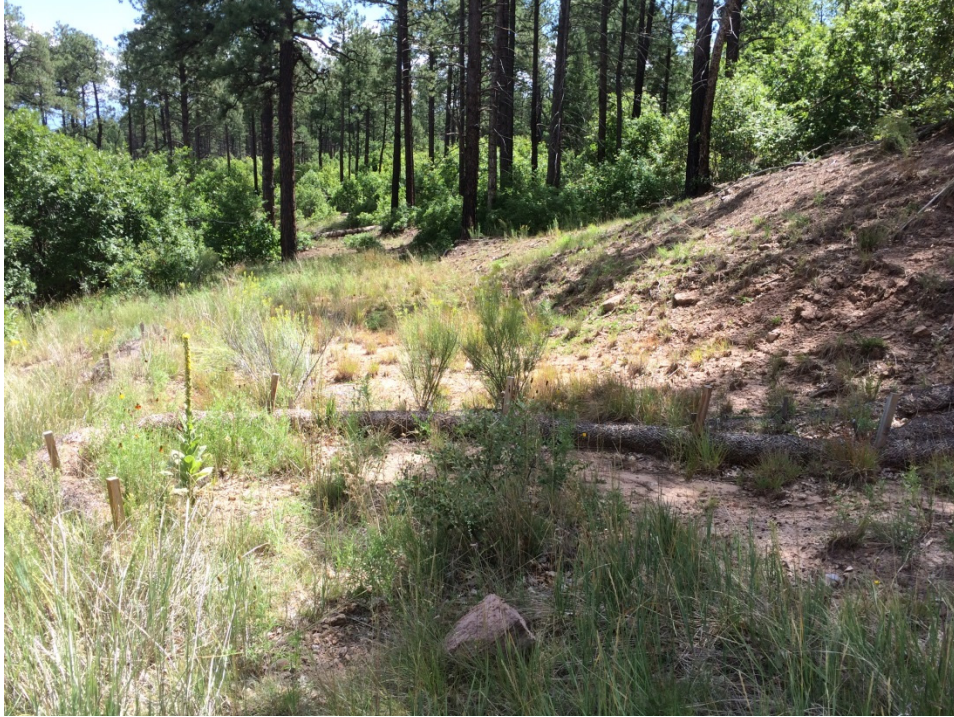
Figure 6 View east of former access road and straw wattle (V007030600028—center of photo) (September 2016). Note established vegetation. Condition of control: very good.

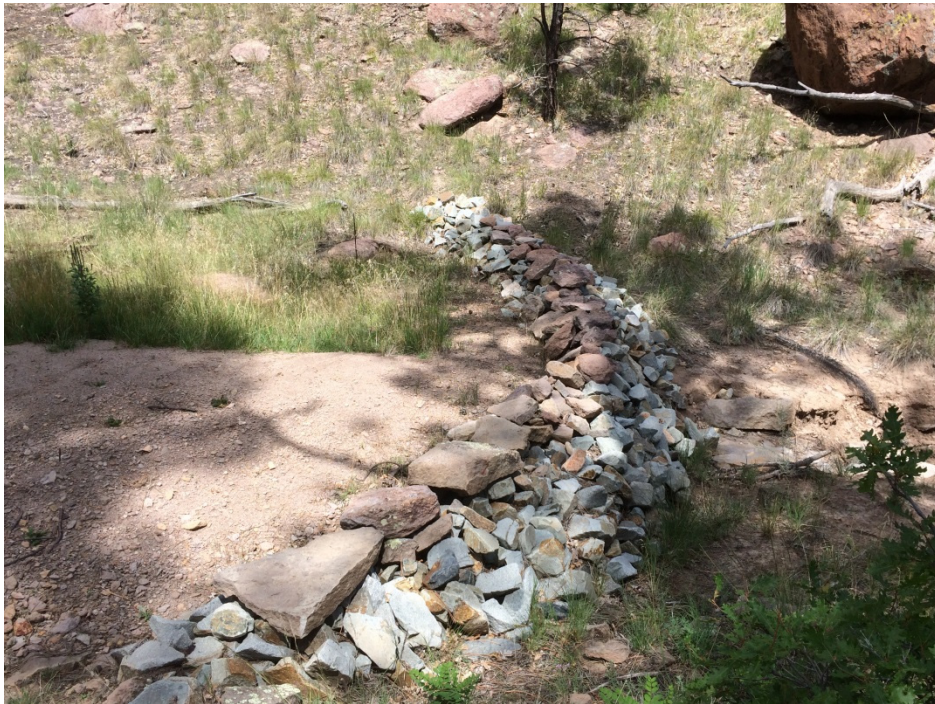
Figure 7 Rock check dam (V00706010024—center of photo) in Fishladder Canyon primary drainage (September 2016). Condition of control: very good.

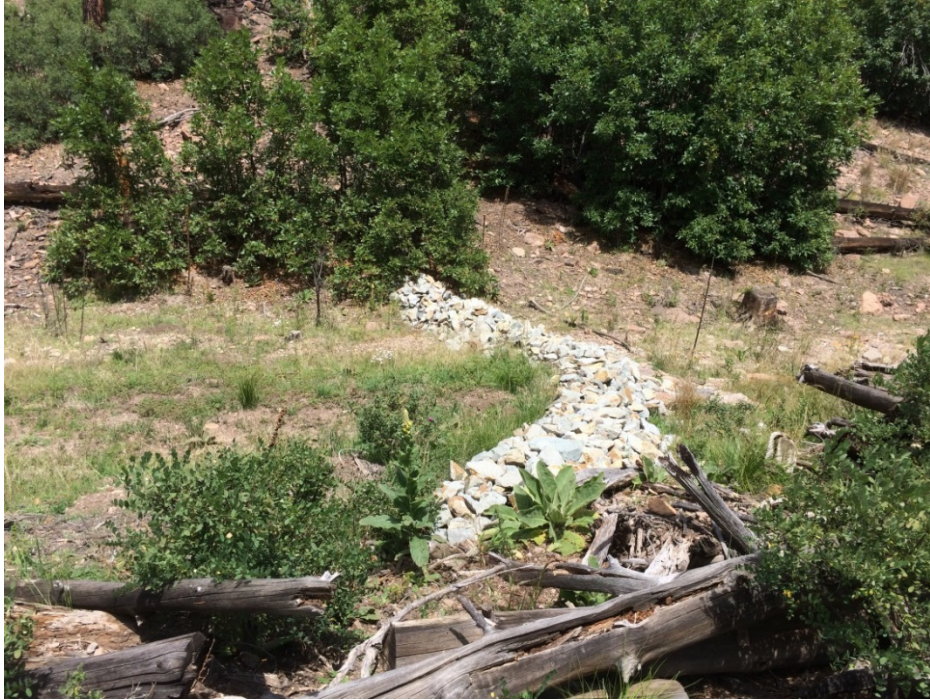
Figure 8 Rock check dam (V00706010025—center of photo) in primary drainage (September 2016). Note established vegetation in channel. Condition of control: excellent.

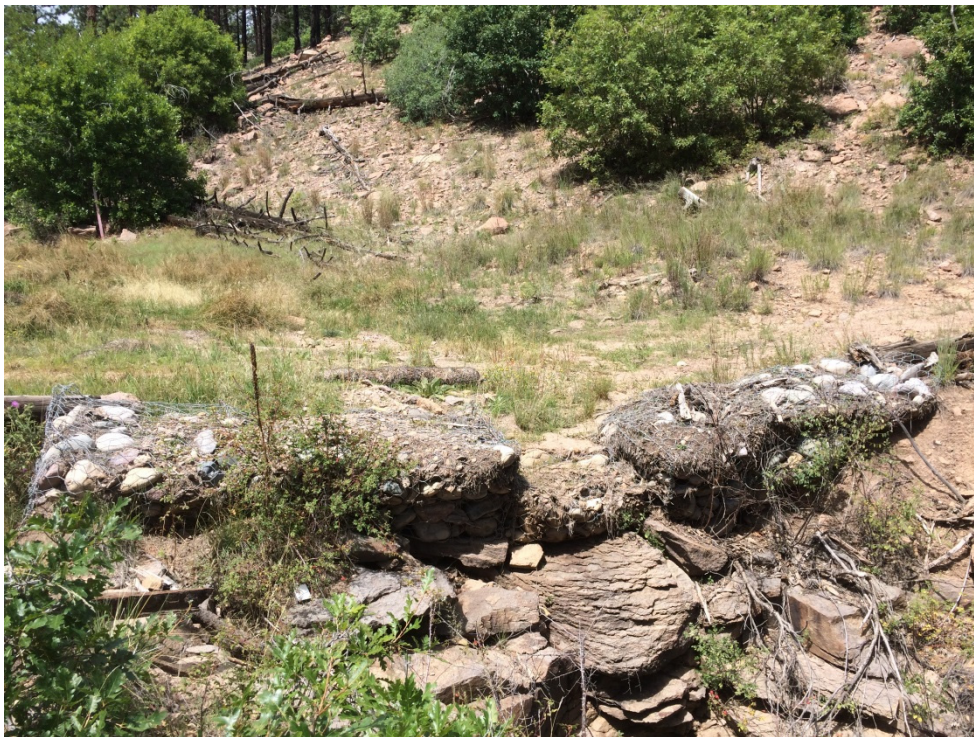
Figure 9 Gabion (V00707010002—center of photo) at access road crossing in Fishladder Canyon (September 2016). Note vegetation in channel upstream of control. Condition of control: good.

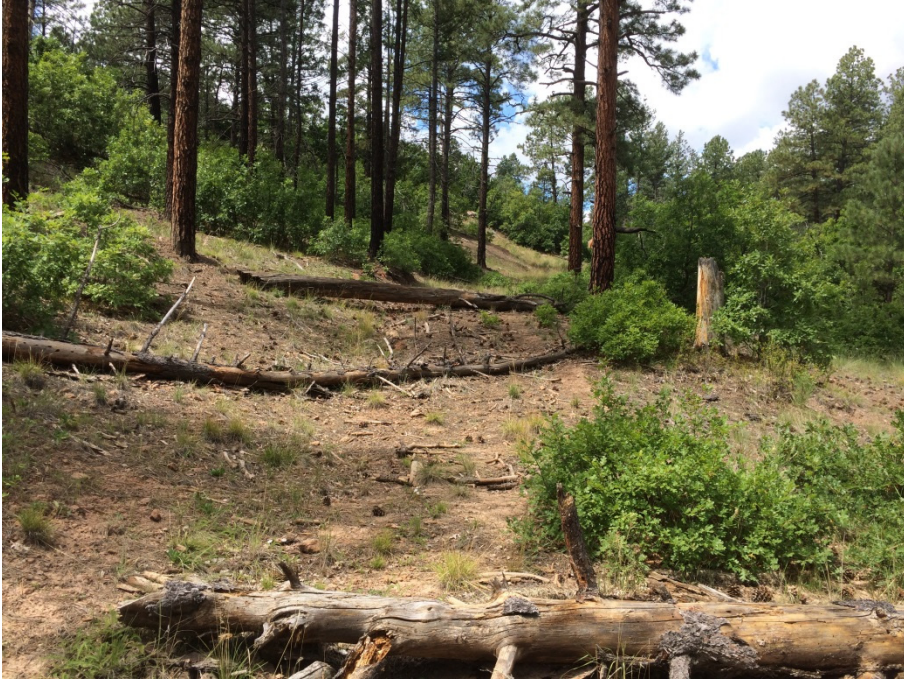
Figure 10 View west of former access road in Fishladder Canyon (September 2016). Note vegetative cover, needle cast, and downed trees along the former access road.
