Subject: Plugging and Abandonment Summary Report for Wells and Boreholes in Cañada del Buey and Cañon de Valle for Fiscal Year 2016

LA-UR-17-21252
March 2017
EP2017-0017

Plugging and Abandonment Summary Report for Wells and Boreholes in Cañada del Buey and Cañon de Valle for Fiscal Year 2016

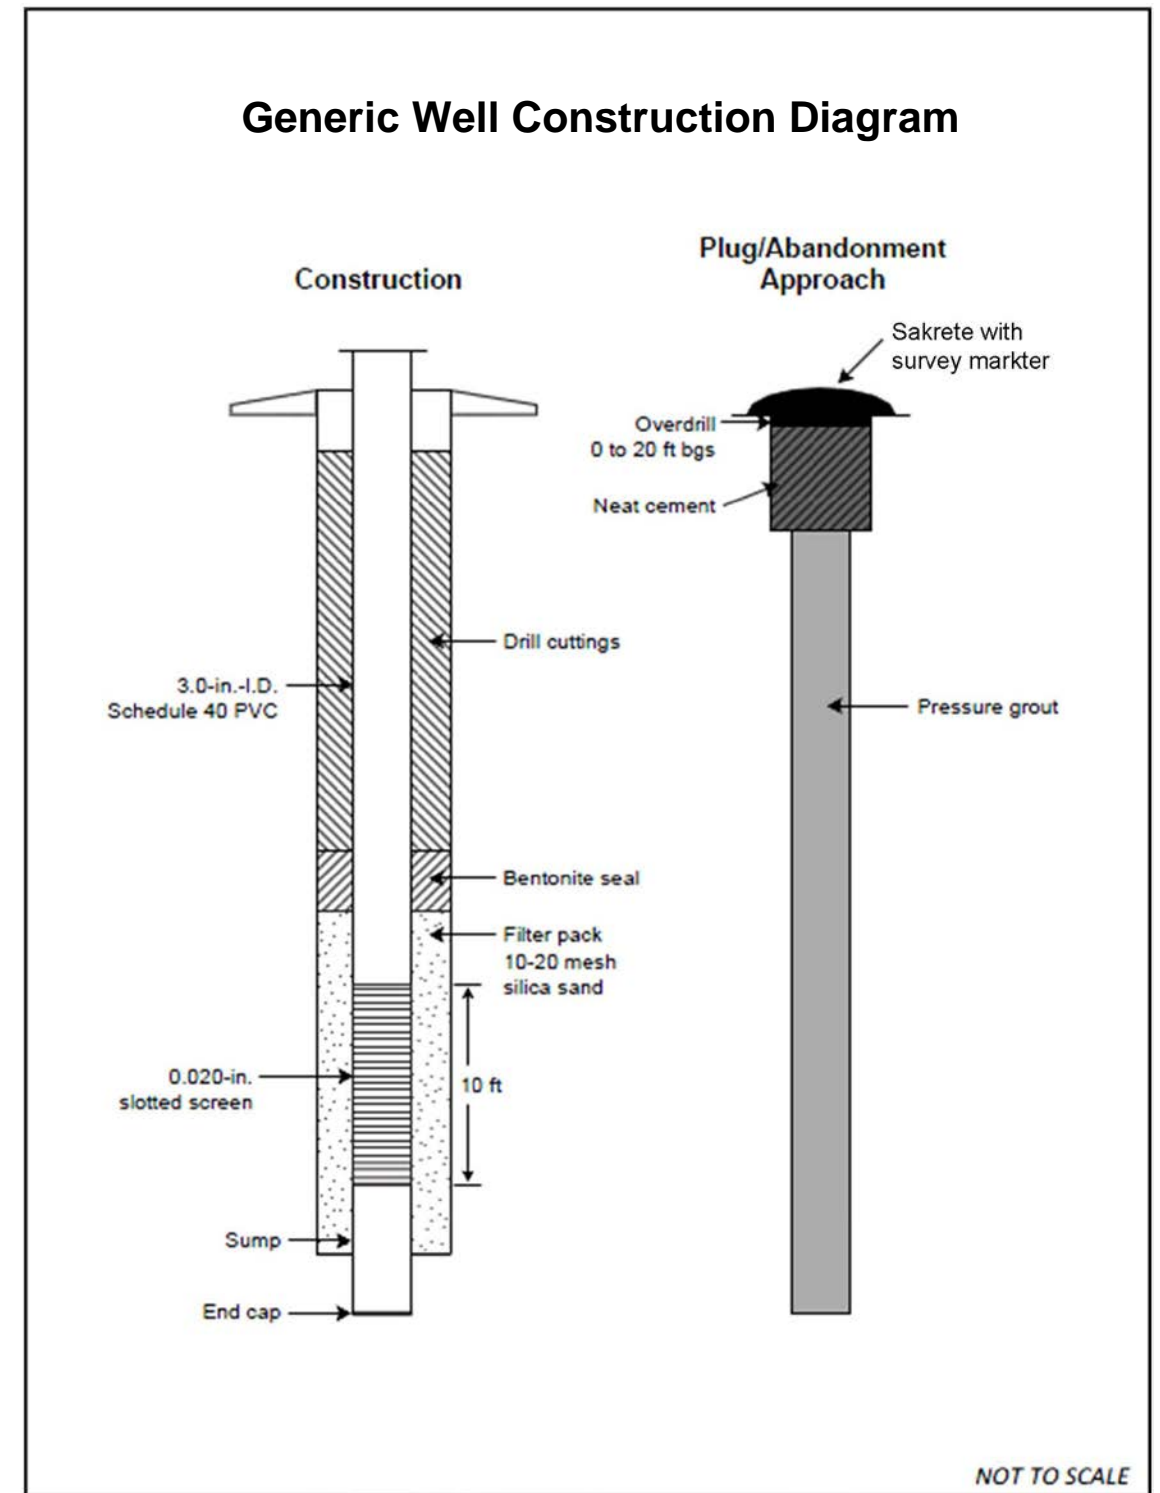
Figure 4.1-1 Generic well construction diagram

drill rig. Well construction information (total depth, well diameter, screen interval) is presented in Table 2.0-1. Well CDBO-3 was drilled to a depth of 13 ft bgs and constructed of 4-in. PVC well casing with a screen interval of approximately 3–12.5 ft bgs with no sump below the screened interval. Well CDBO-4 was drilled to a depth of 12 ft bgs, constructed of 2-in. PVC well casing with a screen interval of approximately 4–12 ft bgs with no sump below the screened interval. Well CDBO-5 was drilled to a depth of 18 ft bgs, constructed of 2-in. PVC well casing with a screen interval of approximately 8–18 ft bgs with no sump below the screened interval. Well CDBO-7 was drilled to a depth of 45 ft bgs, constructed of 2-in. PVC well casing with a screen interval of approximately 31–41 ft bgs and a 4.3-ft sump below the screened interval. Well CDBO-8 was drilled to a depth of 25 ft bgs, constructed of 2-in. PVC well casing with a screen interval of approximately 9–19 ft bgs and a 4.3 ft sump below the screened interval. Well CDBO-9 was drilled to a depth of 32 ft bgs, constructed of 2-in. PVC well casing with a screen interval of approximately 17–27 ft bgs and a 5.4 ft sump below the screened interval. Well CDBM-1 was drilled to a depth of at least 189 ft. The well video could not proceed past the 72 ft bgs interval; however, the well was measured to a depth of 192.7 ft bgs in June 2016. Well CDBM-1 was constructed of 2-in. stainless-steel well casing (no additional information was provided). Well CDBM-2 was drilled to a depth of 100 ft bgs, constructed of 2-in. stainless-steel well casing with no screened interval (cased to full depth). A generic well-construction diagram for the wells is provided in Figure 4.1-1.

A truck-mounted CME-85 HSA drill rig was used to install 1-in.-inside diameter (I.D.) PVC tremie casing to approximately full depth of each well, after which each well was pressure grouted with cement grout from total depth to ground surface. Subsequently, all wells were overdrilled with 4.25-in.-I.D./8-in.-outside diameter (.O.D) HSAs to 20 ft bgs and then grouted from 20 ft bgs to surface with approximately 100 gal. of cement grout. Following abandonment, the top 1 ft of borehole was plugged with neat cement grout, and an aluminum survey marker was embedded in the concrete and labeled accordingly.
