**CERRO GRANDE  
FIRE ASSESSMENT PROJECT:  
An Assessment of the Impact of the  
Cerro Grande Fire on Cultural Resources at  
Los Alamos National Laboratory, New Mexico**

Cultural Resource Report No. 211

**Los Alamos National Laboratory**

**December 2002  
Survey No. 818**

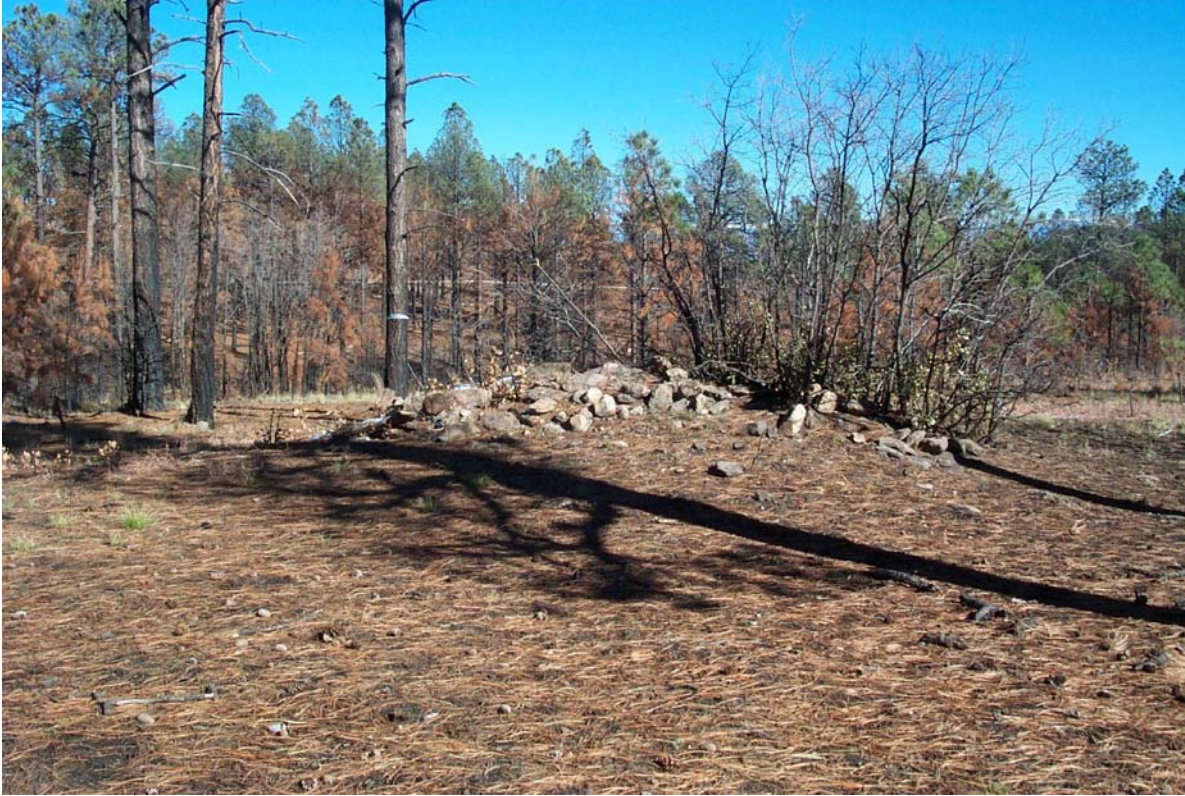
**Figure 7.2.** General view of LA 204, looking east-northeast.

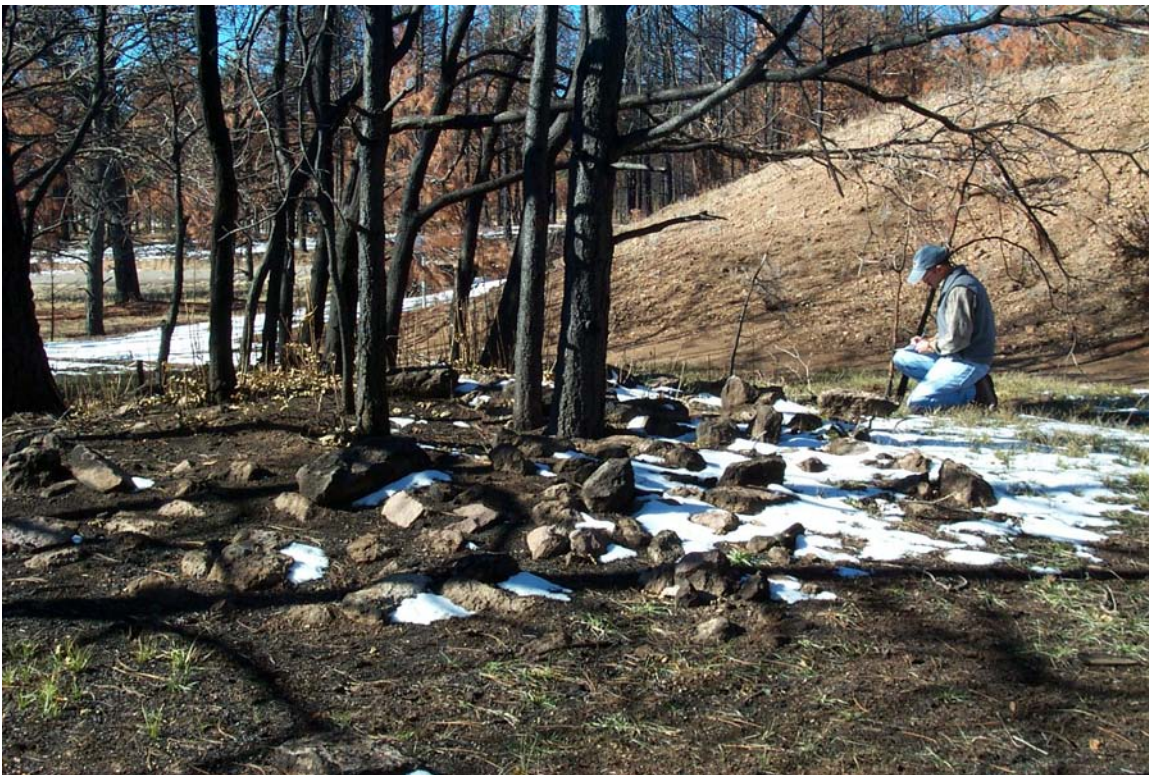
**LA 15858.** This site consists of a one- to two-room structure (4 m by 4 m, 0.3 m high) of roughly shaped tuff blocks (Figure 7.3). Despite being located adjacent to a building in the developed western part of TA-16, there was a fair sized stand of ponderosa pines and some smaller tree species growing on and around the site. The site is composed of lichen-covered, roughly shaped tuff blocks and rubble. No artifacts were

**Figure 7.3.** View looking south of LA 15858 with B. Vierra.

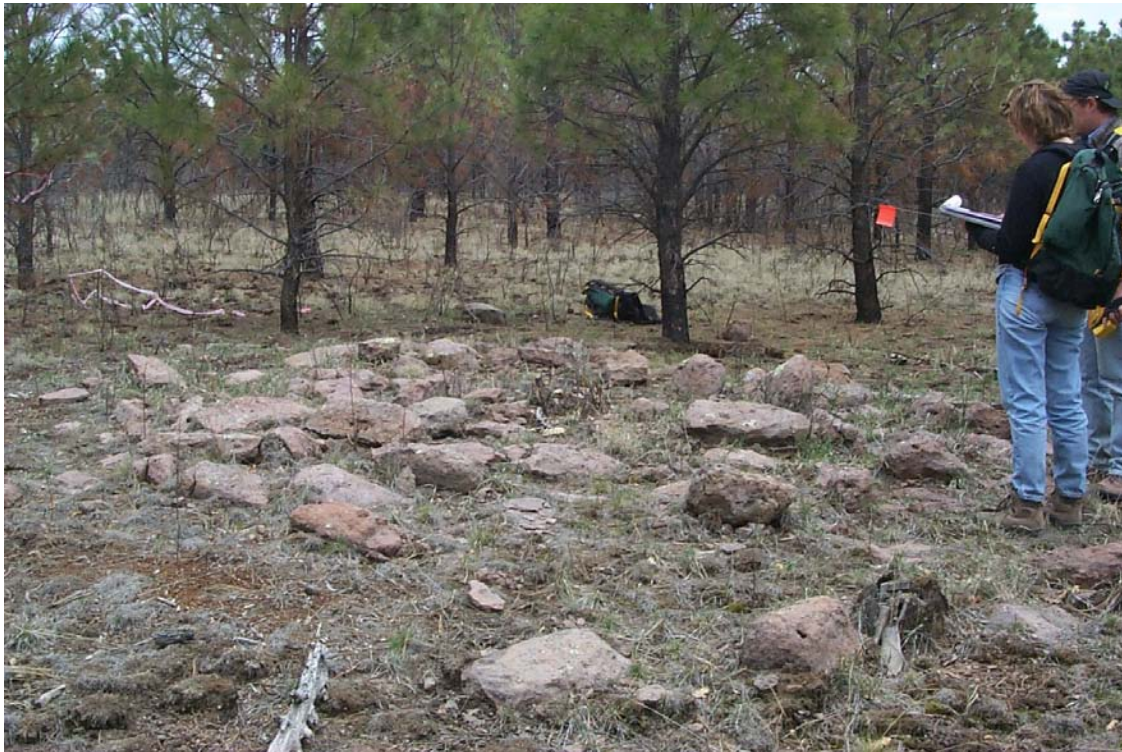
**LA 21370.** This site consists of a small rubble mound of shaped tuff blocks (Figure 7.4). The mound may be recent or the blocks were cannibalized from another site in the vicinity. There are no visible remains of an old horseshoe were located. Due to the lack of artifacts, the site affiliation is undetermined. This site had been previously burned in 1977 during the La Mesa Fire. The site is located in a cleared meadow approximately 150 m north of State Route 4 and 40 m south of the Water Canyon cliff edge. The effects from the Cerro Grande Fire include stump and root holes adjacent to masonry, stump and root holes in the site area, and additional snags or partially burned trees in the site area. There were no suppression impacts to the site. No treatment is recommended for this site.

**Figure 7.4.** General view looking east of LA 21370 with J. Nisengard (left) and B. Harmon.

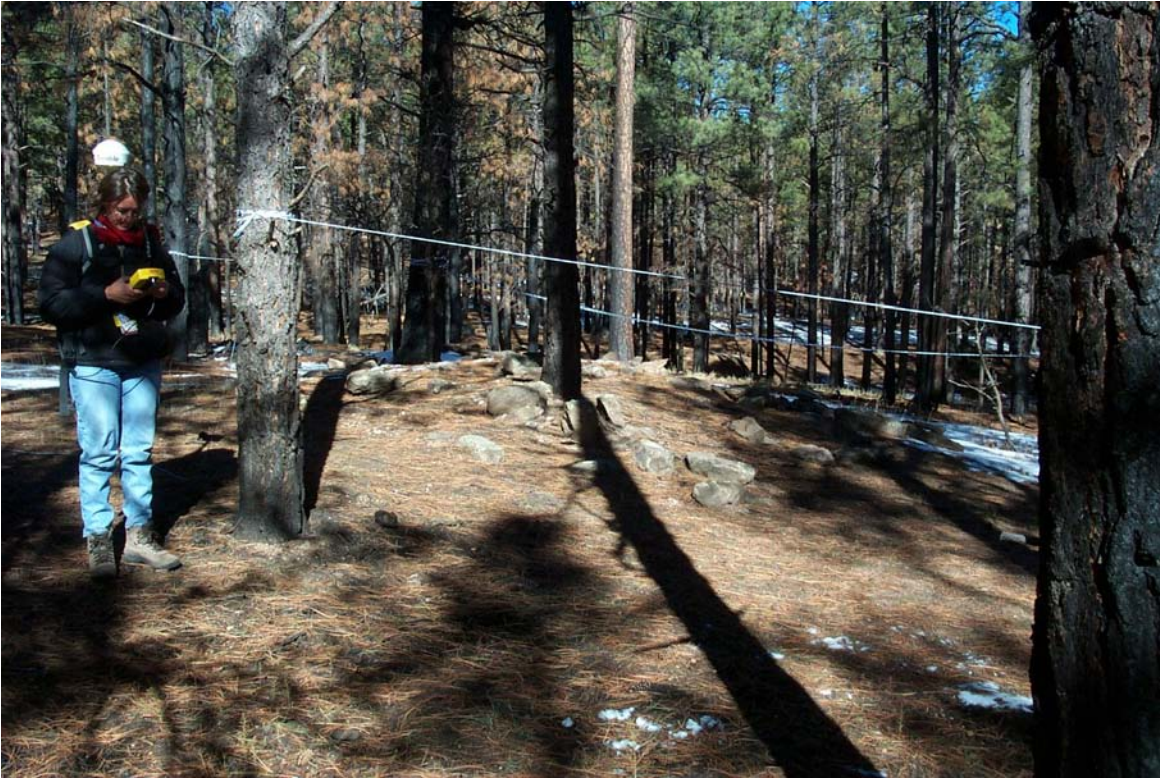
in age. The area around the site was slightly burned. There are four snags in the site area, and 10% of the tuff blocks are soot damaged.

**Figure 7.5.** LA 86653, J. Nisengard at the two-room structure impacted by the fire.

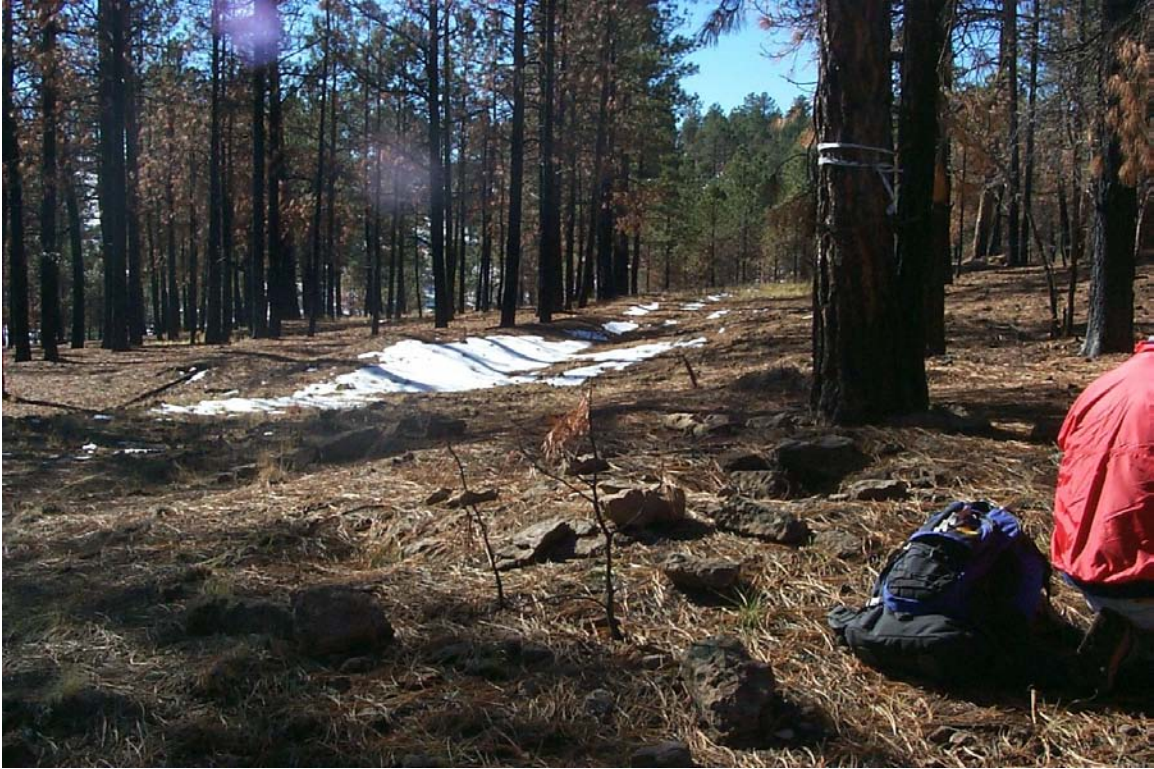
**Figure 7.7.** General view of LA 86656, looking south. Note burned tuff blocks along the edge of an old bulldozed firebreak road.

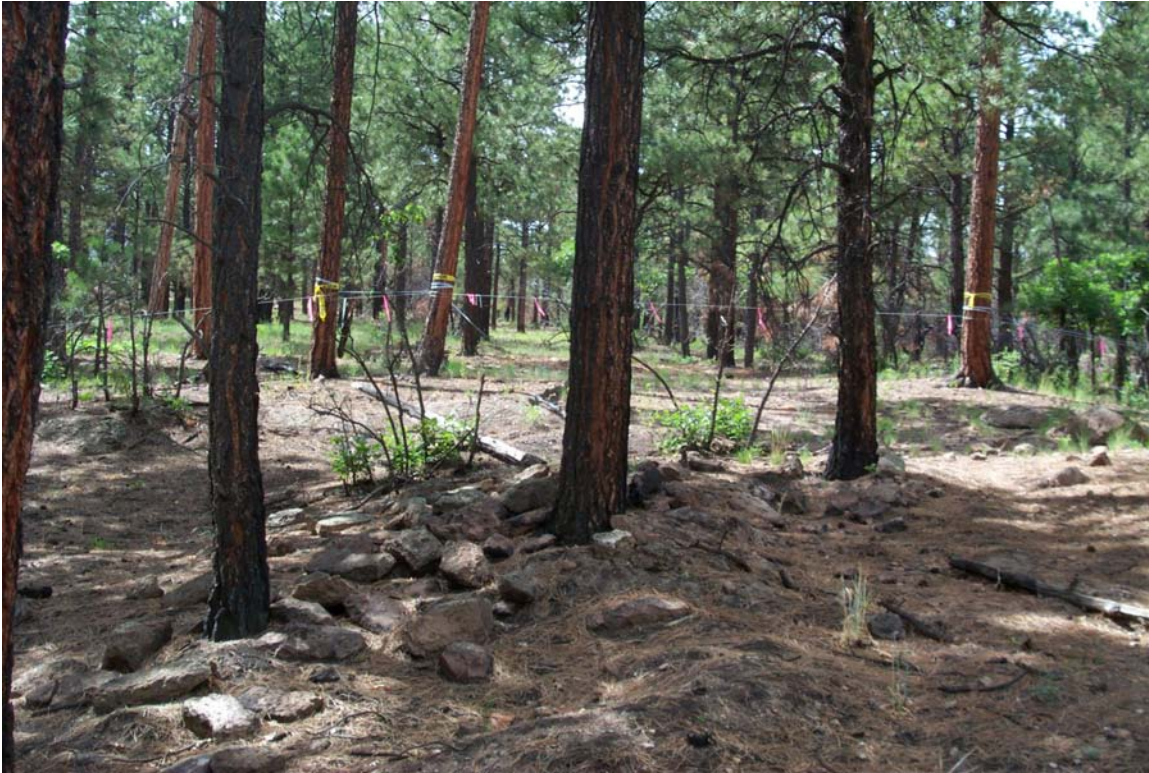
identified at the site, so it has been classified as Ancestral Pueblo. The site burn severity is moderate, and fire effects at the site include cracking and spalling of masonry, smoke damage, and stump and root holes in the site area. Some of the burned trees in the site area were removed, and no treatment is recommended.

**Figure 7.8.** General view of LA 136905 after flagging, looking southeast.

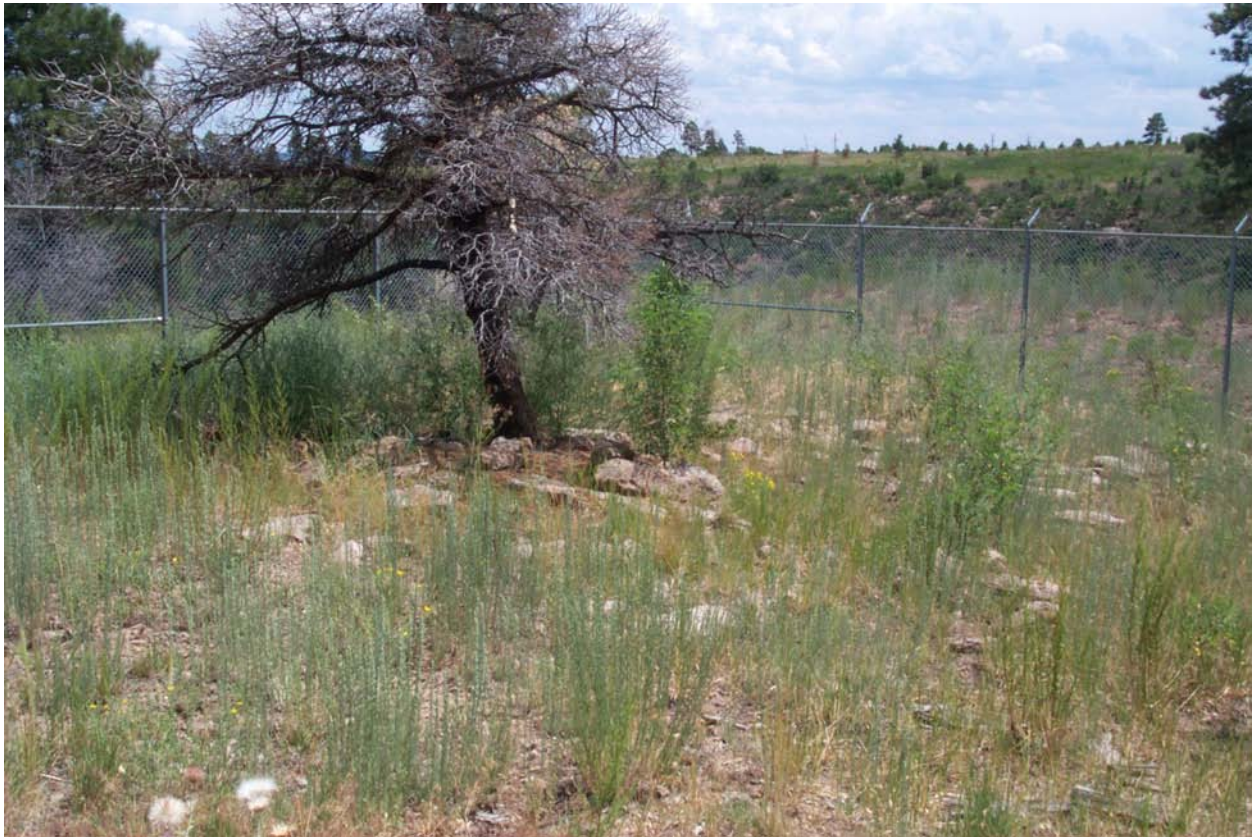
**LA 4654A.** This site consists of a small pueblo roomblock located near the south edge of the TA-37 mesa top that overlooks Water Canyon. The site is approximately 15 m by 13 m, and alignments are visible in the central area of the structure. The tuff blocks are well shaped and unusually large. A chain link fence deviates around the mound on the south side of the site (Figure 7.9). Some bulldozing is evident in this area. The large majority of the roomblock component of this site, despite having been damaged by the fence construction, is undisturbed. Artifacts observed include Santa Fe Black-on-white, some corrugated utility ware, basalt, chert, and chalcedony. Based on the ceramics observed, this site dates to the Coalition period. The effects of the Cerro Grande Fire are moderate and consist of cracking and spalling of masonry, smoke and soot staining, snags and partial burned trees that can damage structures, and additional snags and burned trees in the site area. There were no suppression impacts to this site during the fire. The removal of a burned and dead tree from the center of the rubble mound is recommended treatment for this site.

**Figure 7.9.** LA 4654A; the tree in the center of the rubble mound is recommended for removal.

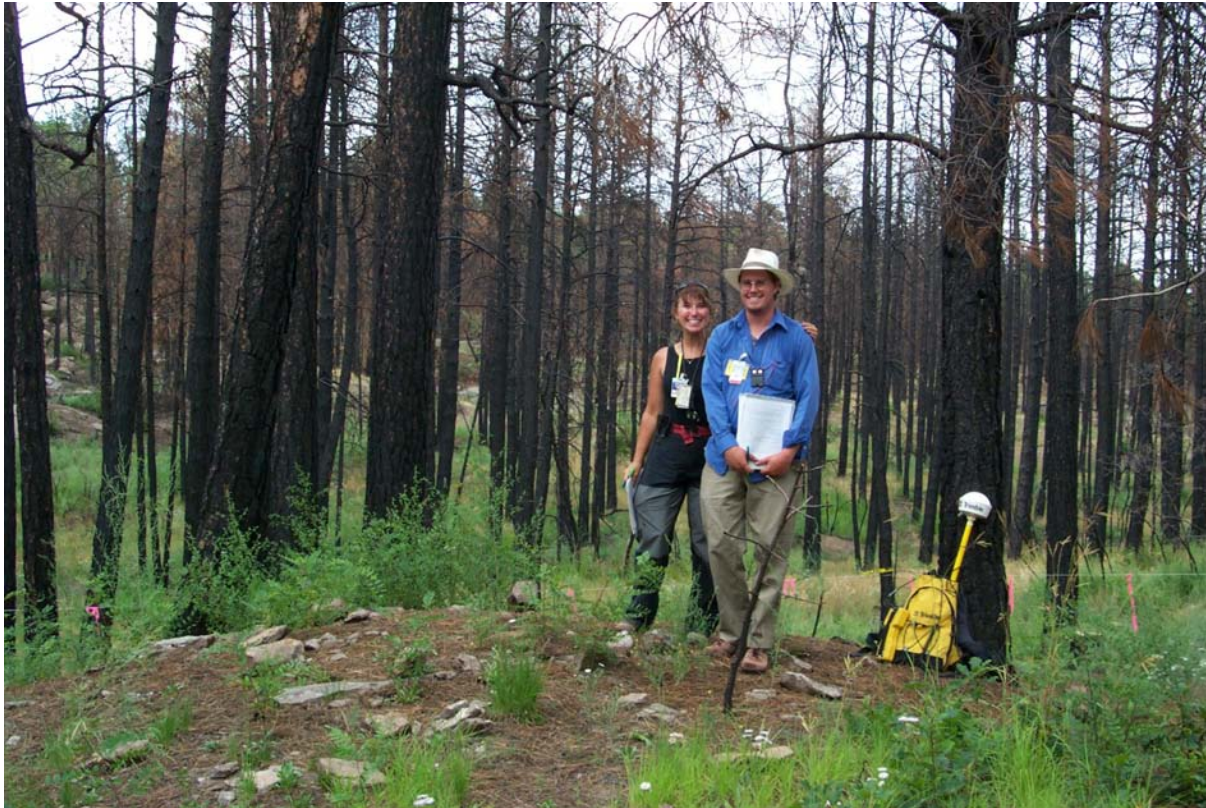
of the site. Because of the severity of the impacts to the site, rehabilitation activities were undertaken. A number of trees in the area have been felled, and several wattles have been placed in the general vicinity of the one- to three-room structure. LA 136833 was not impacted by suppression activities.

**Figure 8.3.** LA 136833, T. Knight and B. Harmon (from left to right) at the one- to three-room structure after the Cerro Grande Fire.

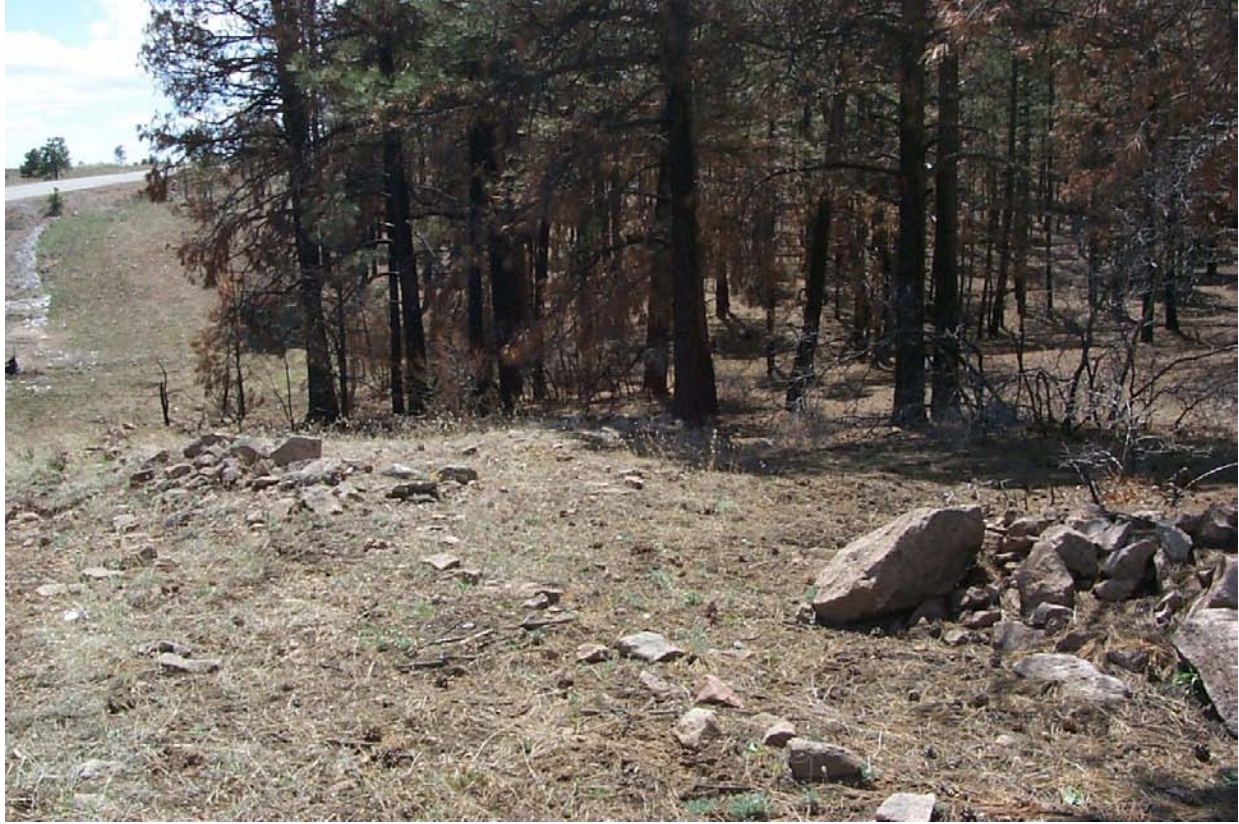
spalling, smoke, and soot damage on the masonry blocks and four partially burned trees on the mound itself. Because of the presence of four dead, burned trees on the mound and the potential damage that can be sustained by the roomblock if these trees fell, it is recommended that the trees be removed. The site was not impacted by rehabilitation or suppression activities.

**Figure 8.4.** LA 89727, a pueblo roomblock after the Cerro Grande Fire.

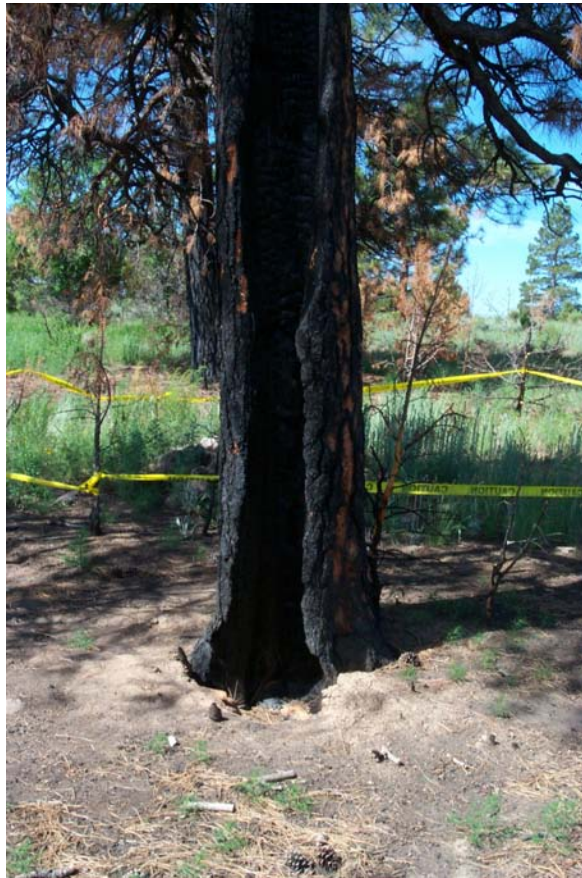
**Figure 8.6.** LA 136944, rock pile in the background and a tree recommended for removal.

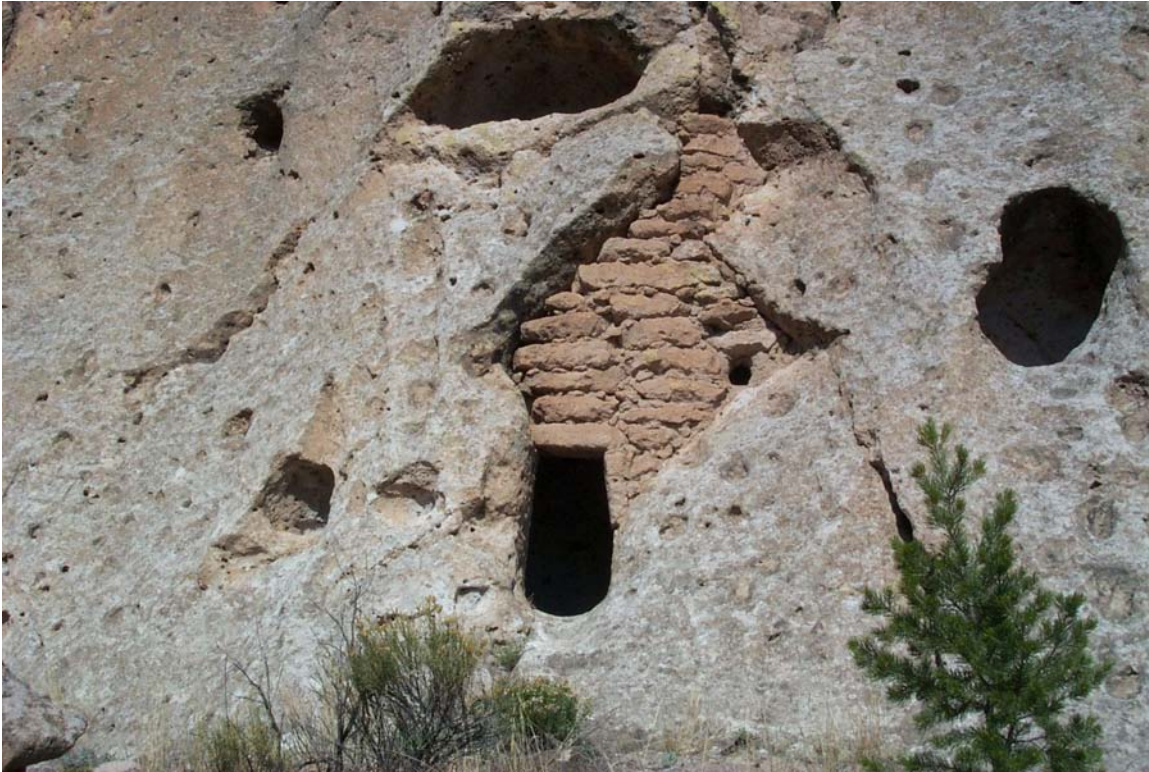
**Figure 9.2.** LA 12609B, masonry walled cavate made visible by the burning of trees in the area.

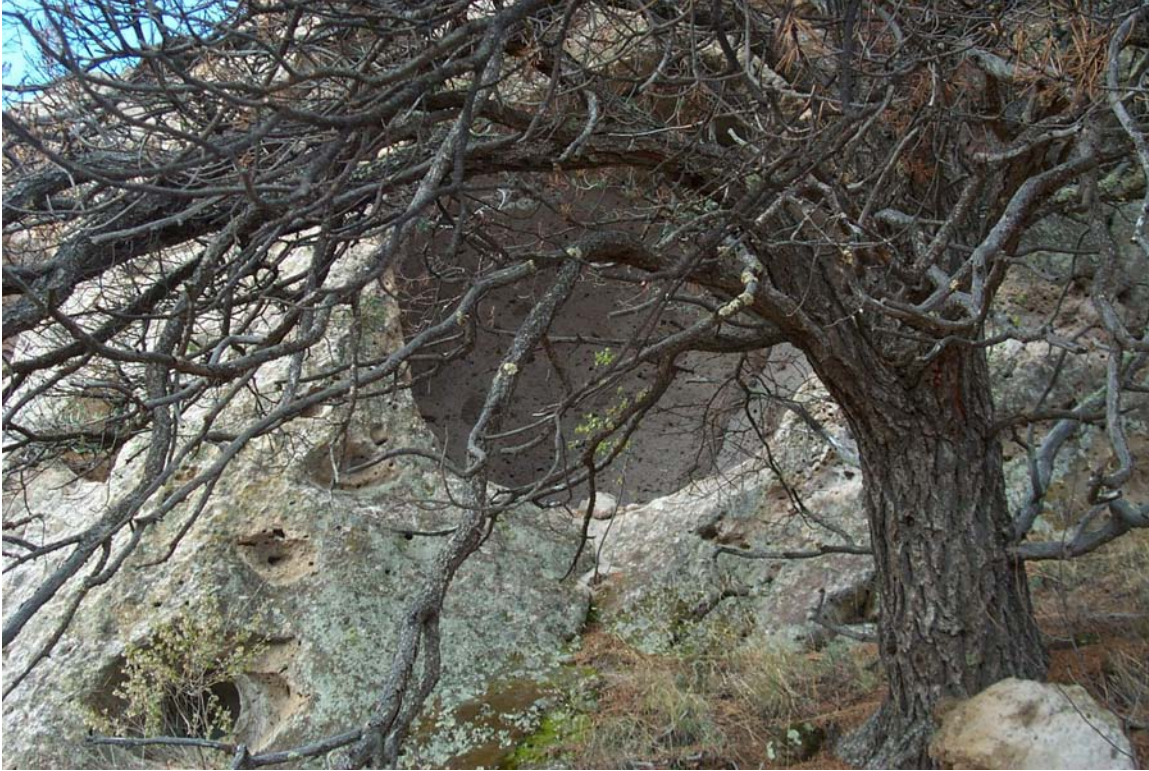
**Figure 9.3.** LA 16799, one of a series of cavates, this one with a snag in front.

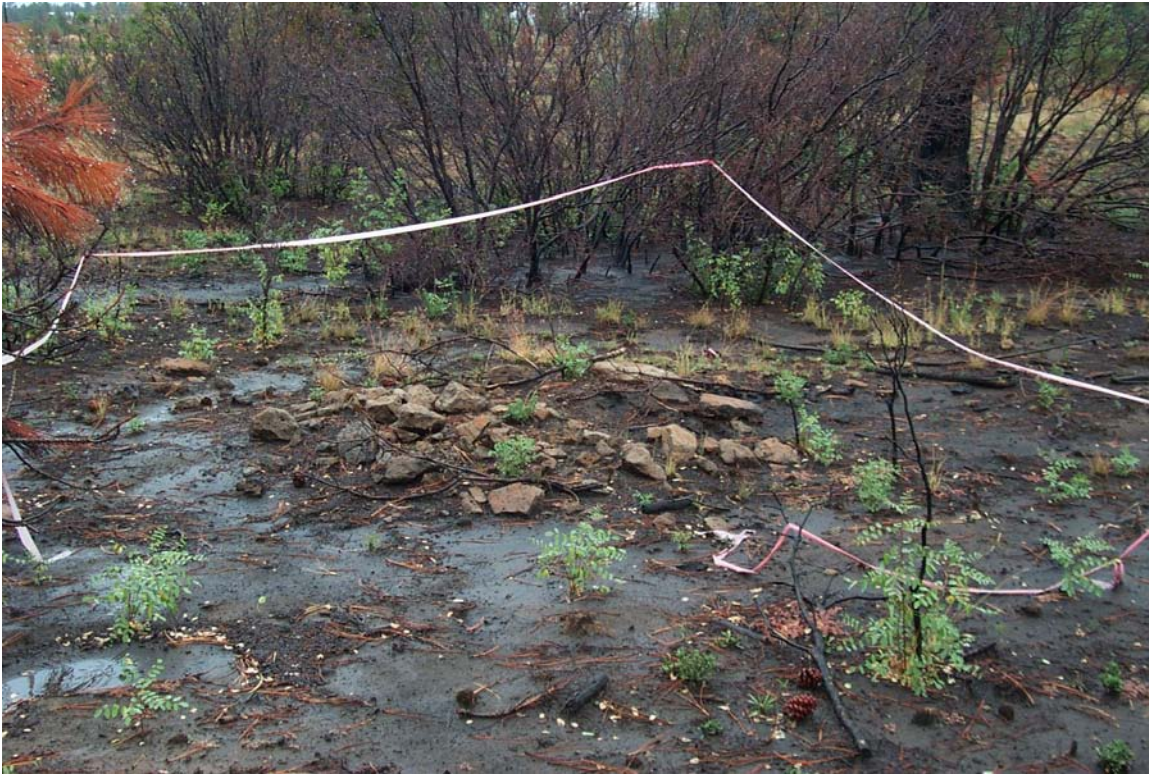
**Figure 9.4.** LA 4687, fire and non-fire (erosion) impacts to a one- to three-room structure.

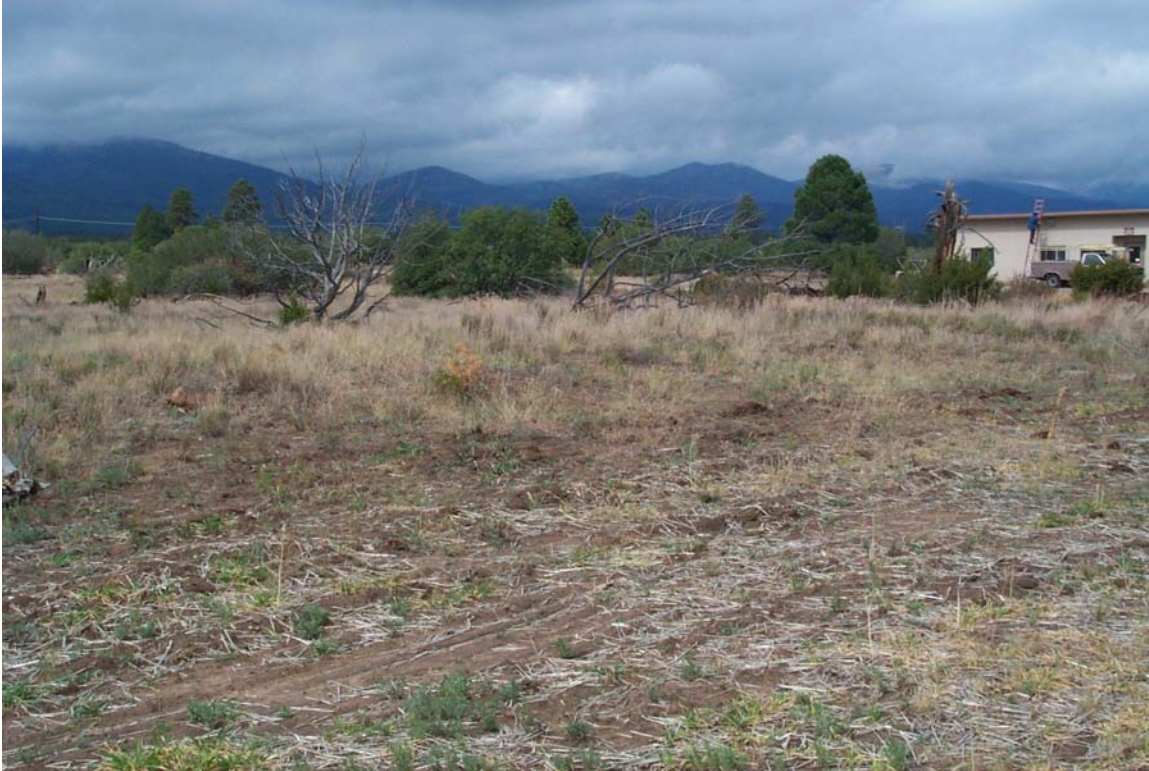
**Figure 9.5.** LA 4690, a pueblo roomblock impacted by suppression efforts (e.g., vehicle ruts).

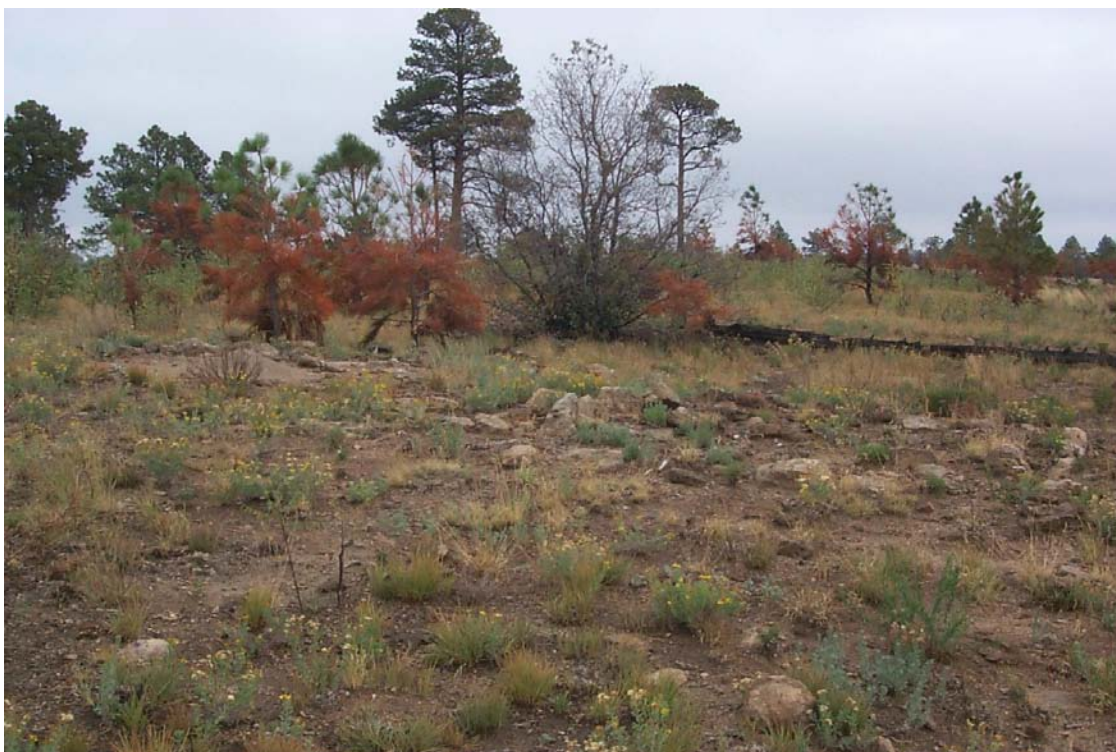
**Figure 9.6.** LA 12657A, a pueblo roomblock in a low-burn area, snags pose a threat to site architecture.

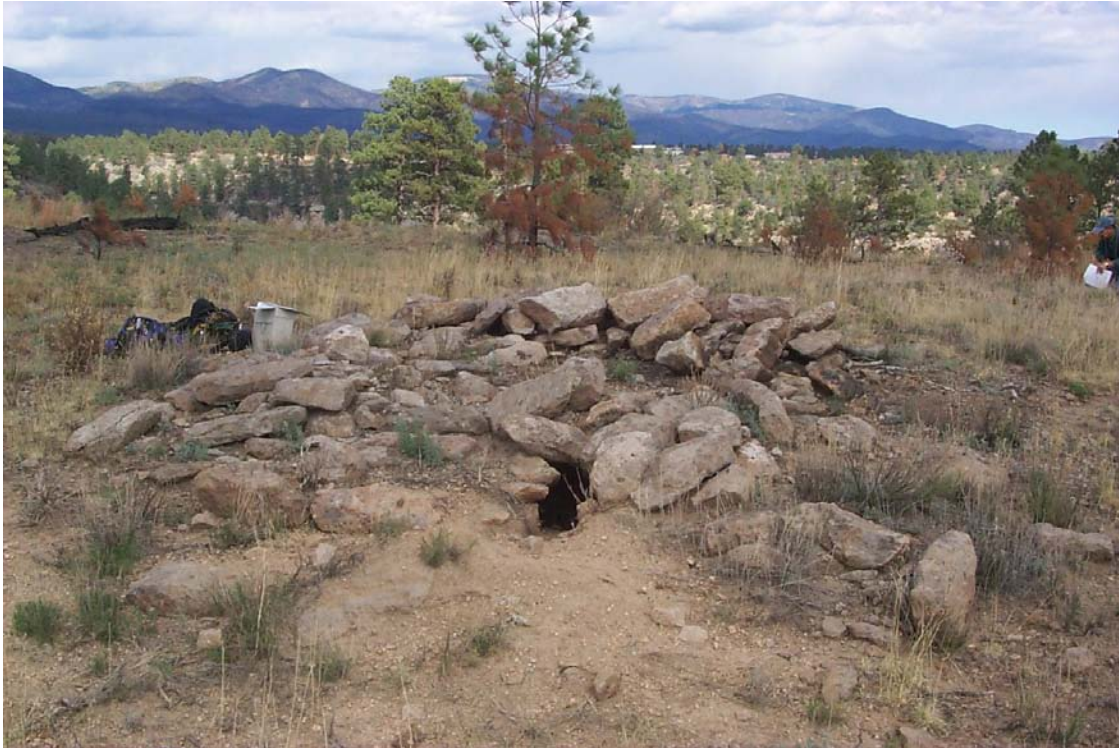
**Figure 9.7.** LA 12657C, a fire-impacted one- to three-room structure (note the stump hole in the foreground of the photograph).

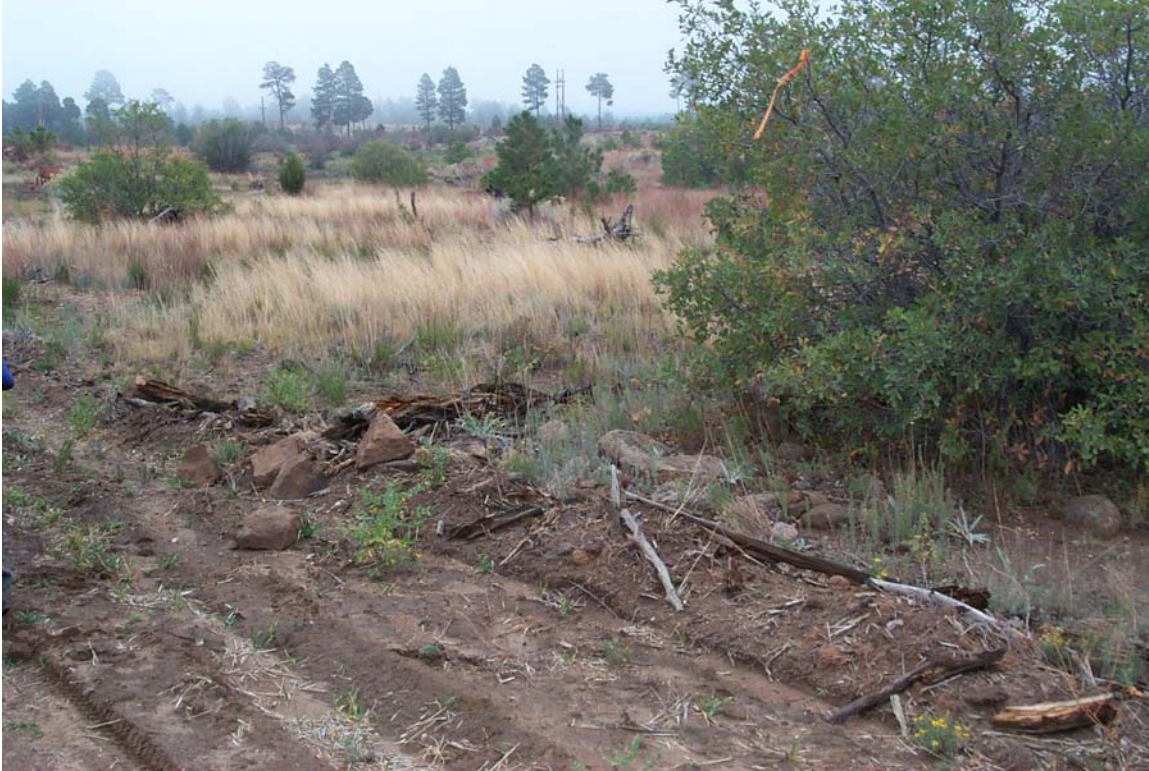
**Figure 9.8.** LA 15862, a one- to three-room structure damaged by suppression activities.

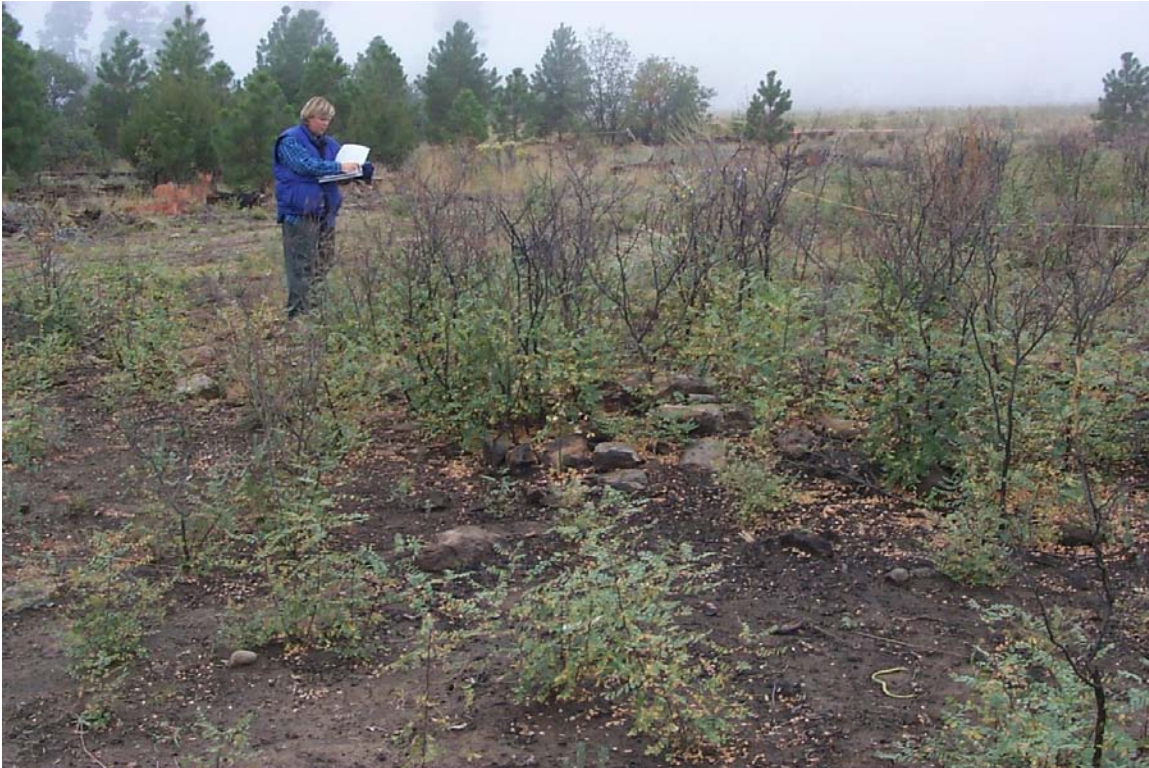
**Figure 9.9.** LA 15865D, K. Schmidt at a fire-impacted one- to three-room structure with soot and smoke staining and small snags.

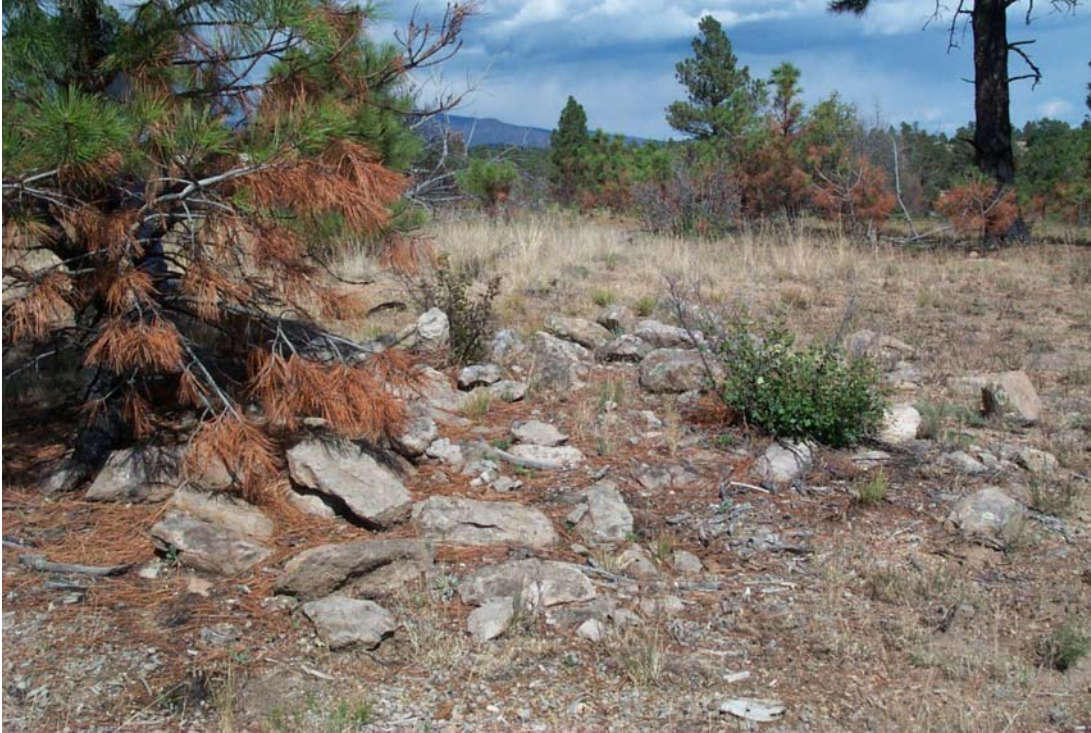
**Figure 9.10.** LA 89760, a one- to three-room structure with a partially burned tree that poses a threat to site masonry.

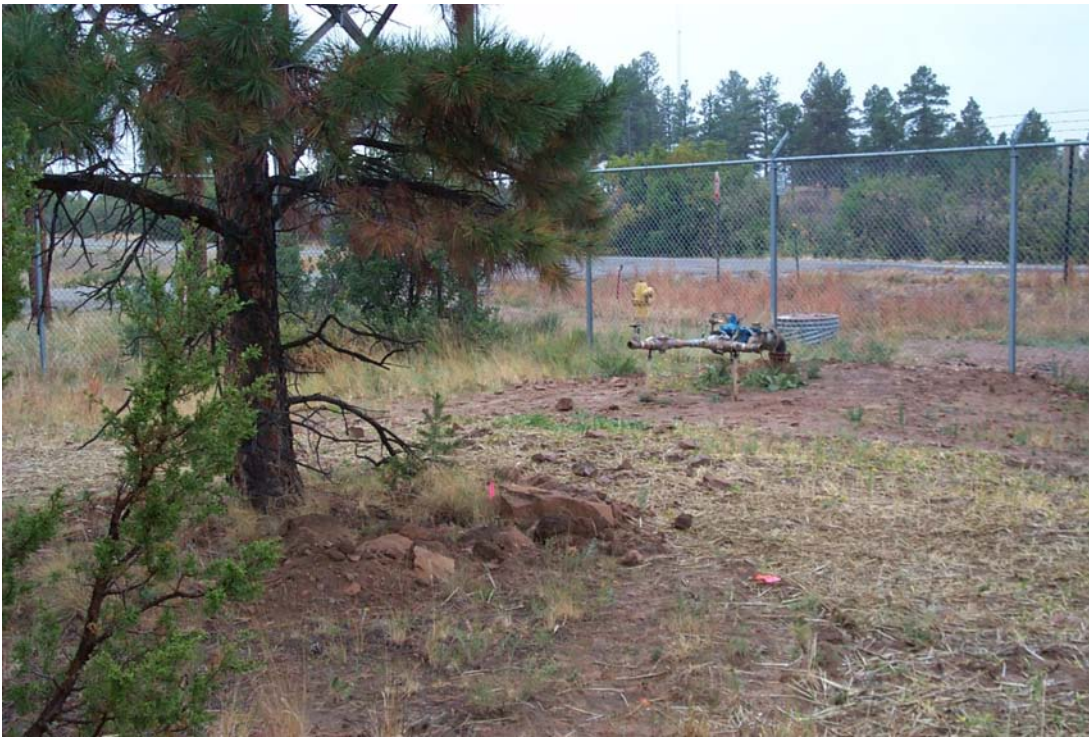
**Figure 9.11.** LA 137755, a one- to three-room structure impacted by a low-level burn, the partially burned tree in the center of the fieldhouse poses a threat to the site's integrity.

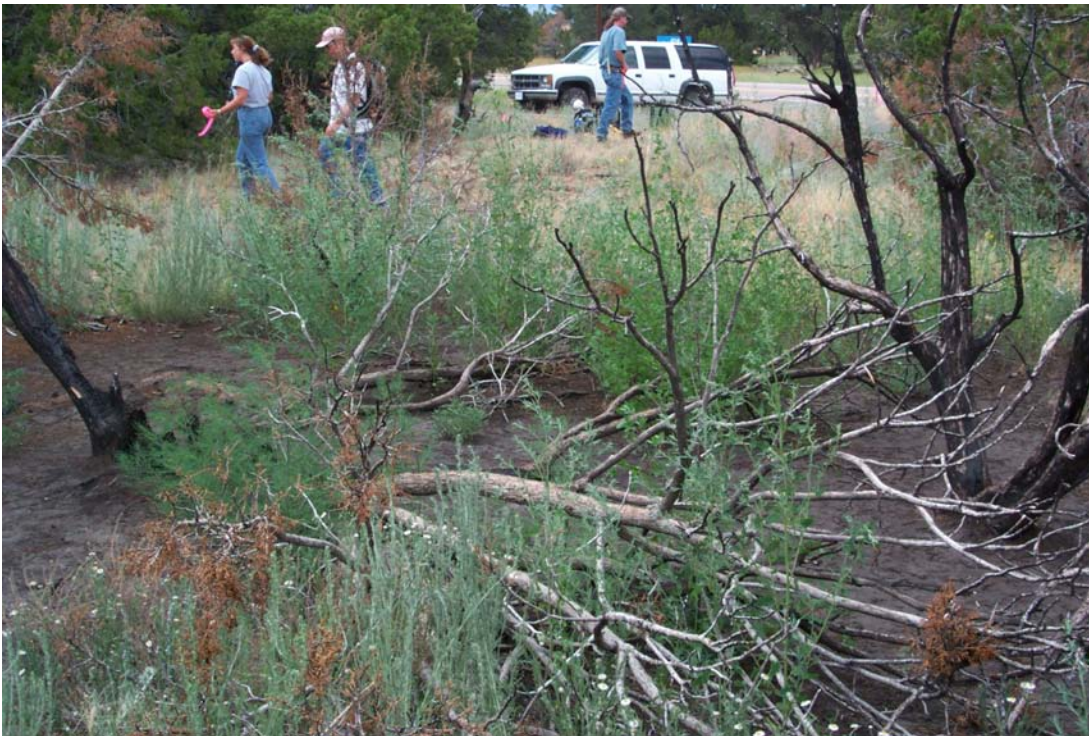
**Figure 9.12.** T. Knight, A. Madsen, and M. Hannaford (from left to right) examine LA 35649, a one- to three-room structure that was subject to a severe burn. There are many snags in the immediate area that may pose threats to the site's integrity.

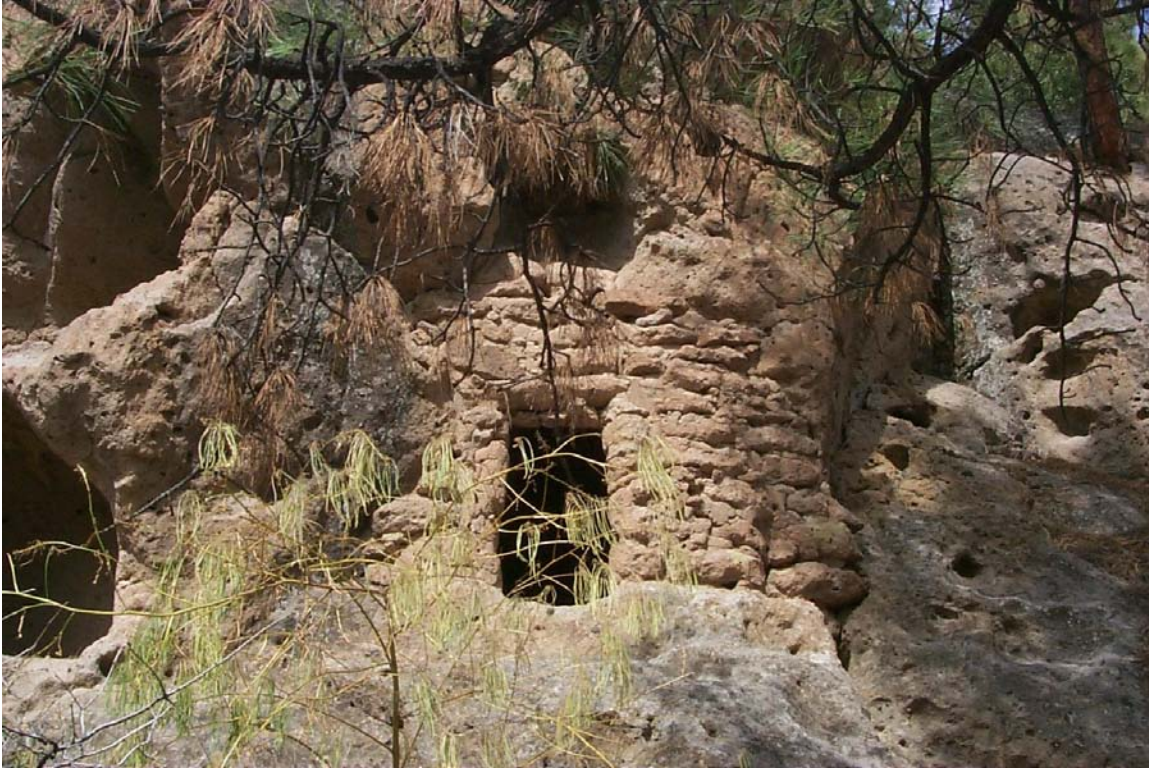
**Figure 9.13.** LA 16801, a masonry walled cavate with a snag recommended for removal in the foreground.

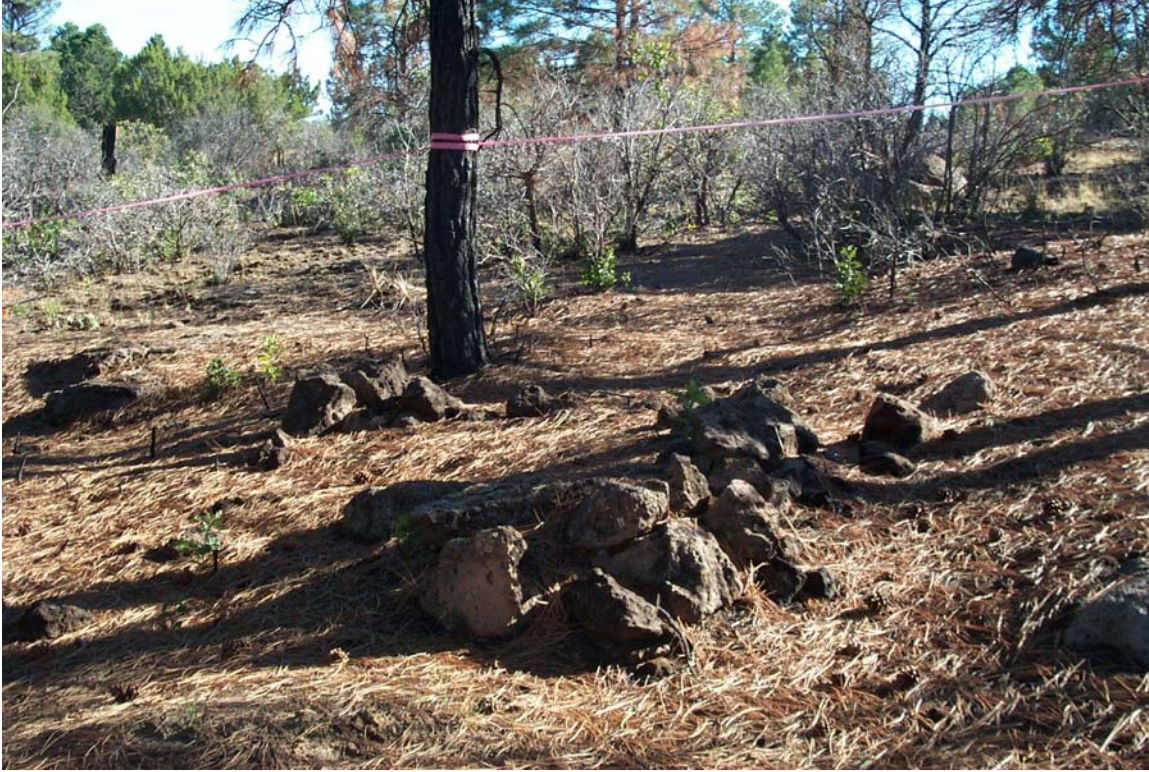
**Figure 9.14.** LA 16805, a one- to two-room structure impacted by a severe burn, removal of the snag in the background of the photograph is recommended.

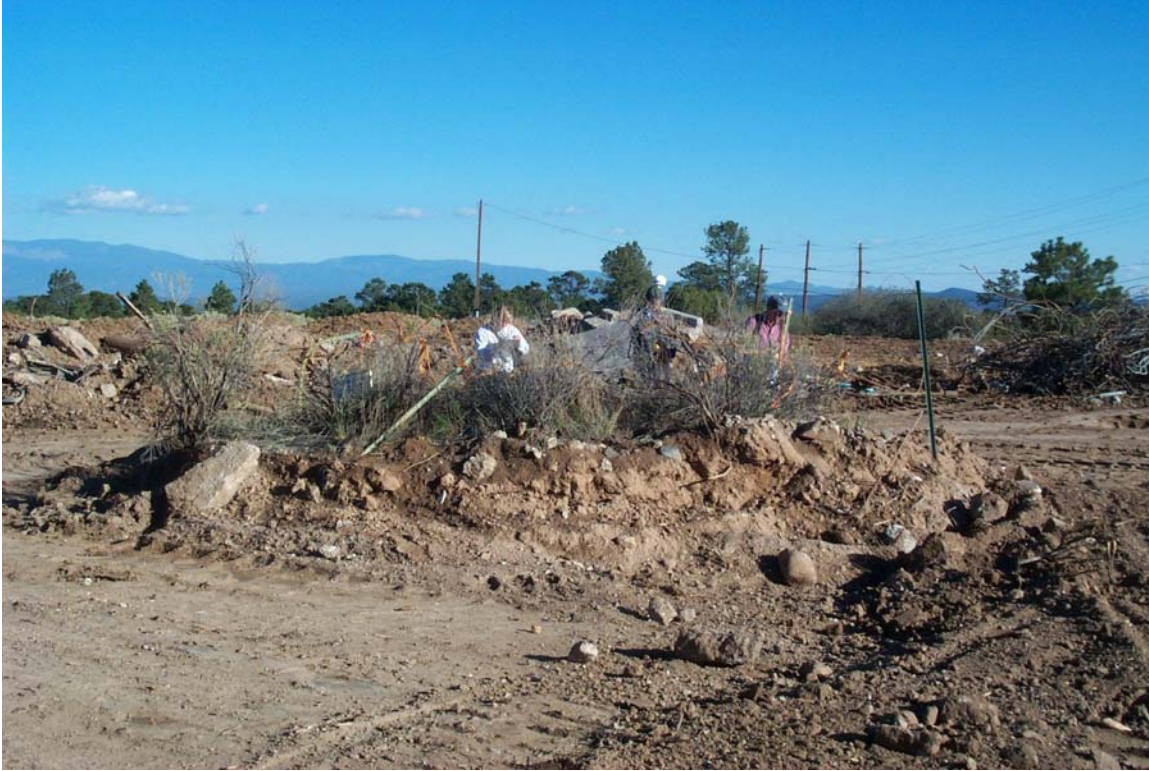
**Figure 9.15.** K. Schmidt, B. Harmon, and B. Vierra (from left to right) at LA 89779, a one- to three-room structure severely impacted by post-fire activities; the site boundaries have been cut by a bulldozer.
