**CERRO GRANDE  
FIRE ASSESSMENT PROJECT:  
An Assessment of the Impact of the  
Cerro Grande Fire on Cultural Resources at  
Los Alamos National Laboratory, New Mexico**

Cultural Resource Report No. 211

**Los Alamos National Laboratory**

**December 2002  
Survey No. 818**

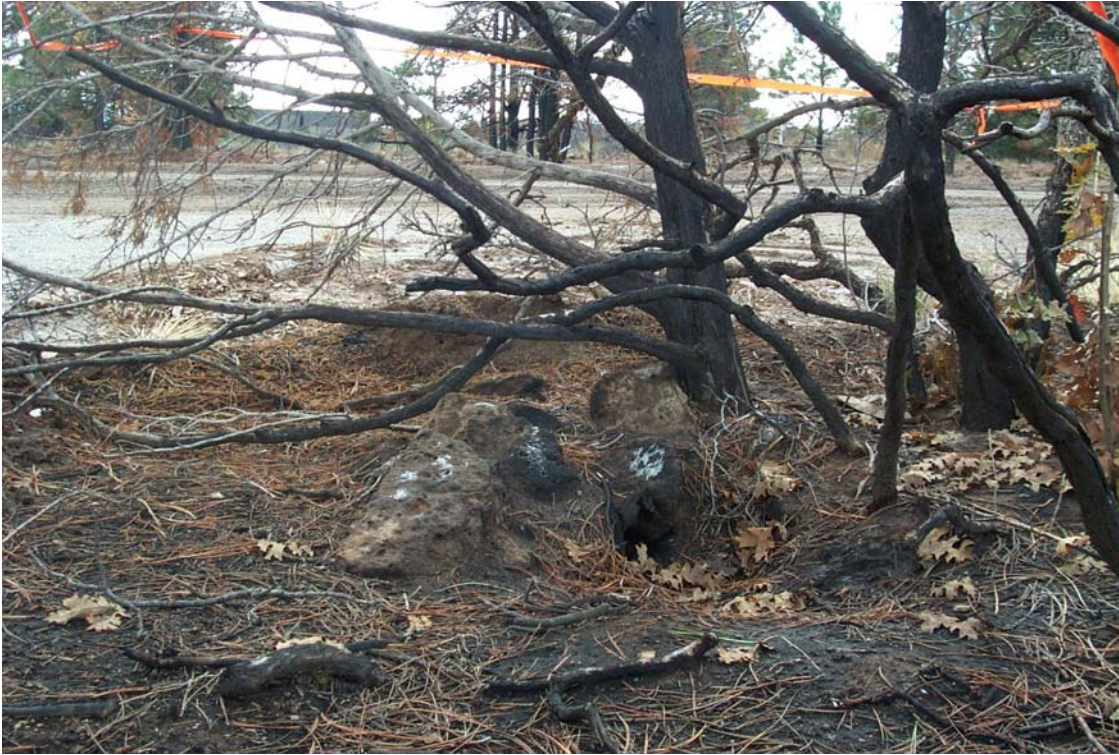
was not determined. Suppression activities undertaken at the site include the removal of trees and bulldozing on the site itself. The site was not impacted by rehabilitation activities.

**Figure 9.16.** LA 136793, a one- to three-room structure impacted by fire and suppression activities; removal of snags and fencing of the site is recommended.

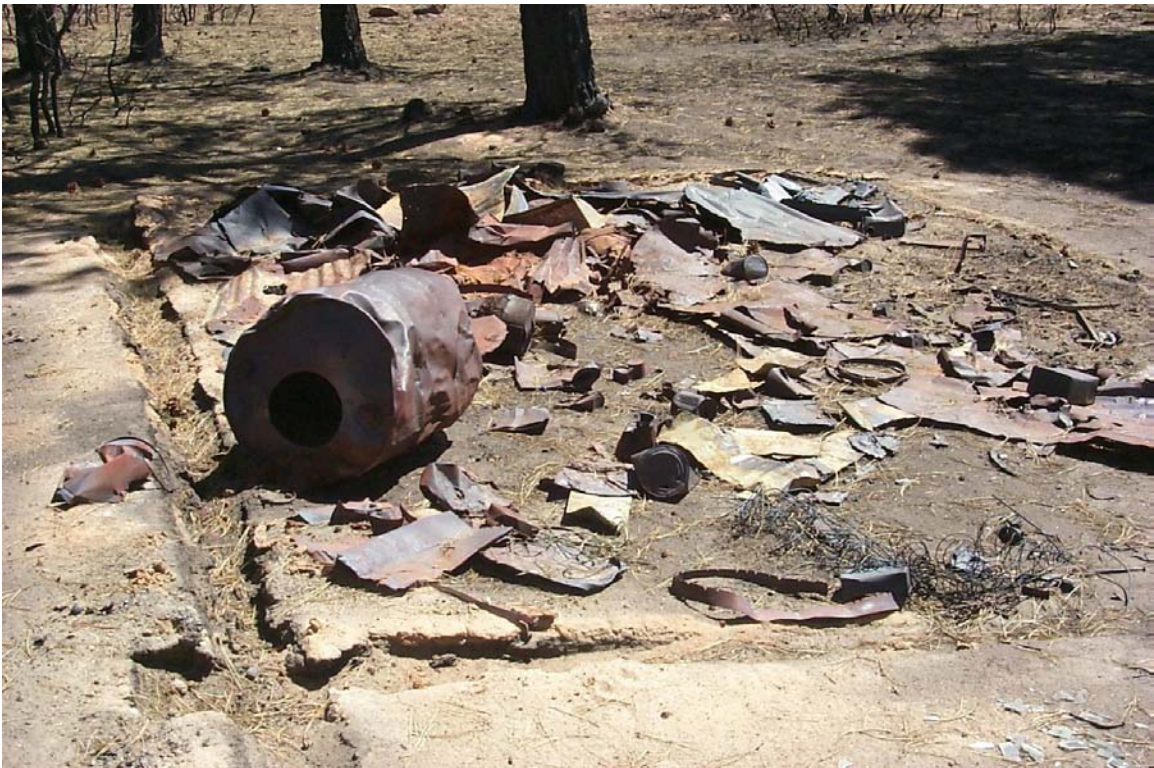
**Figure 11.2.** The Montoya cabin after the Cerro Grande Fire.

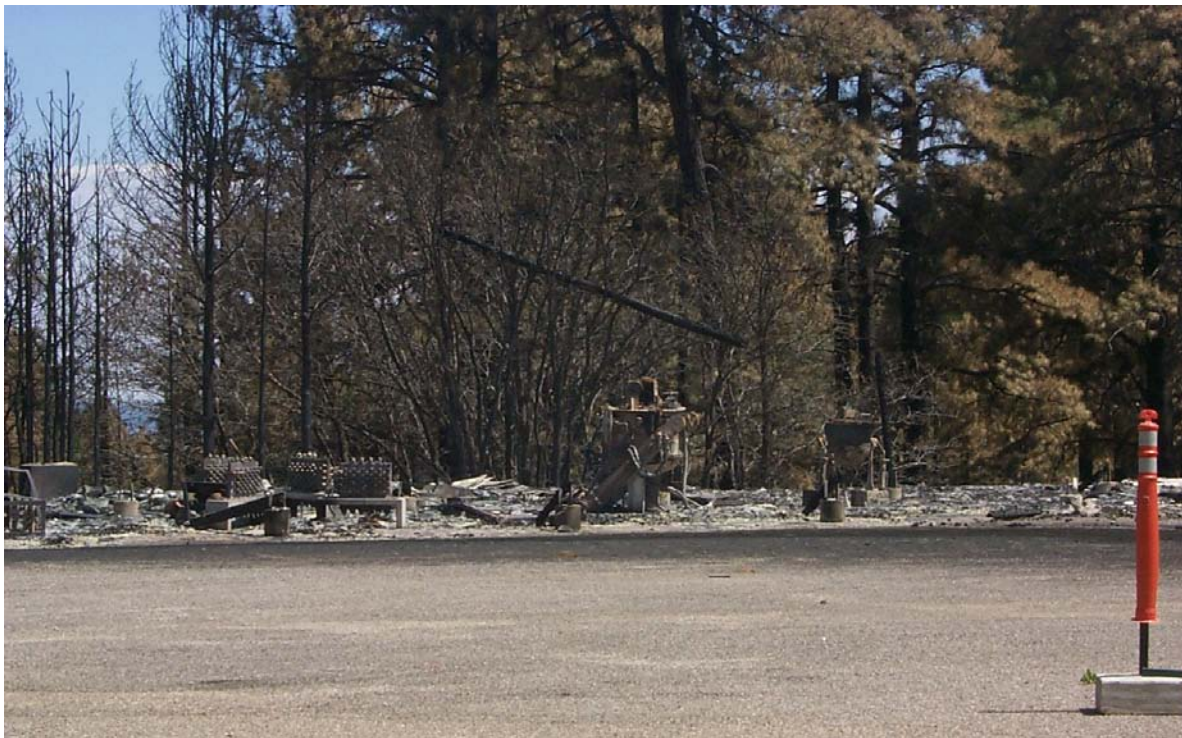
**Figure 11.8.** Artifacts stored at V-Site after the Cerro Grande Fire.

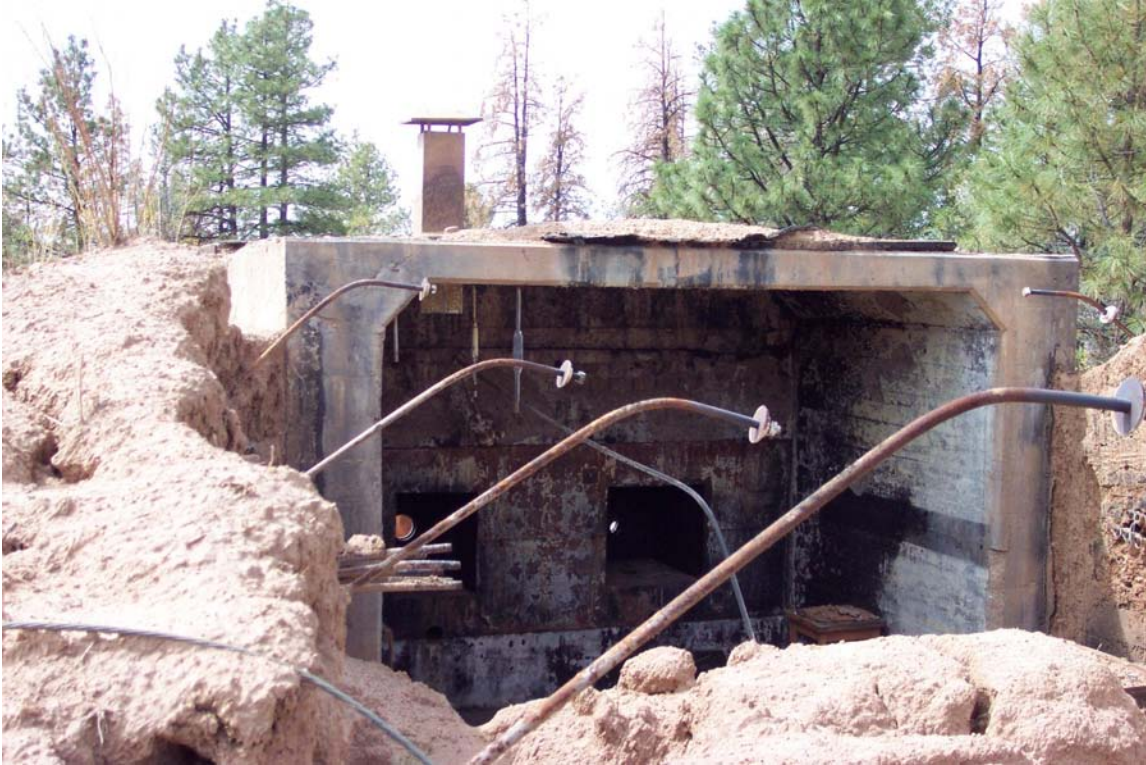
**Figure 11.9.** TA-14-5, remaining concrete portion and berm after the Cerro Grande Fire.

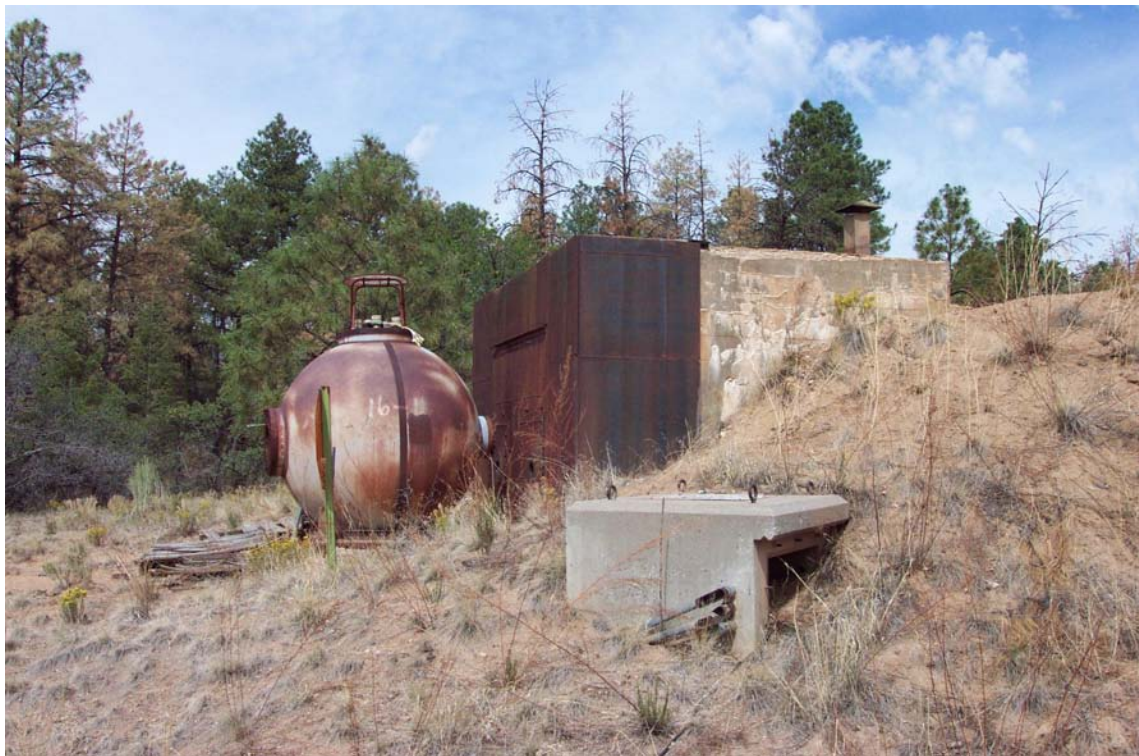
**Figure 11.10.** TA-14-5, rear view of former control room and berm after the Cerro Grande Fire.

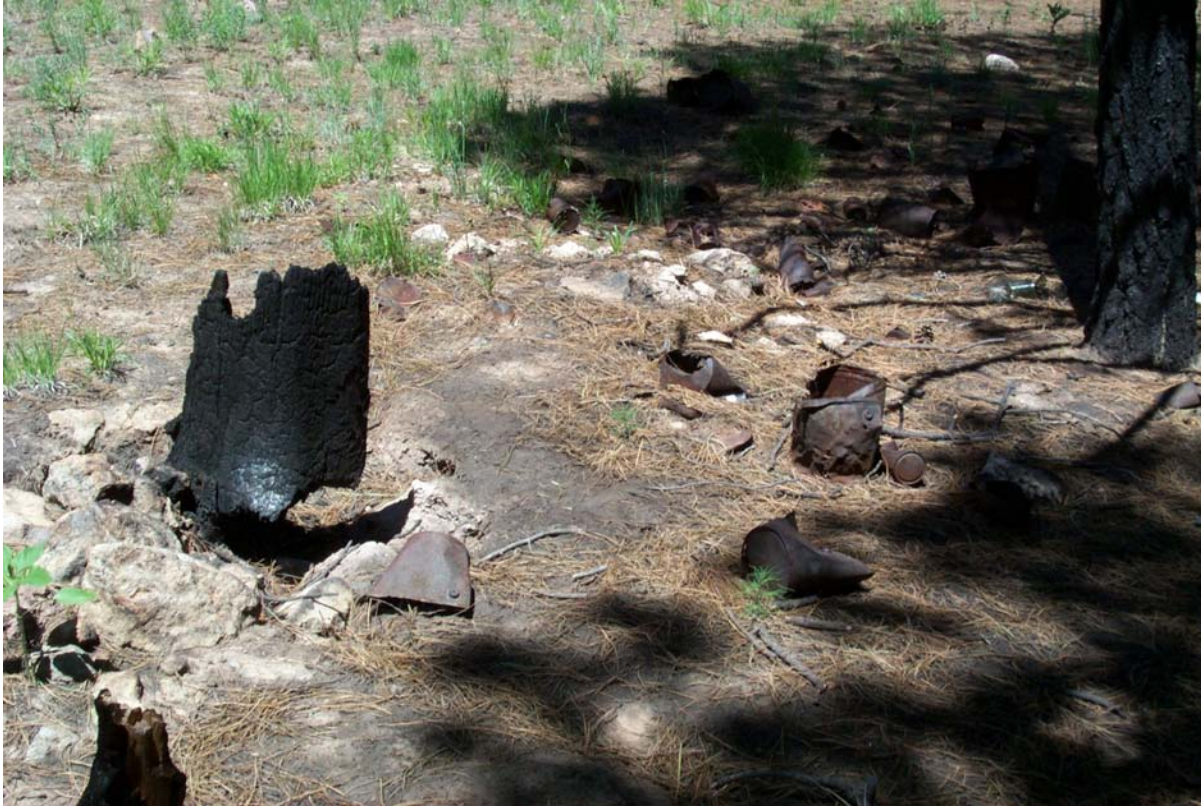
Figure 12.12. LA 131236, with stump holes in the artifact scatter.
