Title **Final Progress Report on Los Alamos National Laboratory
Cerro Grande Fire Rehabilitation Activities**

Prepared by **Kevin J. Buckley and Jeffrey C. Walterscheid,
Water Quality and Hydrology Group
Samuel R. Loftin, Ecology Group
Gregory A. Kuyumjian, USDA Forest Service**

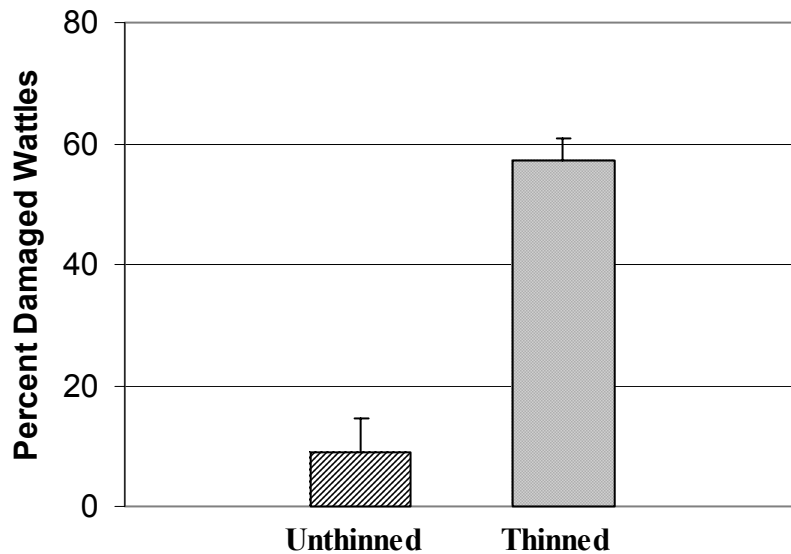
Figure 9. Differences in the percentage of damaged wattles in thinned and unthinned BART units. Samples were significantly different ($p < 0.001$) between unthinned and thinned units.

The percentage of wattles that failed stayed relatively consistent for the first year at 6%. In 2002 and 2003, thinning occurred in 32 of the BART units. The average percentage of failed wattles increased to 34% in 2002 and 46% in 2003. In BART units where thinning was not conducted (nine units) the total average percentage of failed wattles was 8.9%. In BART units (32 units) where thinning was conducted, a total average of 57.3% of the wattles failed (Fig. 9).
