# Historic Preservation Assessment and Recommendation Report for the Gun Site Restoration Project

# **Historic Preservation Assessment and Recommendation Report for the Gun Site Restoration Project**

August 7, 2008

Historic Building Report No. 281

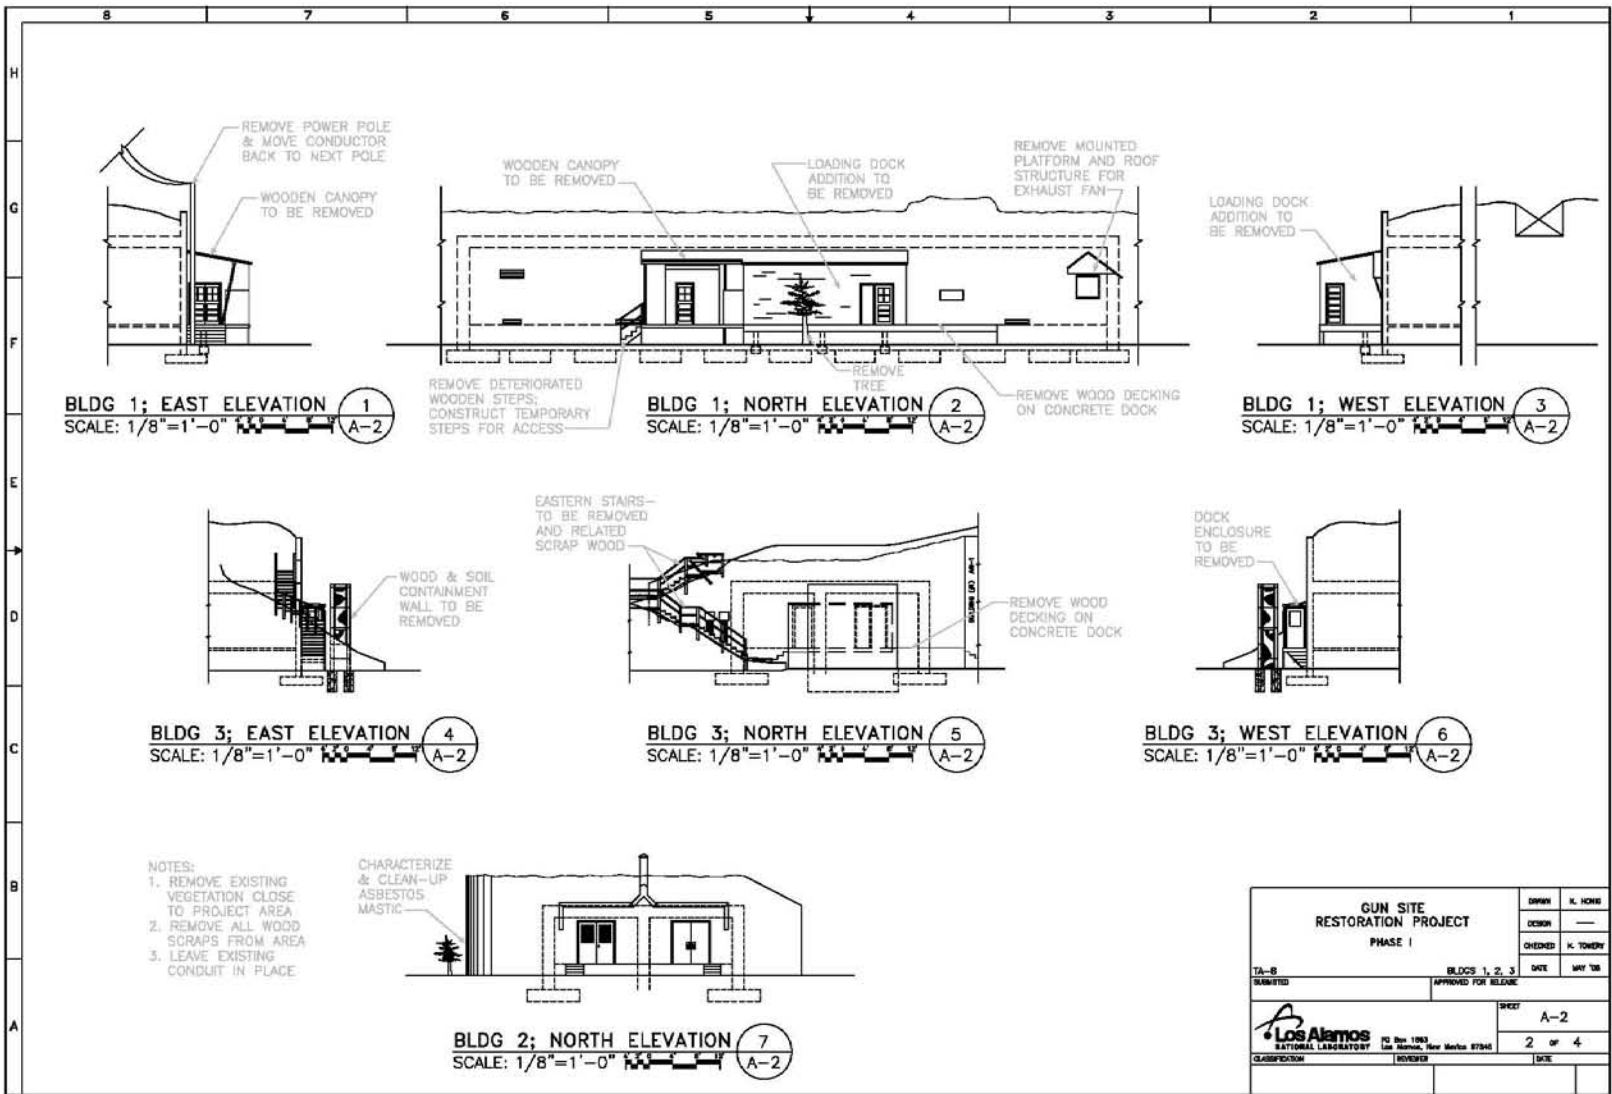
Figure 8. Phase I of restoration project

From a health and safety perspective, accessibility—that is, the ability to move safely in and around the facility—must be addressed as a priority. Safe access is necessary for ongoing assessments and project cost estimating, as well as any abatement that is required. In addition to primary accessibility concerns for each building detailed below, general activities to be completed during Phase I include removing all asbestos materials and loose wood from the site. When Phase I work results in accessibility issues, such as the removal of the loading dock steps to Building 1, temporary replacements shall be constructed until permanent reconstruction from original specifications takes place (Phase III). To facilitate access to the demolition areas, all vegetation close to the project site shall be removed, including two trees located next to Building 1 and Building 2 (Figure 8).

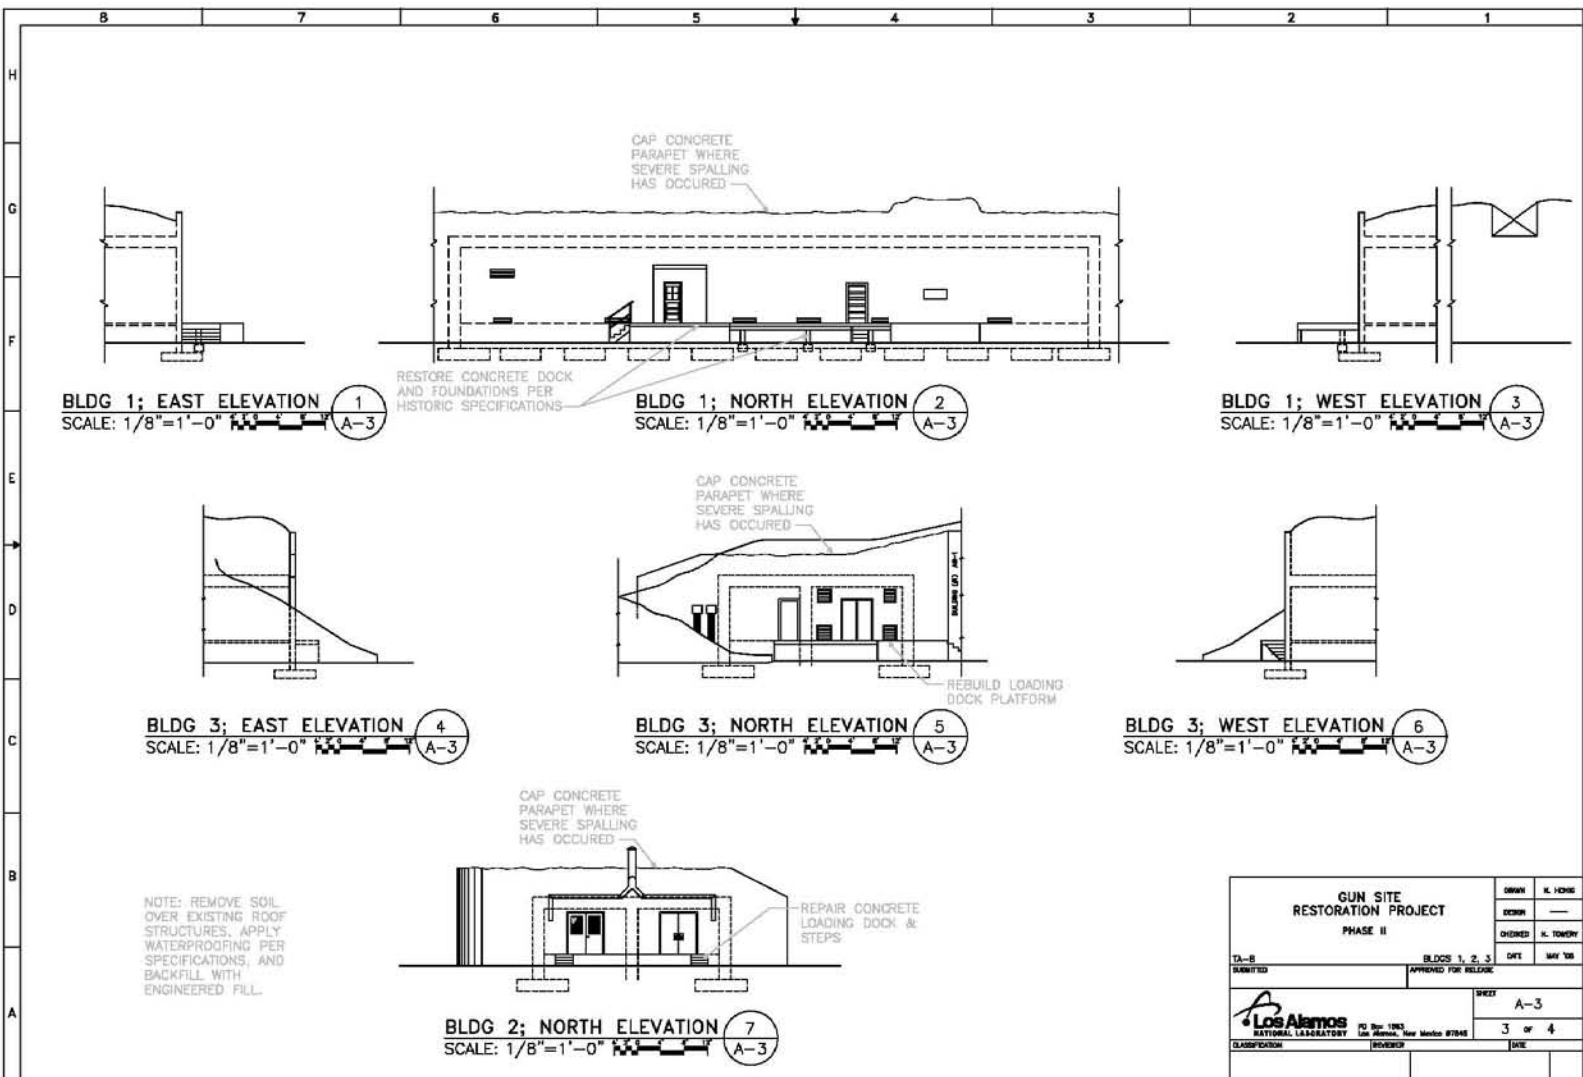
Figure 11. Phase II of restoration project

Phase II is designed to address remediation of major structural issues and/or active pathologies that are causing ongoing deterioration (Figure 11).<sup>3</sup>

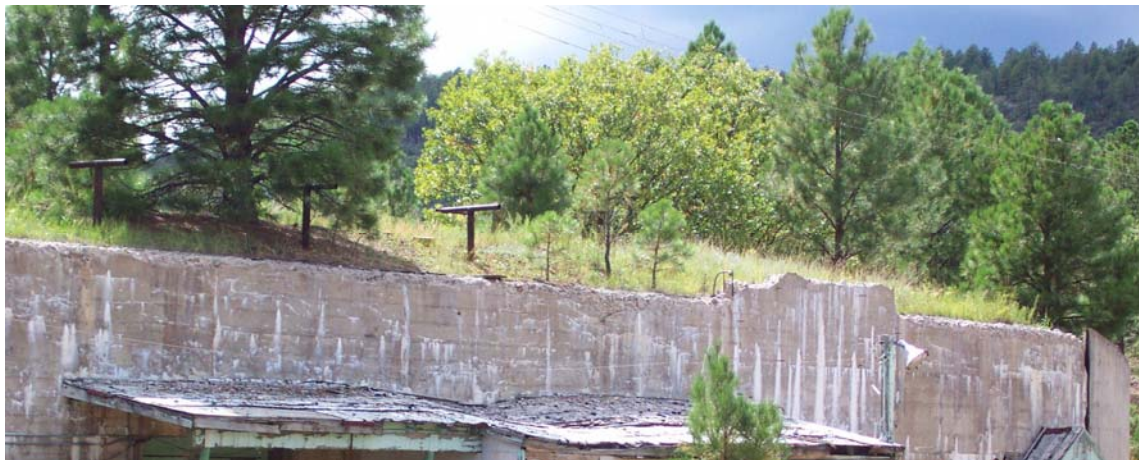
Concrete: The primary structural concern with the entire compound is the decay of the concrete because of moisture infiltration, both at the top parapet and in general. Severe spalling along the top section, within contraction cracks, and at cold joints is a common observation (Figure 13a–b).

Figure 13a. TA-8-1, concrete spalling at parapet, looking southwest

Figure 13b. TA-8-1, concrete spalling at parapet, looking northeast

For much of the concrete that forms the vertical north face, the mix had a high alkali content (based on its sensitivity to moisture and the high levels of efflorescent deposits), as well as extremely large aggregate. There are some sections of concrete retaining walls—sections not structurally tied to the buildings—that appear to be much more stable than others. These sections were likely poured separately from the buildings. The structural walls appear to have been poured monolithically using the high alkali, large aggregate concrete mix. This observation lifts the overall protection and waterproofing of the buildings to an elevated priority, because one may assume that the visible damage along the face of the wall is also occurring within non-visible areas. However, the spalling should have been minimized by the reduced freeze/thaw cycles below the frost line.

The concrete buildings should be waterproofed. All soil on top of the buildings would be removed and modern waterproofing installed. The specific type and technique to be used will depend on engineered specifications and field conditions. The finished grade should provide for positive drainage away from the back of the concrete retaining wall for at least 12 feet. Original architectural plans indicate that two 2,000-gallon diesel fuel oil tanks are buried in the hillside. One is buried six feet to the east of Building 1 with six feet of cover, and the other is approximately six feet directly behind Building 3 with 10 feet of cover.

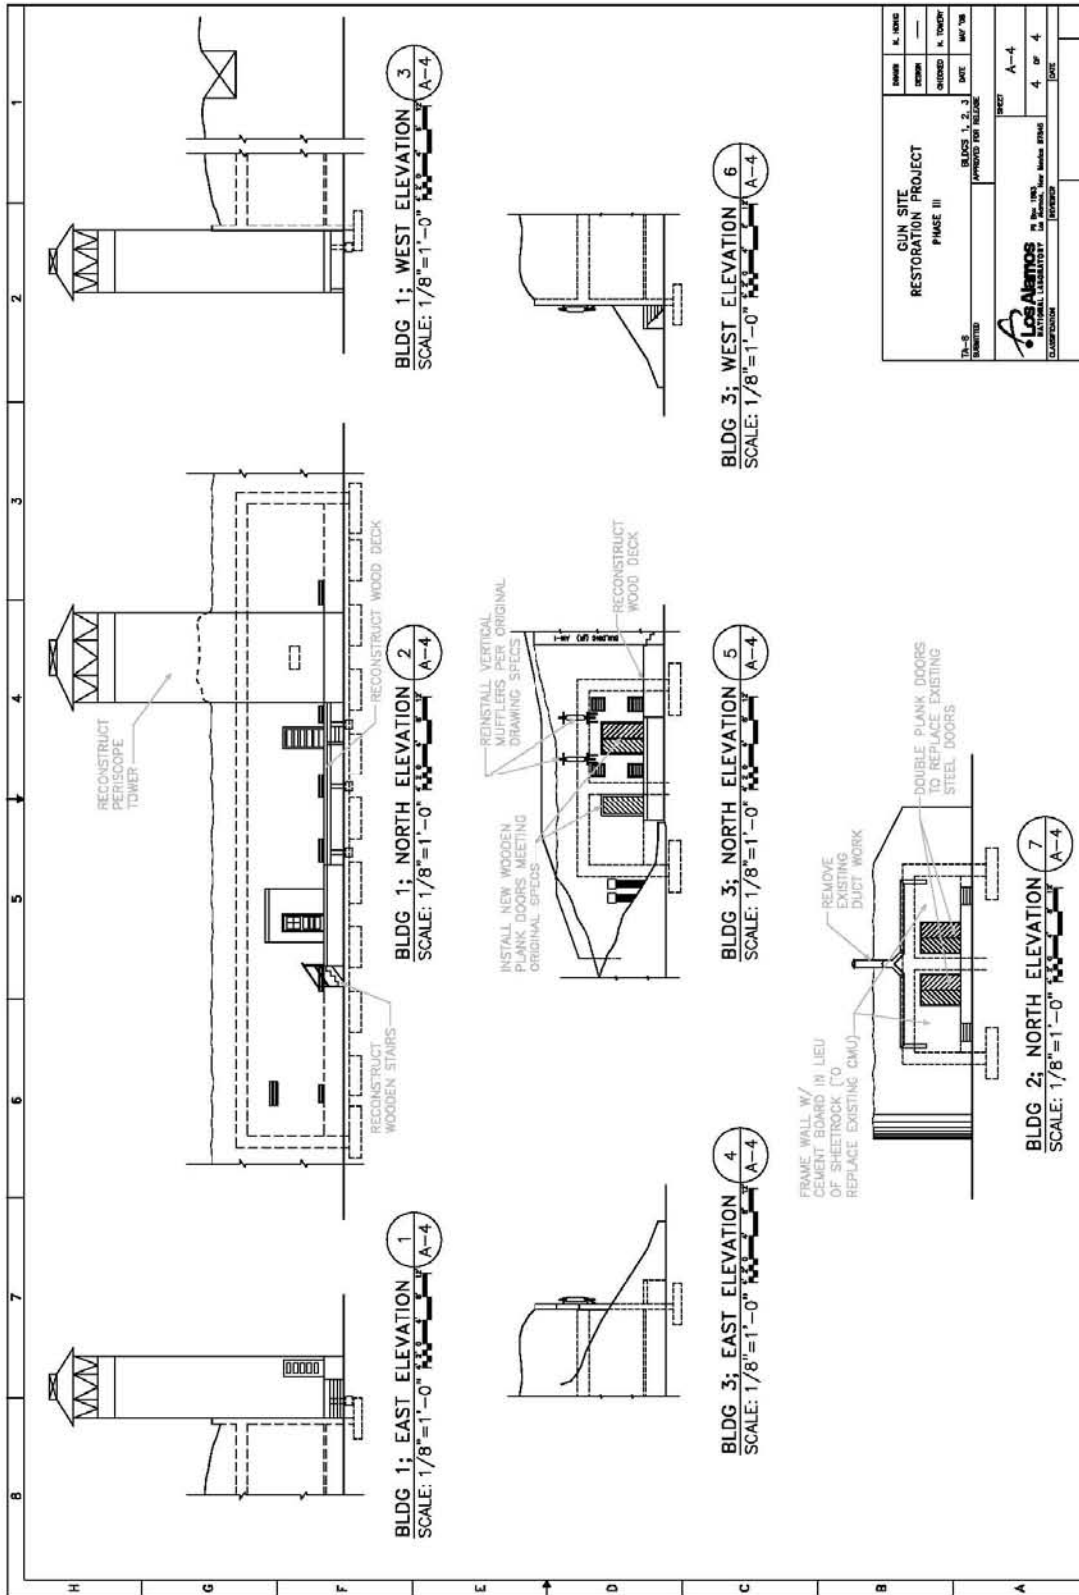
Figure 14. Phase III of restoration project

Phase III is designed to rebuild historically significant portions of the facility that were removed previously and to restore all exterior building components. Current recommendations do not address interior restoration, as ultimate end-use will determine restoration (Figure 14).
