Date: November 30, 2008 Refer To: EP2008-0612

Subject: Submittal of Proof of Inspection of Erosion Controls in Drainages to the

90s Line Pond

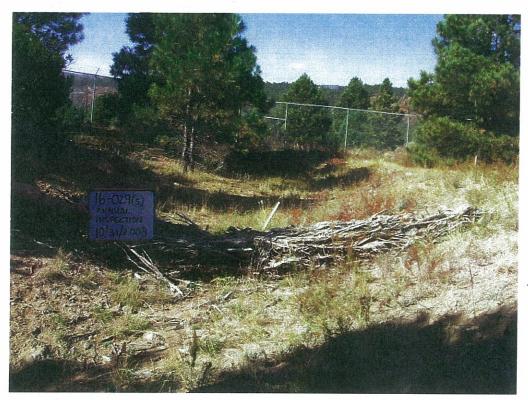
Photo 1 Annual BMP inspection of Consolidated Unit 16-008(a)-99. View to the west, looking at BMPs including juniper bales and vegetation.

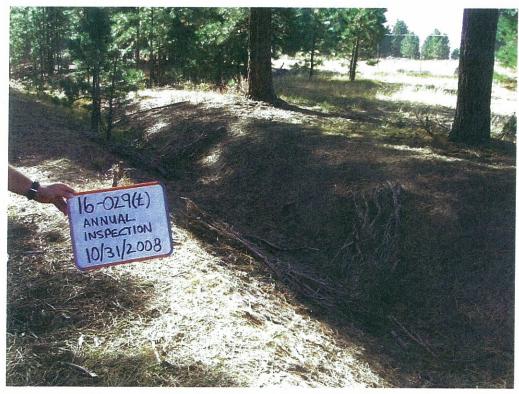
Photo 2 Annual BMP inspection of Consolidated Unit 16-0089a)-99. View to the south, looking at BMPs including juniper bales and vegetation.

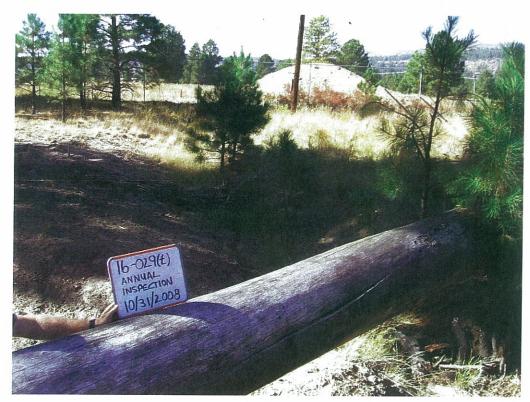
Photo 3 Annual BMP inspection of Consolidated Unit 16-008(a)-99. View to the southwest, looking at BMPs including juniper bales and vegetation.

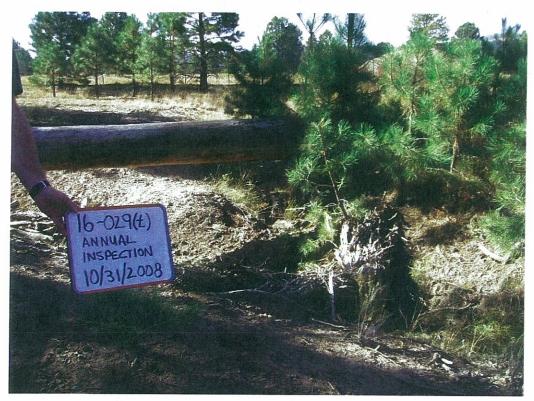
Photo 4 Annual BMP inspection of Consolidated Unit 16-008(a)-99. View to the south, looking at BMPs including juniper bales and vegetation.
