LA-UR-11-0772
February 2011
EP2011-0043

**Inspection Report for
Technical Area 73,
Los Alamos County Airport Landfill,
Solid Waste Management Units
73-001(a) and 73-001(d)**

February 2011

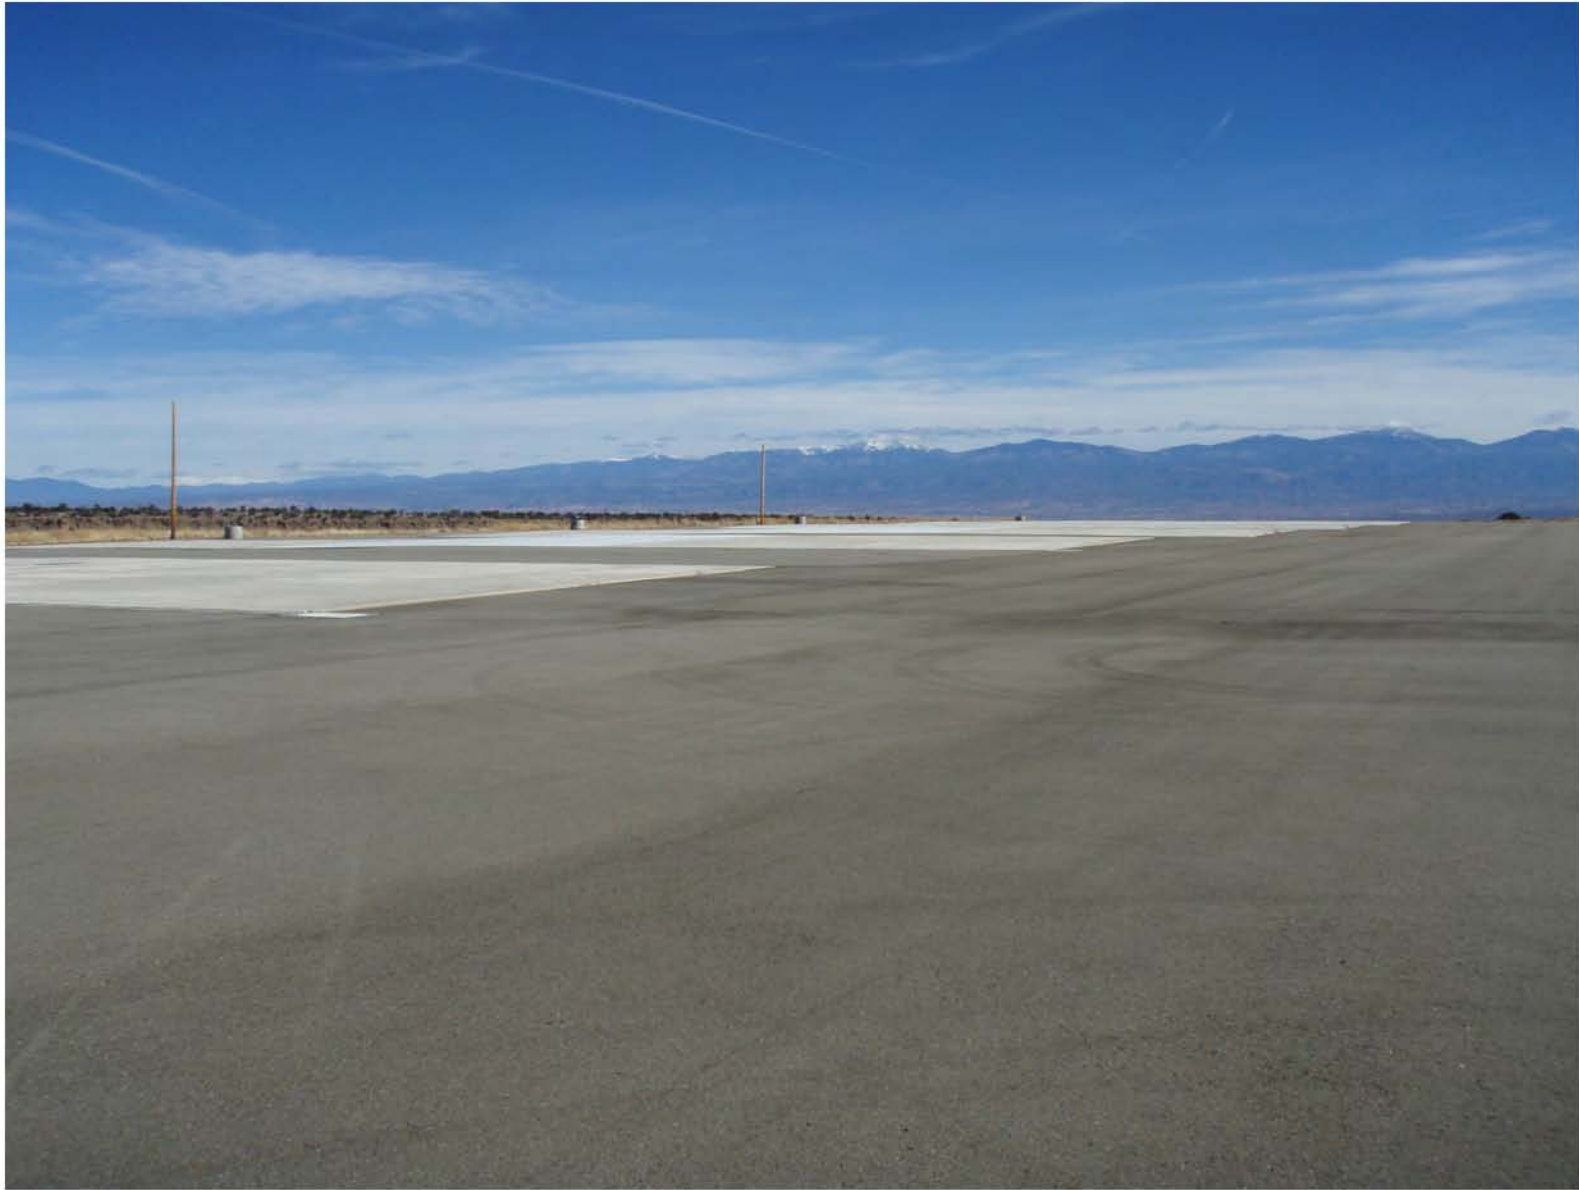
Figure 3 Looking northeast across the MatCon pavement and concrete hangar pads

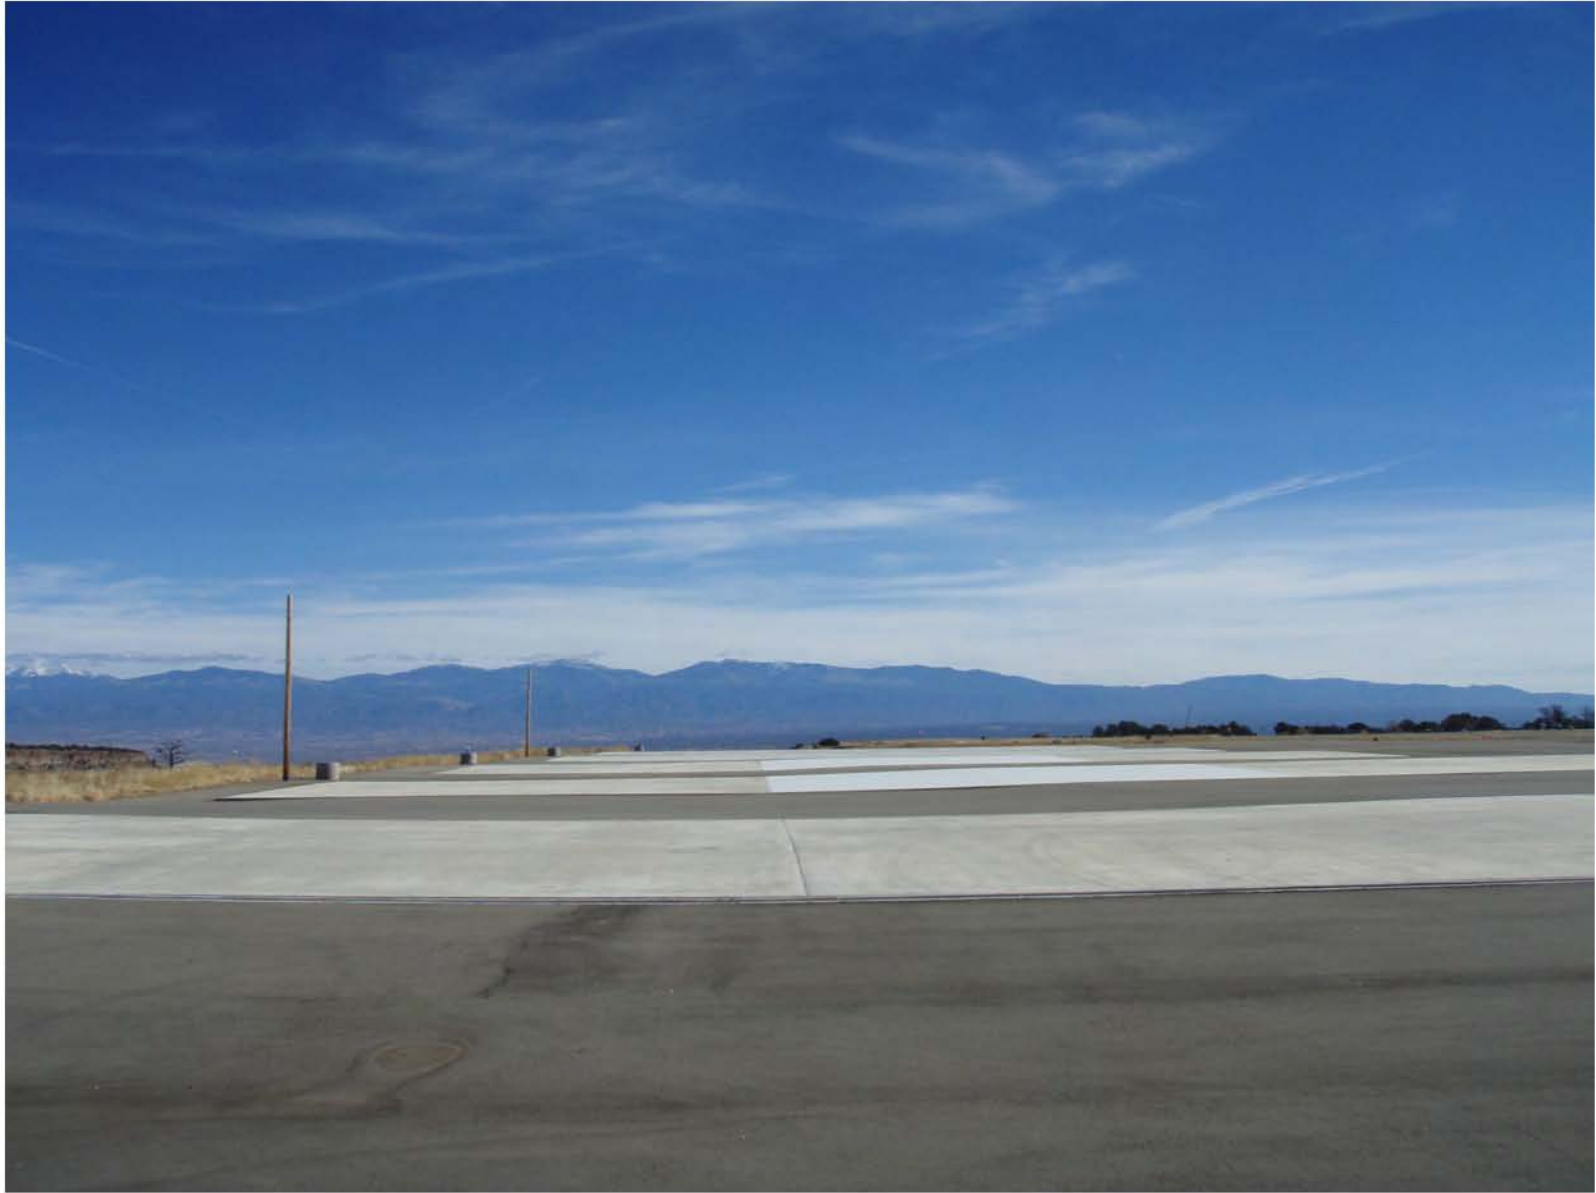
Visible subsidence of the MatCon pavement was noted near the northern half of hangar pads 2 and 3 and, to a lesser degree, along the northern quarter of pad 4. It was noted during the September 23 inspection, after the significant rainfall event, that the MatCon surface was not draining and puddles had formed. It was also noted that various locations have been patched with asphalt pavement, as shown in Figure 8.

Figure 4 View to the east, note uneven appearance of pads and MatCon pavement

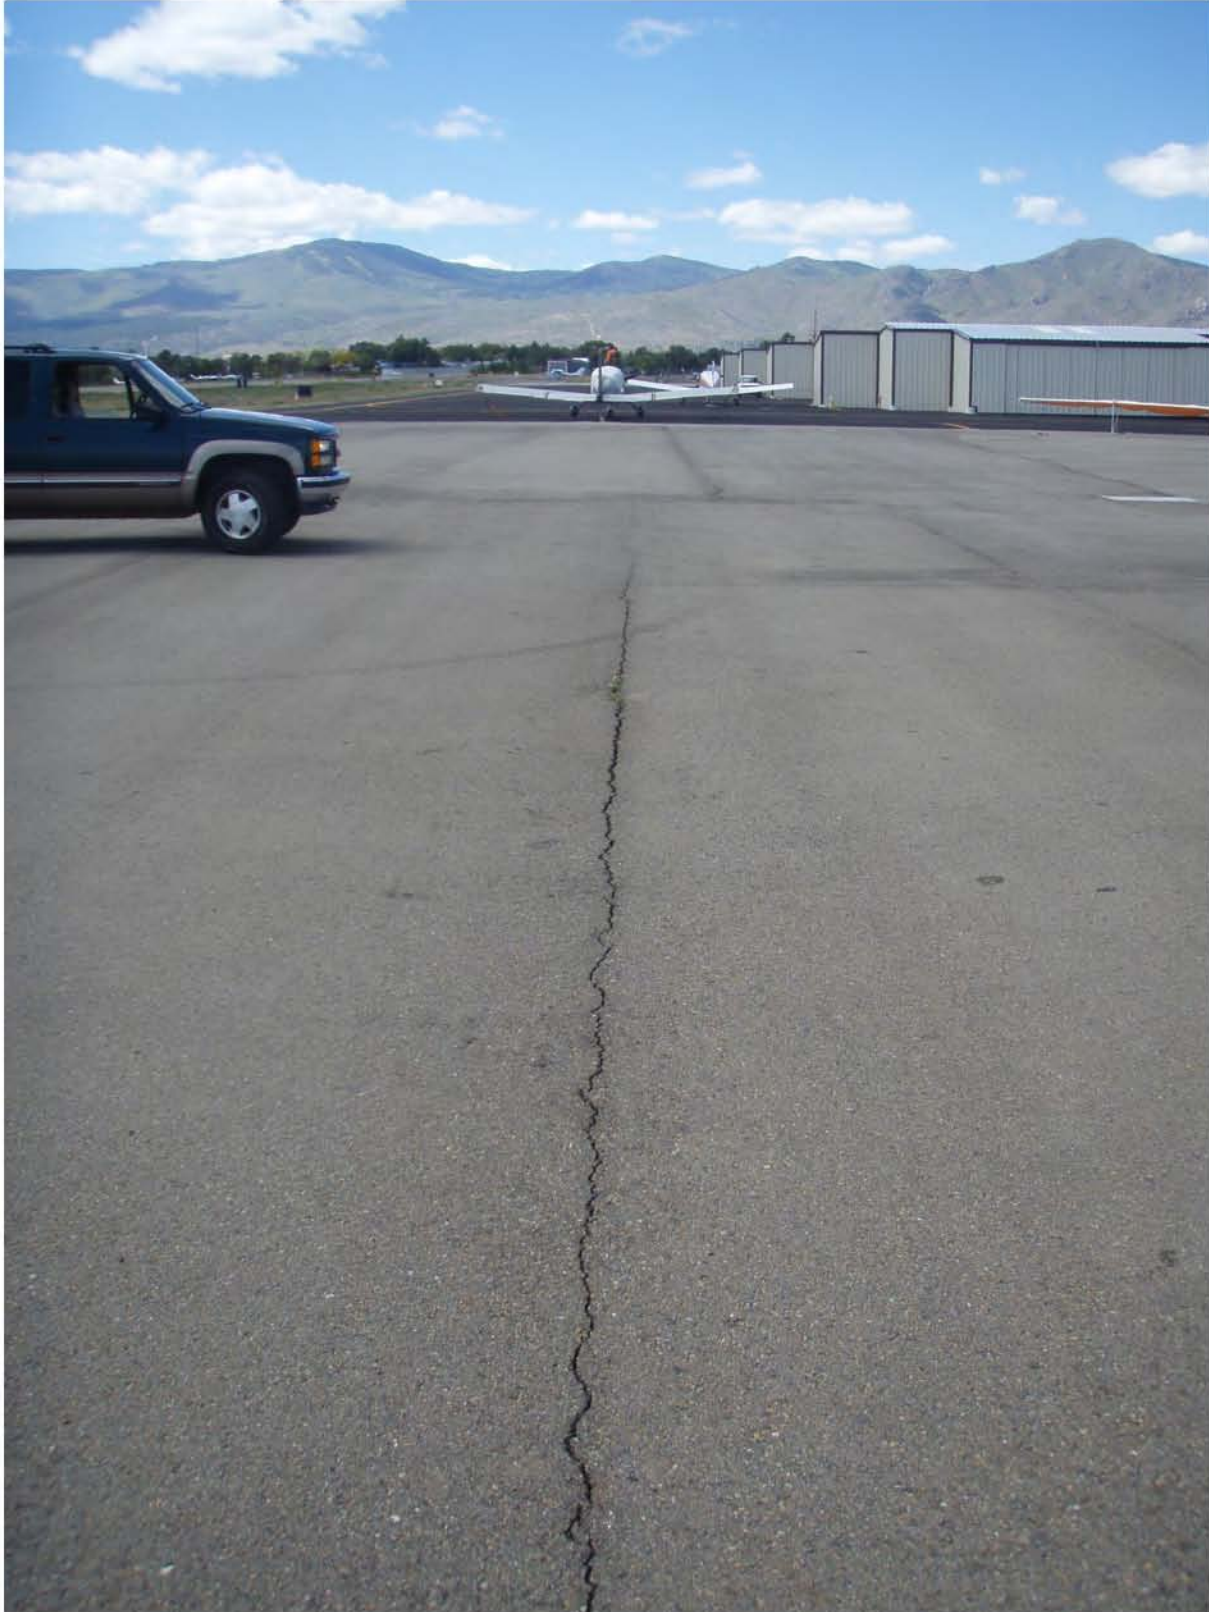
Visible cracking or separation was noted in various locations of the MatCon pavement. The cracks occurred mainly along the contact seam between paving lanes as shown in Figure 5. Cracks ranged from a few feet to over 100 ft in length, up to 0.5 in. wide and approximately 3 in. deep. Weeds were observed growing through the cracks in several locations, as shown in Figures 6 and 7.

Figure 5 Typical crack in MatCon pavement, view to the west

Remedies for the permanent correction of the cracking, separation, and subsidence of the MatCon are being evaluated by the Army Corps of Engineers, but no recommendations have resulted from this evaluation to date. Recommendations, if any, will be presented in the 2011 inspection report.

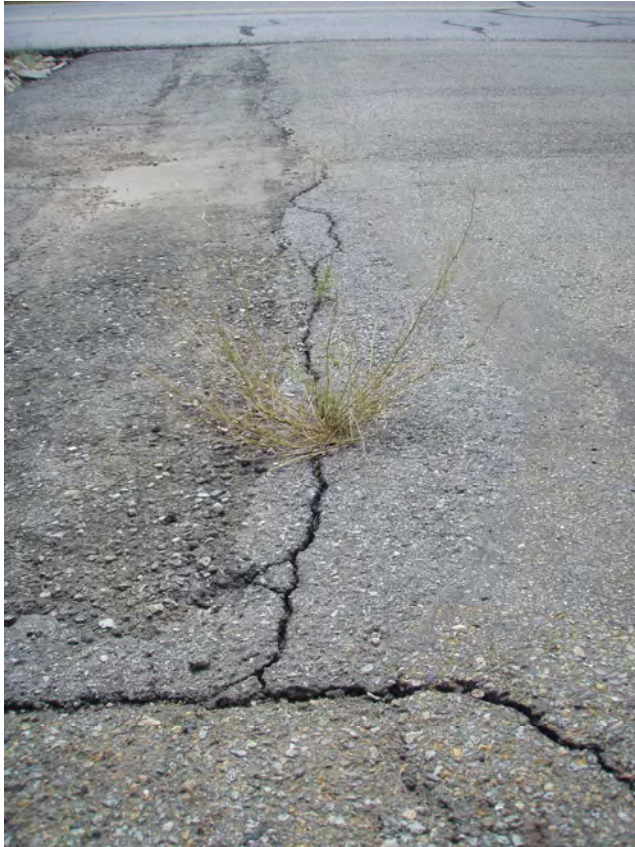
Figure 6 **Vegetation growing within cracks of the MatCon pavement near the gravel drainage channel**

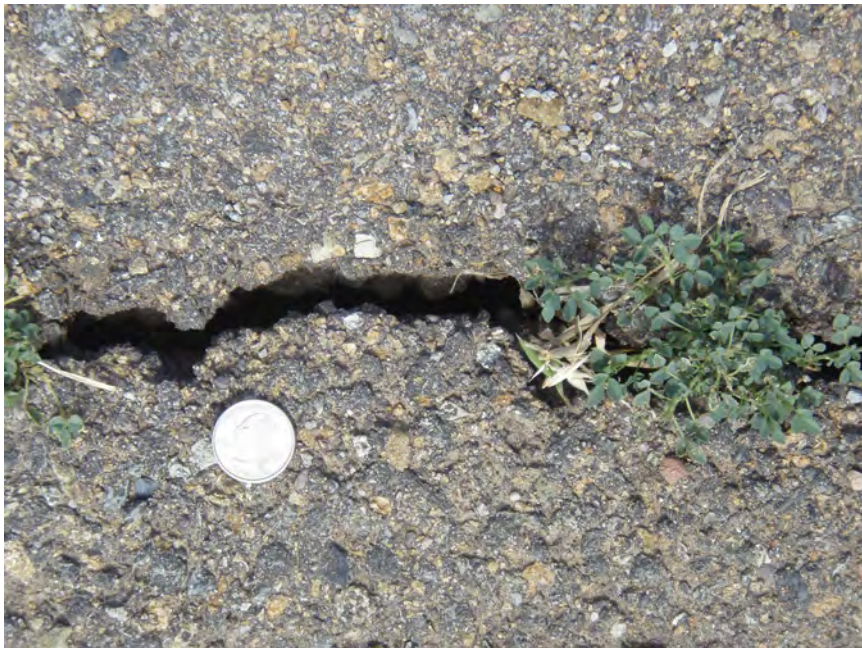
Figure 7 **Vegetation growing in crack in MatCon pavement south of hangar pad 1**

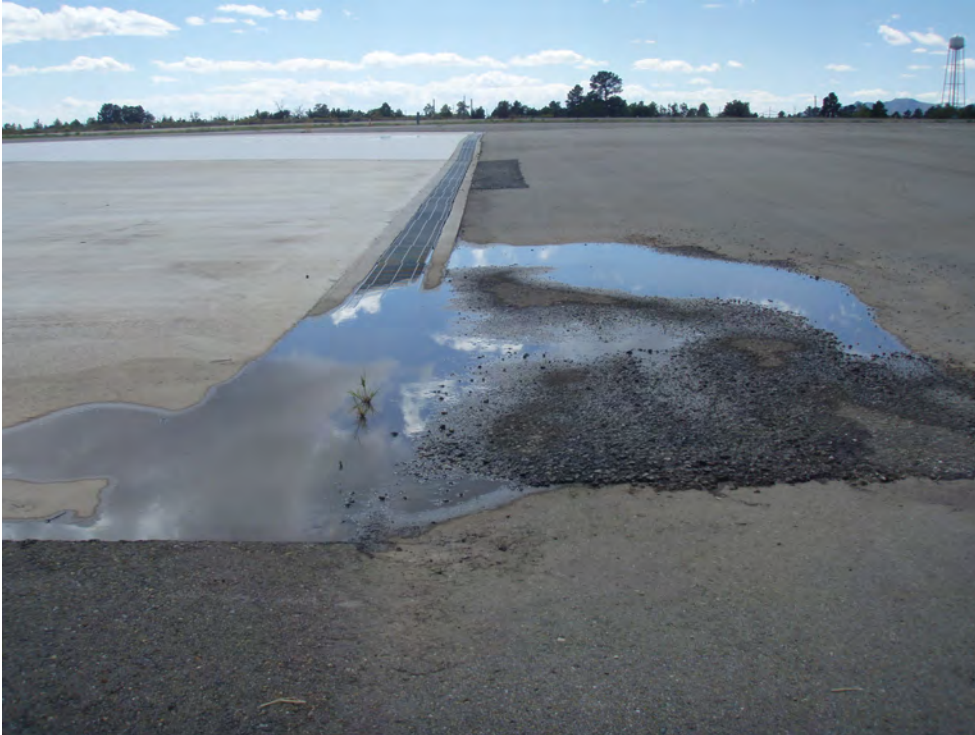
Figure 8 Ponding of water at northwest corner of hangar pad 3, note asphalt patches

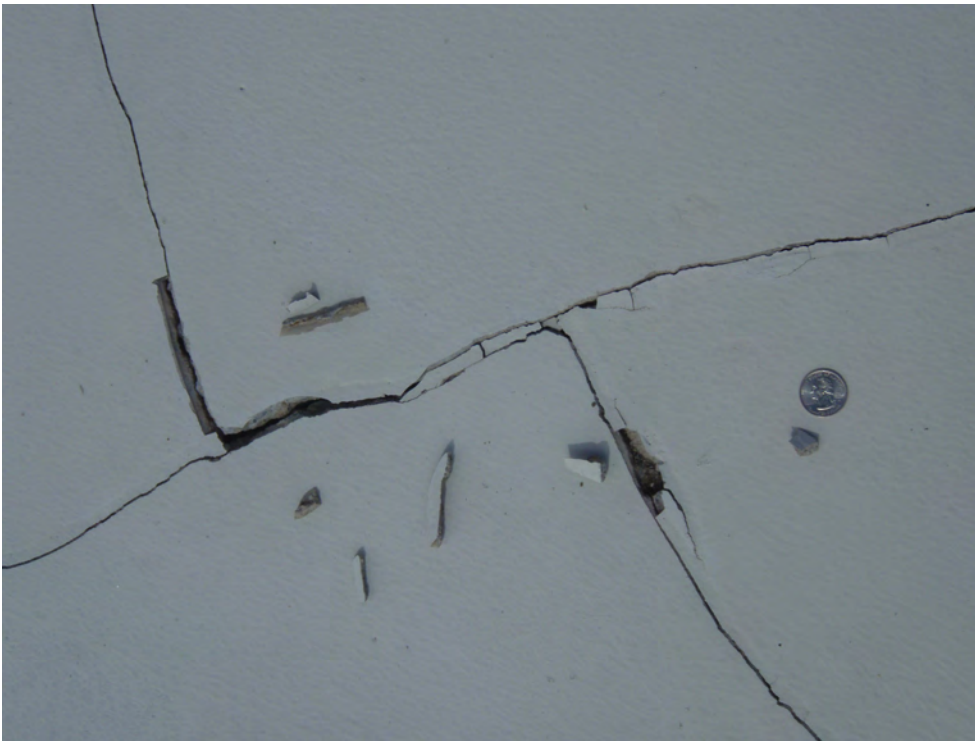
Cracking associated with the subsidence of the pads was also noted throughout the central portion of each pad. Typical cracking observed at pad 3 is shown in Figure 9. Cracks in pads 2 and 3 had been treated in 2009 using polyurethane sealants (Appendix A). Some of the treated cracks have expanded and grown in length and width. Separation of the expansion joints was noted at all the pads, with the exception of pad 5.

Figure 9 Typical cracking observed in hangar pads 1, 2, 3, and 4

The rate of subsidence of the concrete hanger pads is also being evaluated by the Army Corps of Engineers. Based on the findings of their study, it will be determined whether hangars can be constructed on the pads in their current condition or if some type of pad stabilization or repair will be necessary before hangars can be built.

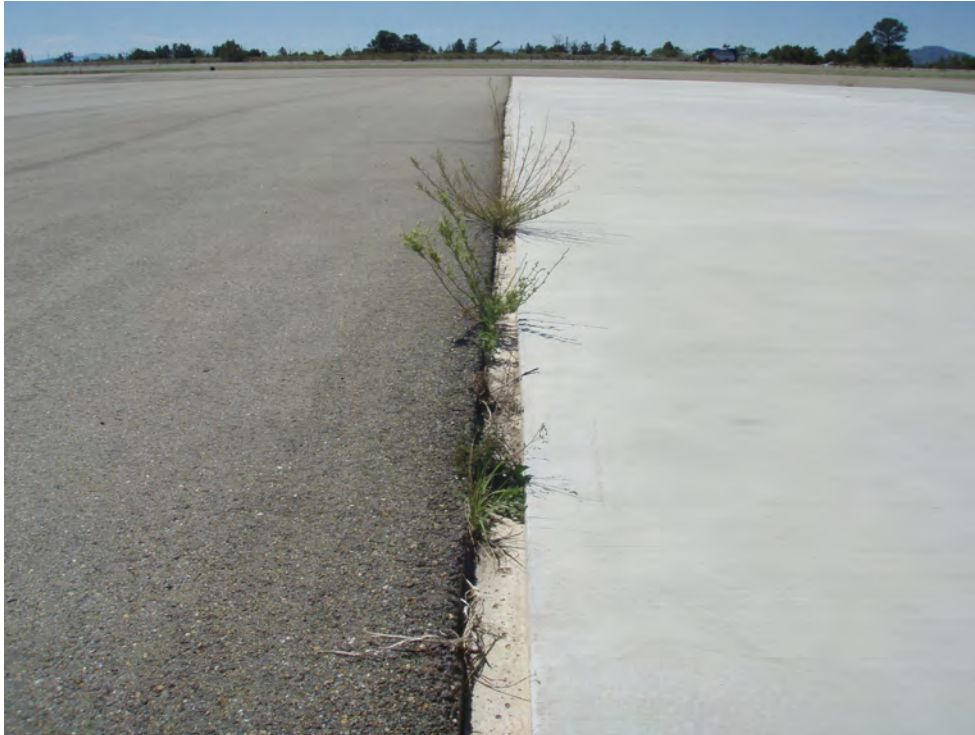
Separation or subsidence of joints between the pads and the MatCon pavement was noted at various locations, with weeds growing between the pad and the MatCon pavement in some locations, as shown in Figure 10.

Figure 10 Vegetation growing between MatCon and hangar pad 4

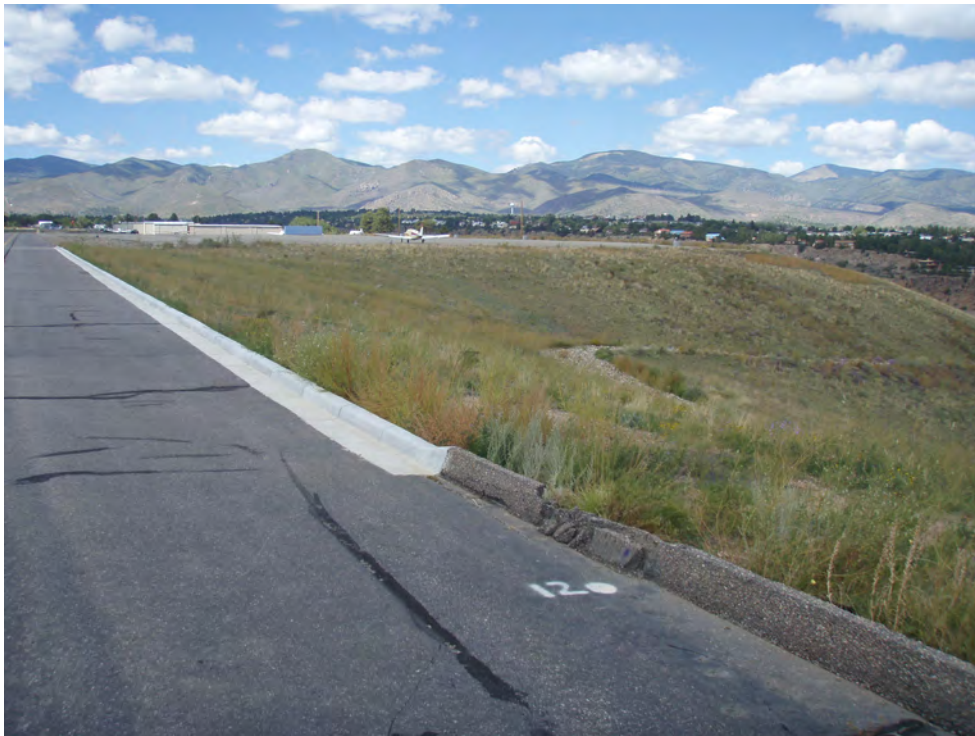
The vegetated areas are well populated with various grasses, some shrubs, and seasonal weeds, as shown in Figure 11. A few areas have sparse vegetation but are covered with TRM. No animal burrows were noted. Erosion caused by stormwater runoff was noted in one area during the inspection. Rills are forming along the northeast margin of the vegetated slope and the straw wattle area, as shown in Figure 12. Minor sediment accumulation is evident behind the wattles shown in Figure 13. In general, the vegetated cap is functioning as designed.

Figure 11 Curb installed in 2009 to control run-on to vegetative cap

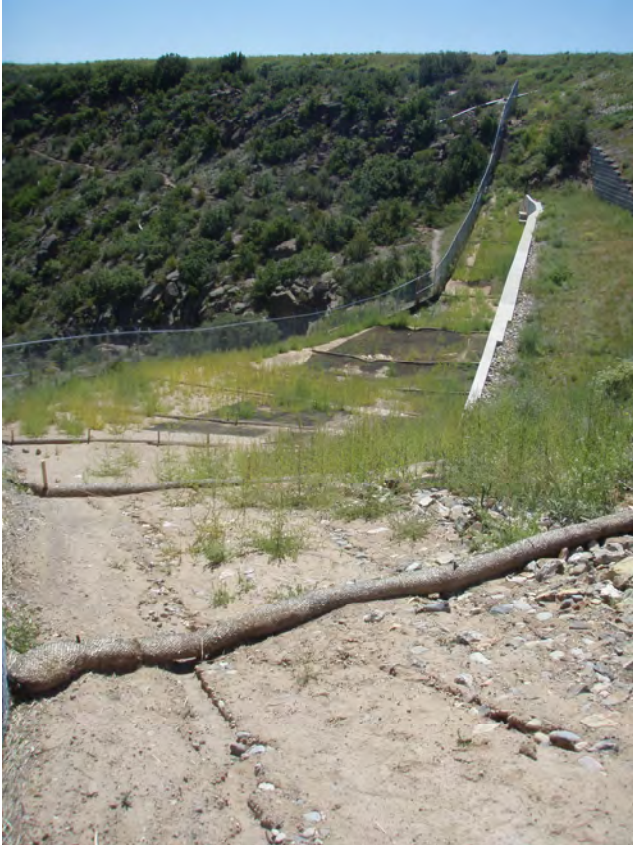
Figure 12 Rilling in wattle area

Based on the findings of the inspection activities, it is recommended that measures be taken to install gas-vent risers and spinners at the capped vent locations and to restore the rilling area to meet the original design configuration. A detailed engineering evaluation is currently being conducted by the Army Corps of Engineers to assess the rate of subsidence of the MatCon pavement and associated concrete hangar pads.

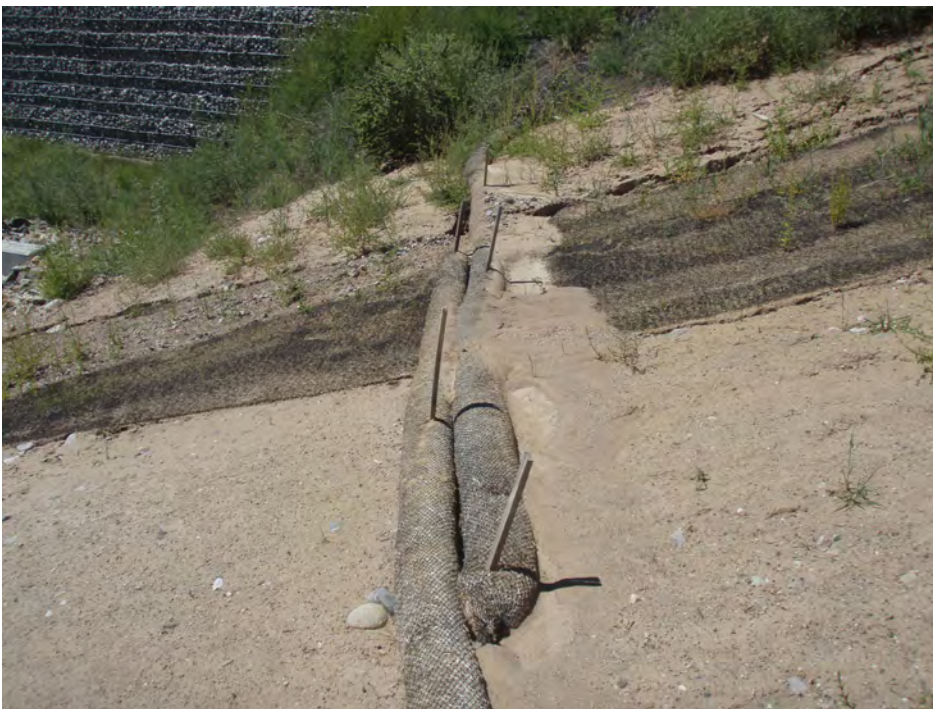
Figure 13 Sediment accumulation behind wattles in the wattle area

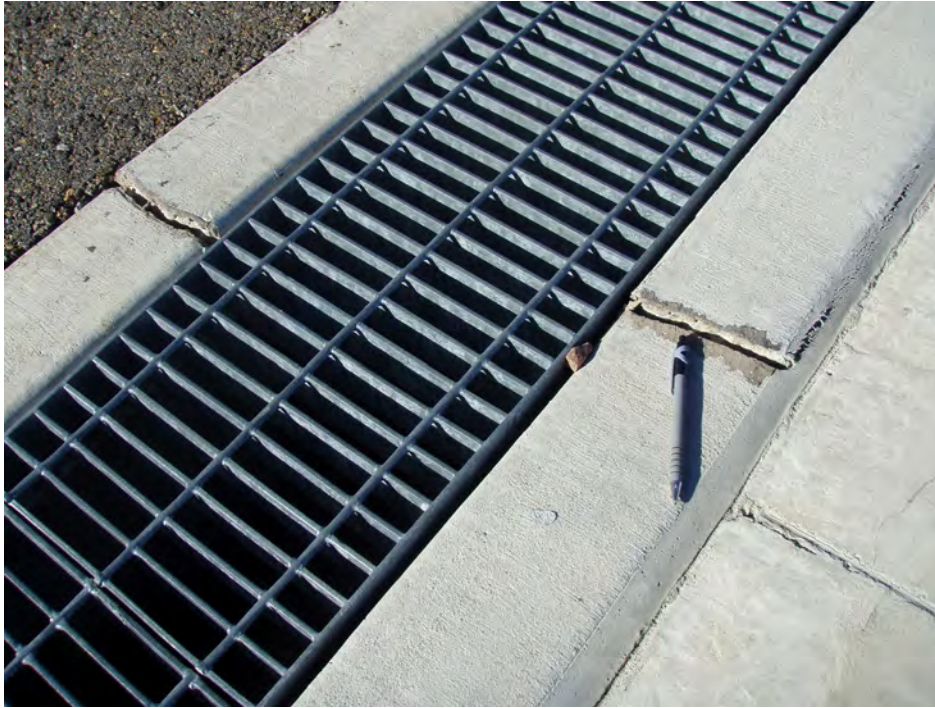
General cracking was noted along the concrete channels of the five trench drains next to the hangar pads. Larger cracks (approximately 0.25 to 0.5 in. in width), as shown in Figures 14 and 15, and displacement of the concrete channels associated with hangar pad subsidence were noted in the trench drains next to hangar pads 1, 2, 3, and 4, as shown in Figure 16. Cracks in the trench drains next to pads 2 and 3 appear to have been previously repaired with grout. Drain inlets associated with pads 1, 2, and 3 are cracking or flaking and contain standing water. The remaining 10 drain inlets, manhole, and outfall appear to be in good working order. Underground piping runs were not inspected.

Figure 14 Crack across trench drain at hangar pad 1

Remedies for the permanent correction of the cracking, separation, and subsidence of the stormwater-collection system are being evaluated by the Army Corps of Engineers, but no recommendations have resulted from this evaluation to date. Recommendations, if any, will be presented in the 2011 inspection report.

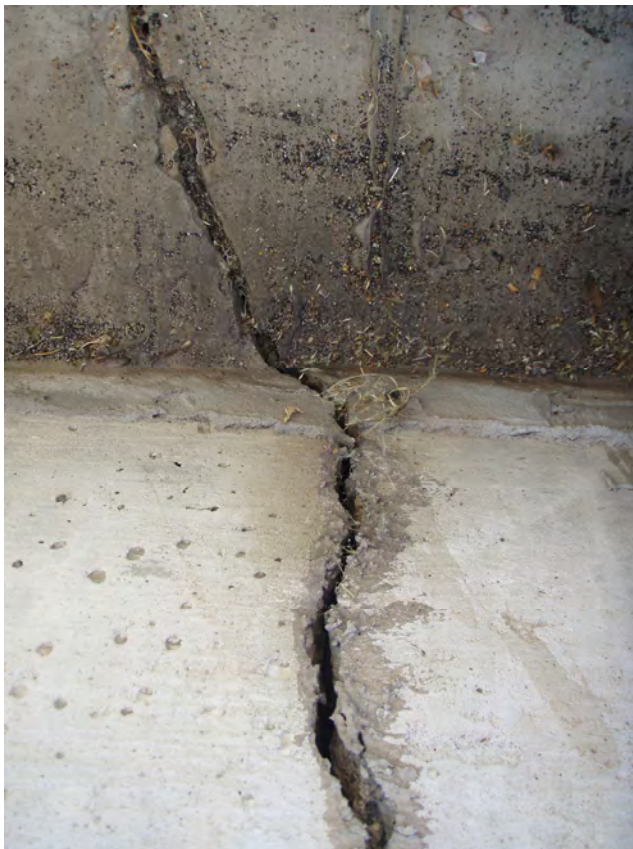
Figure 15 Crack across bottom and side of trench drain at hangar pad 1

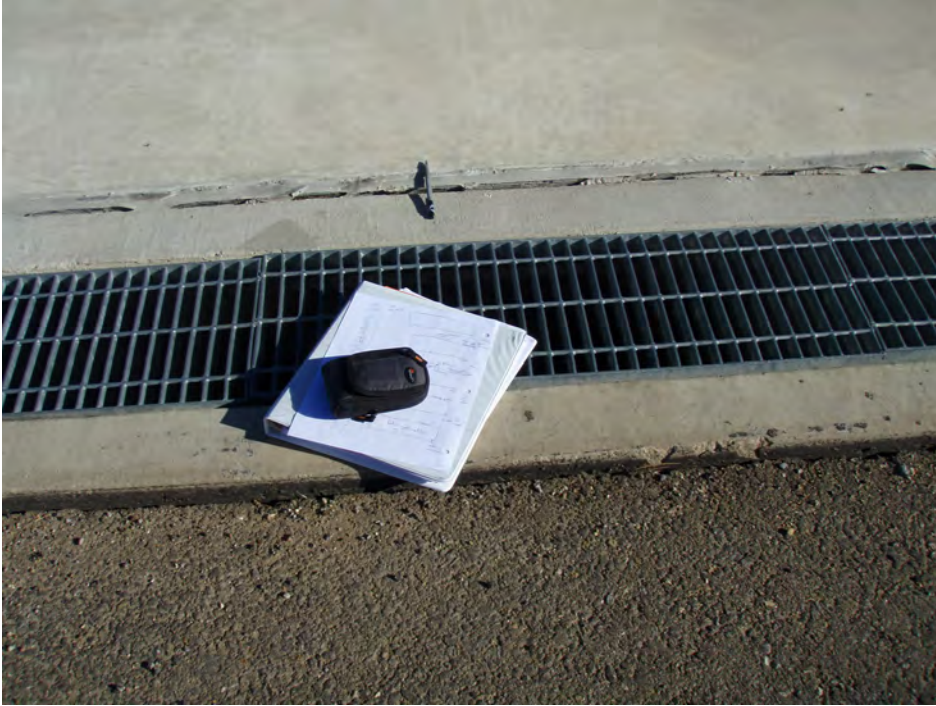
Figure 16 Separation between hangar pad and trench drain, note subsidence of MatCon pavement

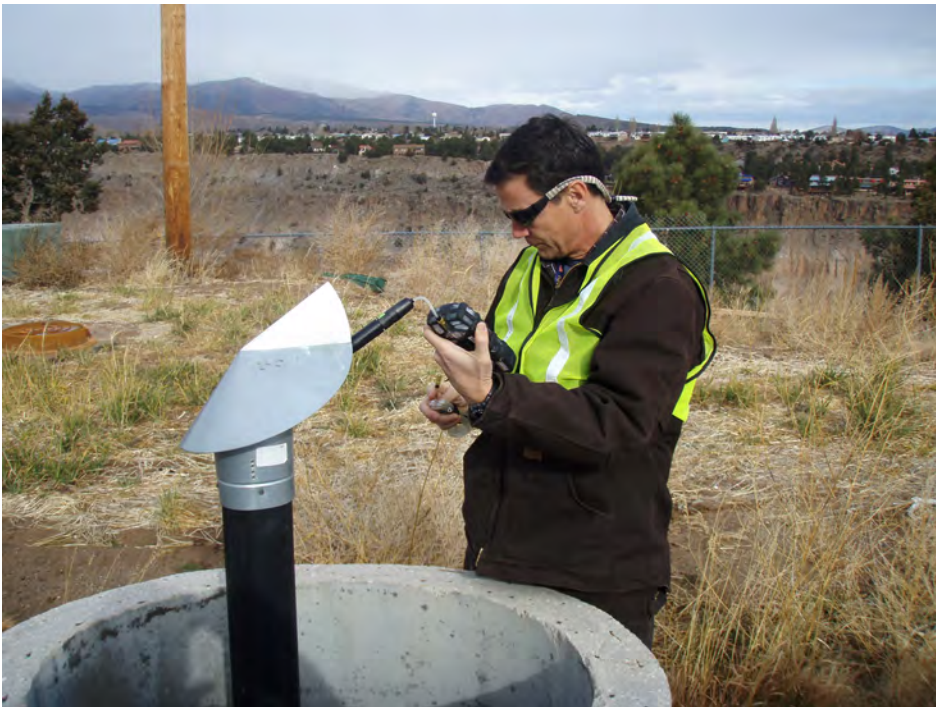
Figure 17 Gas survey at vent riser with spinner

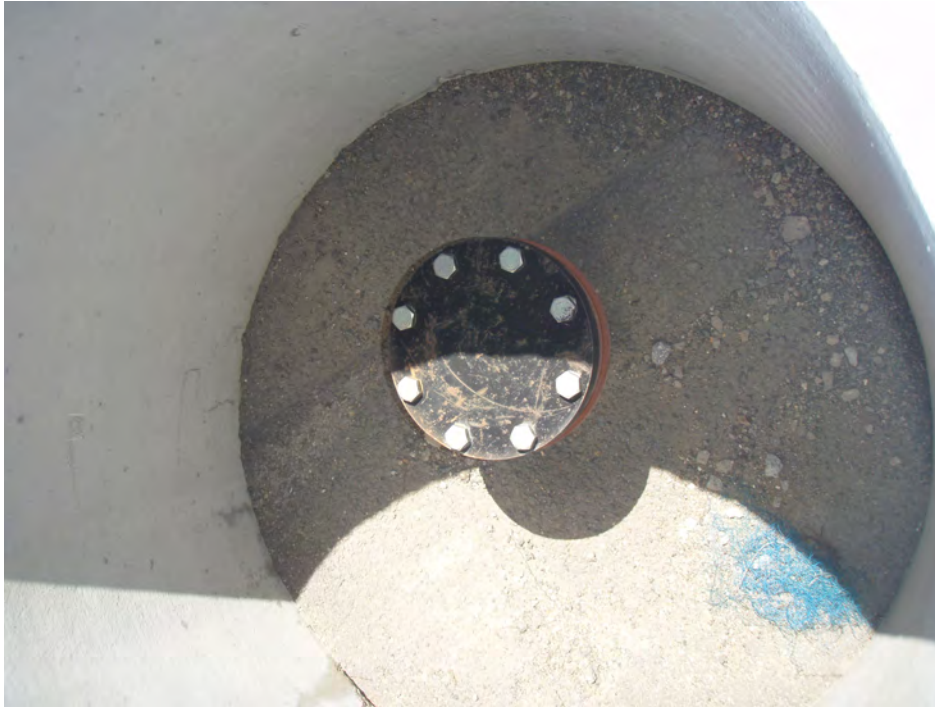
Figure 18 Gas vent with capping flange

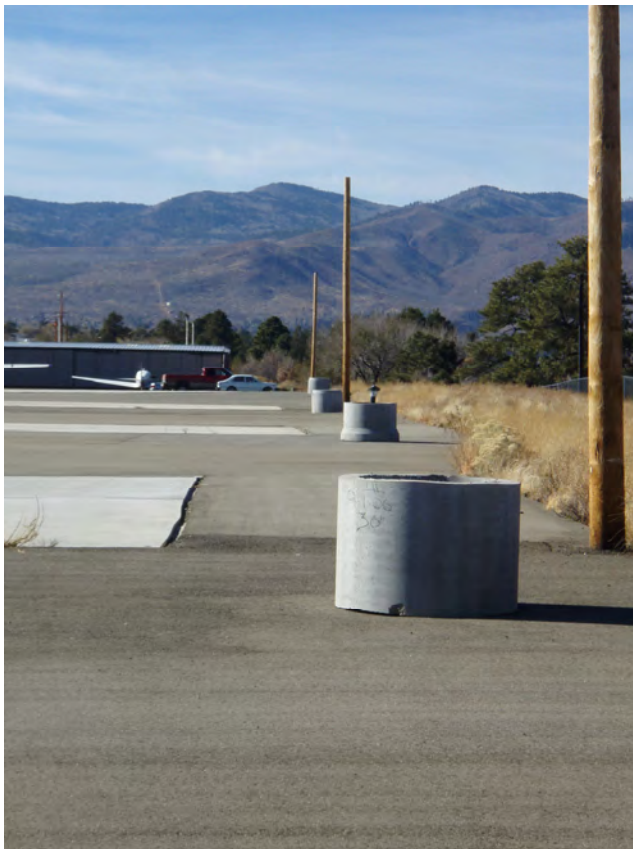
Figure 19 Gas vent locations, note missing risers and spinners

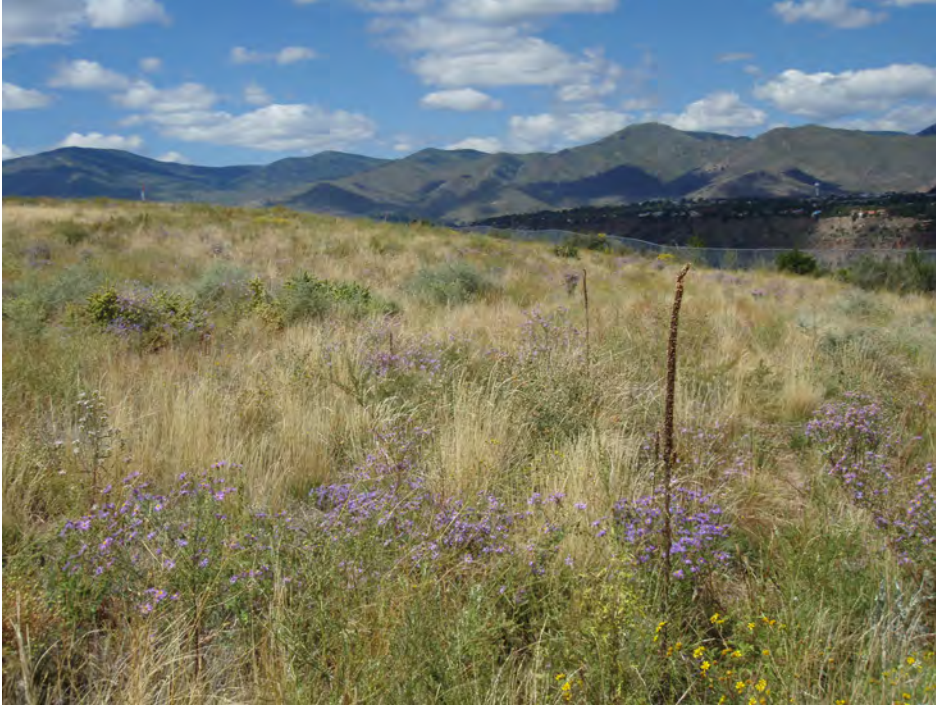
Figure 20 Vegetated DDA

The vegetative cover is functioning properly at the DDA; therefore, there are no recommendations for the DDA.

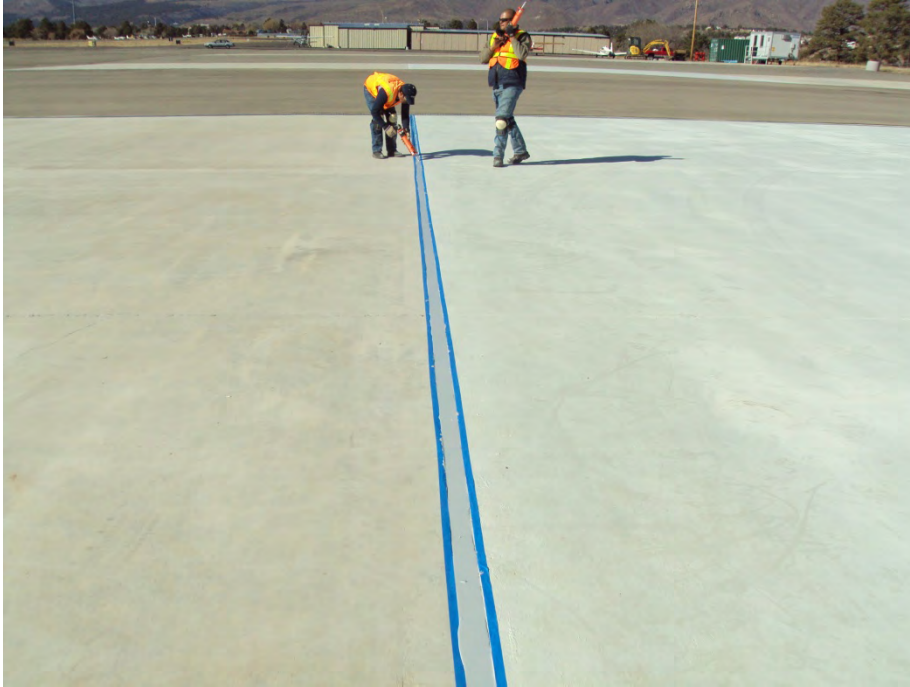
HANGAR PADS-FILLING CRACKS
