2015 Update to the Site Discharge Pollution Prevention Plan, Revision 1

Los Alamos National Laboratory
NPDES Permit No. NM0030759
LA-UR-16-22469 • May 1, 2016

Los Alamos/Pueblo Watershed

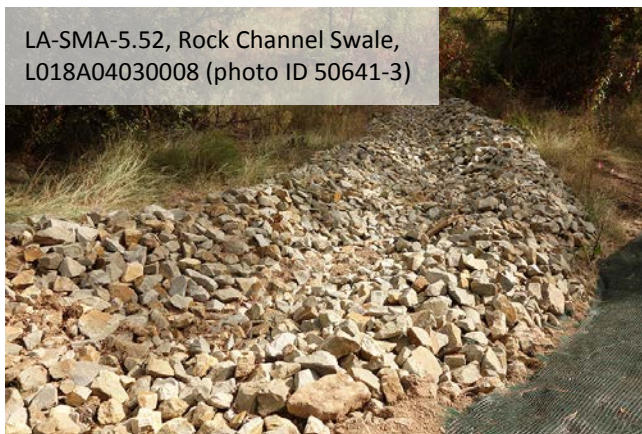
LA-SMA-5.52, Rock Channel Swale, L018A04030008 (photo ID 50641-3)

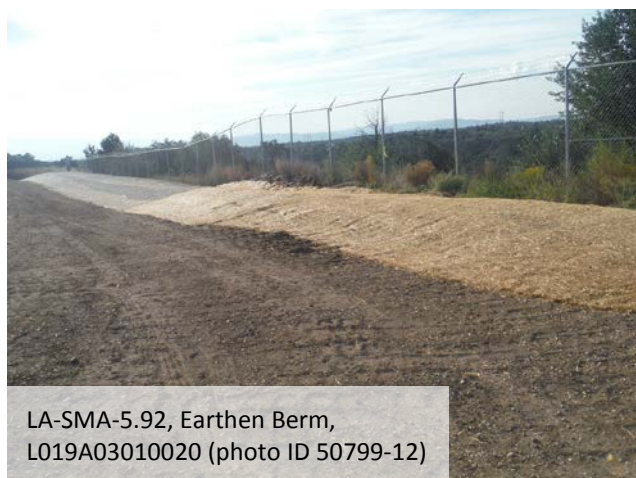
LA-SMA-5.92, Earthen Berm,
L019A03010020 (photo ID 50799-12)
