Completion Documentation for Construction of Three Cross-Vane Structures in Pueblo Canyon

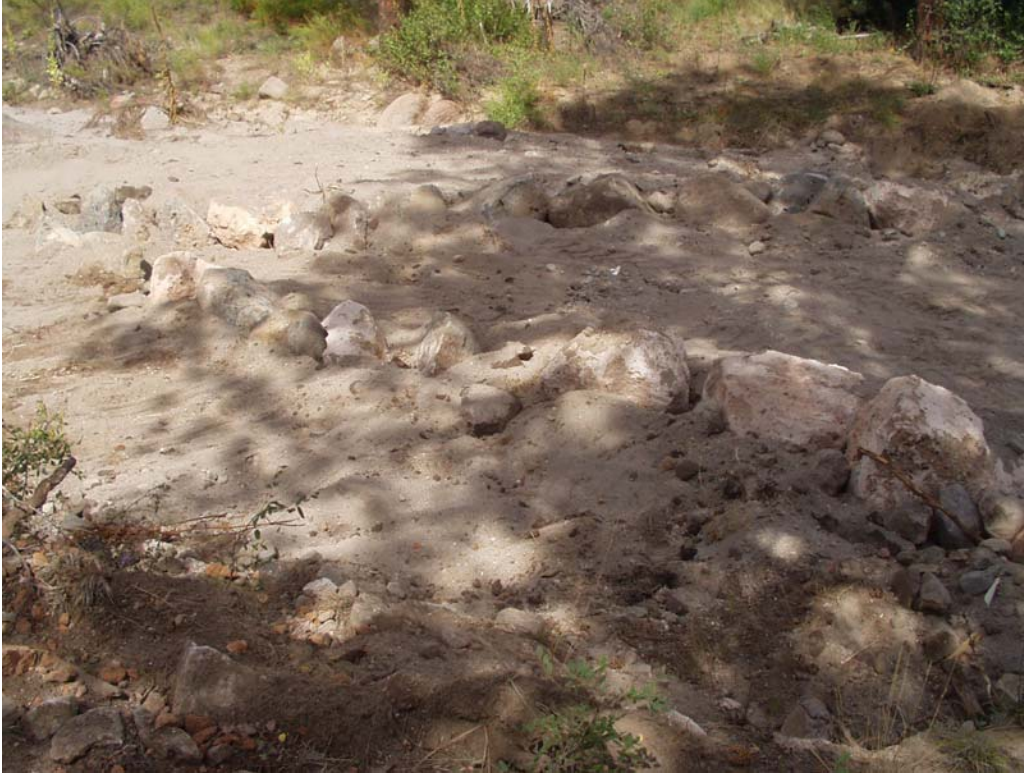
Figure 1a View of upper cross-vane structure looking north across the Pueblo Canyon channel

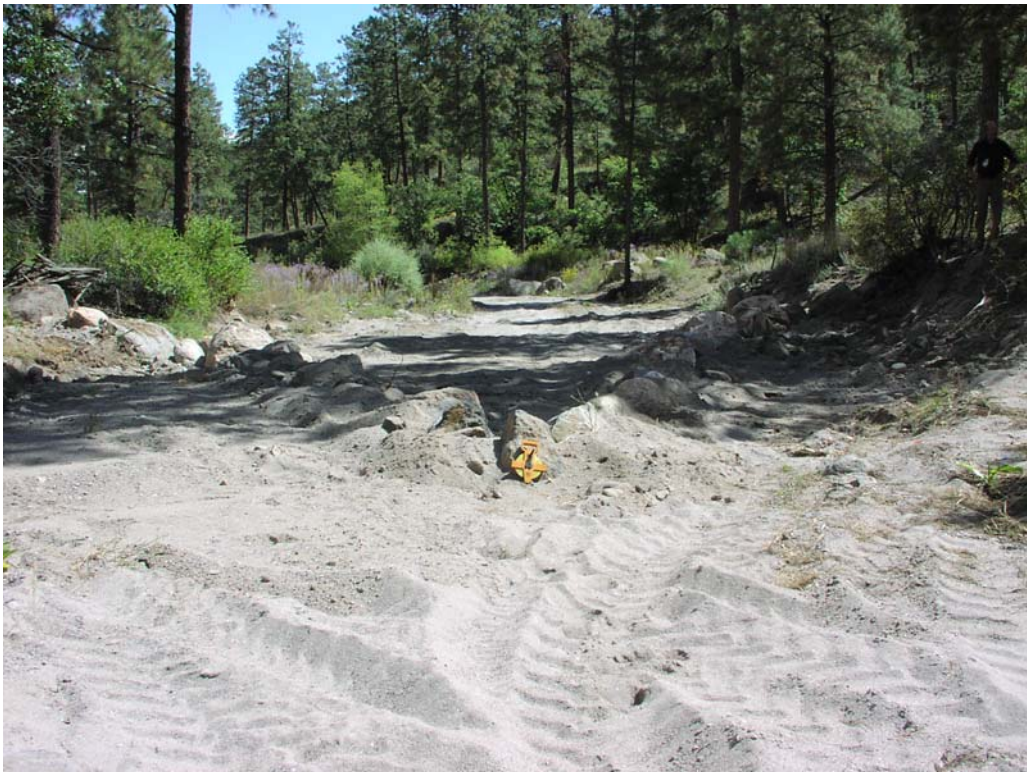
Figure 1b Downcanyon view of the upper cross-vane structure

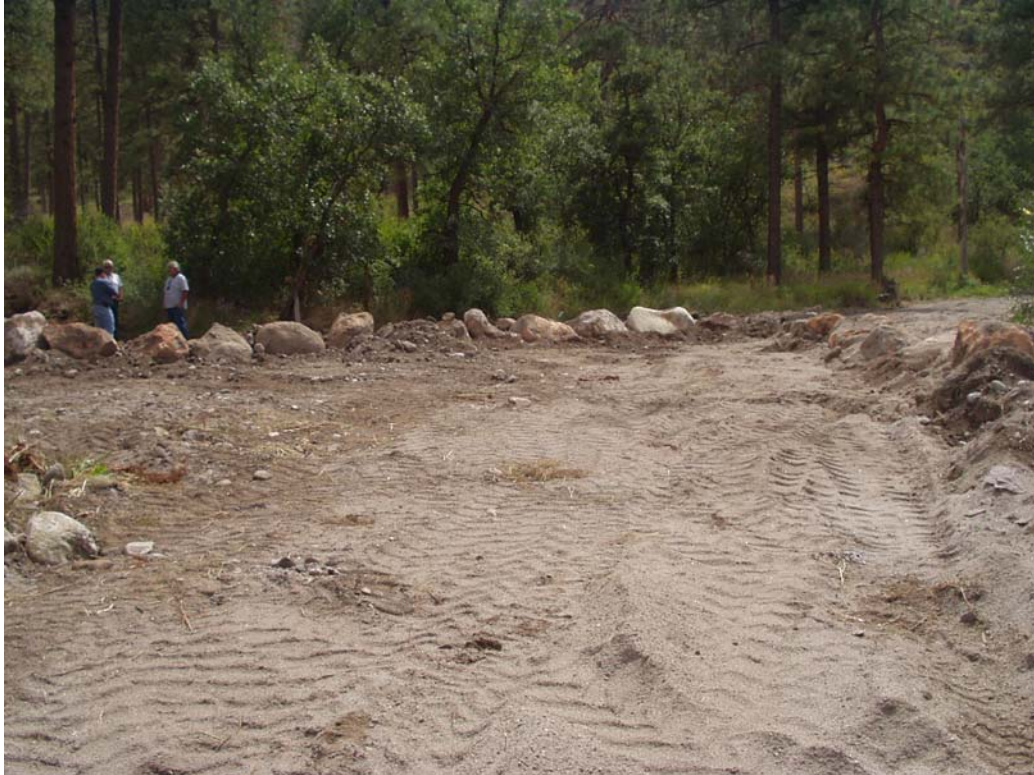
Figure 2a Upcanyon view of the middle cross-vane structure

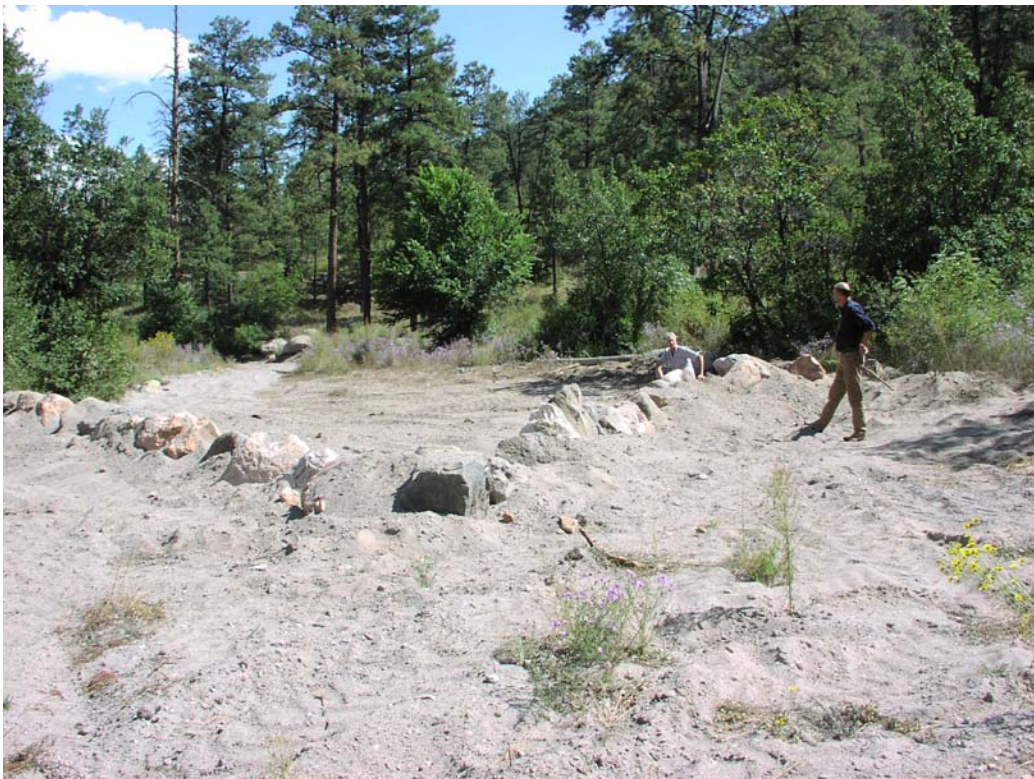
Figure 2b View looking downcanyon at the middle cross-vane structure

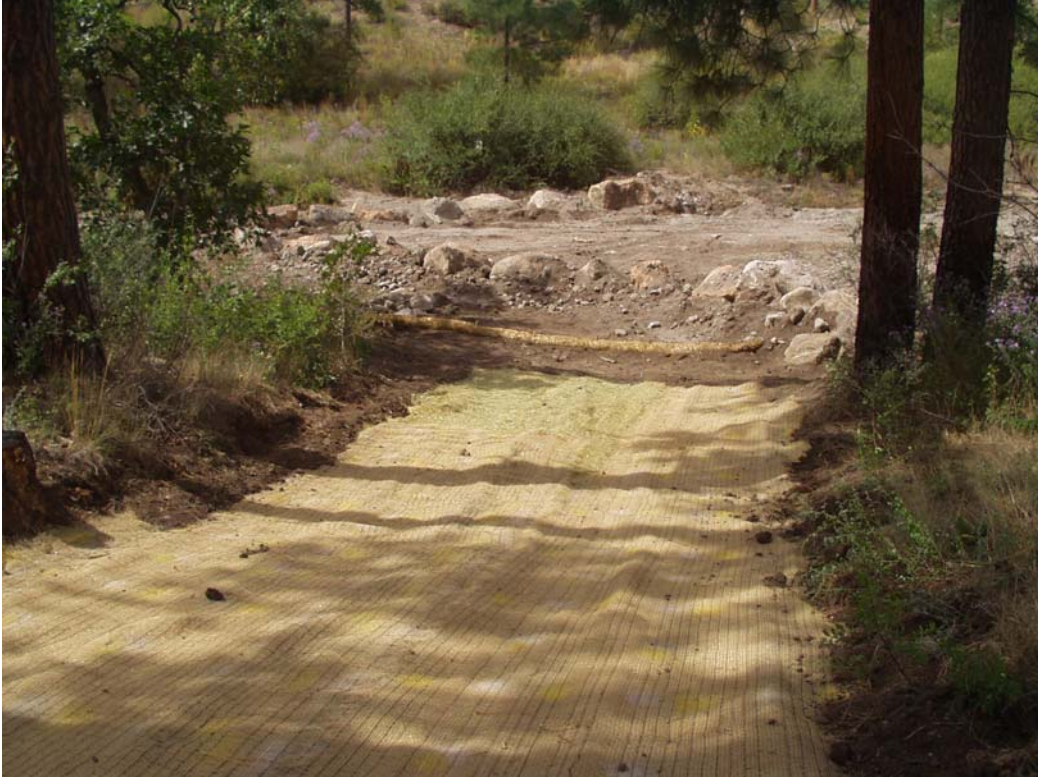
Figure 3a View looking north across the lower cross-vane structure showing rehabilitation of access road

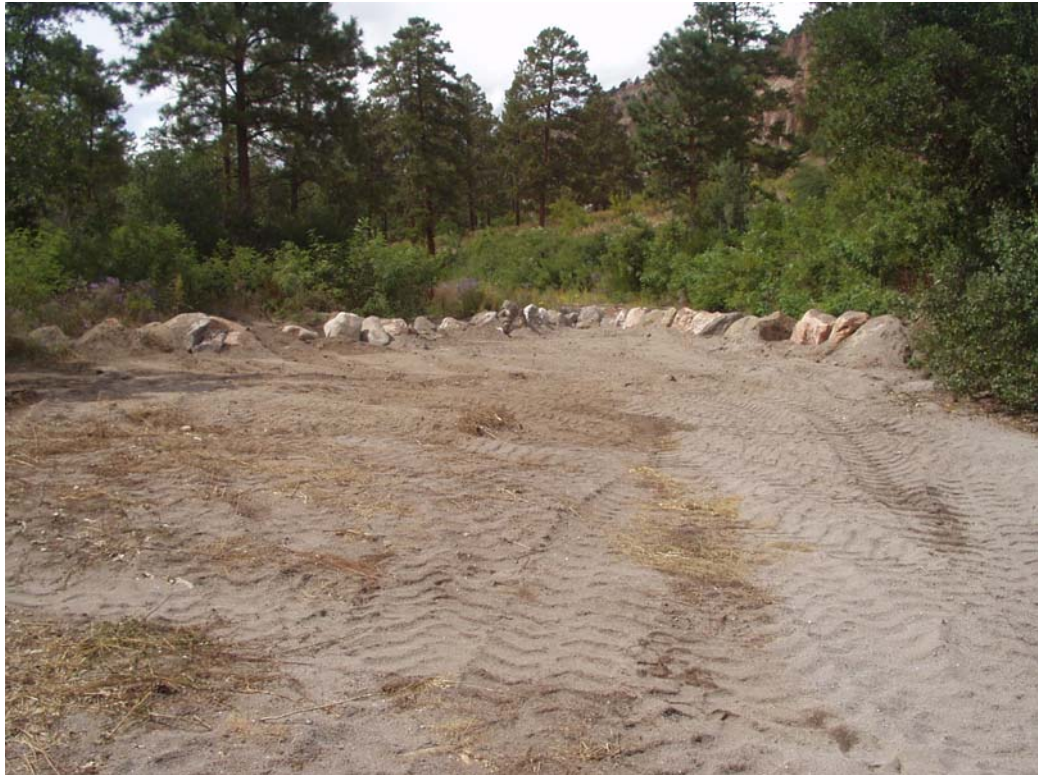
Figure 3b View looking upcanyon at the lower cross-vane structure
