2012 Update to the Site Discharge Pollution Prevention Plan, Revision 1

Los Alamos National Laboratory
NPDES Permit No. NM0030759
LA-UR-13-21503 • May 1, 2013

Water/Cañon de Valle Watershed

Volume 4

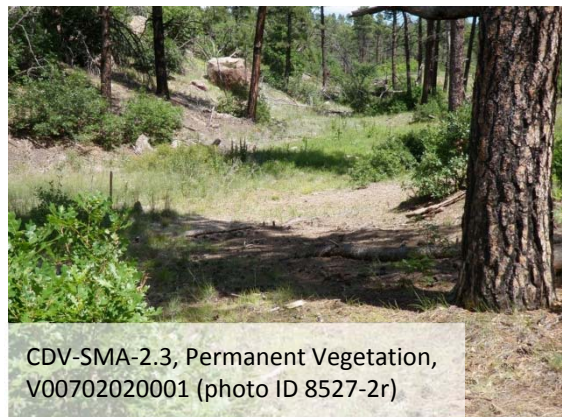
CDV-SMA-2.3, Permanent Vegetation, V00702020001 (photo ID 8527-2r)

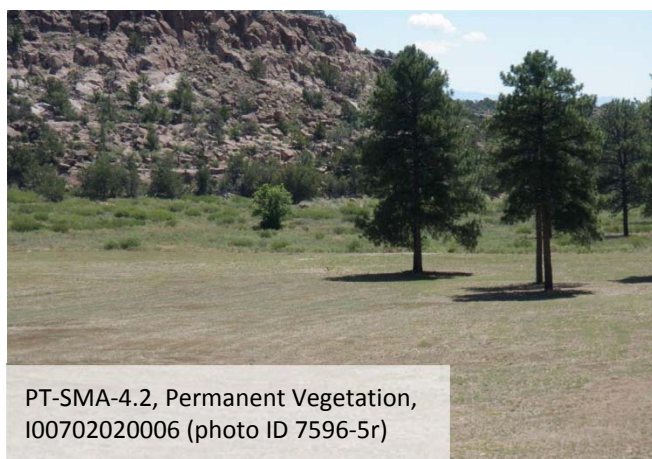
PT-SMA-4.2, Permanent Vegetation, I00702020006 (photo ID 7596-5r)
