Subject: Inspection and Maintenance of Erosion Controls in Drainages to the 90s Line Pond at Technical Area 16

Enclosures: Two hard copies with electronic files – Inspection and Maintenance of Erosion Controls in Drainages to the 90s Line Pond at Technical Area 16 (LA-UR-14-28411)

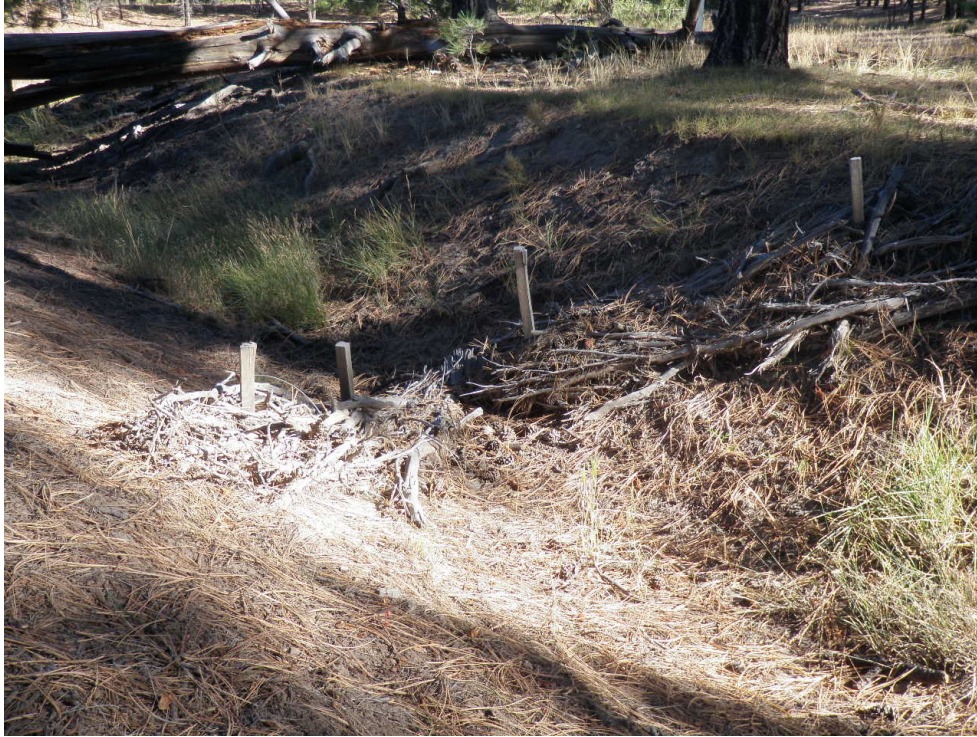
Best management practices (BMPs) were previously installed in 2008 in the two major drainages to the 90s Line Pond. The BMPs consist of juniper bales designed to block sediment transport down the drainages into the pond. All controls are currently in good operating condition (Figures 1 to 3) with no evidence of erosion in the drainages.

Figure 1 Juniper bale check dam in channel draining to 90s Line Pond, October 2014. Note needle cast and vegetation in channel.

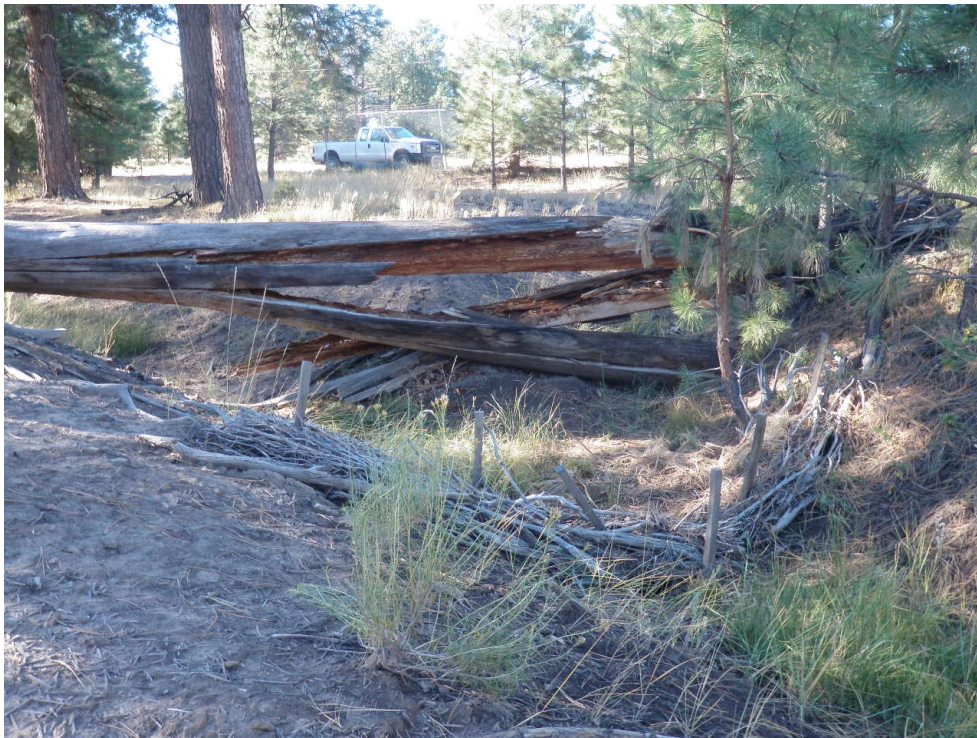
Figure 2 Juniper bale check dam in channel draining to 90s Line Pond, November 2014. Note needle cast and vegetation in channel.

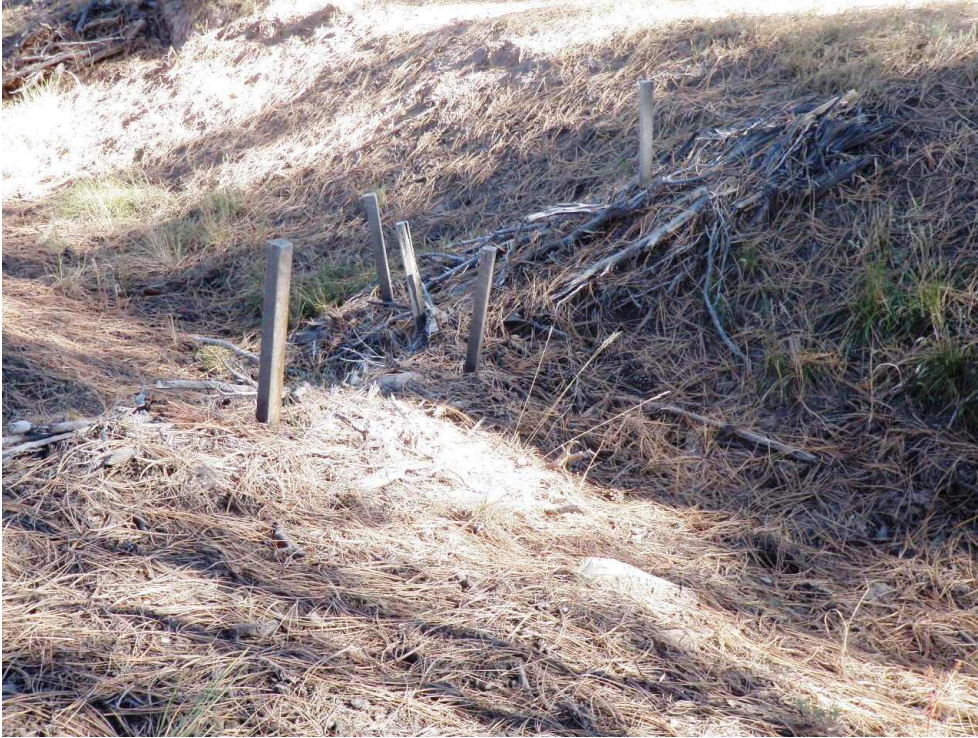
Figure 3 Juniper bale check dam in channel draining to 90s Line Pond, November 2014
