Subject: Inspection and Maintenance of Erosion Controls in Drainages to the 90s Line Pond at Technical Area 16

This letter documents the status of storm water management associated with the drainages entering the 90s Line Pond, Consolidated Unit 16-008(a)-99. This letter is required as part of the New Mexico Environment Department's (NMED's) Notice of Approval with Direction (for the) Investigation Report for Consolidated Units 16-007(a)-99 and 16-008(a)-99 at Technical Area 16, Revision 1, dated February 11, 2008, and Approval with Modifications (for the) Supplemental Investigation Work Plan for Consolidated Units 16-007(a)-99 and 16-008(a)-99 at Technical Area 16, dated December 31, 2008.

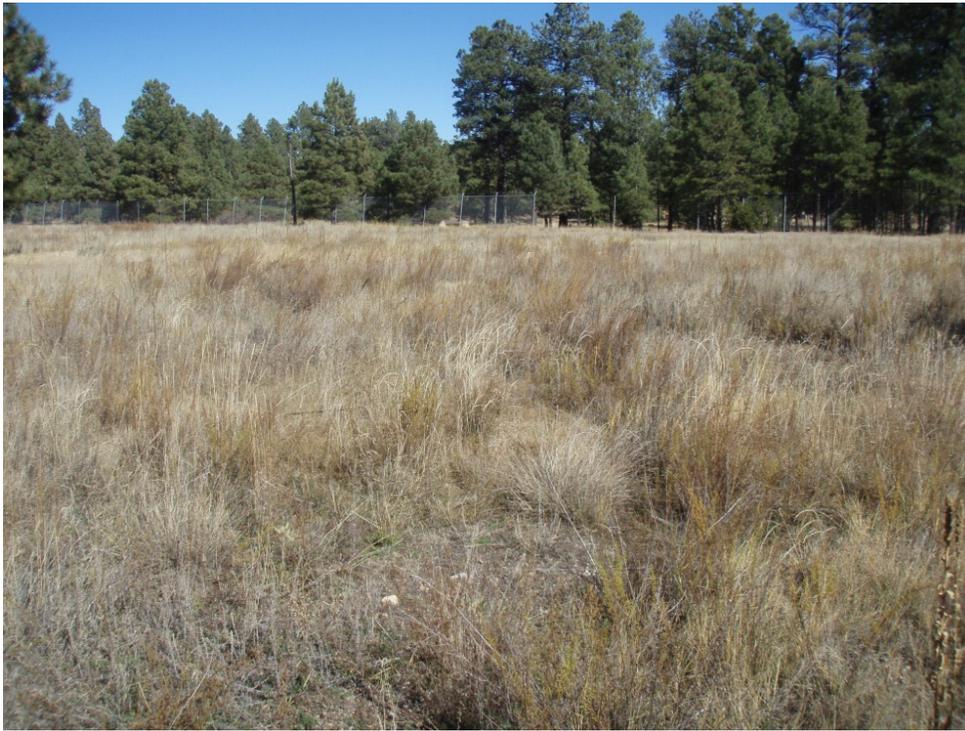
The individual solid waste management units (SWMUs) within Consolidated Unit 16-008(a)-99 are located within a level, well-vegetated area in Technical Area 16 (Figures 1 and 2). Surface flows generated in the area discharge to the 90s Line Pond have little potential to reach any waters of the U.S. The 90s Line Pond was remediated and has no outlet.

Figure 1 Vegetated area draining to 90s Line Pond

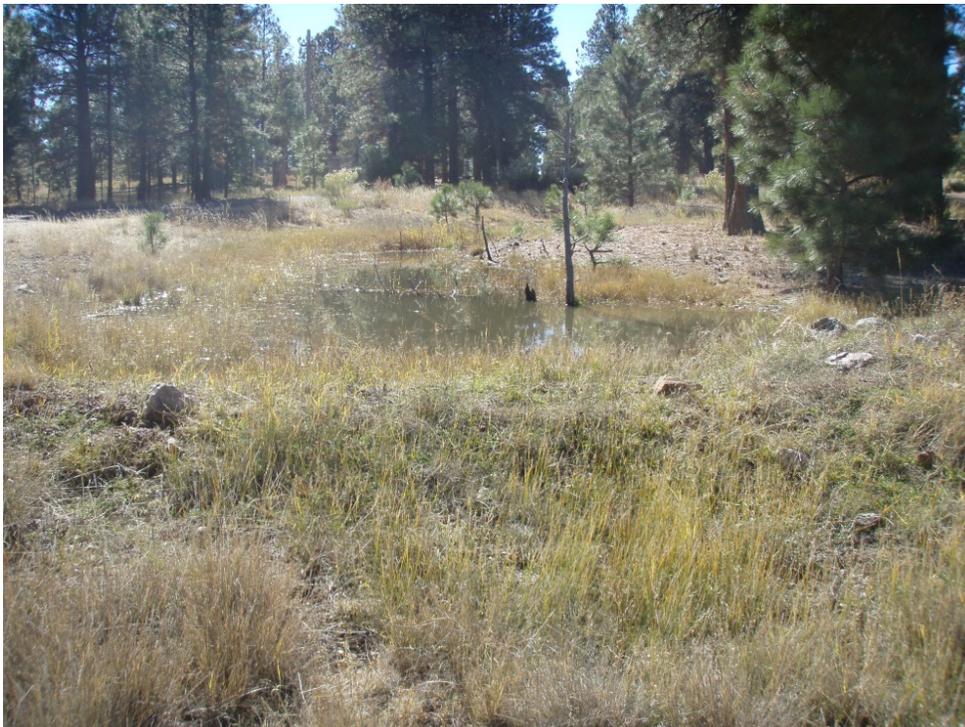
Figure 2 Run-on control berm in the vegetated area draining to 90s Line Pond

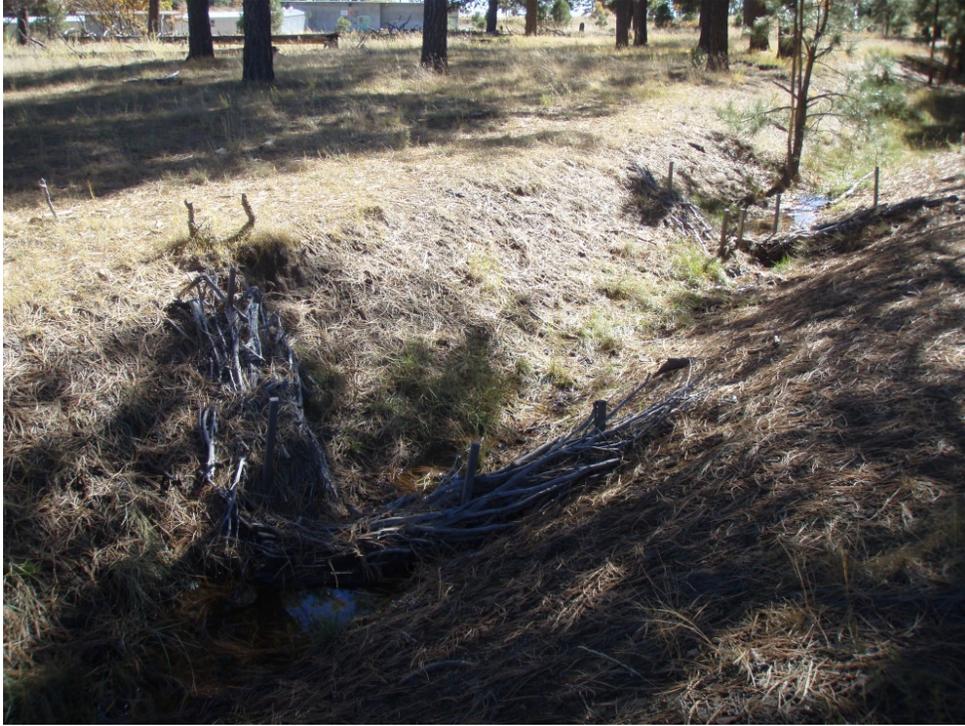
Best management practices (BMPs) were installed in 2008 in the drainages to the 90s Line Pond. The BMPs consist of juniper bales designed to block sediment transport down the drainages into the pond. All controls are currently in good operating condition with no evidence of erosion in the drainages (Figures 3 to 5).

Figure 3 Juniper bale check dams located in drainage channel to 90s Line Pond, November 2015. Note needle cast and vegetation in channel.
