Subject: Solid Waste Management Unit Assessment Report Work Plan for the Los Alamos Canyon Borrow Pit, Revision 1

Solid Waste Management Unit Assessment Report Work Plan for Los Alamos Canyon Borrow Pit, Revision 1

FORMER BORROW PIT CONTAINING LA WEIR EXCAVATED SEDIMENTS AS-BUILT CONDITIONS

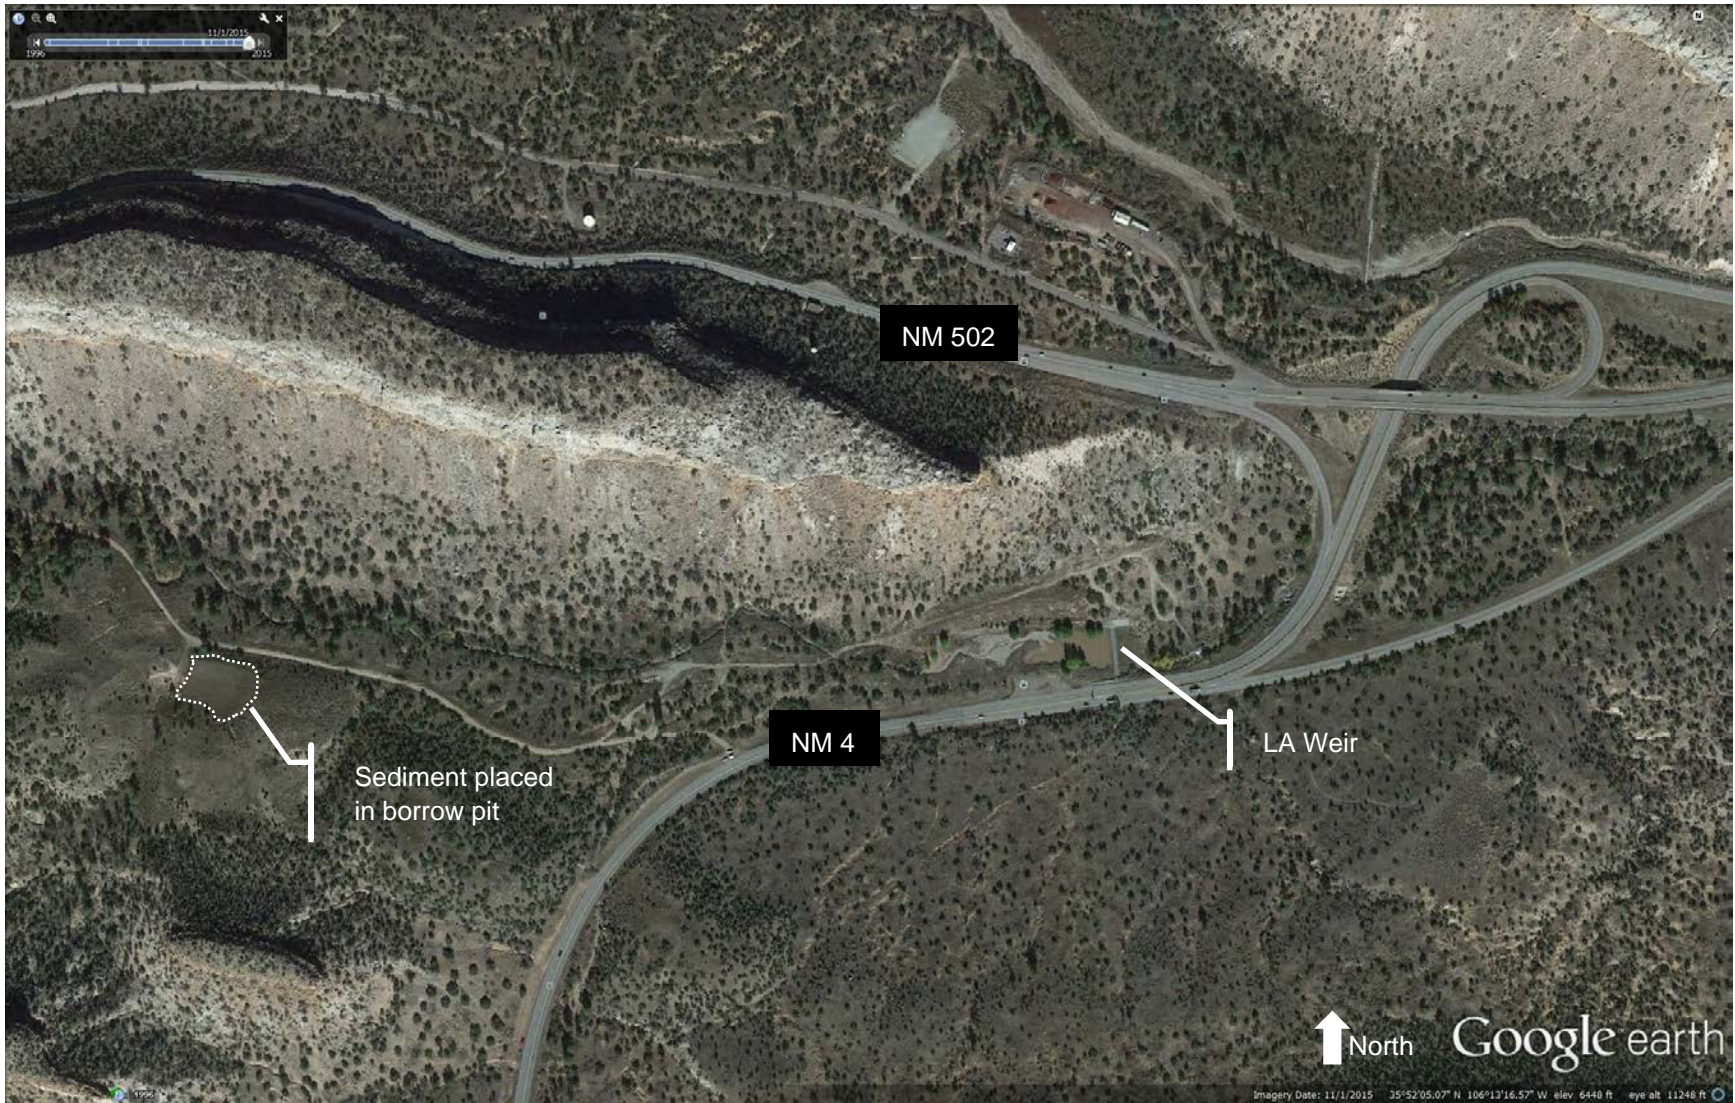
Figure 1.0-1 2015 orthophoto showing locations of the Los Alamos Canyon weir and borrow pit near the intersection of NM 502 and NM 4

This SWMU assessment report (SAR) work plan addresses a former borrow pit located within Los Alamos Canyon at the Laboratory (Figure 1.0-1). This borrow pit was used to permanently emplace sediments removed from basins located immediately upgradient of the Los Alamos Canyon low-head weir, which was constructed to reduce downstream flood potential beyond the Laboratory boundary post-Cerro Grande fire. The sediments emplaced within the borrow pit are potentially contaminated with hazardous chemicals and radionuclides. For this reason, the sediments placed in the borrow pit are being evaluated as a potential SWMU or AOC. The New Mexico Environment Department (NMED), pursuant to the New Mexico Hazardous Waste Act, regulates cleanup of hazardous wastes and hazardous constituents. DOE regulates cleanup of radioactive contamination, pursuant to DOE Order 458.1, Administrative Change 3, "Radiation Protection of the Public and the Environment," and DOE Order 435.1, "Radioactive Waste Management." Information on radioactive materials and radionuclides, including the results of sampling and analysis of radioactive constituents, is voluntarily provided to NMED in accordance with DOE policy. The purpose of this SAR work plan is to comply with Section X.C of the 2016 Compliance Order on Consent, which states that "DOE shall develop and implement a preliminary screening plan (including sampling and investigation activities and schedule for those activities) for such newly discovered potential SMWU or AOC, and provide NMED with the results of the preliminary screening." The results of investigation activities identified in this work plan will be submitted to NMED in a SAR.

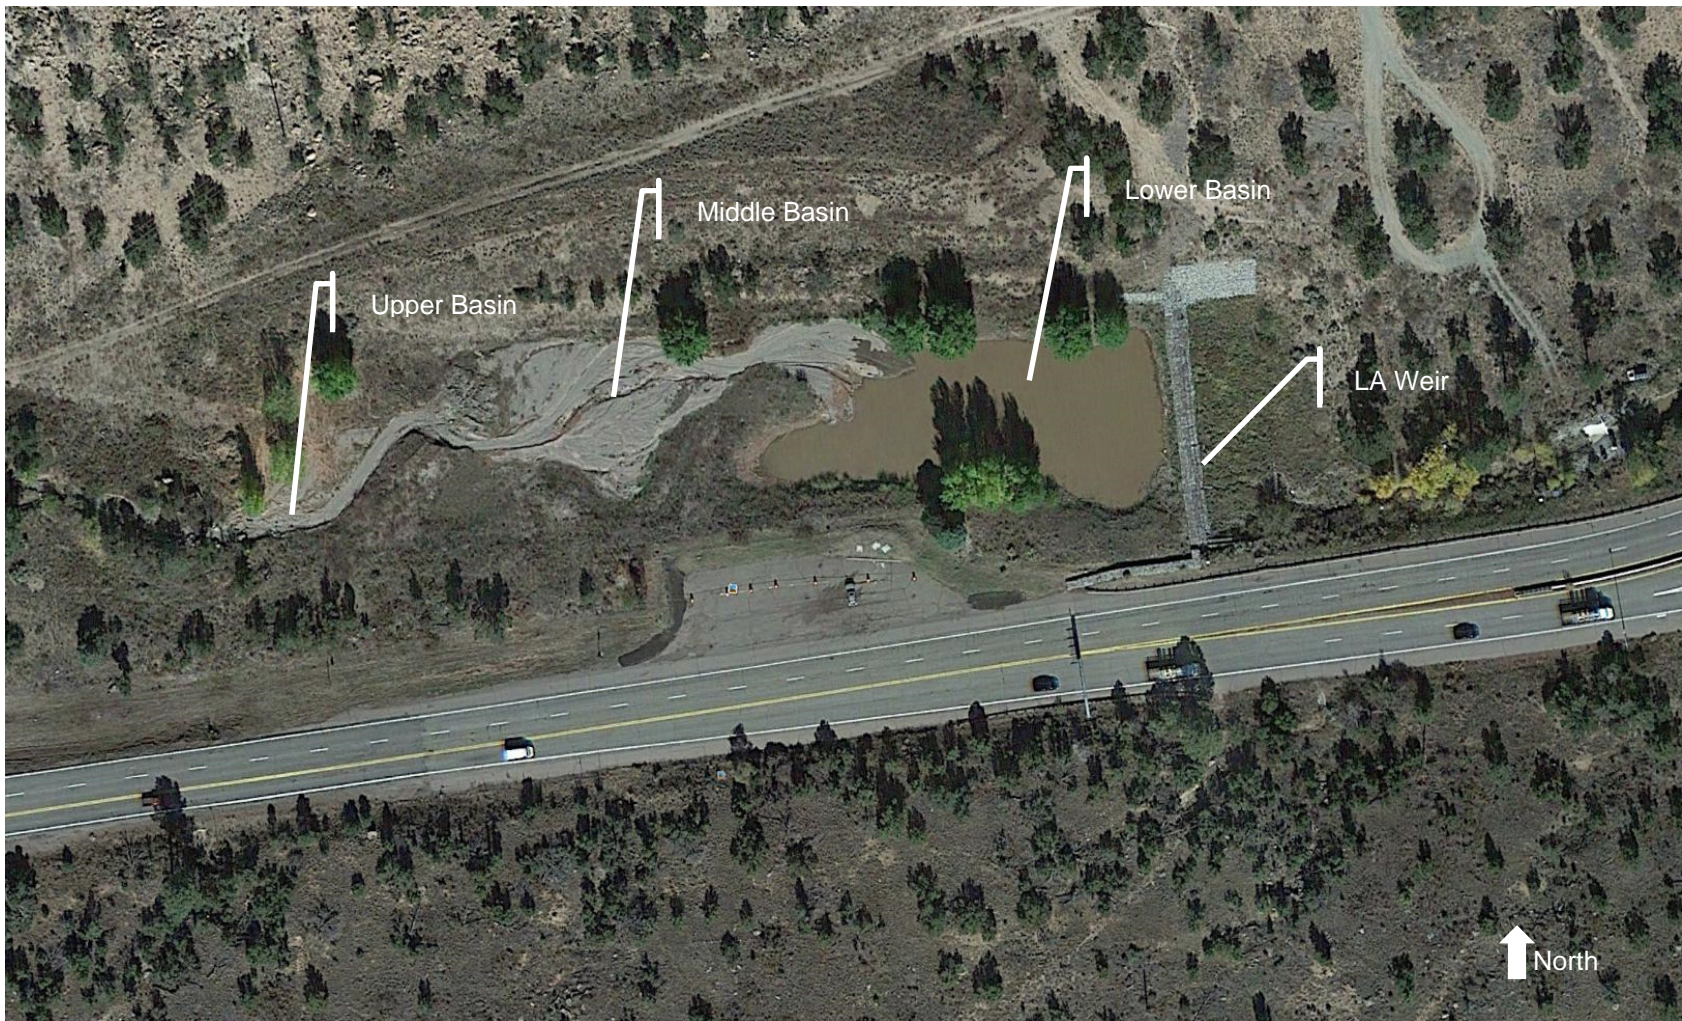
Figure 2.1-1 2015 orthophotograph showing the Los Alamos weir and sediment basins

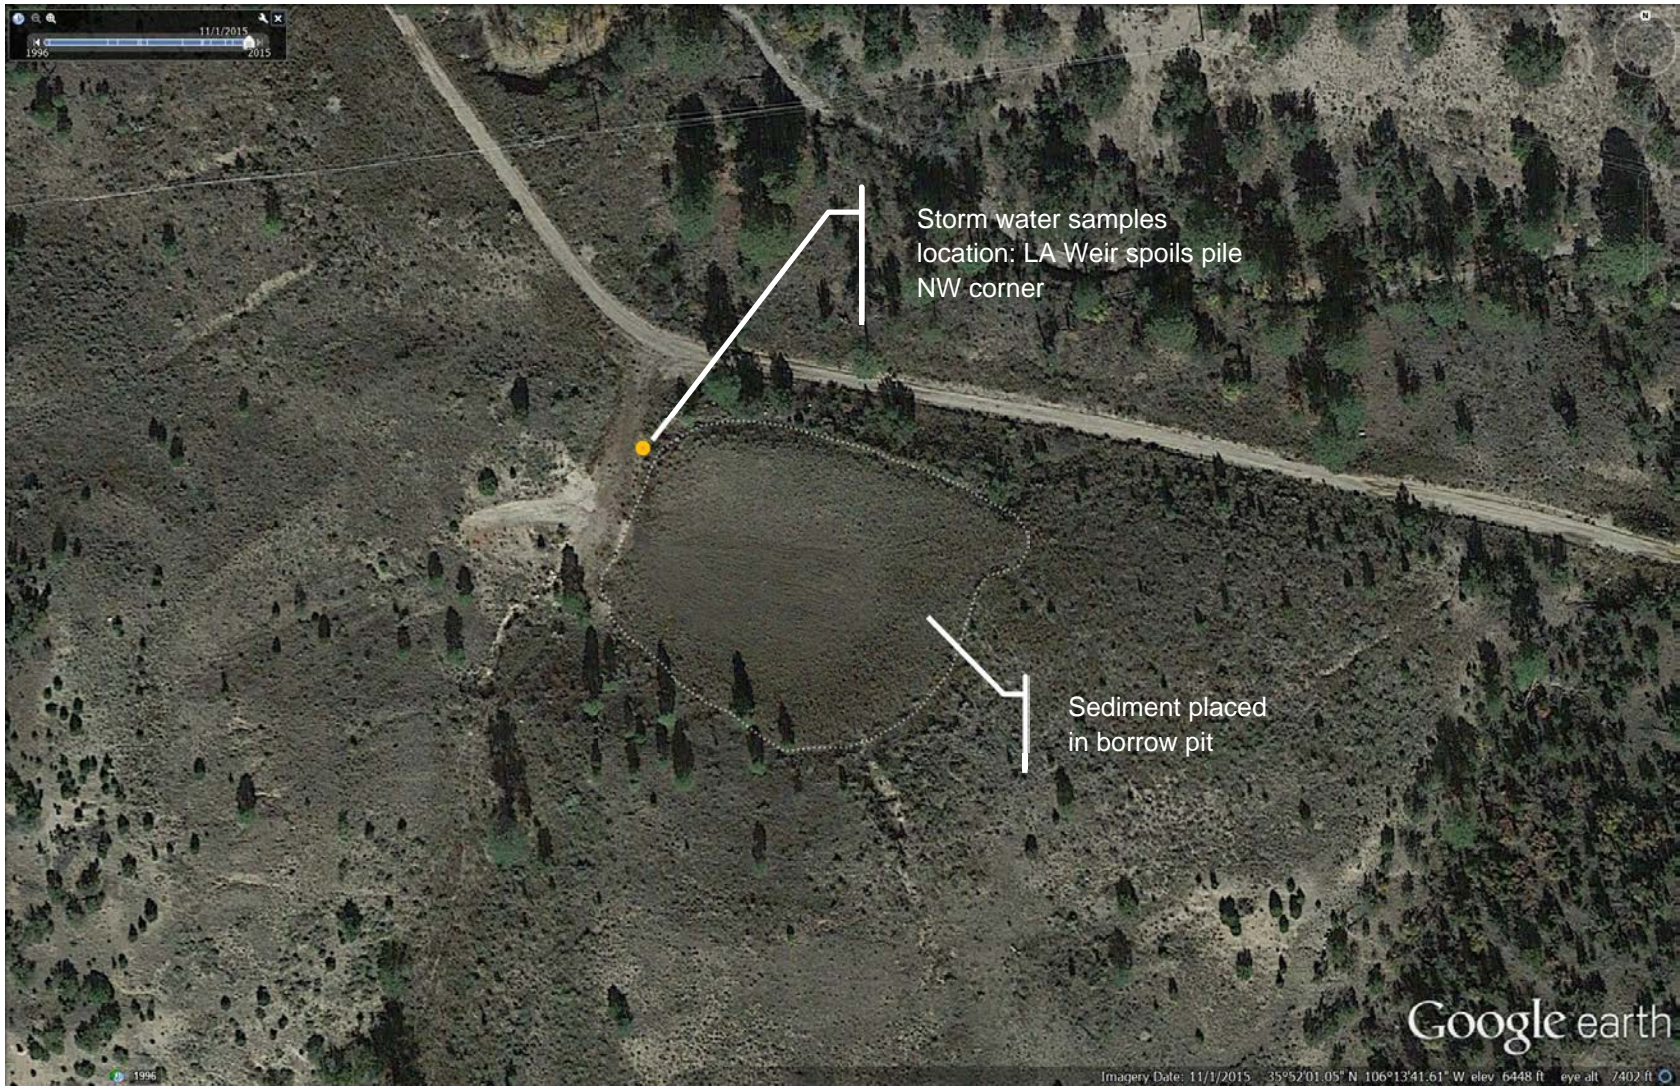
Figure 2.4-3 2015 orthophotograph showing the location of the sediments placed in the borrow pit and 2013 NMED Oversight Bureau storm water sampling location

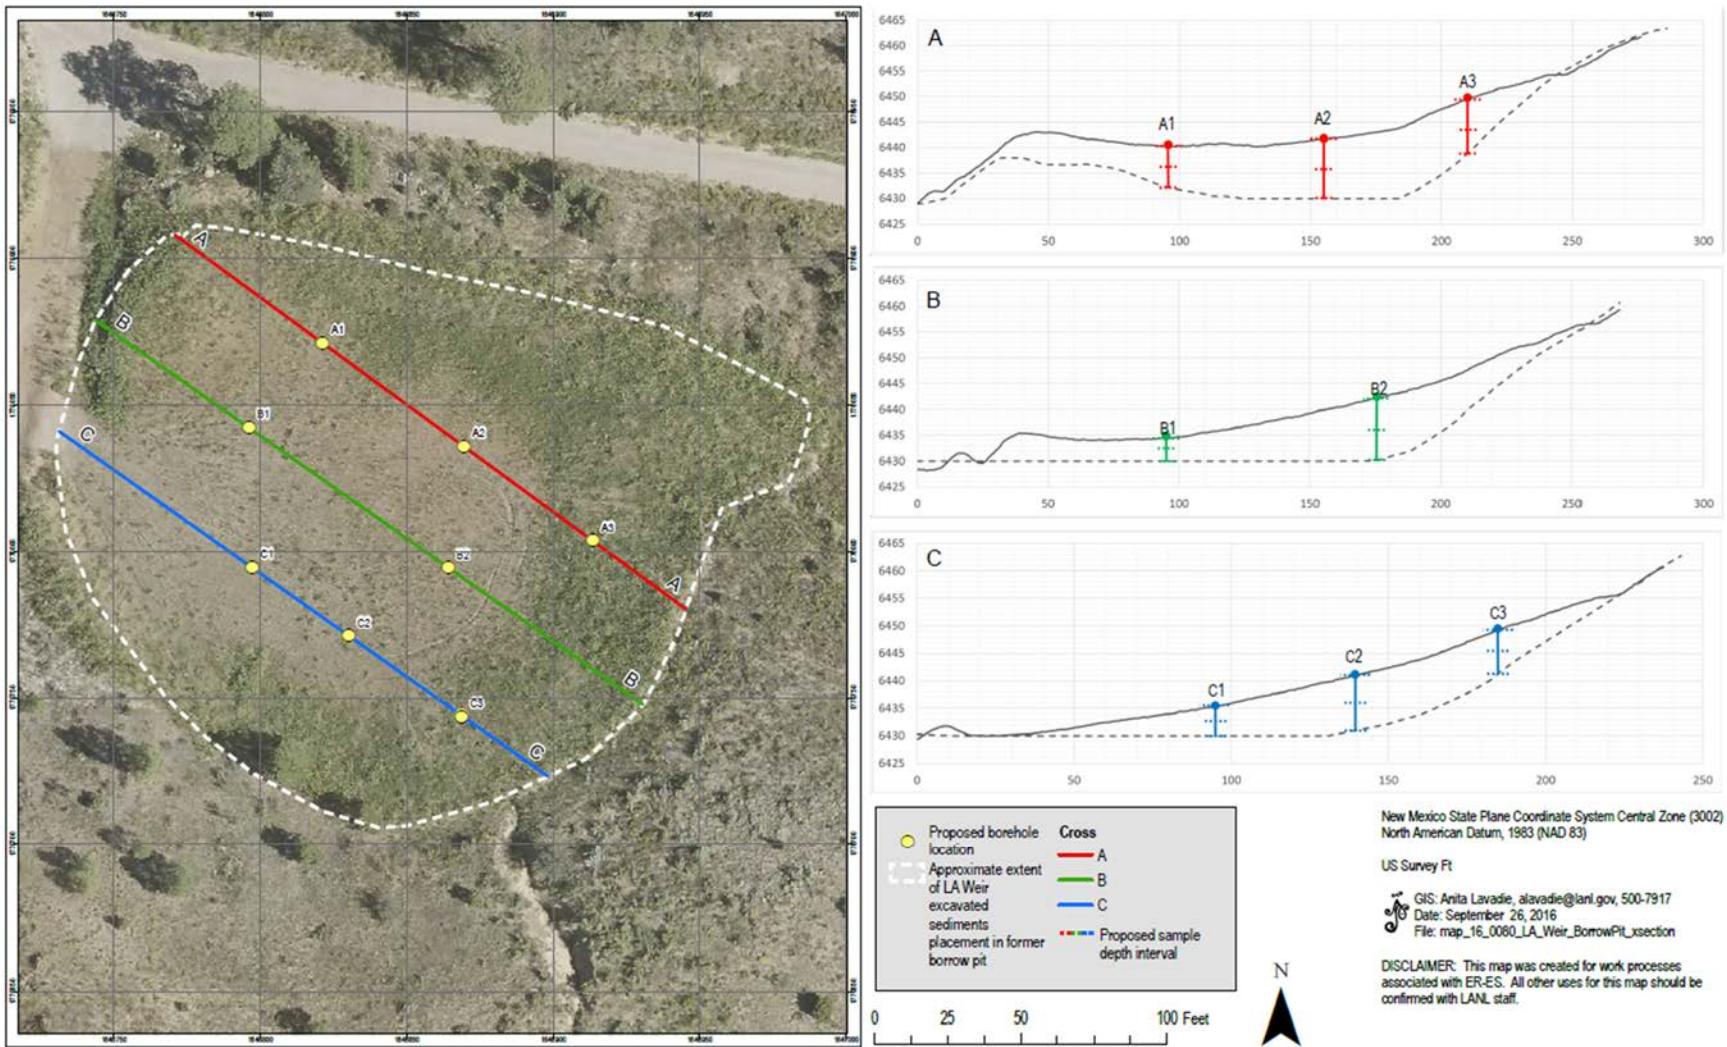
Figure 3.1-1 Proposed borehole locations and sampling depths

Sampling and analysis of the sediments in the borrow pit will be performed to identify hazardous and radionuclide constituents currently present in the sediments and to evaluate whether they would pose a potential unacceptable human health risk or dose. Per the June 21, 2016, meeting with NMED-HWB, the Laboratory proposes to collect samples at eight borehole locations within the footprint of the fill area in the borrow pit at approximate locations and sampling depths shown in Figure 3.1-1. Borehole locations were biased towards areas of the borrow pit that were a minimum of 3 ft thick. As-built technical specifications presented in Appendix C will be used to estimate the thickness of the fill in the borrow pit. The actual thickness at each location will be verified by hand-augering until the installed demarcation liner is encountered.

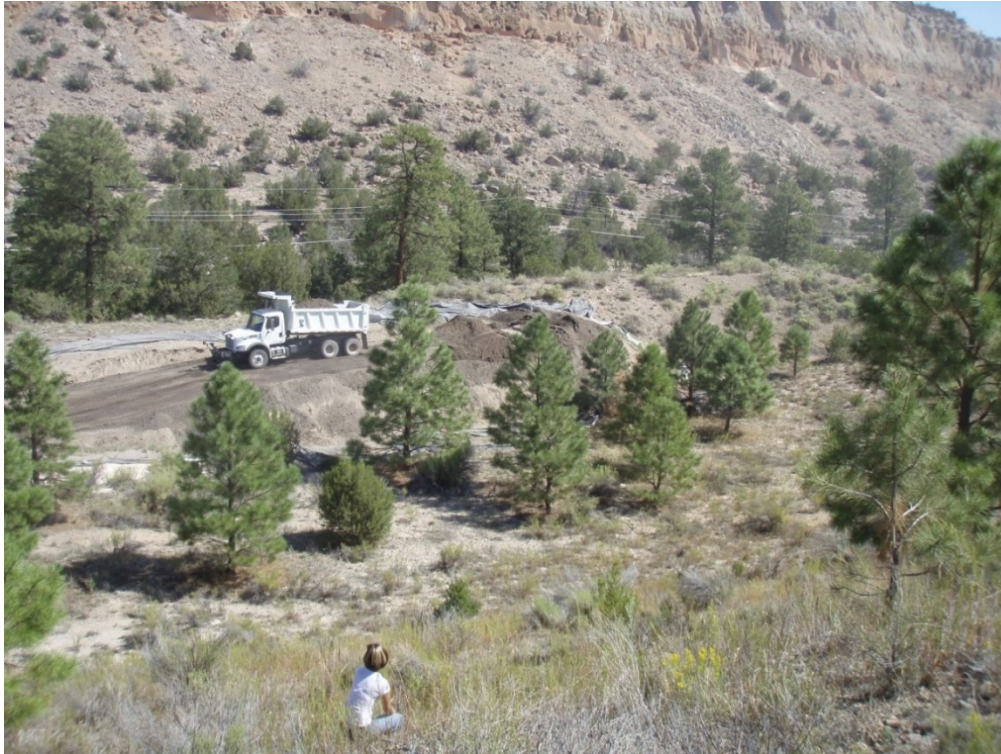
Figure B-4 Emplacement of excavated Los Alamos weir sediments in the borrow pit in 2012. The liner is visible around the sediments.

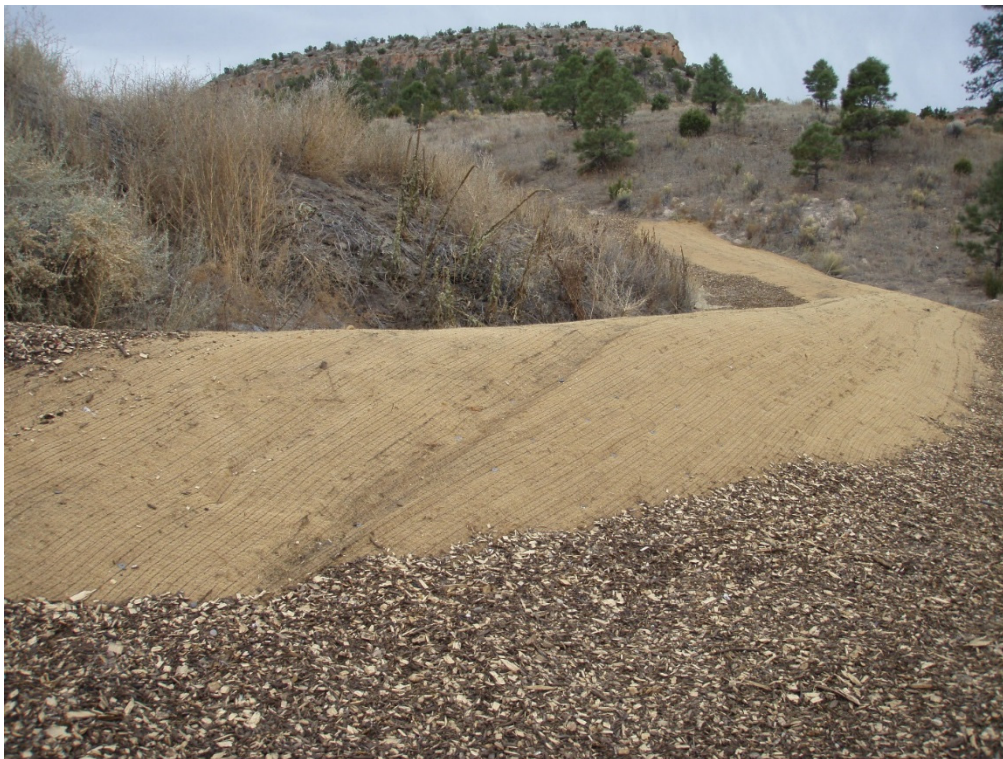
Figure B-11 Runoff retention berm following 2015 maintenance activities

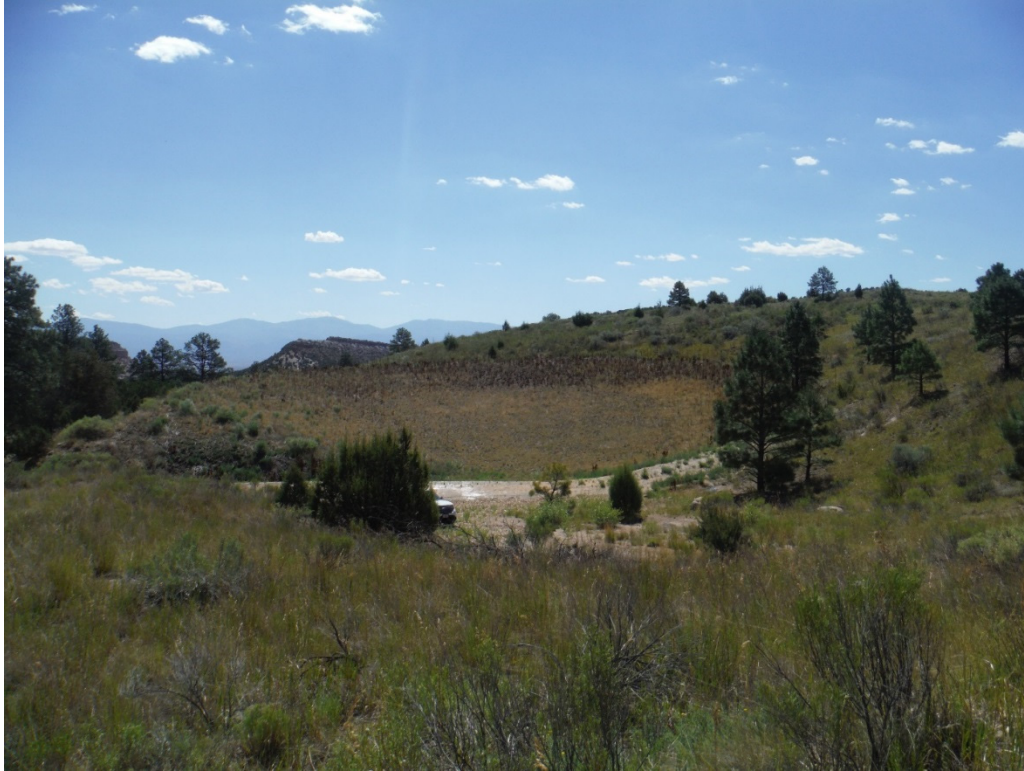
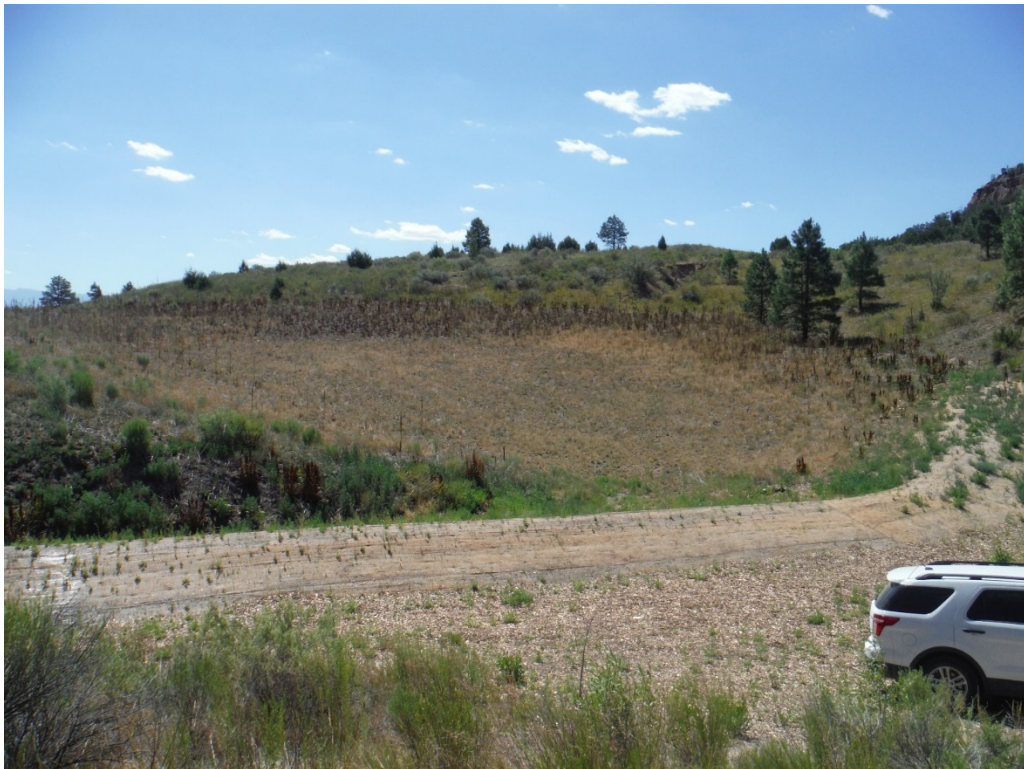
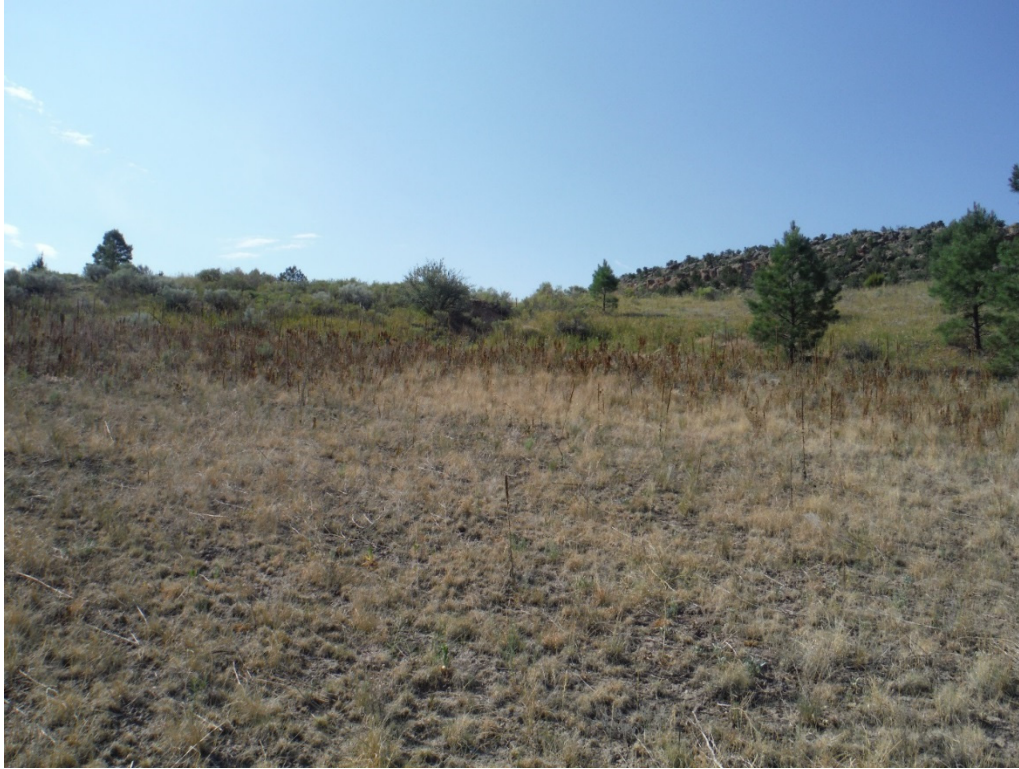
Figure B-12 July 2016 photograph showing current conditions of the borrow pit

Figure B-13 July 2016 photograph showing current conditions of the sediments placed in the borrow pit

Figure B-14 July 2016 photograph showing current conditions of revegetation (foreground) of the sediment in the borrow pit

Current site conditions as of June 2016 are shown Figures B-12 through B-14 in Appendix B. As-built drawings of the sediments emplaced in the borrow pit, as well as erosion controls installed at the borrow pit, are presented in Appendix C. Appendix C includes all the technical specifications for placement of borrow pit material and installation of storm water controls. The area is well vegetated with no visual evidence of rilling or erosion. The latest visual inspection report can be found in Appendix E.

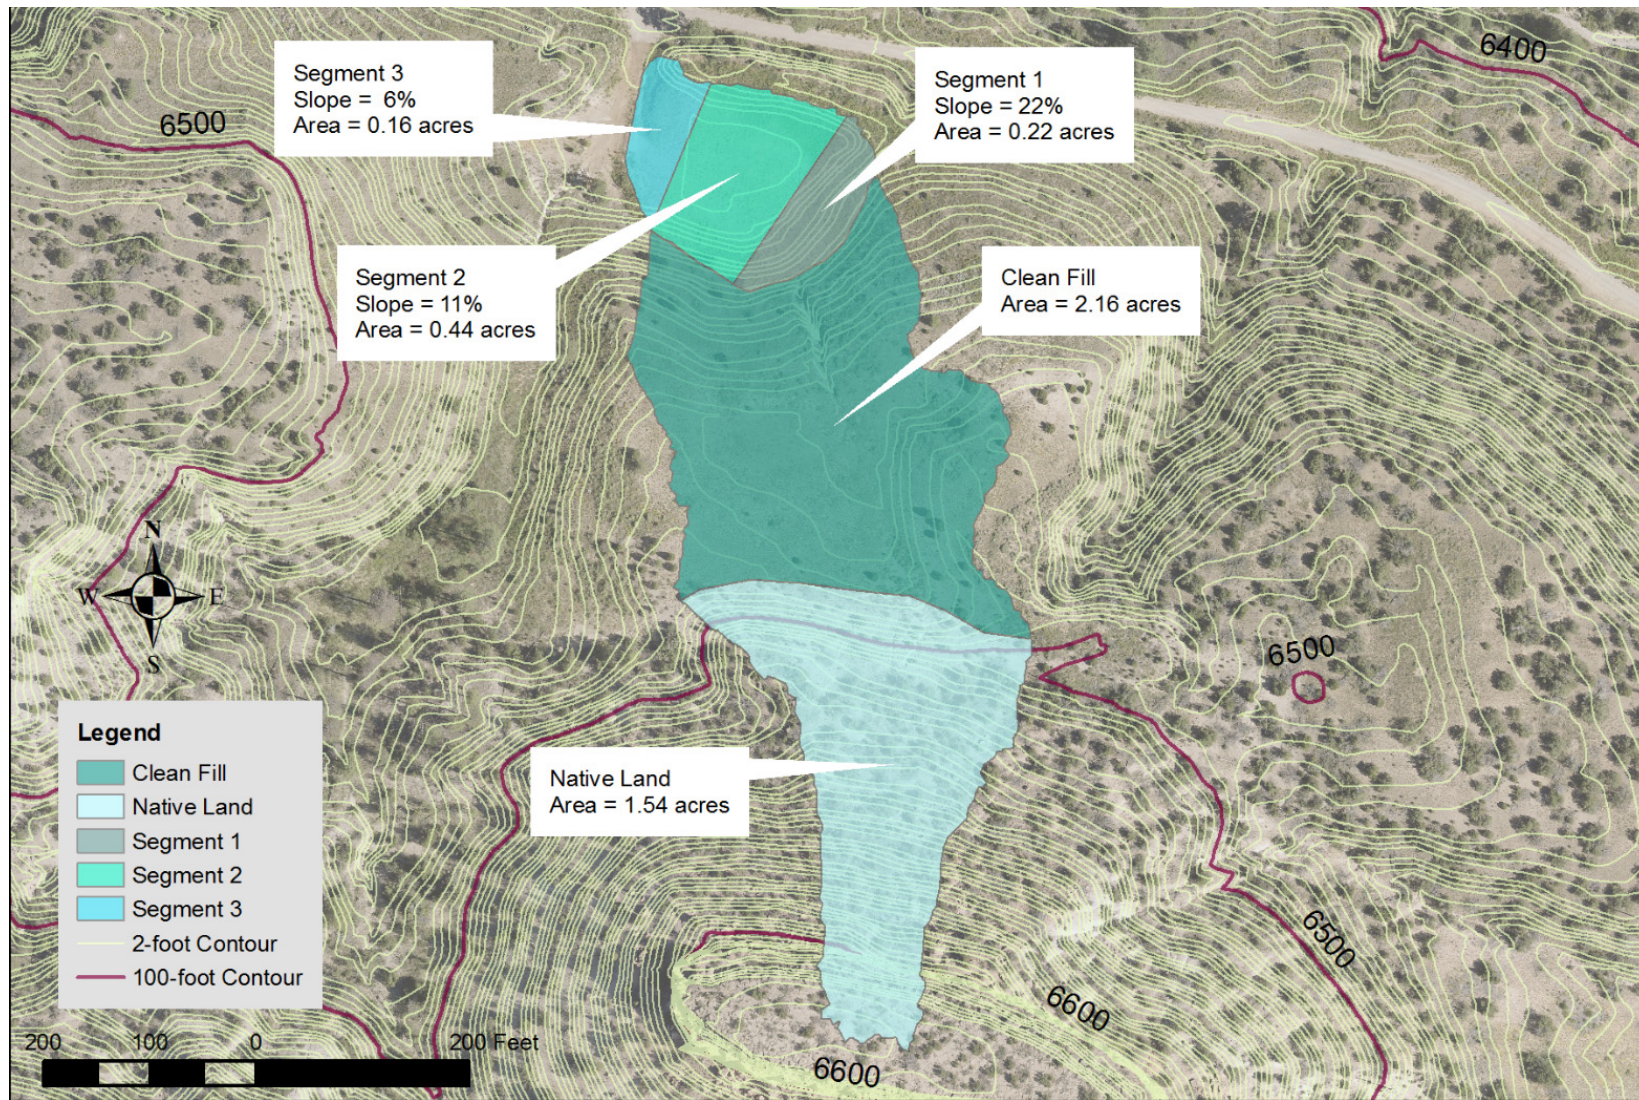
Figure E-3.4-1 Orthophoto showing the RUSLE2 modeling computation areas (Segment 1, 2, and 3) as well as clean fill and native land run-on areas

As shown in Figure E-3.4-1, a 3.7-acre area of clean fill and native earth runs on to the area where the Los Alamos weir—excavated sediments were placed in the borrow pit. The most recent biannual inspections (included as Attachment E-1) observed that this run-on area does not result in additional soil loss of the excavated sediments. In fact, sediment deposition from the run-on area was observed on top of the weir-excavated sediments. Based on these observations, the run-on area was not considered in the RUSLE2 modeling.

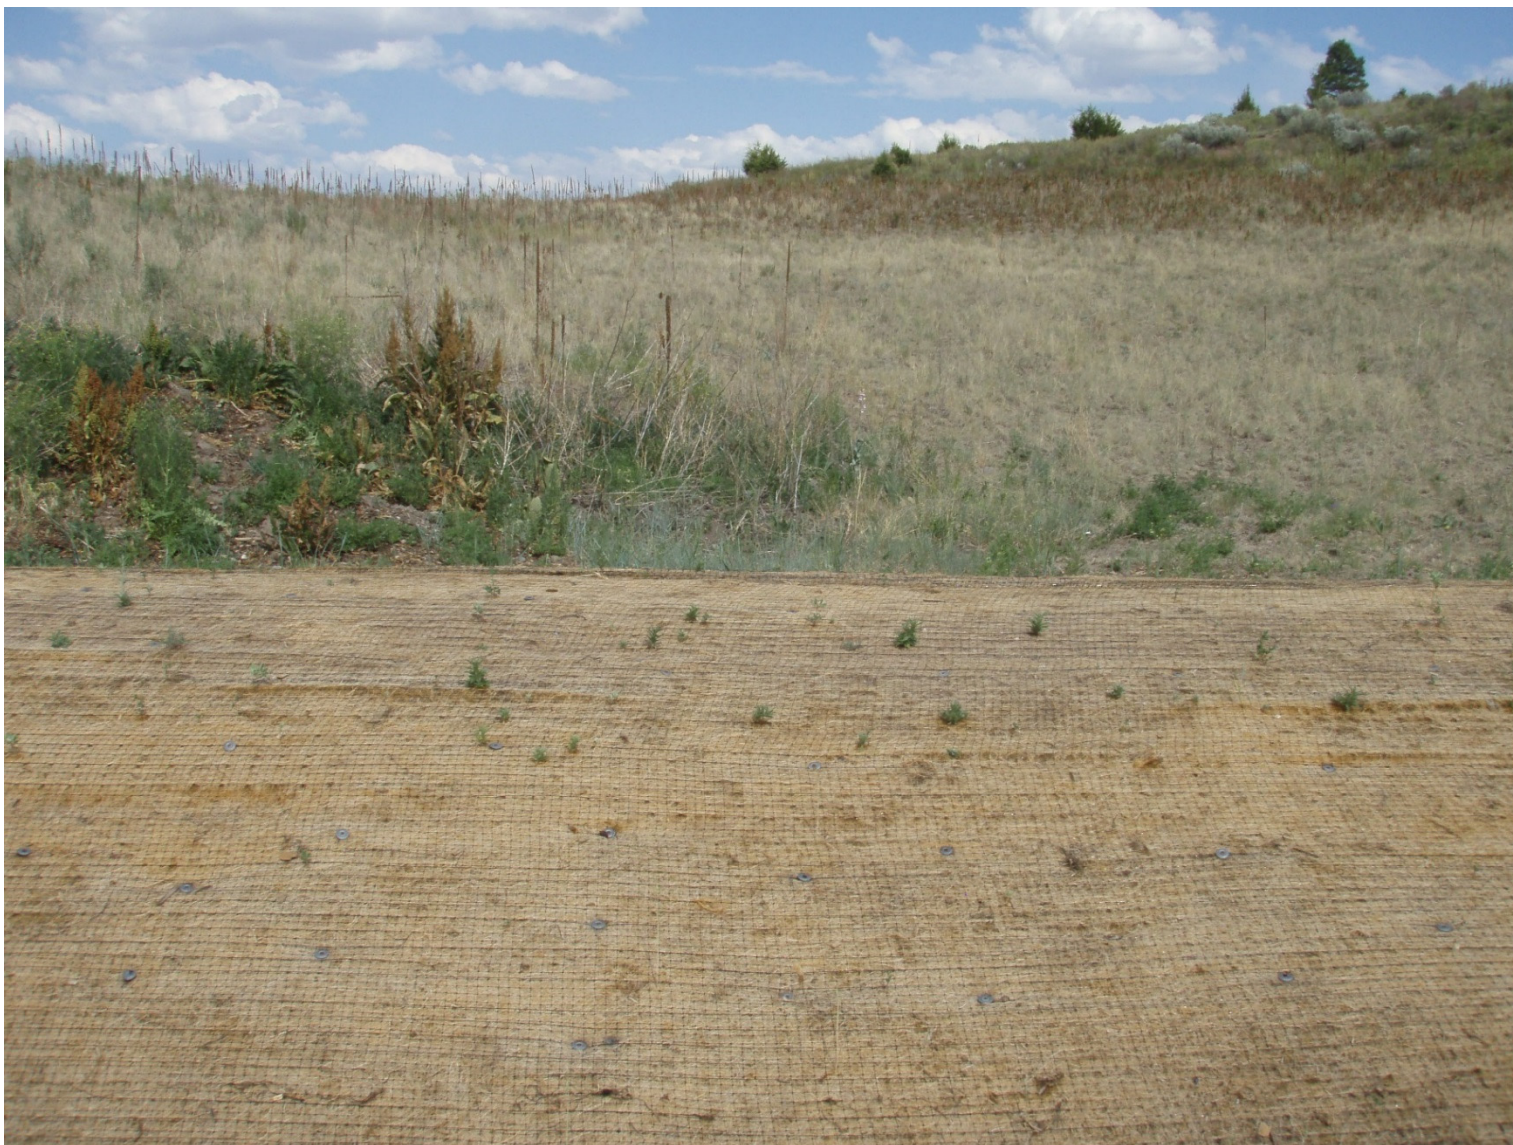
Photo 1 **Borrow pit berm matting**

BORROW PIT					
430	Borrow Pit [LA Weir Borrow Pit] Inspect sediment for vegetation Comments: No action recommended.	see photo 1.	SL	<input type="checkbox"/>	<input checked="" type="checkbox"/>
440	Borrow Pit [LA Weir Borrow Pit] Inspect presence for rilling/erosion Comments: No action recommended.		SL	<input type="checkbox"/>	<input checked="" type="checkbox"/>
450	Borrow Pit [LA Weir Borrow Pit] Inspect berm for vegetation/matting Comments: No action recommended.		SL	<input type="checkbox"/>	<input checked="" type="checkbox"/>
460	Borrow Pit [LA Weir Borrow Pit] Inspect for presence of trash/debris Comments: No action recommended.		SL	<input type="checkbox"/>	<input checked="" type="checkbox"/>
470	Borrow Pit [LA Weir Borrow Pit] Inspect for rodent burrows Comments: No action recommended.		SL	<input type="checkbox"/>	<input checked="" type="checkbox"/>

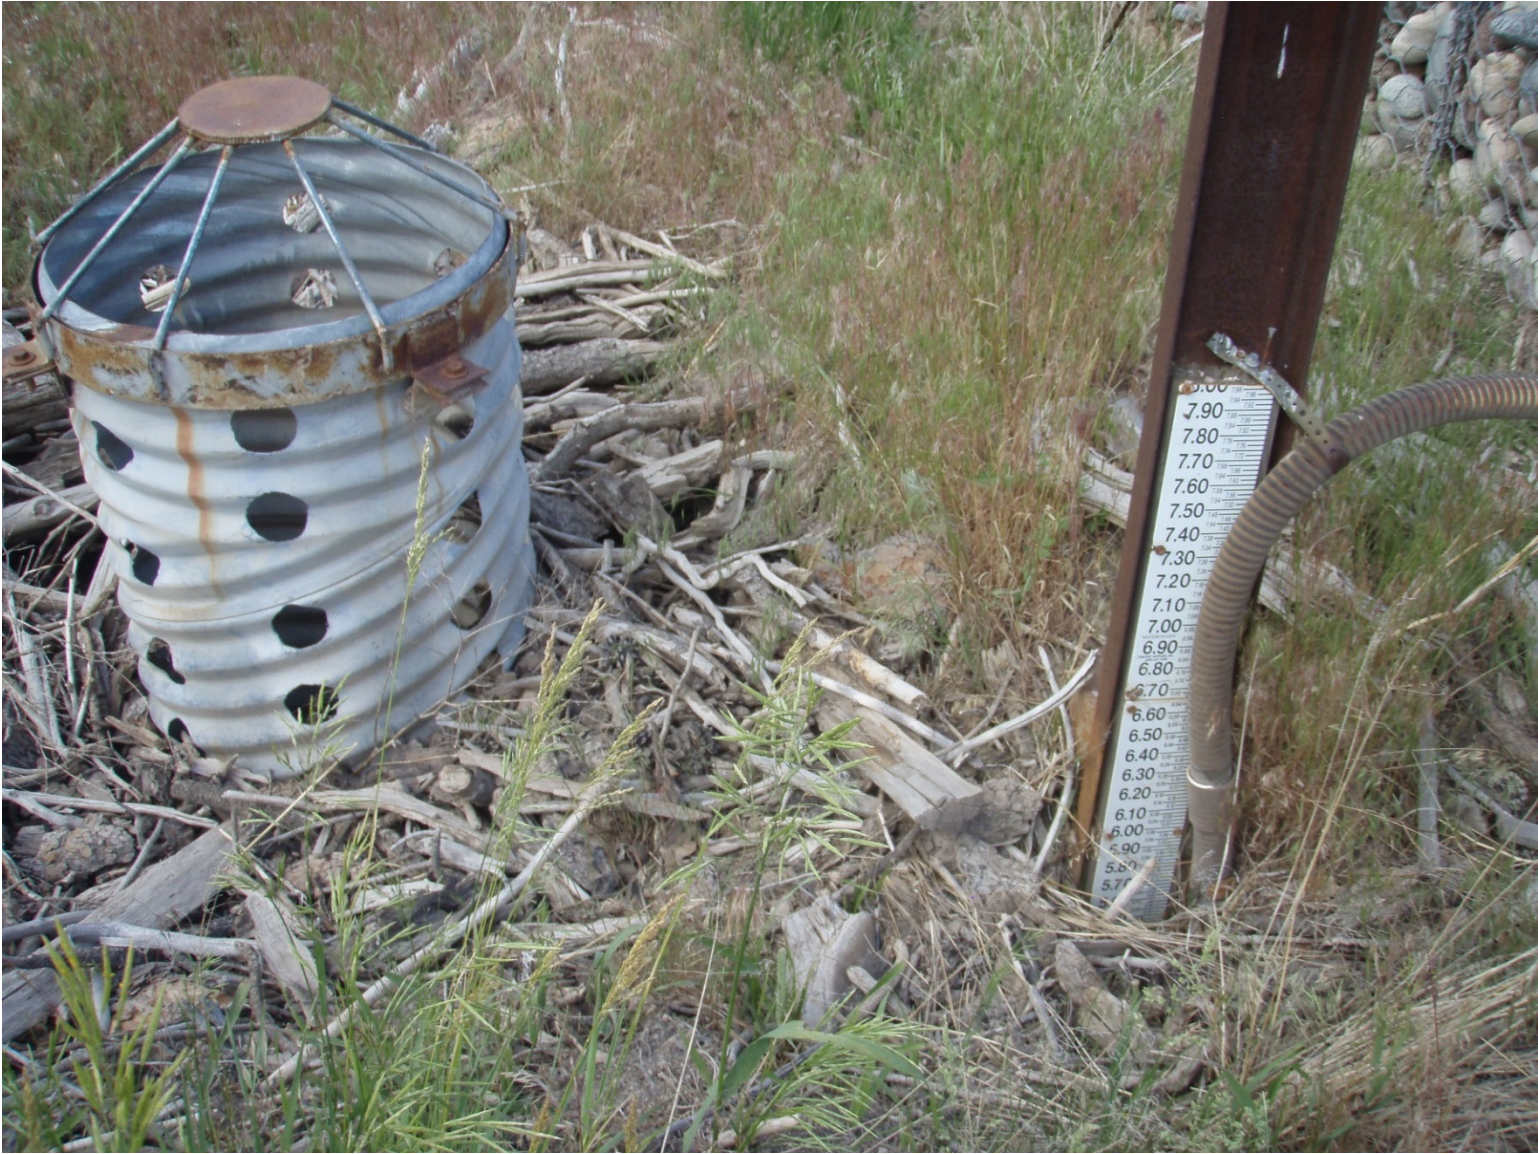
Photo 4 Los Alamos weir standpipe inlet

Overflow Weir Structure [LA Weir Overflow Weir Structure] Inspect d/s face of weir structure for presence of trash/debris Comments: No action recommended.				
STANDPIPE					
300	Standpipe [LA Weir Standpipe] Inspect standpipe for corrosion Comments: No action recommended.		SL	<input type="checkbox"/>	<input checked="" type="checkbox"/>
310	Standpipe [LA Weir Standpipe] Inspect for amount of sediment present Comments: No action recommended.		SL	<input type="checkbox"/>	<input checked="" type="checkbox"/>
320	Standpipe [LA Weir Standpipe] Inspect for presence of trash/debris Comments: No action recommended.		SL	<input type="checkbox"/>	<input checked="" type="checkbox"/>
330	Standpipe [LA Weir Standpipe] Inspect standpipe for height of inlet Comments: No action recommended. Standpipe unobstructed for 4 top holes. Staff gage reads 5.7 feet.	see photo 4.	SL	<input type="checkbox"/>	<input checked="" type="checkbox"/>

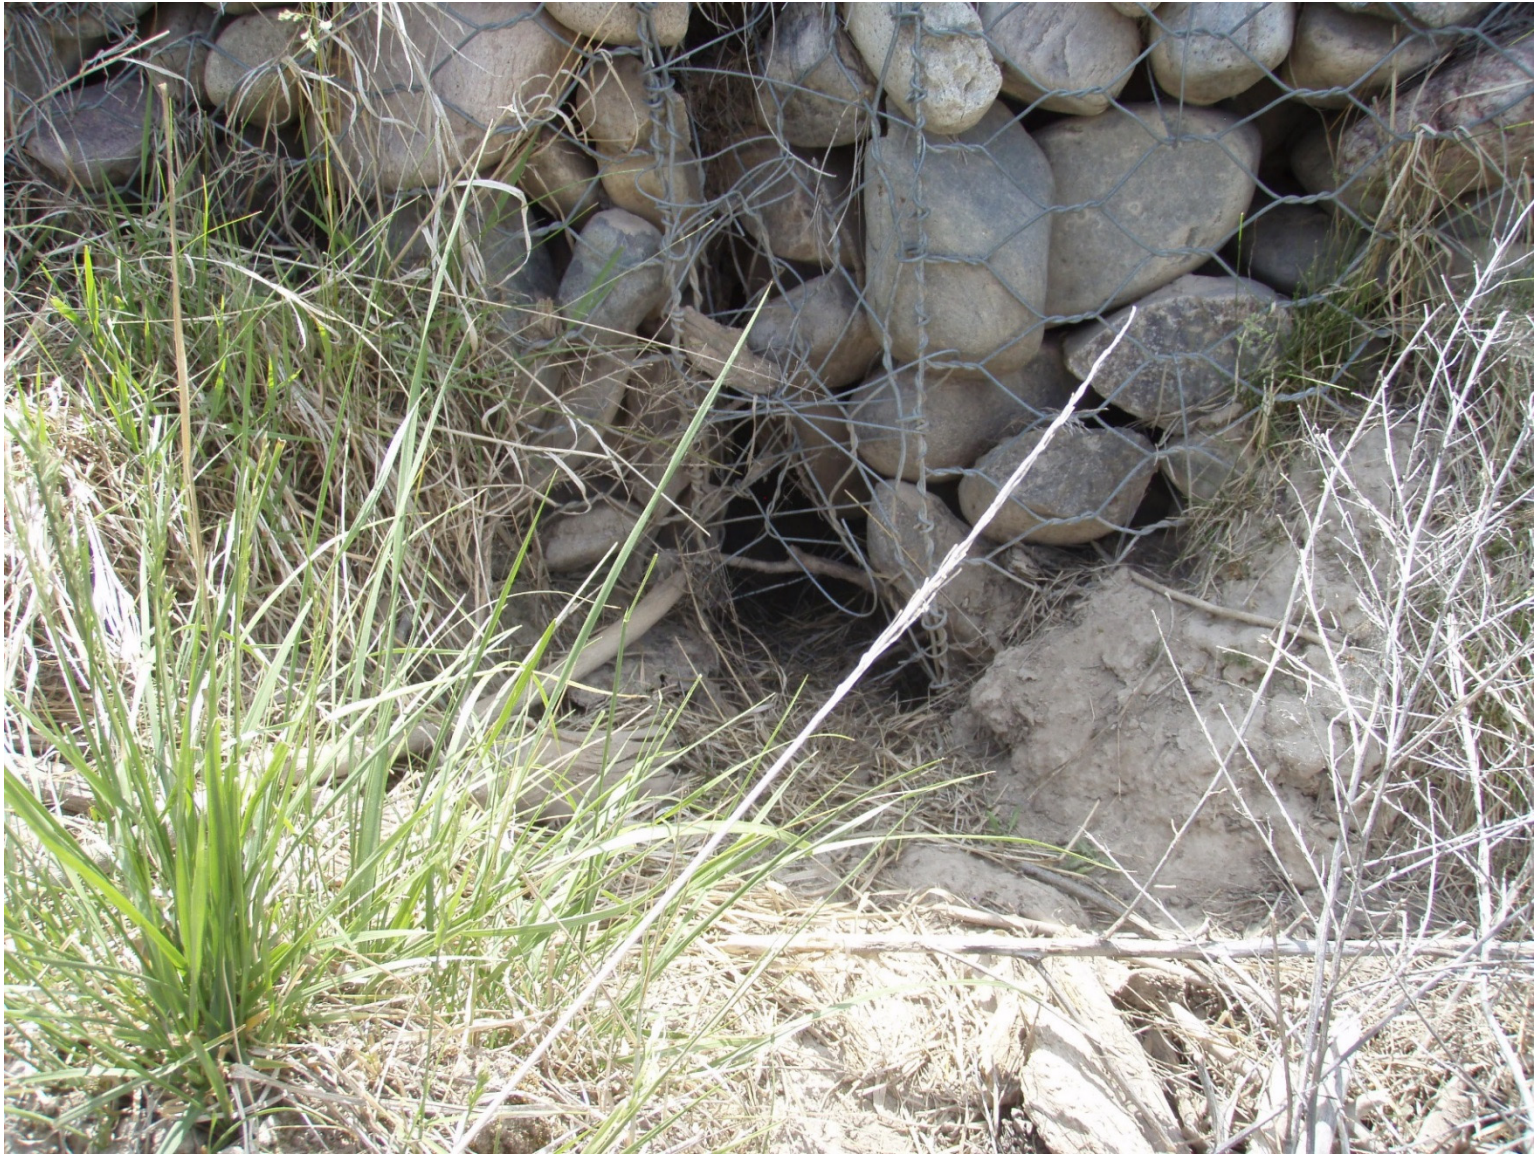
Photo 6 Los Alamos weir gabion structure at bottom of weir appearing to have undercutting

OUTLET					
360	Outlet [LA Weir Outlet] Inspect outlet for seepage/piping Comments: See comments under Task 270.	see photo 6.	SL	<input type="checkbox"/>	<input checked="" type="checkbox"/>
370	Outlet [LA Weir Outlet] Inspect outlet for undercutting Comments: No action recommended.		SL	<input type="checkbox"/>	<input checked="" type="checkbox"/>
380	Outlet [LA Weir Outlet] Inspect outlet for erosion Comments: Monitor downstream side of outlet pipe where evidence of erosion exists.	Monitor	SL	<input type="checkbox"/>	<input checked="" type="checkbox"/>
390	Outlet [LA Weir Outlet] Inspect for presence of trash/debris Comments: No action recommended.		SL	<input type="checkbox"/>	<input checked="" type="checkbox"/>
400	Outlet [LA Weir Outlet] Inspect for amount of sediment present Comments: Sediment with mature vegetation on gabion apron.		SL	<input type="checkbox"/>	<input checked="" type="checkbox"/>

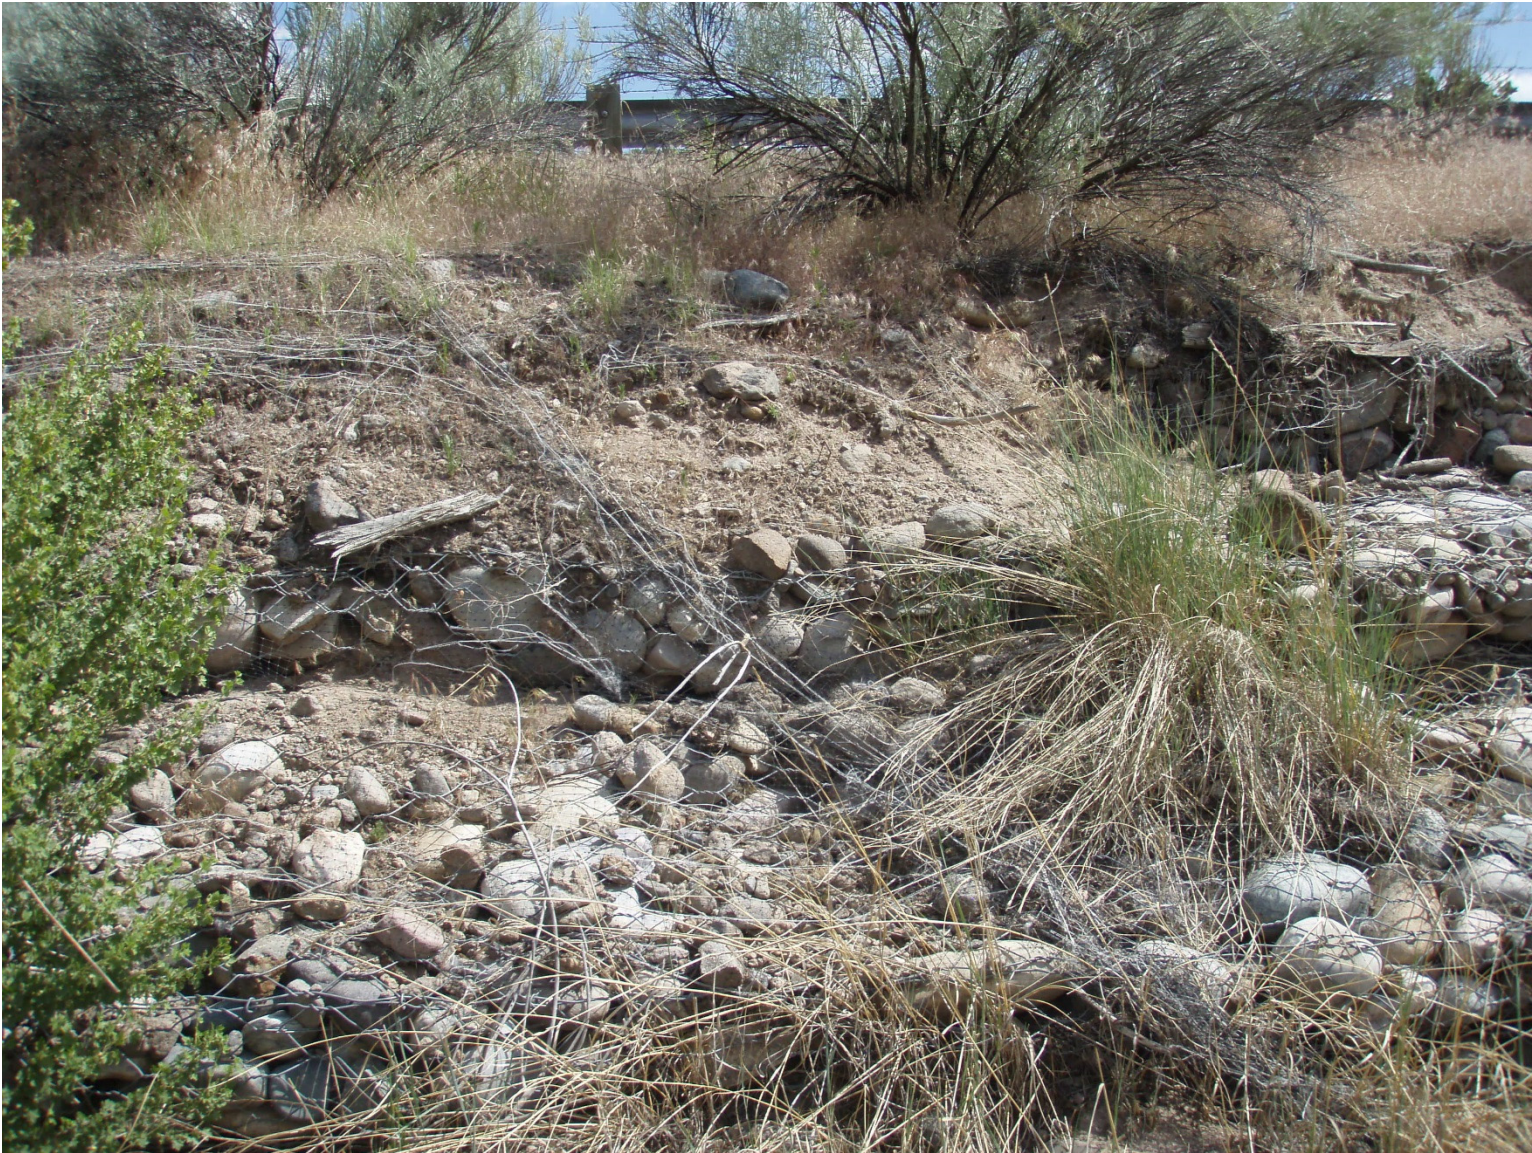
Photo 7 Turf-reinforcing matte present on south side of Los Alamos weir embankment
