Subject: Solid Waste Management Unit Assessment Report Work Plan for the Los Alamos Canyon Borrow Pit, Revision 1

Solid Waste Management Unit Assessment Report Work Plan for Los Alamos Canyon Borrow Pit, Revision 1

FORMER BORROW PIT CONTAINING LA WEIR EXCAVATED SEDIMENTS AS-BUILT CONDITIONS

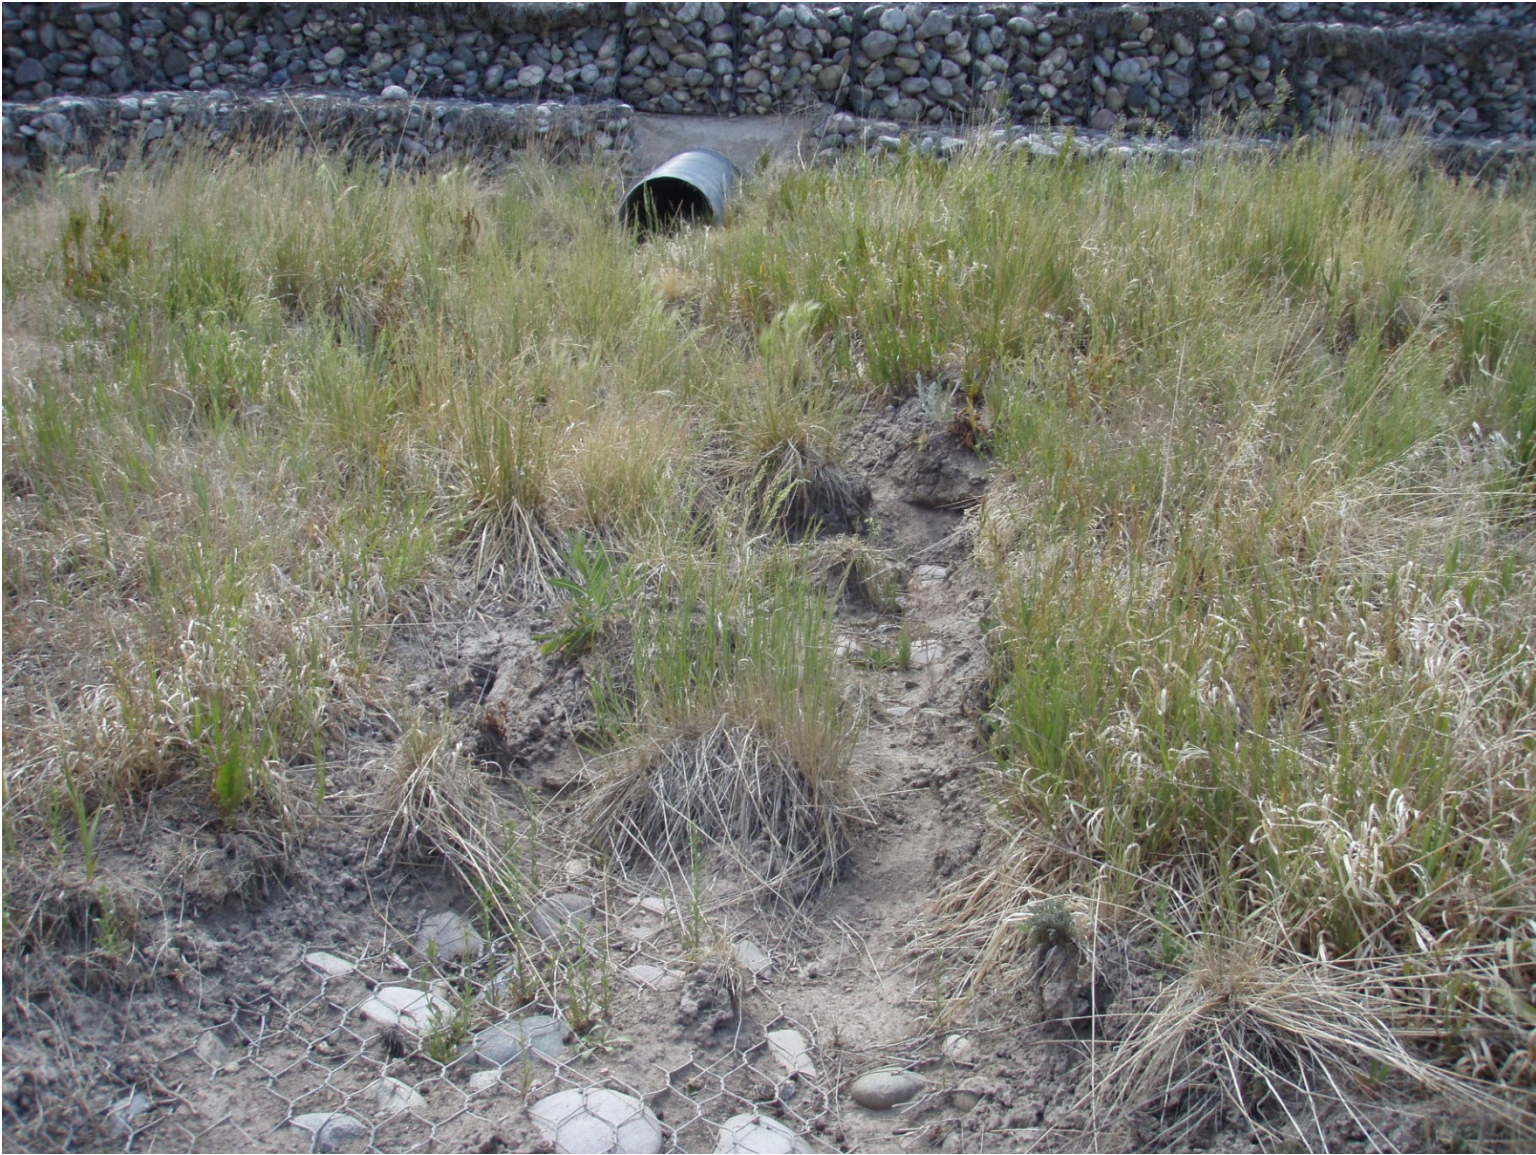
Photo 8 Downstream side of Los Alamos weir outlet pipe where erosion is occurring
