**Subject: 2016 Triennial Ordnance Survey Report, Solid Waste  
Management Units 00-011(a, d, and e), Guaje/Barrancas/Rendija  
Canyons Aggregate Area**

LA-UR-16-29284  
December 2016  
EP2016-0155

# **2016 Triennial Ordnance Survey Report, Solid Waste Management Units 00-011(a, d, and e), Guaje/Barrancas/Rendija Canyons Aggregate Area**

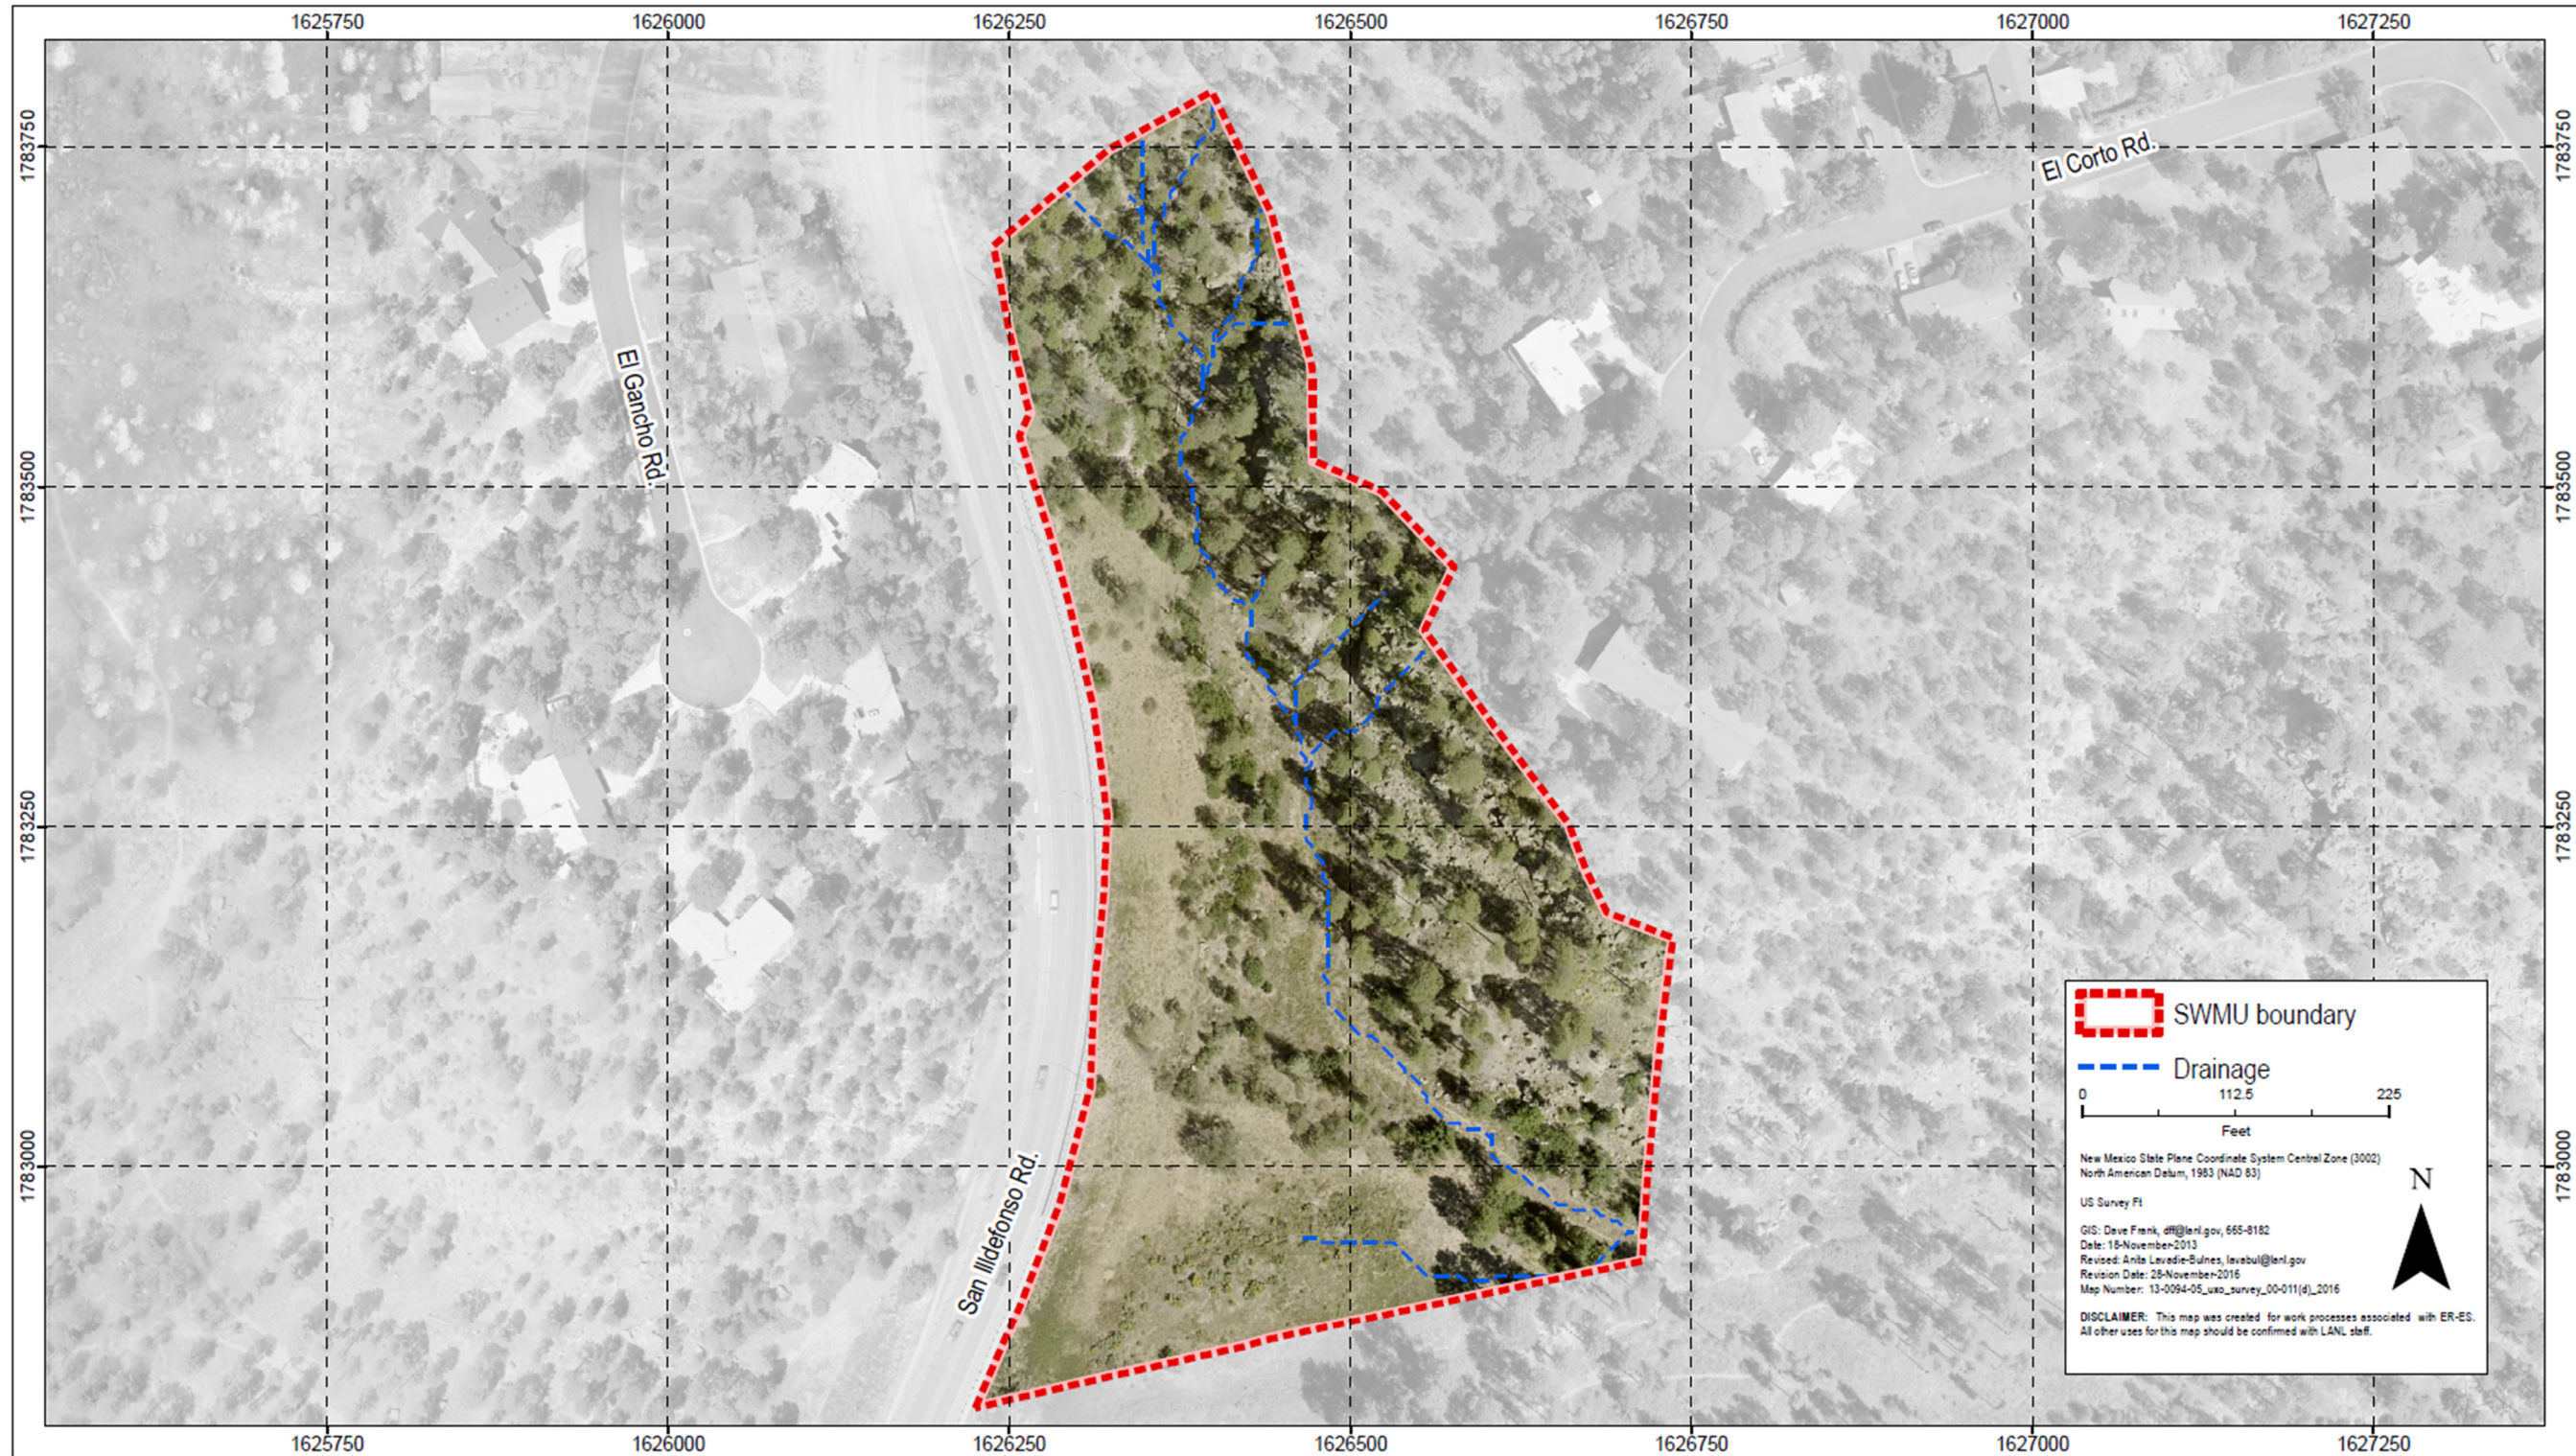
SWMU 00-011(d) (Figure 2.2-1) is a “bazooka” firing area located largely on Los Alamos County land, except for a small section along a cliff edge on private property. The area is in a small north-trending tributary of Bayo Canyon northeast of the intersection of San Ildefonso Road and Diamond Drive in the Los Alamos townsite. The approximately 6-acre area was used in the mid-1940s as a target area for 2.36-in. bazooka rounds; operations ceased in the late 1940s (LANL 1990, 007511).

SWMU 00-011(d) is located near a hiking trail at the head of Bayo Canyon. A north-south trending drainage channel bisects SWMU 00-011(d), and a cliff is located on the eastern edge of the site. The southern section of the site is open and grassy with some shrubs and trees; the northern section of the site is forested with pine trees. The site is open to the public.

Figure 2.2-1 Aerial photograph of SWMU 00-011(d)

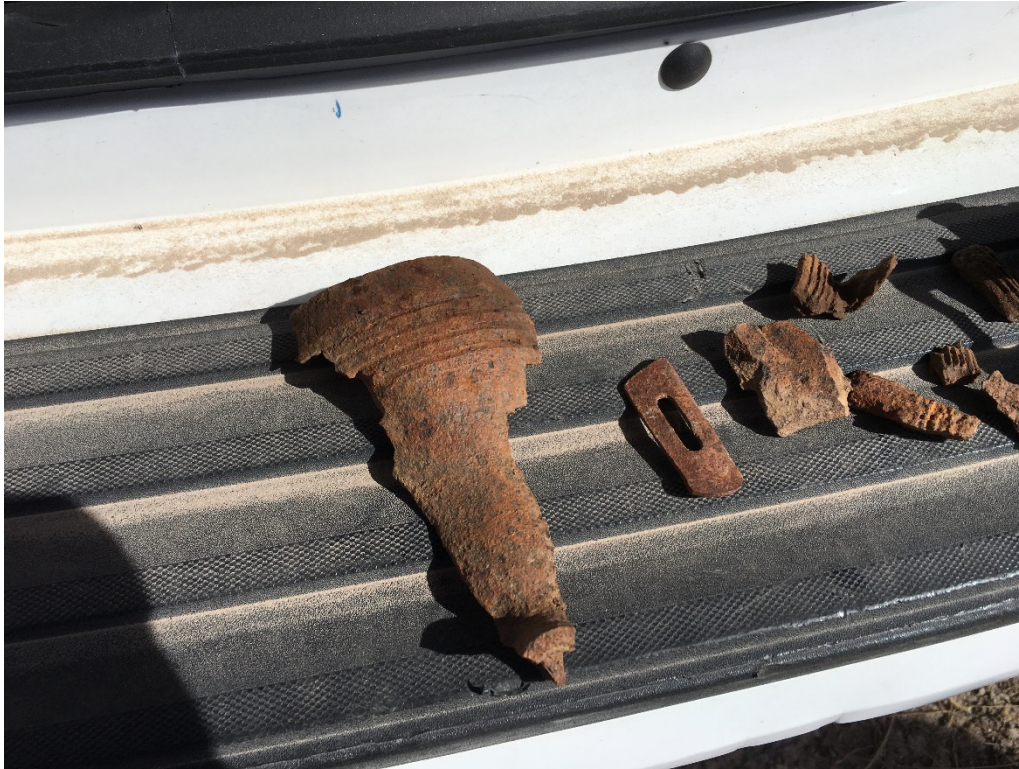
The 2016 ordnance survey resulted in the recovery and removal of several 60-mm and 81-mm shell fragments. Figures 5.1-1 and 5.1.2 show the MD found at SWMU 00-011(a). Most of these fragments were small (less than 2 in. in the longest dimension); however, a mortar tail and a mortar side wall were also found and their sizes were approximately 4.5 in. in the longest dimension. Most of the small fragments were found in the southern portion of the site within a drainage, while two were found north of Rendija Road. The mortar side wall was located on the north side of Rendija Road between the road and the DOE fence. The mortar tail was located just north of the SWMU boundary. The fragments were removed, photographed, and retained by Emergency Response personnel. Figure 2.1-1 shows the locations where MD was found at SWMU 00-011(a). No UXO or MEC was discovered or recovered at SWMU 00-011(a) during the 2016 ordnance survey.

**Figure 5.1-1** Fragments of MD found at SWMU 00-011(a) in 2016

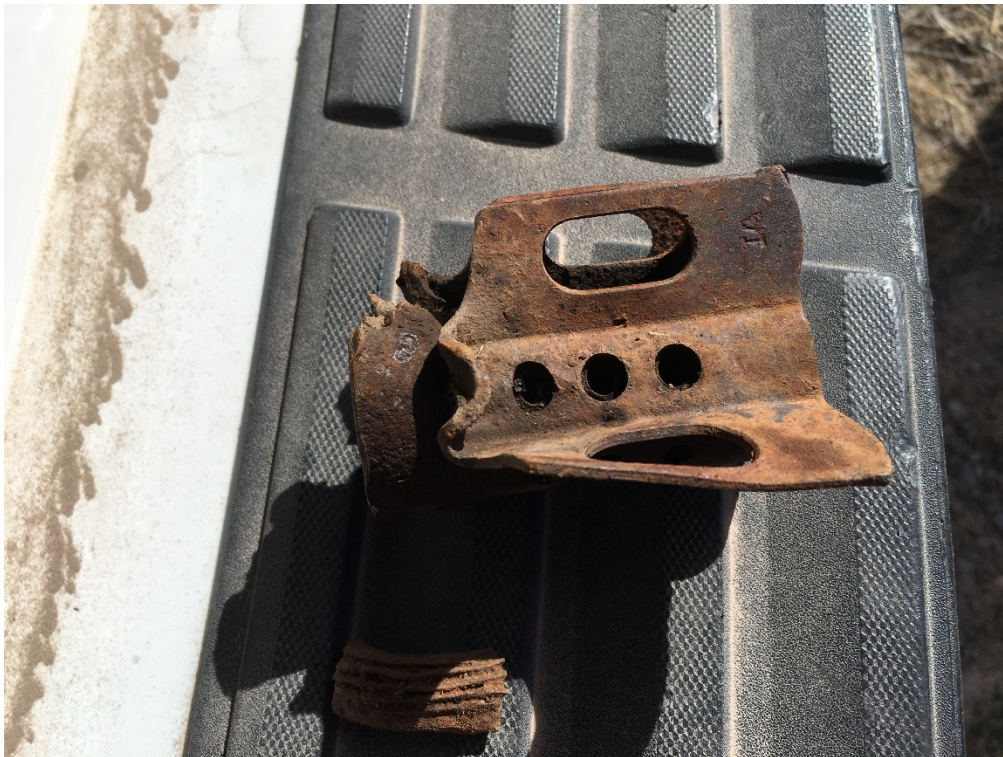
**Figure 5.1-2** Fragment of MD found at SWMU 00-011(a) in 2016

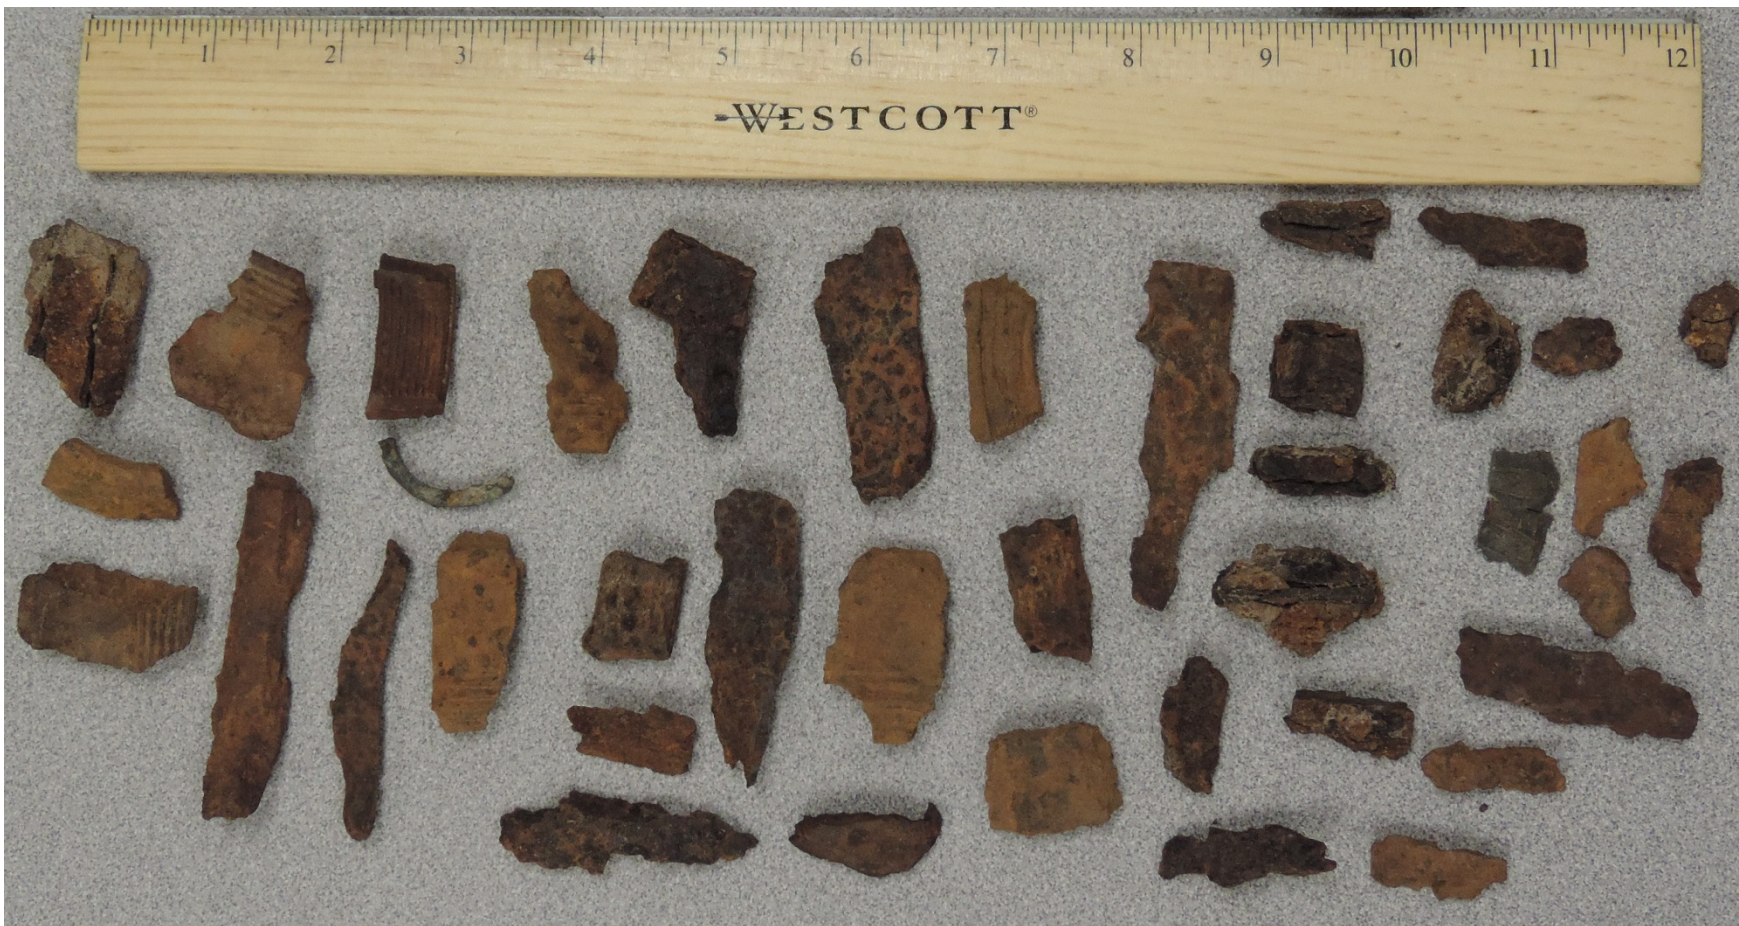
The 2016 ordnance survey resulted in the recovery and removal of several MD fragments in the form of rotating band pieces and side-wall fragments scattered over the area shown in Figure 2.3-1. Figure 5.3-1 shows the MD found at SWMUs 00-011(a and e). All of these fragments were small (less than 2 in. in the longest dimension). In addition to fragments found at the site, there is abundant evidence of impact to cliffs and boulders from larger munitions. No noticeable distribution pattern or area of significant MD concentration was found at SWMU 00-011(e). The fragments were removed and retained by Emergency Response personnel. Abundant scars and holes resulting from munitions impact are present in the cliff face and boulders at the site. No UXO or MEC was discovered or recovered at SWMU 00-011(e) during the 2016 ordnance survey.

Figure 5.3-1 Fragments of MD found at SWMUs 00-011(a and e) in 2016
