Subject: 2016 Sandia Wetland Performance Report

2016 Sandia Wetland Performance Report

The 2016 Sandia wetland performance report is the third annual performance report following the 2012 to 2014 baseline that assessed the overall condition of the wetland at the head of Sandia Canyon in the context of the wetland's ability to prevent or minimize migration of contaminants of concern (i.e., chromium, polychlorinated biphenyls [PCBs] and polycyclic aromatic hydrocarbons) detected in wetland sediments as a result of historical releases at Los Alamos National Laboratory (LANL or the Laboratory). The geochemistry and physical stability of wetland sediments and the extent of wetland vegetation are the indicators of wetland conditions. The condition of the wetland is assessed to evaluate the effectiveness of the grade-control structure (GCS) completed in 2013 at the terminus of the wetland and to monitor changes to the Laboratory's operational practices that have affected outfall volumes discharging to the wetland. This report presents the results of monitoring conducted for surface water, alluvial groundwater, vegetation, and geomorphology between January and December 2016. The data are

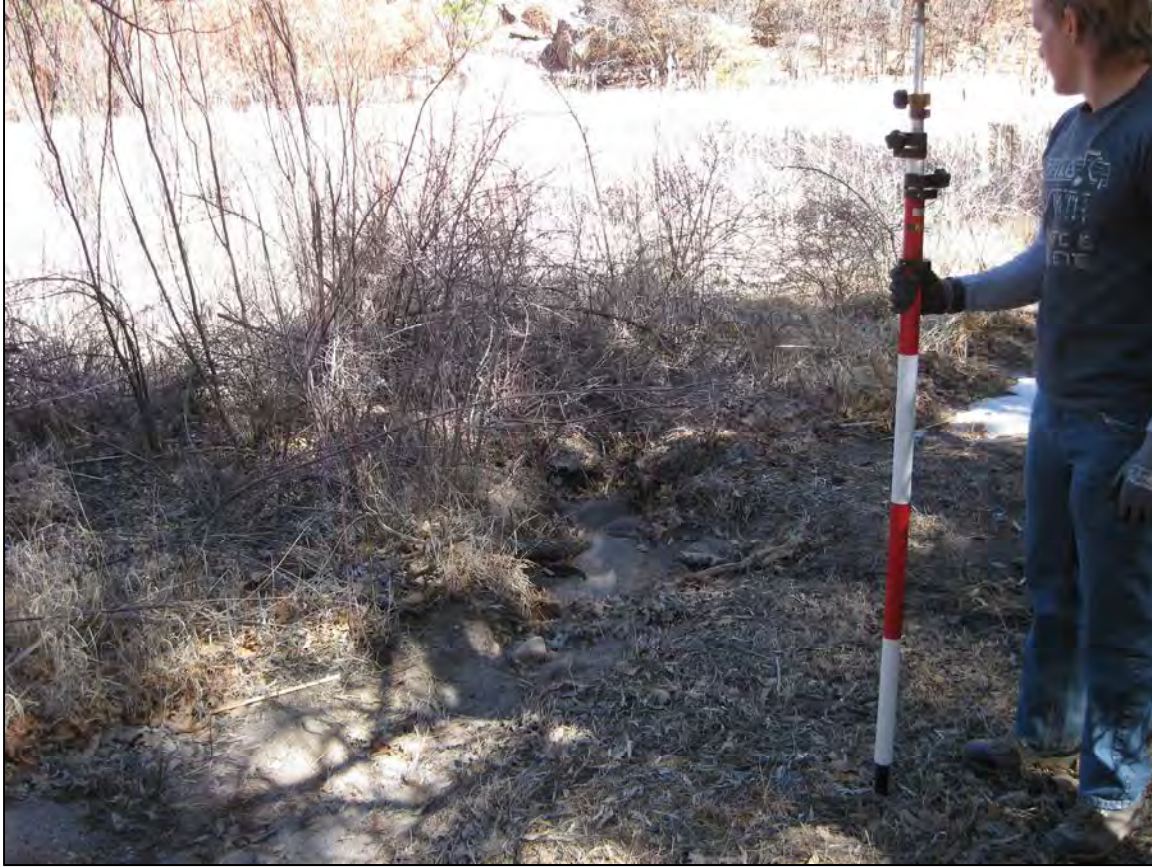
Photo B1-1 Maximum detected negative change (erosion) in reach S-2. March 2017 photo looking to north of the channel incision of 0.7 ft into alluvial fan on southern edge of the reach.

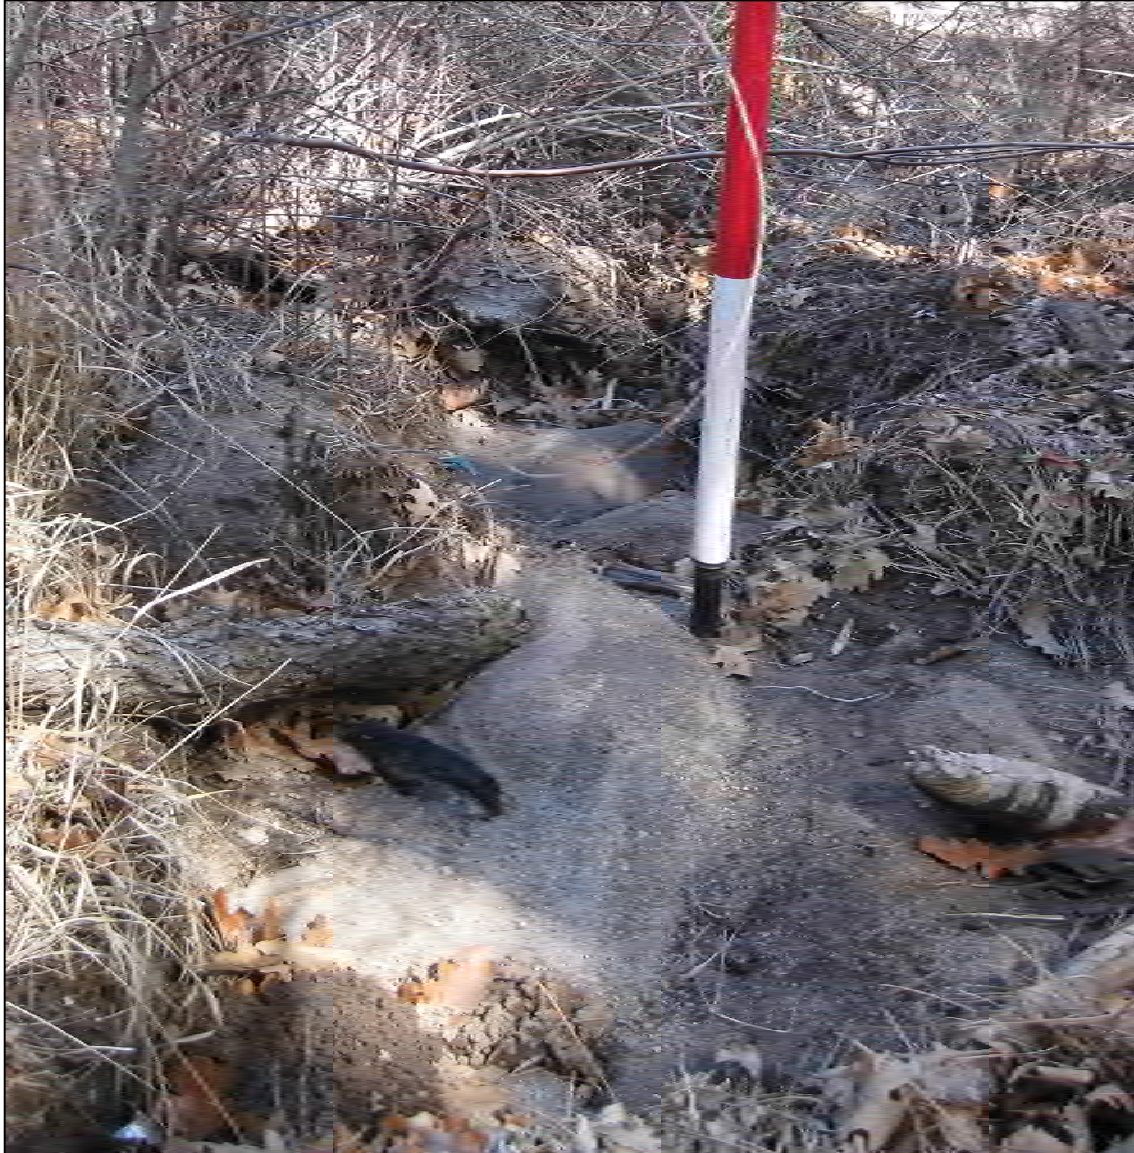
Photo B1-2 Closeup of incised alluvial fan where maximum erosion was noted. March 2017 photo looking north.

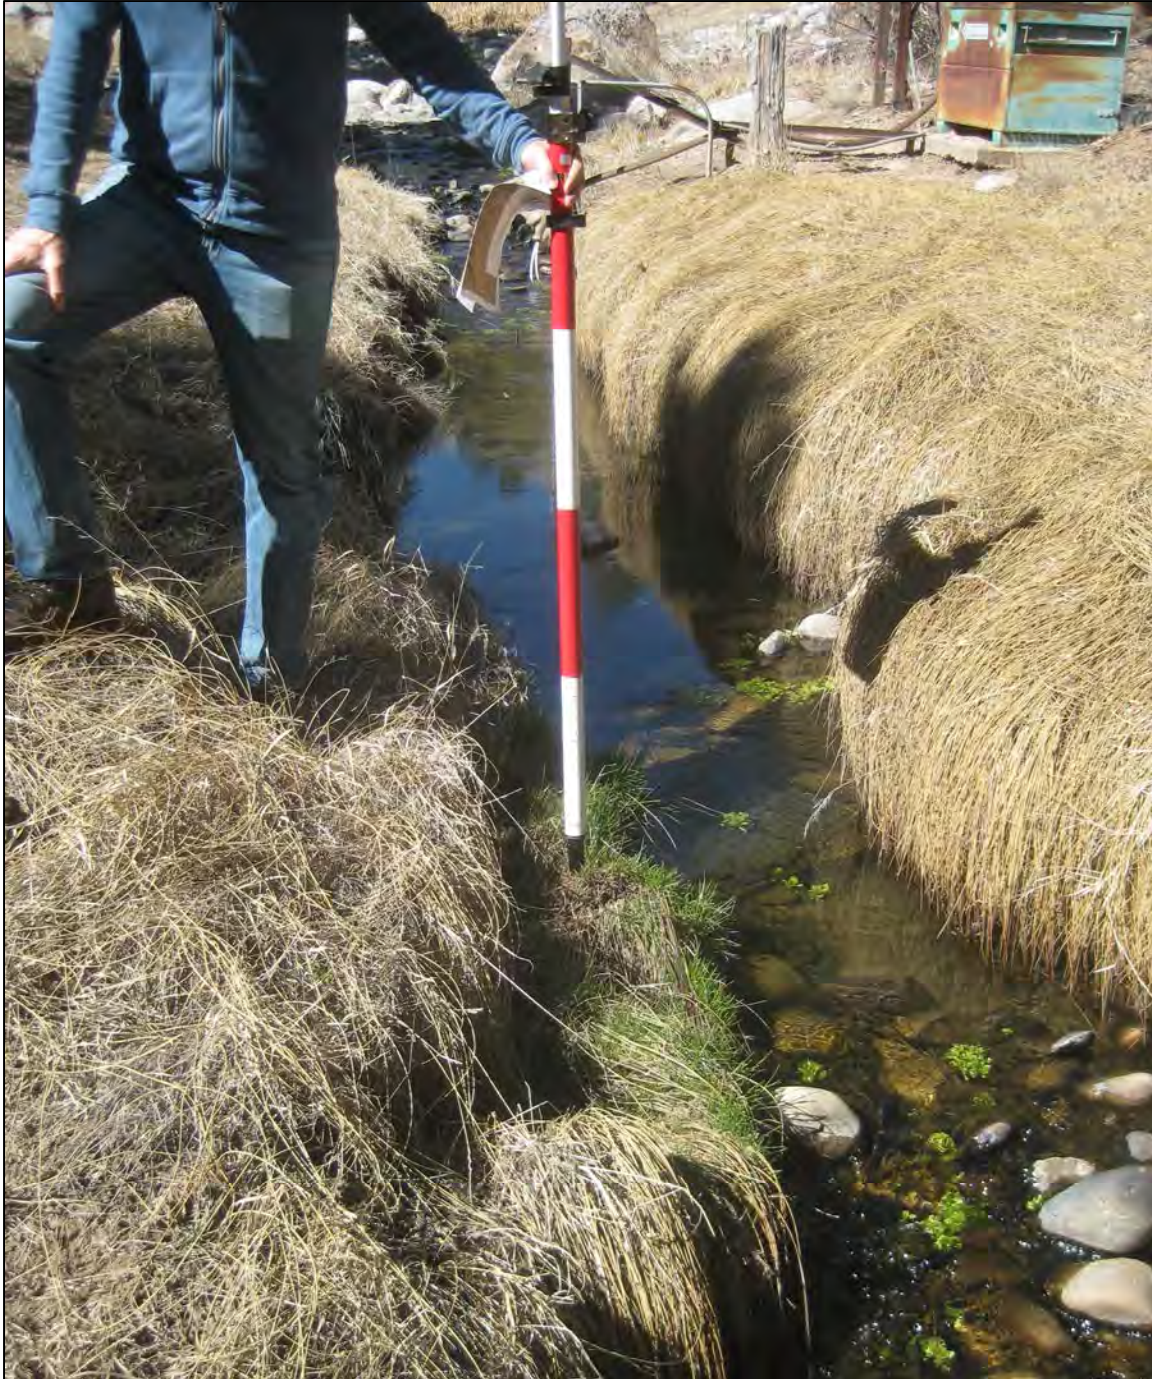
Photo B1-3 Maximum detected and field confirmed positive geomorphic change (deposition) of +1.61 ft in reach S-2. Slumping of channel banks below gage station E123 resulted in deposition of large blocks of bank sediment on the channel surface. March 2017 photo looking northwest (upstream).

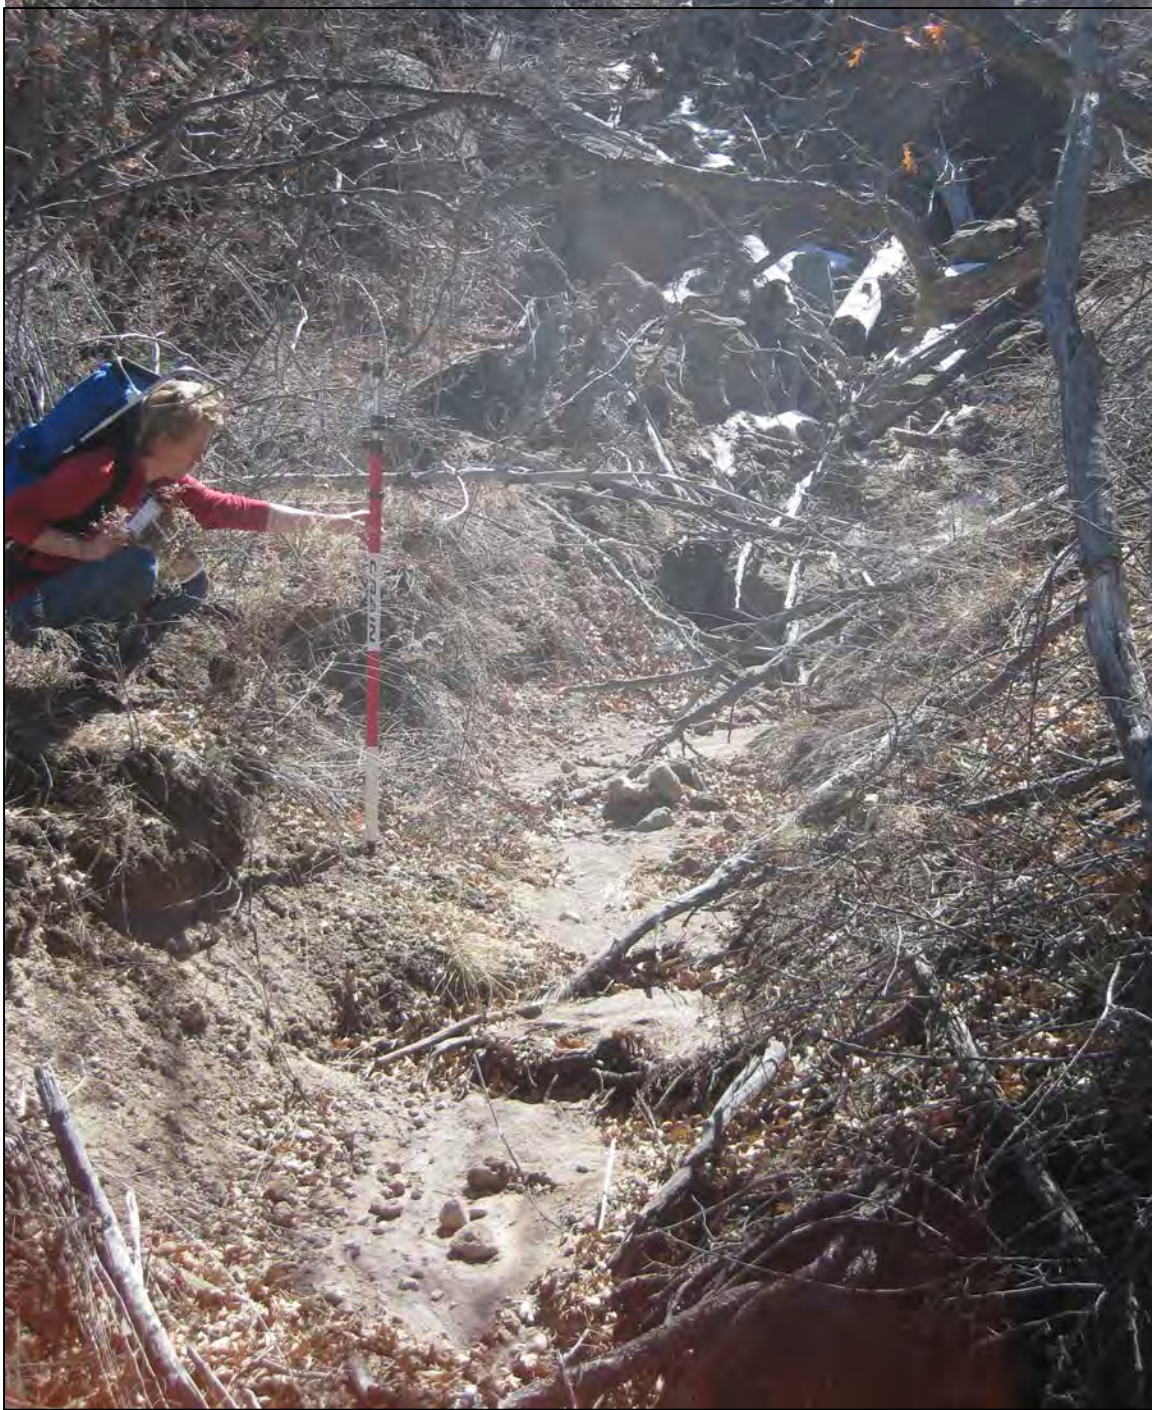
Photo B1-4 Deposition in side channel located approximately 50 ft downstream of plunge pool on south side of reach S-2. March 2017 photo looking south at storm drain outfall and cliff edge of Sandia Canyon.

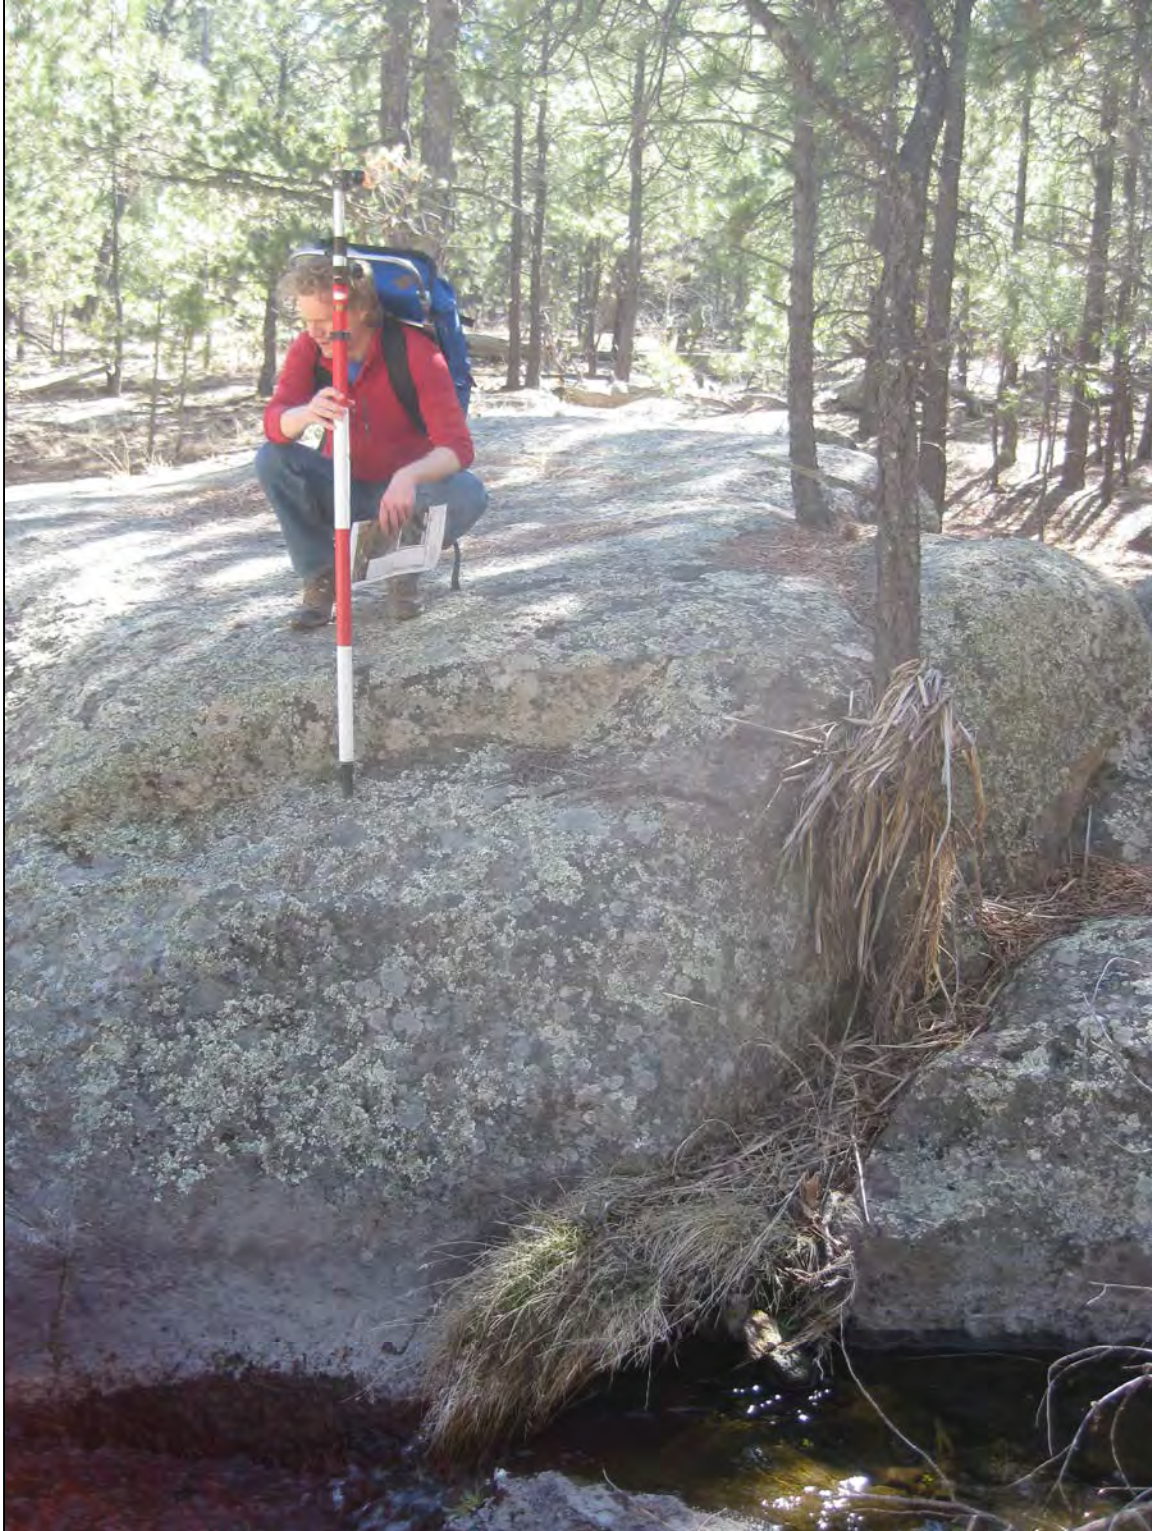
Photo B1-5 Location of maximum elevation change (+5.5 ft) detected. No actual geomorphic change occurred. This boulder at the eastern end of reach S-2 was classified as ground in 2016 but not in 2015. March 2017 photo looking south.

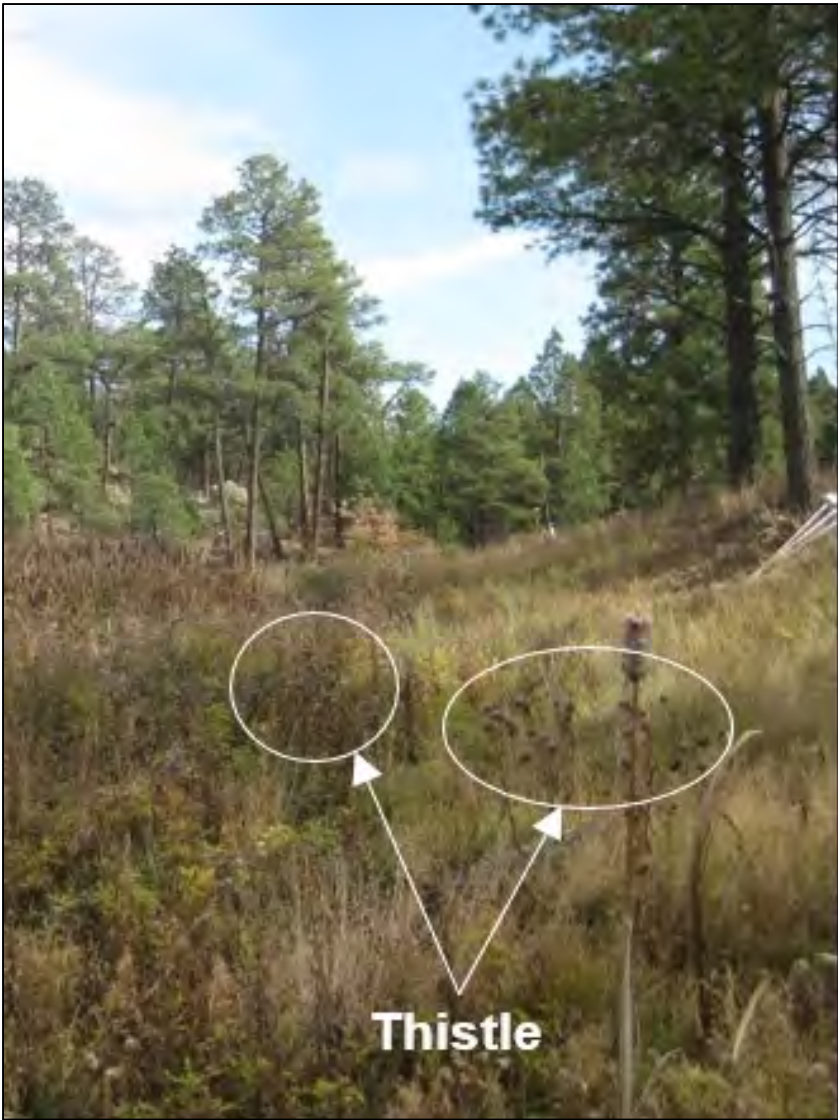
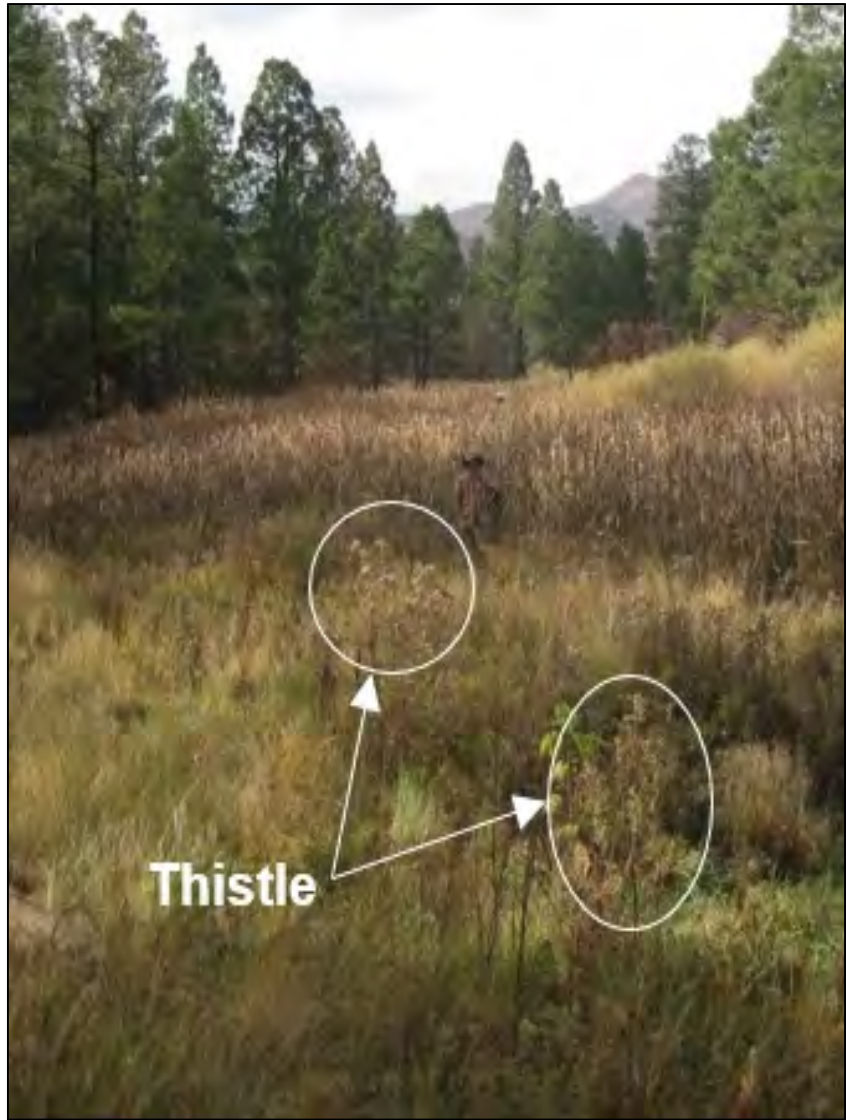
Photo C1-14 Observed thistle species expansion (2016) between southern end of transects SGCS-14 and -16: looking east toward grade-control structure (left) and looking west from south end of SGCS-16 (right)

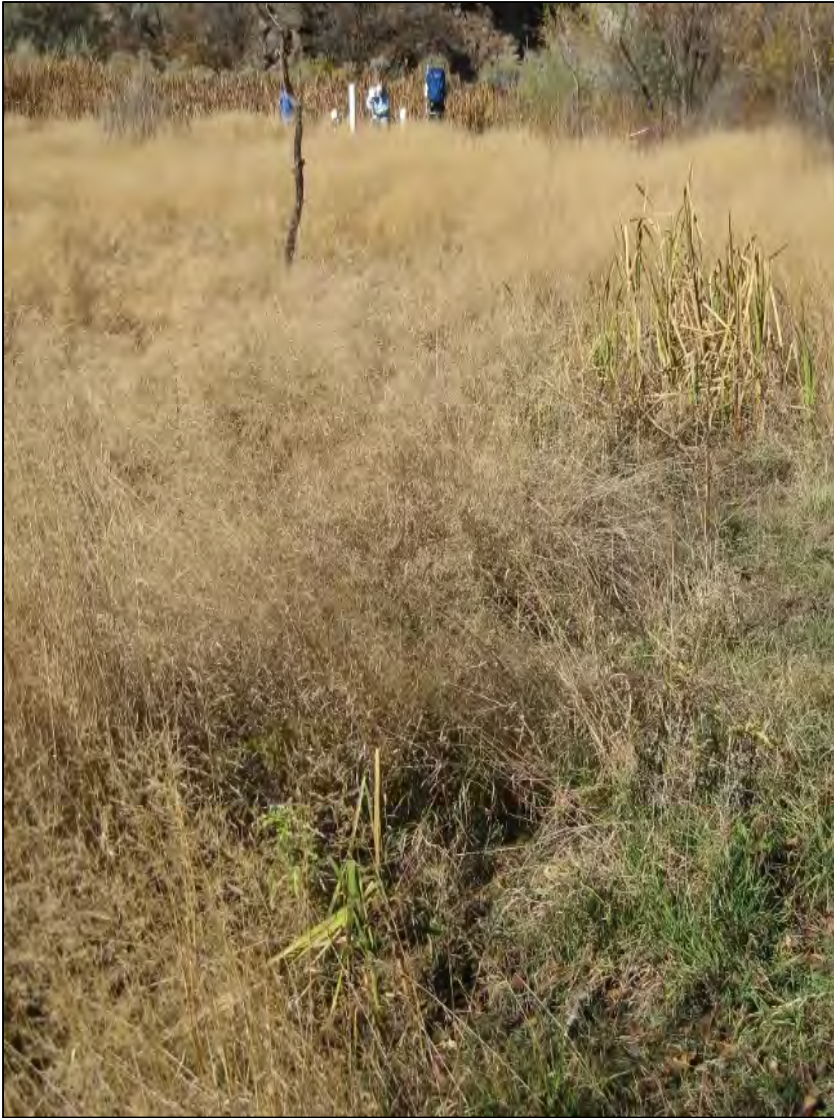
Photo C1-15 Newly observed cattail populations in 2016: discrete populations living within giant reedtop grass along southern end of SGCS-3A and -3B (left) and new population on southwestern bank of plunge pool (right)

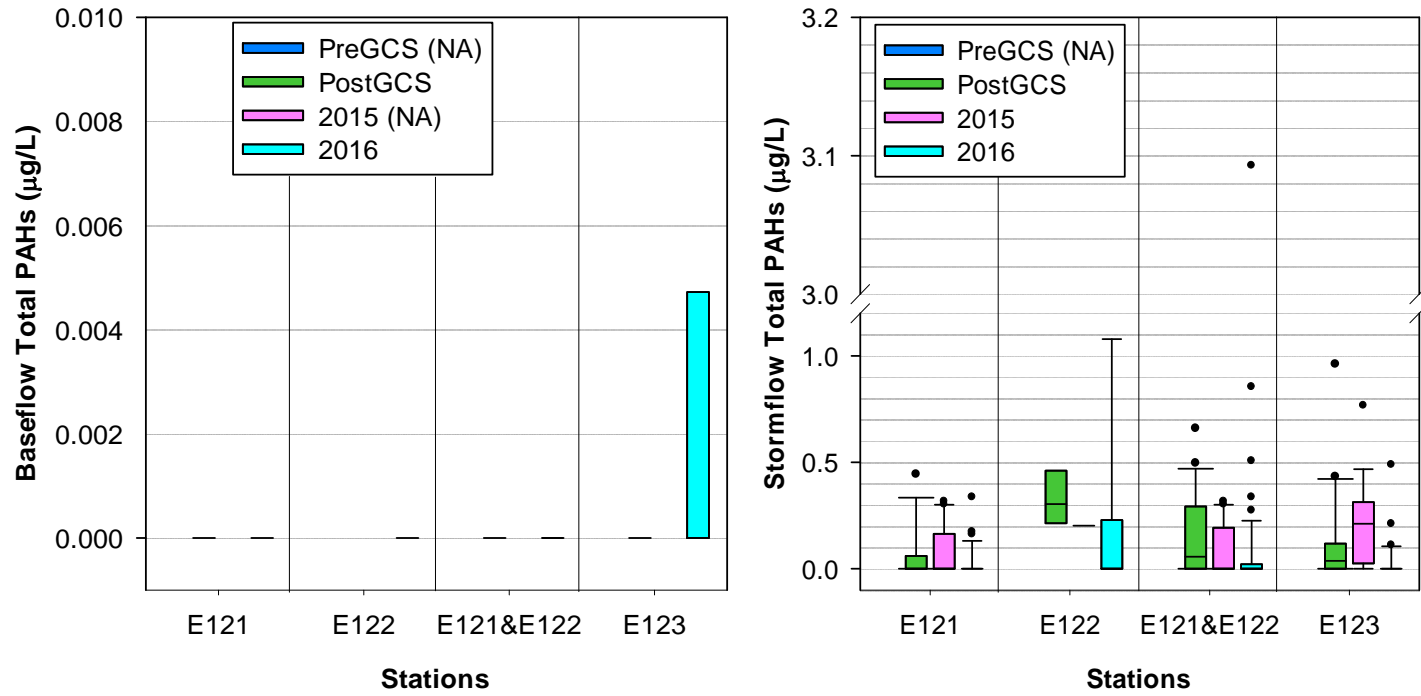
Figure D-2.0-7 Box-and-whisker plots of peak discharge, TSS/SSC, PCBs, unfiltered chromium and Cr(VI), and PAHs for base flow and storm flow at gaging stations E121, E122, and E123, pre- and post-construction of the GCS, respectively, in 2015 and 2016. (NA = Not analyzed.)

Figure D-2.0-7 (continued) Box-and-whisker plots of peak discharge TSS/SSC, total PCBs, unfiltered chromium and Cr(VI), and total PAHs for base flow and storm flow at gaging stations E121, E122, and E123, pre- and post-construction of the GCS, respectively, in 2015 and 2016. (NA = Not analyzed.)

In 2016, concentrations of PCBs, chromium, and PAHs in storm water were similar at gaging stations E121 and E123 (Figure D-2.0-7). Continued decreases of PCBs and chromium were observed at E123 over time compared with pre-GCS conditions (Figure D-2.0-7). In 2015, PAH concentrations downgradient of the wetland were slightly higher than upgradient of the wetland; however, in 2016, PAH concentrations downgradient of the wetland were lower than upgradient of wetland. Overall, the annual mass flux of sediment and contaminants of concern has decreased both spatially from E121 to E123 and temporally from 2014 to 2016 (Figures D-2.0-10 to D-2.0-13). These results indicate that, per volume of storm water, fewer contaminants are moving through the wetland. This steady reduction in mass flux corresponds to wetland vegetation expansion over the same time period and observed success of the GCS in stabilizing the terminus of the wetland. Therefore, the cause of the mass flux reduction may be multifaceted.

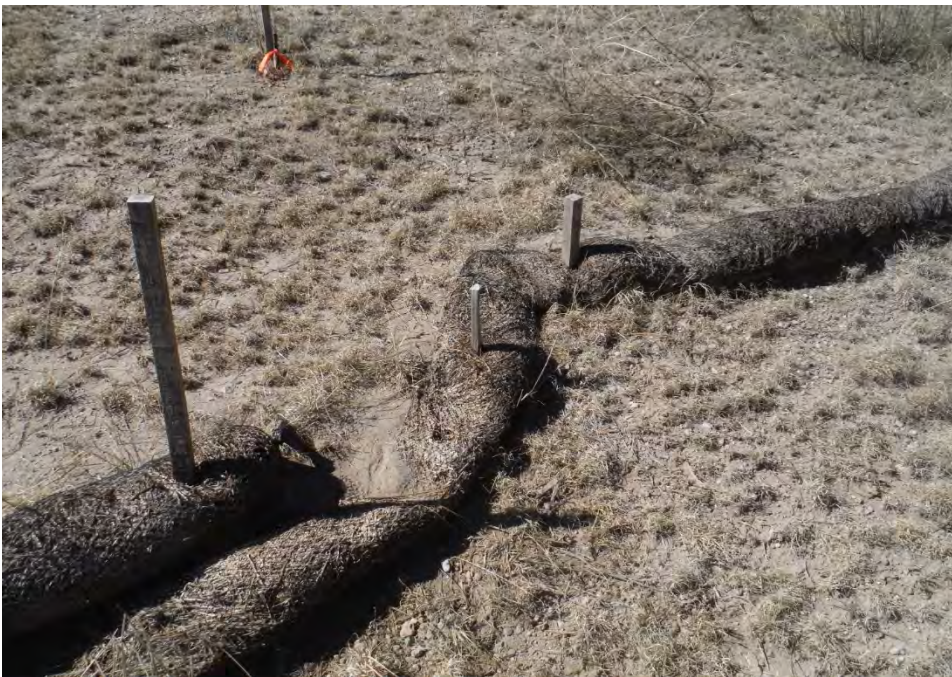
Figure E-2.4-1 March 2016: Straw wattle damaged by animal or persons walking on wattle. Recommend maintenance action.

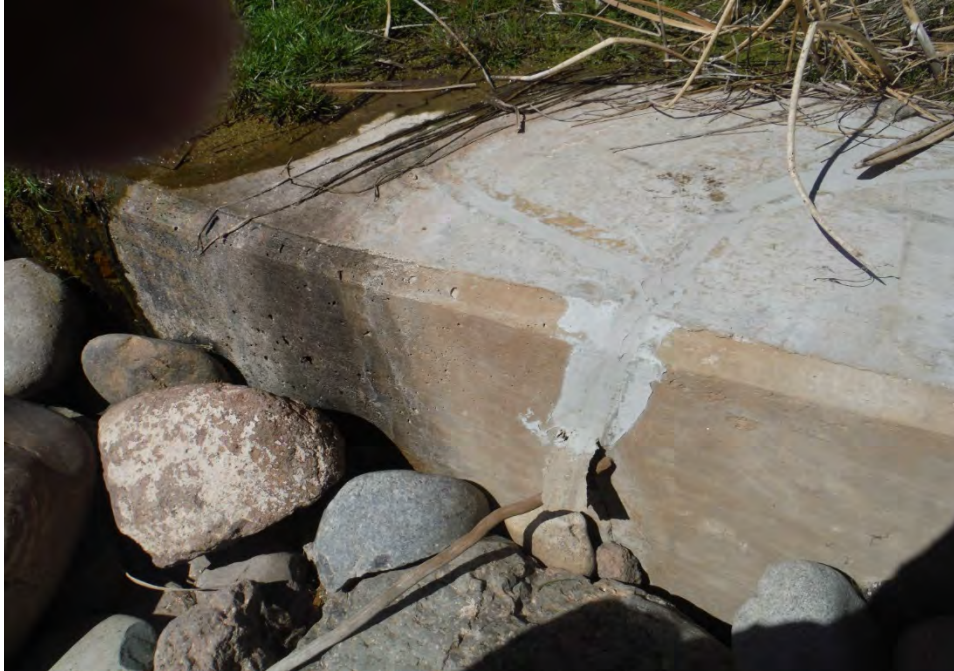
Figure E-2.4-2 March 2016: Previous crack repair on middle grade-control structure. No change from past inspections.

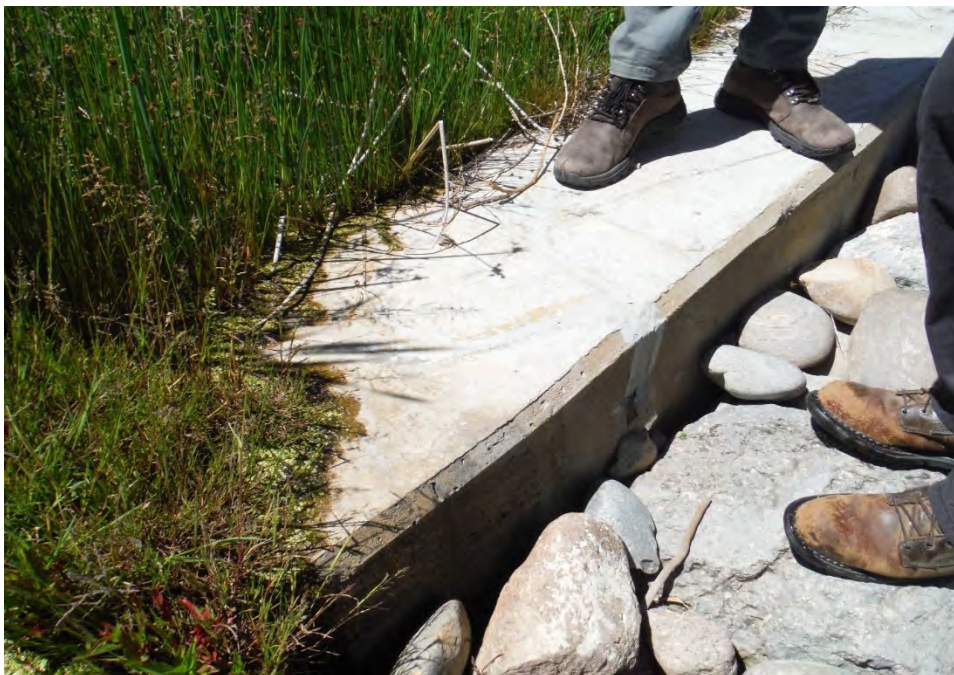
Figure E-2.4-3 June 2016: Crack repair on middle GCS. No change from past inspections.

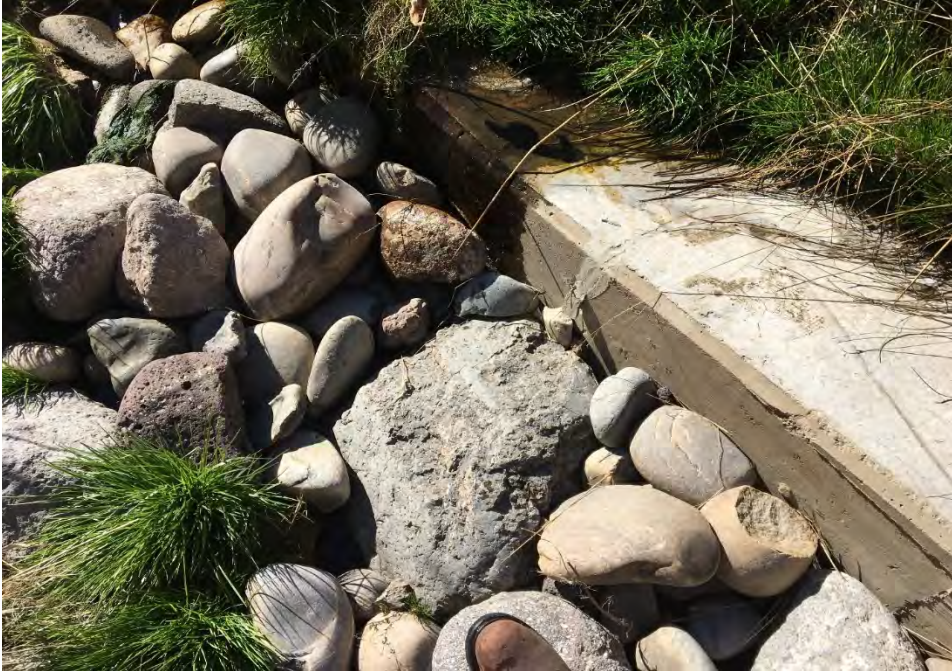
Figure E-2.4-4 November 2016: Crack repair on middle GCS. No change from past inspections.

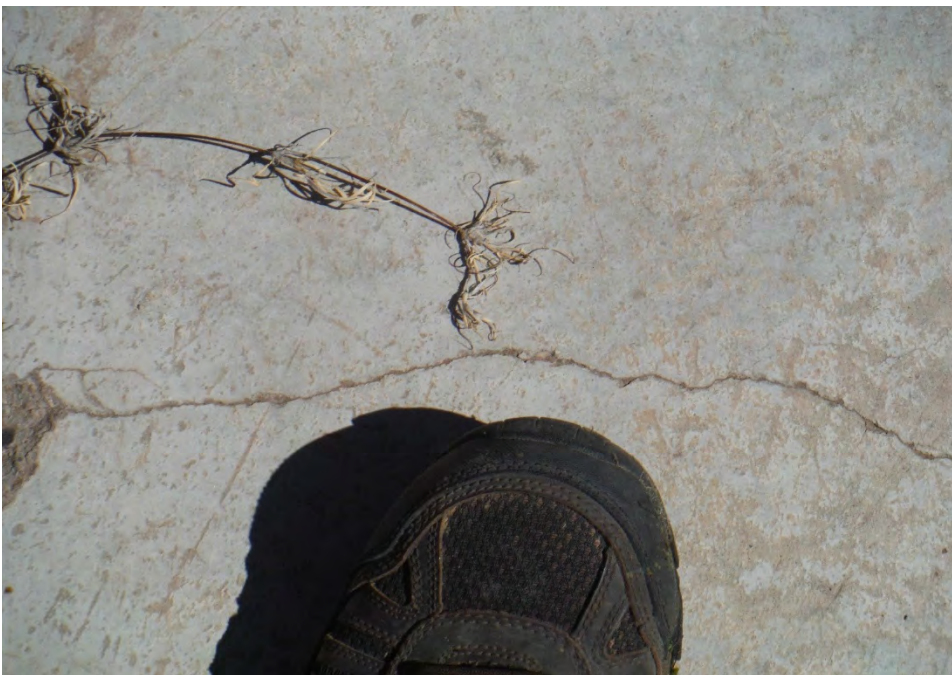
Figure E-2.4-5 March 2016: Crack monitoring. No change from last inspection.

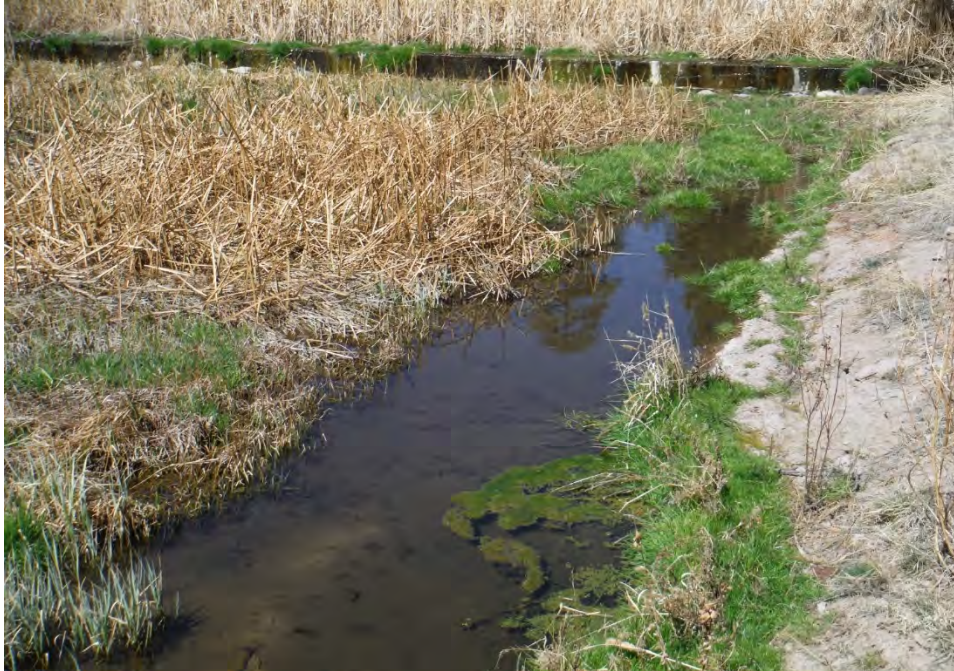
Figure E-2.4-6 March 2016: Preferential flow path monitoring on north bank between lower and middle GCS

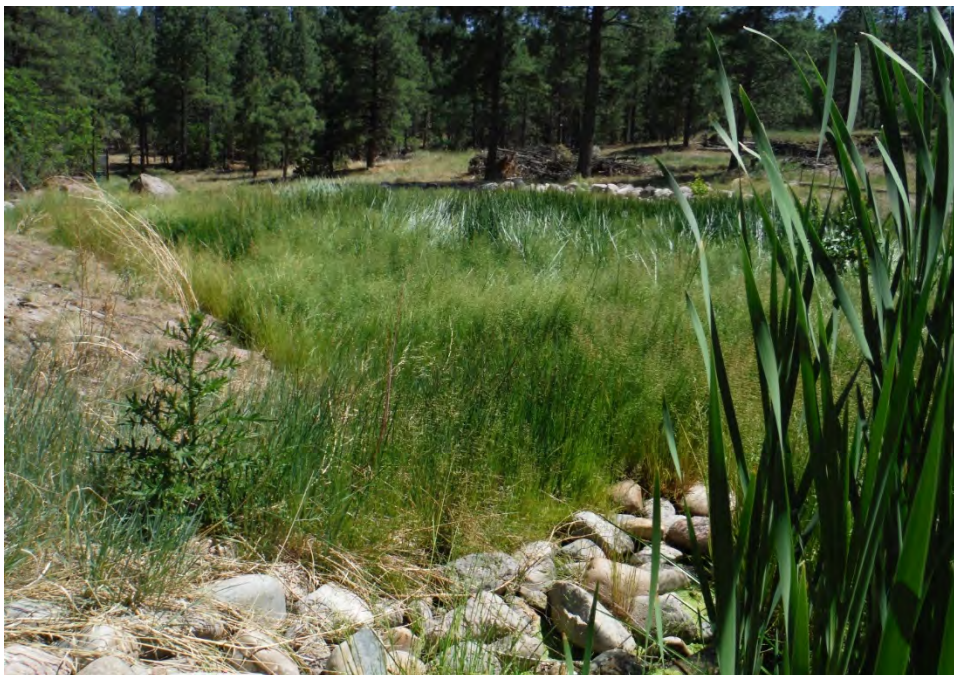
Figure E-2.4-7 June 2016: Preferential flow path not evident from vegetation in-fill. Continued monitoring recommended.
