LA-UR-01-2793

Los Alamos National Laboratory Permit Modification Request

No Further Action Proposals

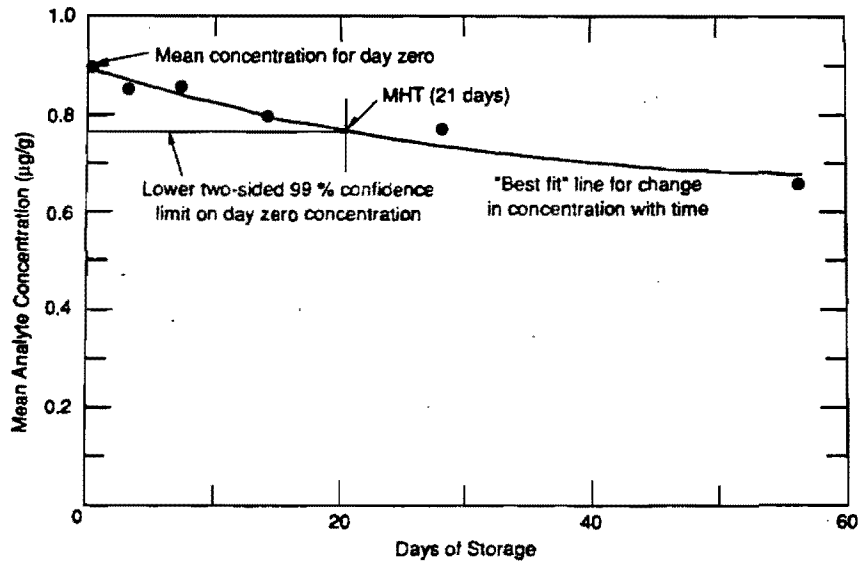
Figure 1. Illustration of ASTM method for estimating maximum holding time.

We also have concerns with the data treatment. MHTs were estimated using two definitions: a modified version of an ASTM procedure (1986) and one reported by Prentice et al. (1986). In ASTM, MHT is defined as the "maximum period of time during which a properly preserved sample can be stored before such degradation of the constituent of interest occurs or change in sample matrix occurs that the systematic error exceeds the 99% confidence interval (not to exceed 15%) of the test about the mean concentration found at zero time." The zero time mean concentration and standard deviation are estimated from an appropriate number of samples (usually 10) analyzed immediately after collection. If an analyte concentration is less than one order of magnitude higher than the crite-

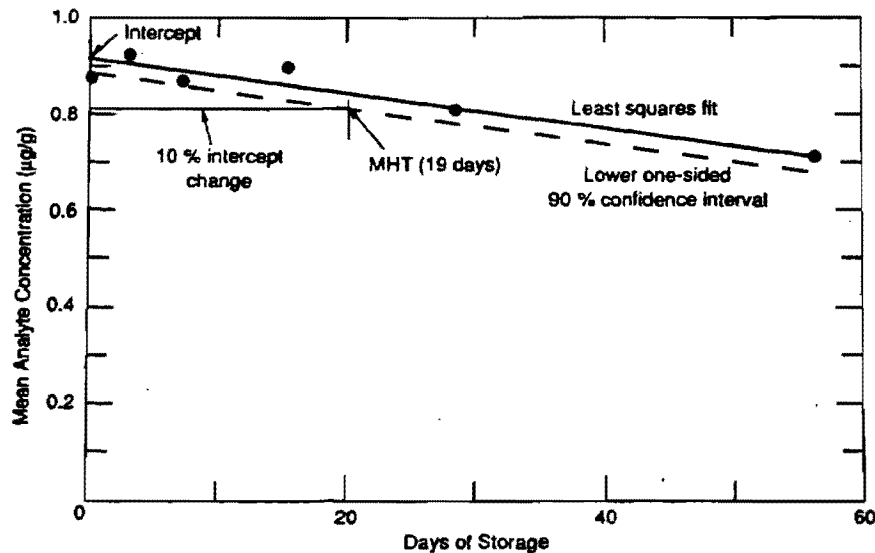
Figure 2. Illustration of ESE method for estimating maximum holding time.

According to Maskarinec et al. (1991), their "working definition differed slightly from the exact ASTM definition...." We believe it differs greatly. Their data are fitted via least squares to linear zero-order or first-order kinetic models or, in some

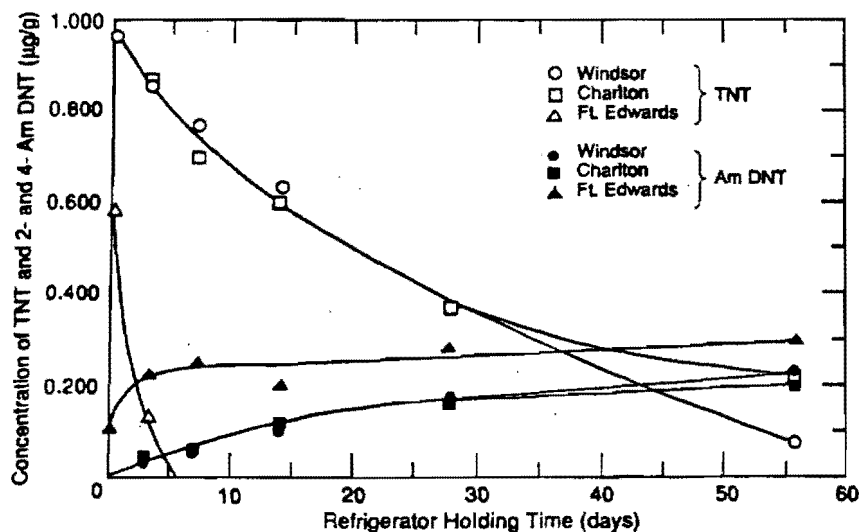
Figure 11. Refrigerator storage effects on TNT for three fortified soils.

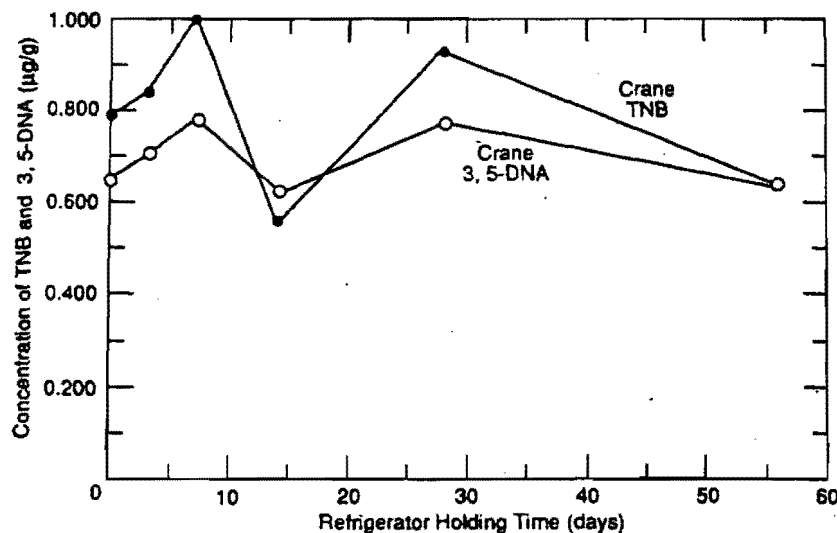
Figure 12. Refrigerator storage effects on TNB and 3,5-DNA for field-contaminated soil.

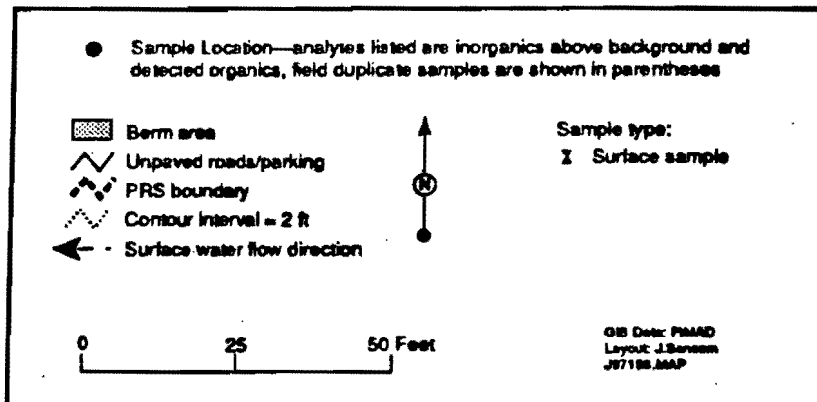
Figure 3.2-2 PRS 14-003, Site map of sample locations with detected analytes
