Title **A CURRENT ASSESSMENT OF THE NAKE'MUU
MONITORING PROGRAM**

Prepared for **U.S. Department of Energy
National Nuclear Security Administration
Los Alamos Site Office**

Prepared by **Bradley J. Vierra, Ecology and Air Quality Group
Kari M. Schmidt, Ecology and Air Quality Group**

Cultural Resources Report No. 288
Survey No. 817

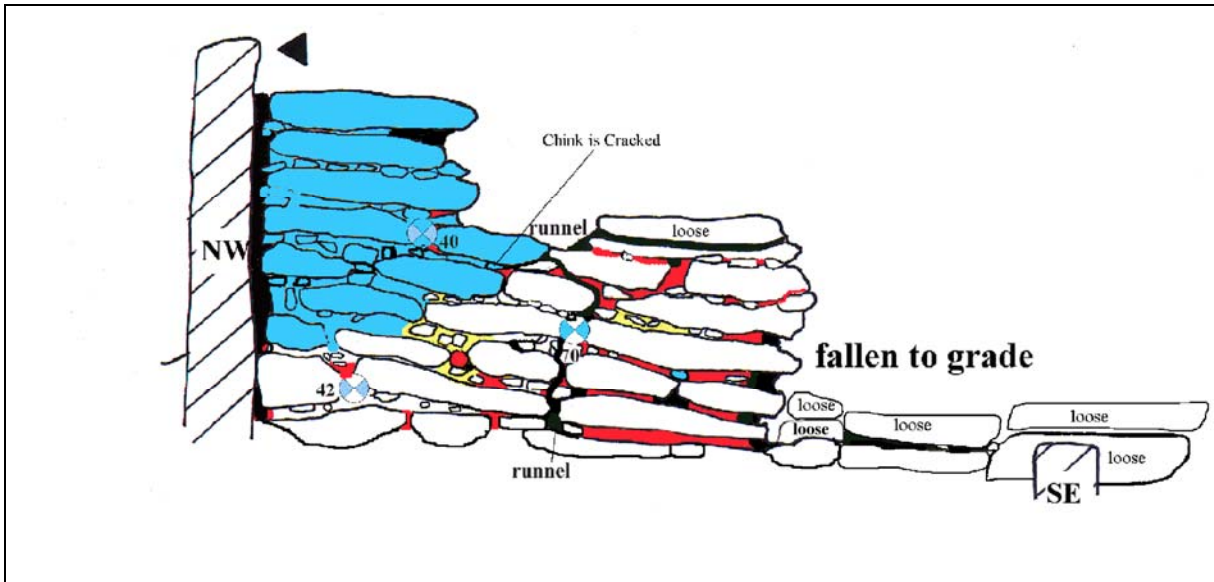
Figure 9. Collapsed wall segment (in blue) in Room 12 (northeast elevation).

As noted in the 2001 site visit section, several elk trails runs through the Nake'muu area (see Figure 8). In 2001, the northeast wall of Room 13 was (presumably) knocked over by an elk, as was evidenced by two piles of scat identified adjacent to the collapsed wall segment. During the 2005 visit, the northeast wall of Room 12/southwest wall of Room 14 was partially knocked over (Figure 9). Figure 8 shows this wall is also in the area of the elk trail, and may have been knocked over by elk movement. Of note, however, is that in both the 2001 and 2005 monitoring periods, levels of precipitation, especially snowfall, were markedly higher than in other years, and this may have weakened the walls at the site, making them more susceptible to damage and/or destruction from the elk. Given that the two years with the highest snowfall levels since the monitoring program began have witnessed wall collapse, it is very likely that levels of snowfall directly affect the stability of the walls because of the extra weight of the snow. Elk appear to exacerbate this instability.

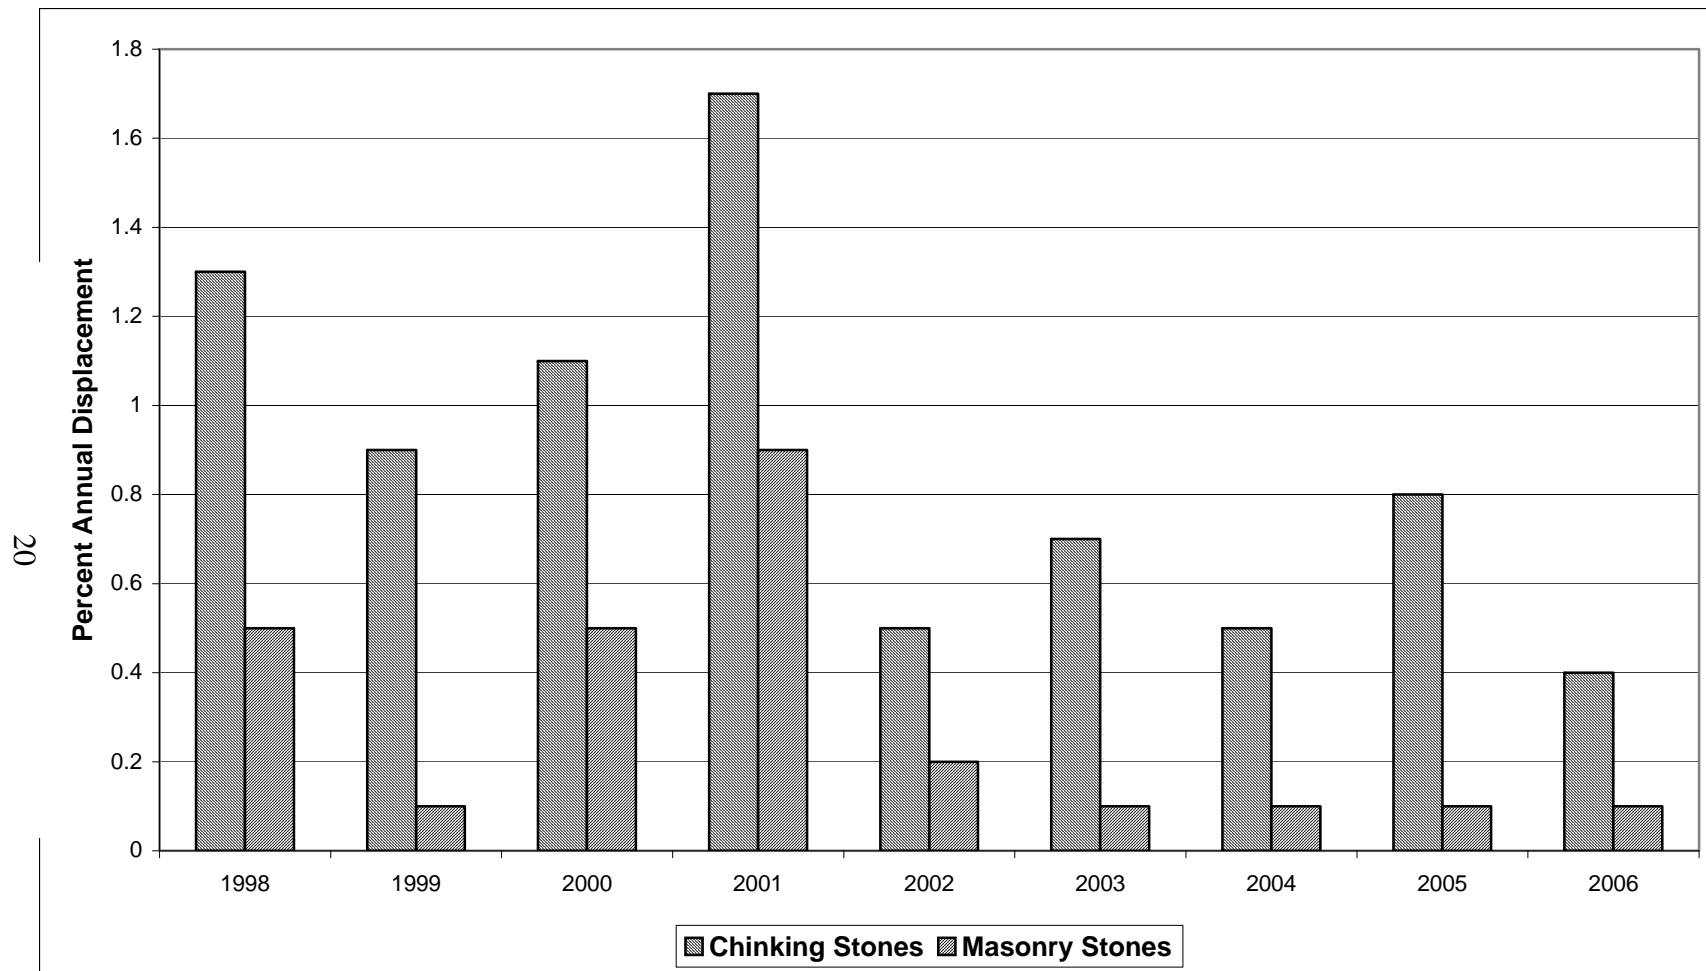
Figure 10. Annual displacement rate for chinking stones and masonry blocks.

A total of 606 chinking stones and 130 masonry blocks have been displaced over the nine-year monitoring program. If we consider that there were a total of 6578 chinks and 3994 masonry stones originally forming standing-walled architecture at Nike'muu, then we have witnessed a 0.9 percent displacement of chinking stones and 0.3 percent displacement of blocks during this period, and these numbers are unchanged to the totals derived in 2005. Overall, the annual lost rate ranges from 0.5 to 2.0 percent for the chinking stones and 0.05 to 1.3 percent for the masonry blocks. However, this includes a marked increase in stone loss rates during the 2001 and 2005 monitoring sessions, which is likely associated with increased levels of precipitation, especially snowfall, which weakens the walls and makes them more susceptible to damage from elk in the site area. Otherwise, the rates are generally closer to the nine-year mean.

Figure 10 graphically illustrates the annual changing pattern of chinking stone and masonry block displacement rates. Stone loss due to the collapse of the northeast wall in Room 13 were removed from the 2001 counts, and stone loss due to the collapse of the southwest wall of Room 14 were removed from the 2005 counts since this loss is presumably due to the impact of elk, but may have as much to do with increasing levels of precipitation in these years. As can be seen in this figure, there is a distinctive pattern represented during this nine-year period. That is, a high in 1998, then a general decrease and step-like increase from 1999 to 2001 and then a general low from 2002 to 2006, with a slight increase in 2005. The question is, does this pattern correlate with changes in the ambient environment (e.g., rainfall) or to the number of annual test shots from the DARHT facility?

The nine-year monitoring program indicates that about 0.9 percent of the chinking stones and 0.3 percent of the masonry blocks are falling out of the walls on an annual basis. The annual displacement rate of chinking stones is significantly correlated with the amount of snowfall and not rainfall or test shots from DARHT. Although the amount of annual snowfall appears to have the greatest effect on chinking stone loss, rainfall does undercut the walls and could cause the catastrophic loss of a wall due to instability. On the other hand, the limited six-year data on shots from DARHT do not seem to correlate with chinking stone loss.

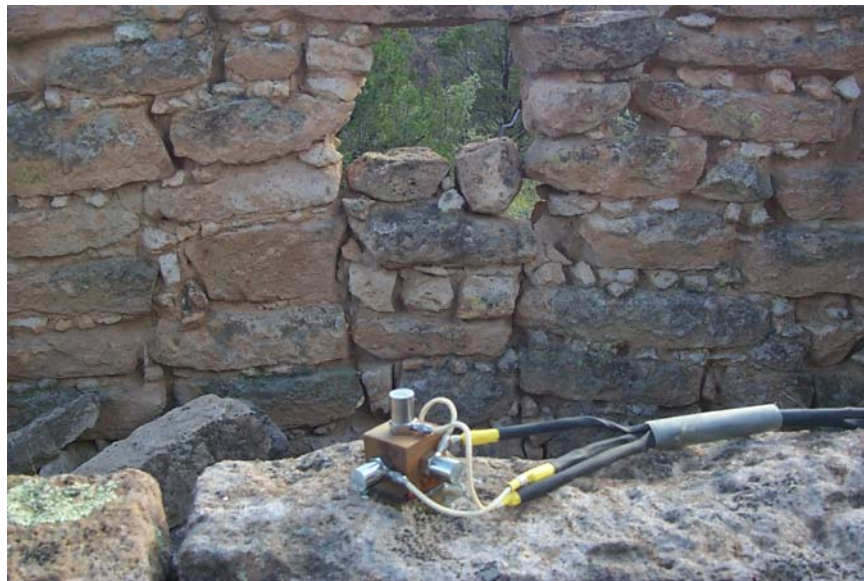
Figure 11. Accelerometer on Room 32 wall.

Two test shots were fired at the DARHT facility on September 6, 2000. Each explosive was composed of 15.6 pounds of flaked TNT enclosed in a cylindrical cardboard tube. The tube was then placed on a wooden stand. Accelerometers were placed on two walls at Nike'muu to record the events. One was placed on the southeast wall of Room 21 located in the northeastern corner of the site nearer to the DARHT facility. The other was placed on the northeastern wall of Room 32 in the southwestern area of the site (Figure 11). A phenolic block was glued to the top of each wall, and three Endevco ± 25 g accelerometers were mounted on each block. The "x" accelerometer was oriented in the direction of the shot, the "z" accelerometer was oriented upward and the "y" accelerometer was oriented perpendicular to the "x" in the horizontal direction. Therefore, six individual accelerometers were used to monitor each test. The location closer to the shot at Room 21 was denoted as Station 1 and the location in Room 32 as Station 2. Data were collected for a 10-second interval during both tests.

The peak accelerations for all sensors on these tests were between 50 and 100 mg. The oscillation frequencies were about 80 Hz at Station 1 and slightly higher at Station 2. When records are integrated, we find roughly a 6 mm per second of peak velocities and peak

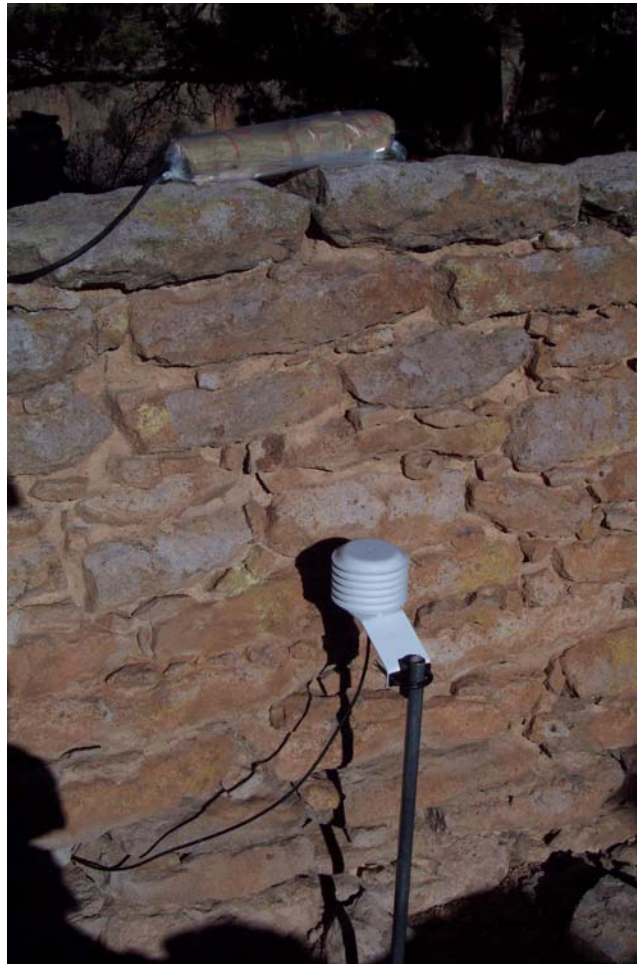
Figure 12. Displacement and temperature sensors.

The measurements were conducted at Nake'muu for a week. The sensor was connected to two separate rocks (Figure 12). The rocks were not touching each other, but the mortar beneath was strongly connected to both rocks. Thus, we could expect to measure the expansion and contraction of the rock – mortar system with this instrument. The results from day to day reproduced nicely. When the sensor extension with temperature was subtracted, a clear picture of the extension relation to air temperature emerged – as the air temperature increased during the day, the extension between the two positions increased, but with a phase lag with respect to the temperature. As the temperature cooled, the extension decreased, but again with a phase lag. A plot of the extension and the air temperature are shown in Figure 13 as functions of the point

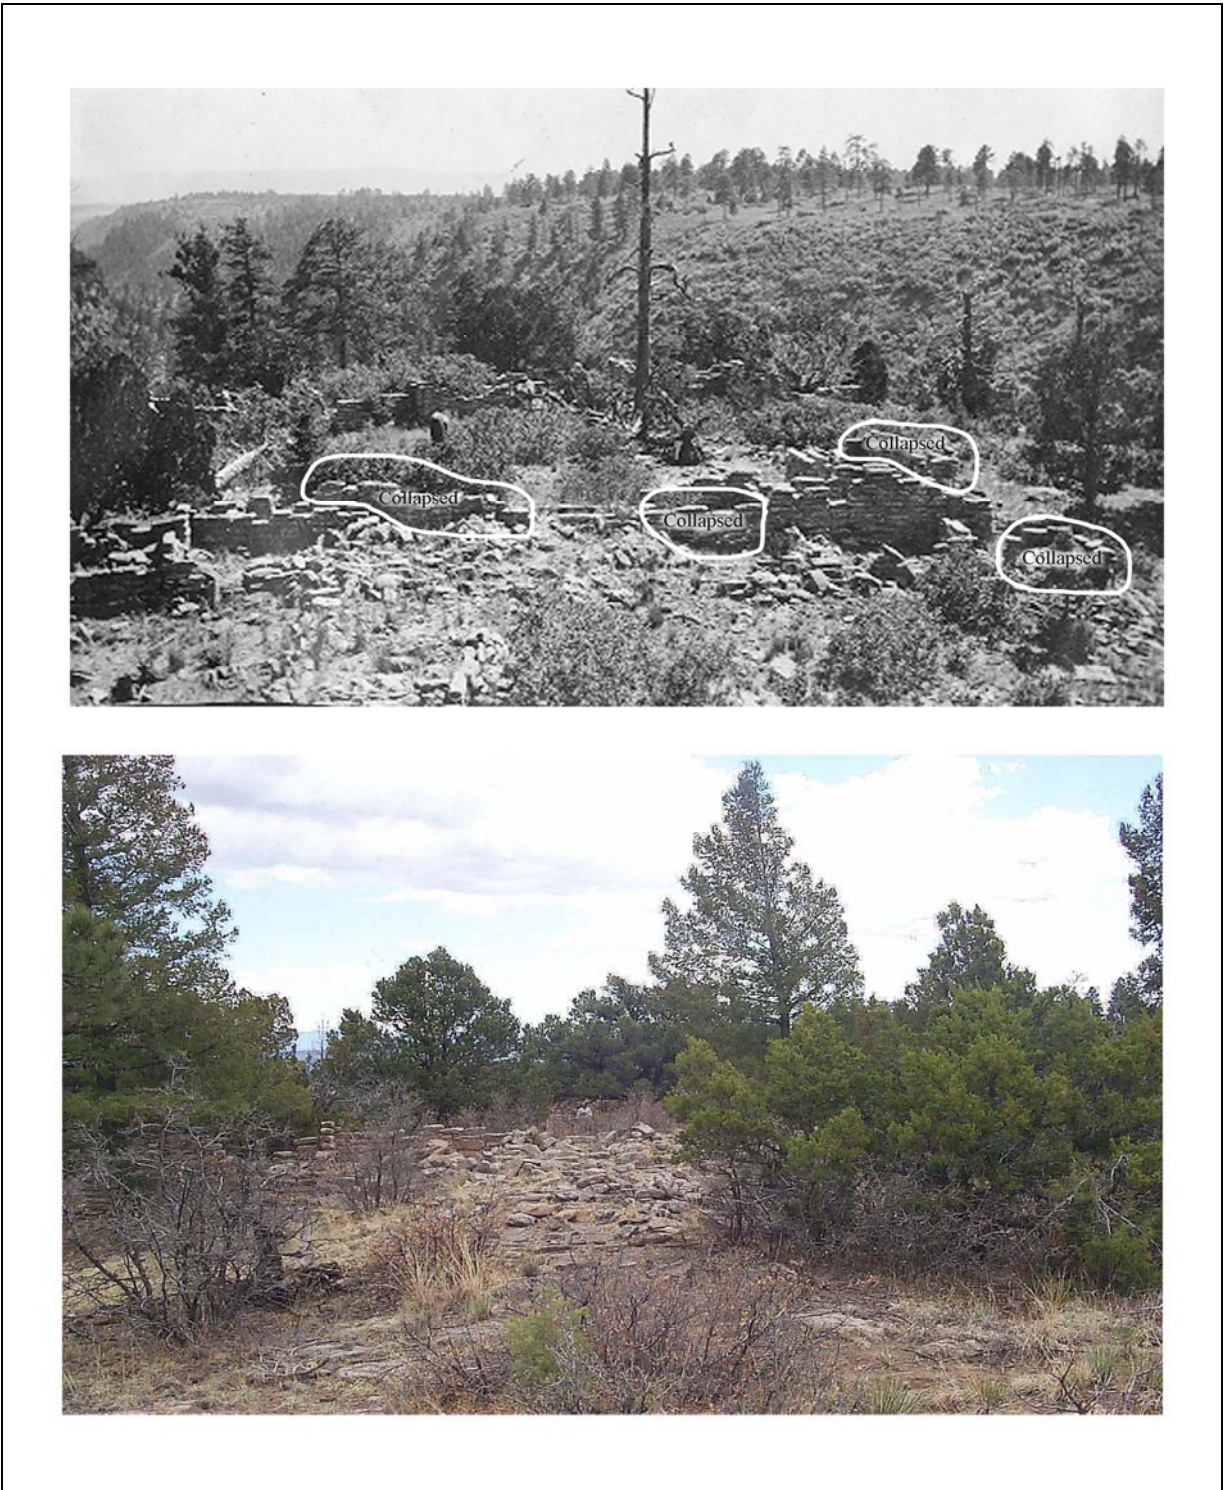
Figure 15. 1915 and 2000 photographs of Rooms 25 to 28 and 33.

fallen to grade. Along the south side of the pueblo, Rooms 15, 16, and 47 seem to have partially collapsed, but Rooms 43 or 44 may still have standing walls. In the eastern roomblock, Rooms 4 and 5 may also have standing walls. The standing ponderosa pine in the photograph has fallen, destroying the walls in Room 16.

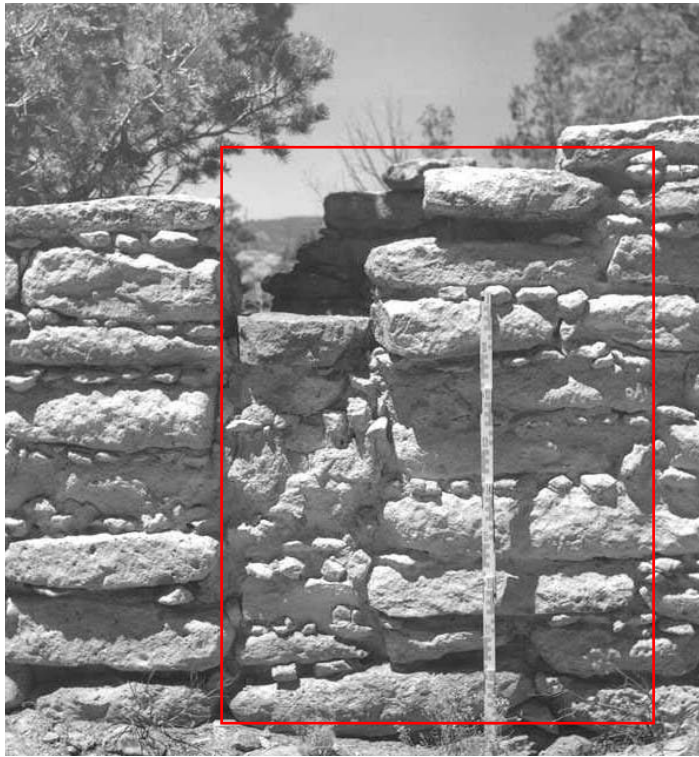
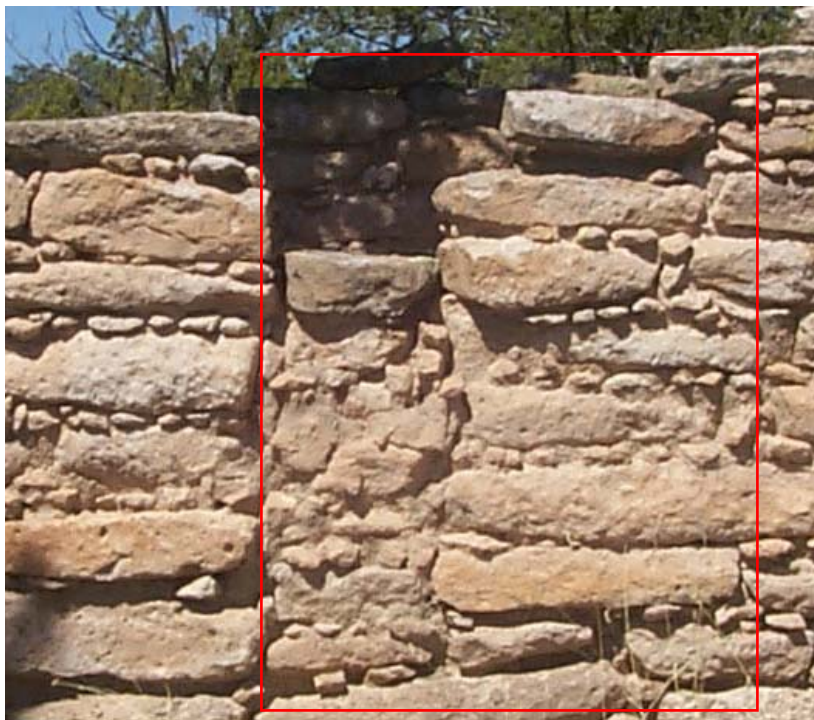
Figure 20. 1975 and 2000 photographs of the exterior northwest wall of Room 7.

Several of the 1975 photographs also revealed that sections of four walls have collapsed during this 25-year period. This collapse includes 10 masonry blocks from the northeast wall of Room 16, another 10 blocks from the northwest wall of Room 17, four blocks from the northwest wall of Room 36, and three blocks from the southwest wall of Room 40. The wall in Room 16 is situated adjacent to a large juniper that may have affected the stability of the wall. The collapsed section in Room 17 is located adjacent to an elk trail that might have also affected this wall. Rooms 36 and 40 are situated near each other in the northwestern area of the site. The blocks in these sections were located in unstable situations at the freestanding ends of partially standing walls. And, in 2005, the northeast wall of Room 12/southwest wall of Room 14 was partially knocked over, presumably by an elk.

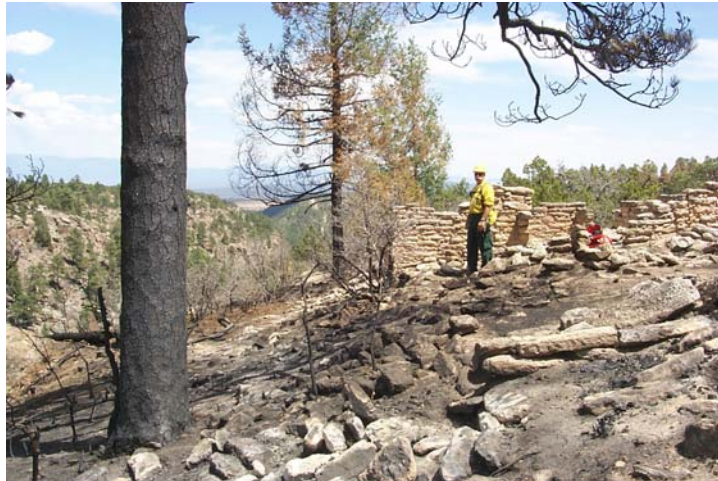
Figure 21. Site before Cerro Grande fire rehabilitation.

Portions of Nake'muu were burned by the 2000 Cerro Grande wildfire. Much of this burning was limited to the northern edge of the site where ground cover like scrub oak was burned. The rooms in this area have mostly fallen to grade, so that mostly ground-level rubble was exposed and burned. Nonetheless, two large trees were also burned and these posed a threat to the standing walls situated in the northeastern section of the site (Figures 21 and 22). Consultation with San Ildefonso Pueblo was initiated and they agreed that the two trees should be cut. A Johnson Controls Northern New Mexico work crew, under the direction of Manny L'Esperance, cut the trees down on June 16, 2000. Two members of San Ildefonso Pueblo were present during the activity. The fact that much of the scrub oak had already been removed from the site helped to avert the potential for further damage. Besides cutting the trees, the crew placed a series of wattles along the northern side of the site to reduce erosion. Some straw was also placed on the ground in the area of the burned rubble to enhance plant growth.

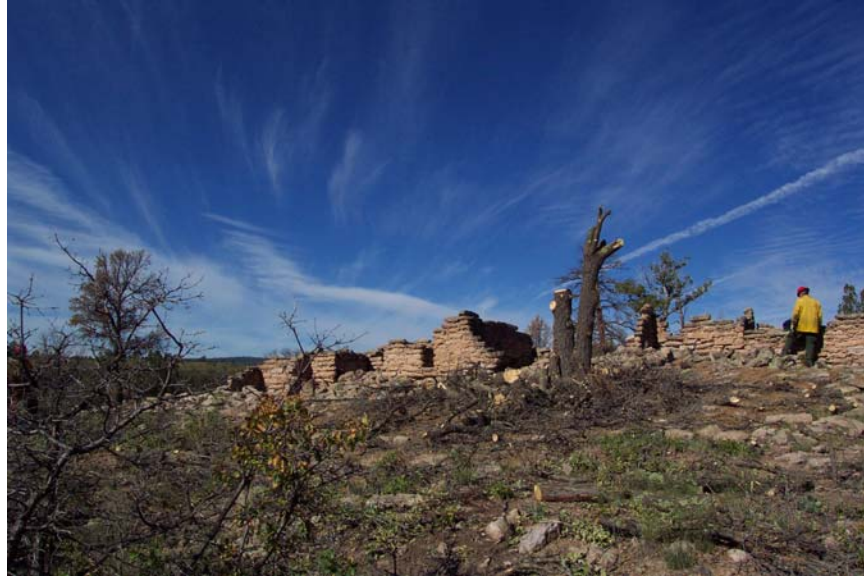
Figure 23. Nake'muu after the removal of brush and trees.

Bruce Masse escorted the San Ildefonso CGRP crew to Nike'muu on September 22 –25, 2003. The crew removed brush, cut trees and laid some soil erosion control features composed of cut limbs (Figure 23). Figure 24 illustrates the location of trees cut down by the thinning crew. As a result of efforts associated with this project, the area in and around Nike'muu has mostly been cleared of vegetation, and the site area is much more open. It is unclear what effect this might have on the site in respect to both elk visitation and exposure to the weather (e.g., rain and snow).
