Completion Documentation for Construction of the Wing Ditch in Pueblo Canyon

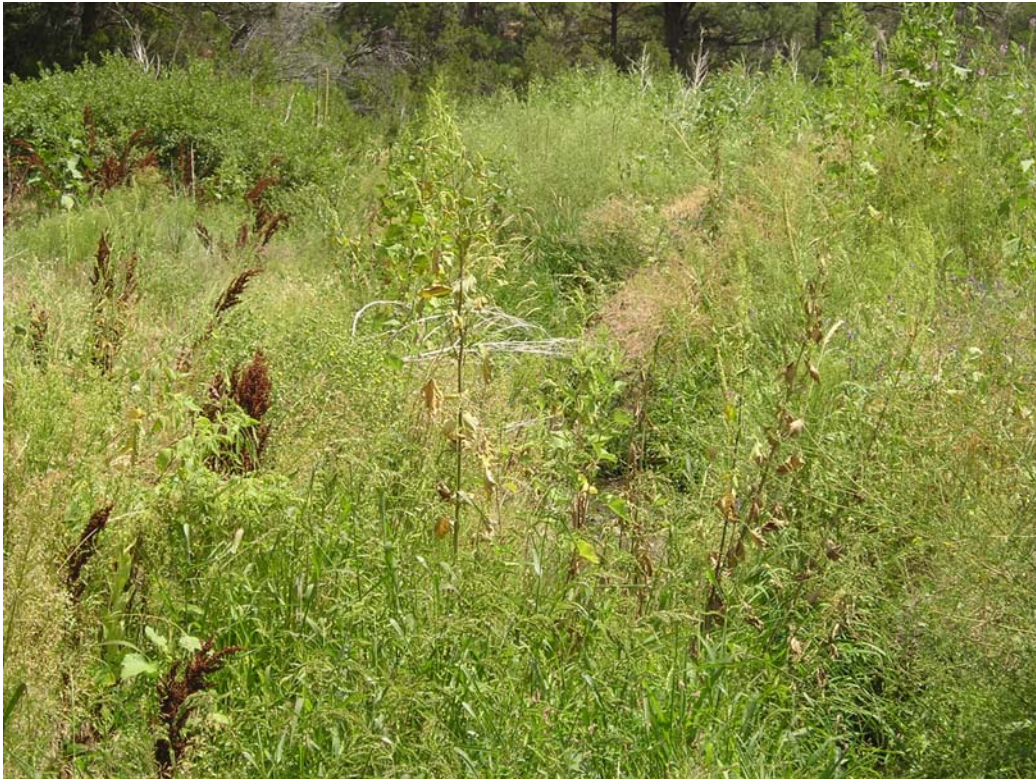
Figure 1 Wing ditch site before excavation

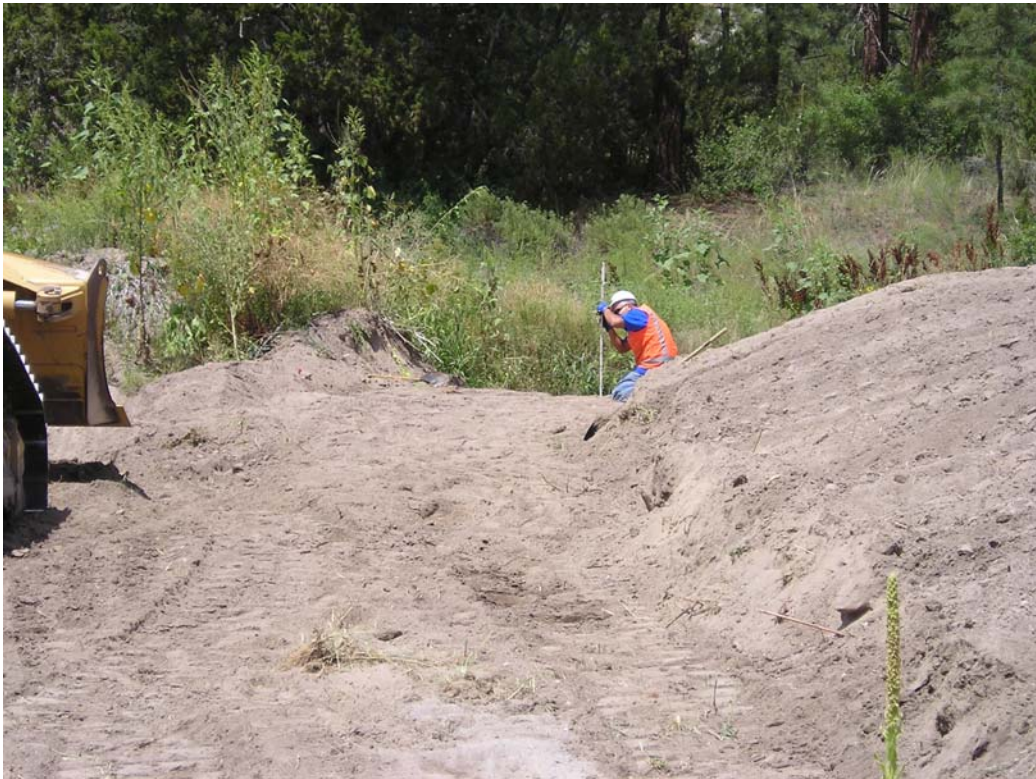
Figure 2 View looking upgradient along wing ditch towards existing channel. Initial excavation and surveying for grade.

The ditch is approximately 77 ft long and 10 ft wide with a 2% grade. It is lined with a geotextile fabric overlain by 6- to 12-in. cobbles. The downstream (east) side of the ditch is bermed to direct flow within the ditch towards the former (currently dry) channel on the floodplain. The former channel sits at an elevation approximately 2 ft above the current active channel. The berm is constructed from material excavated for the wing ditch.

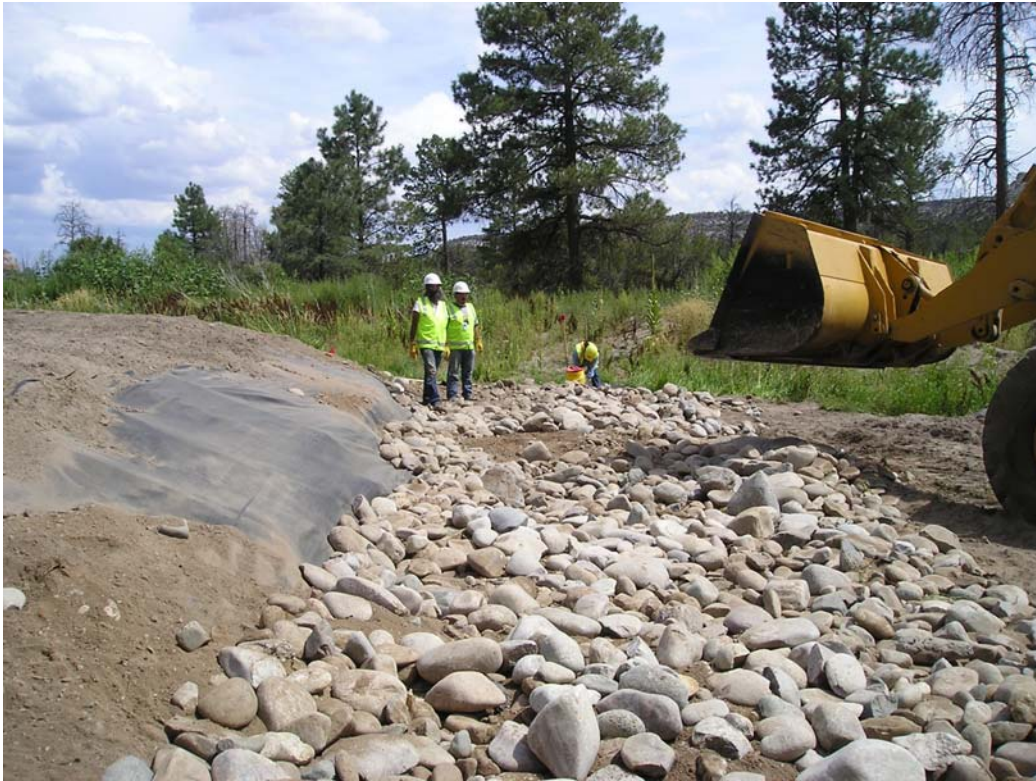
Figure 3 View looking downgradient along wing ditch. Placement of geotextile and rock liner.

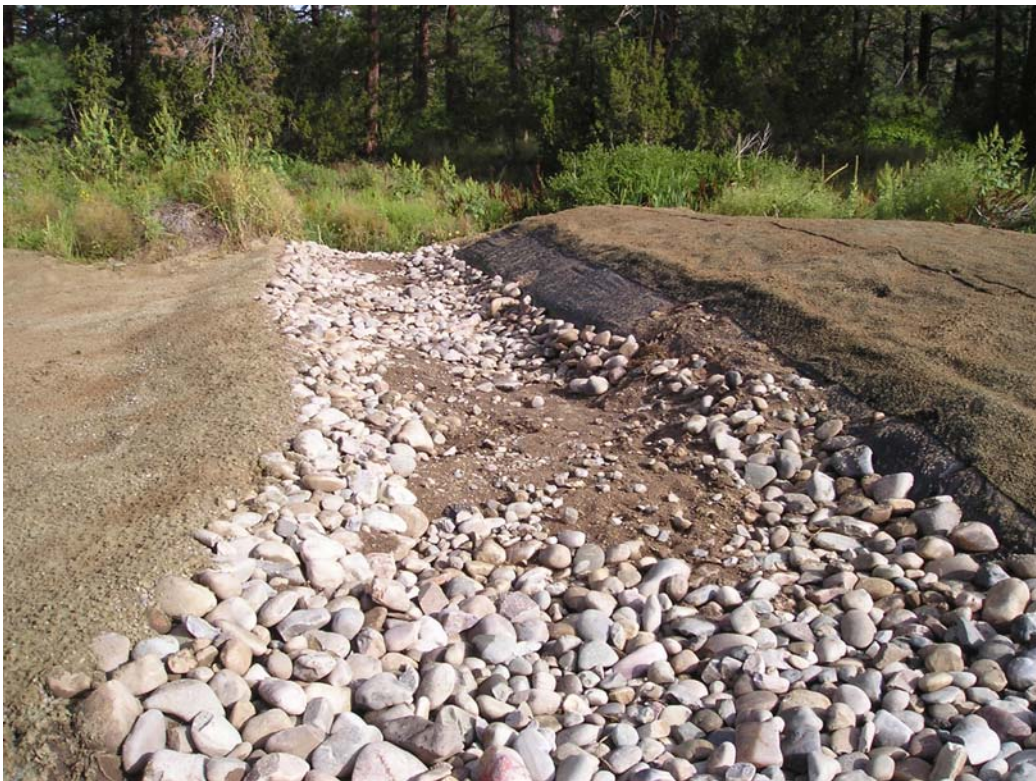
Figure 4 View looking upgradient along wing ditch after stabilization and hydromulching

The wing ditch is stabilized as described above. Excavated sediment was used for the berm on the downstream side of the wing ditch. The berm was draped with Enkamat, then seeded and hydromulched. The seeds in the excavated material were inherently incorporated into the berm and are expected to germinate and contribute to stabilization. Immediate stabilization is in place because all exposed soil was seeded and hydromulched.

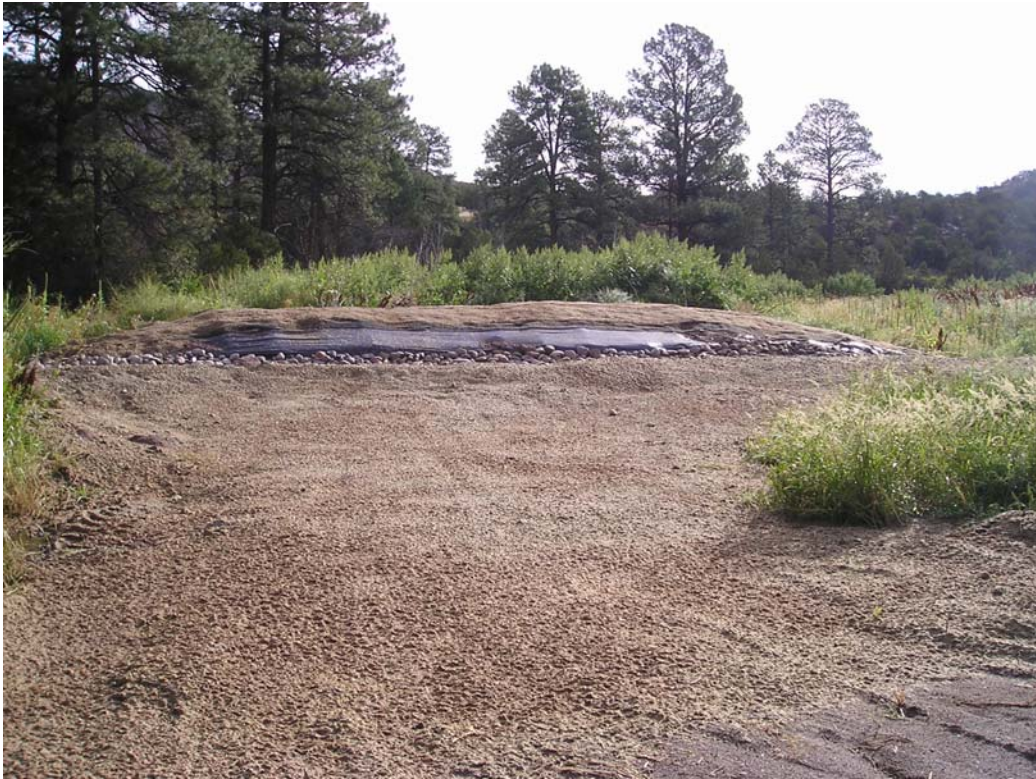
Figure 5 View looking down Pueblo Canyon. Stabilized wing ditch berm and rock liner are visible. Hydromulched surface is visible in foreground. Main Pueblo Canyon channel is just to the left of area shown in the photo.
