LA-UR-09-6181
September 2009
EP2009-0463

**Investigation Report for
Direct-Push Sampling
Material Disposal Area B,
Solid Waste Management Unit
21-015, at Technical Area 21**

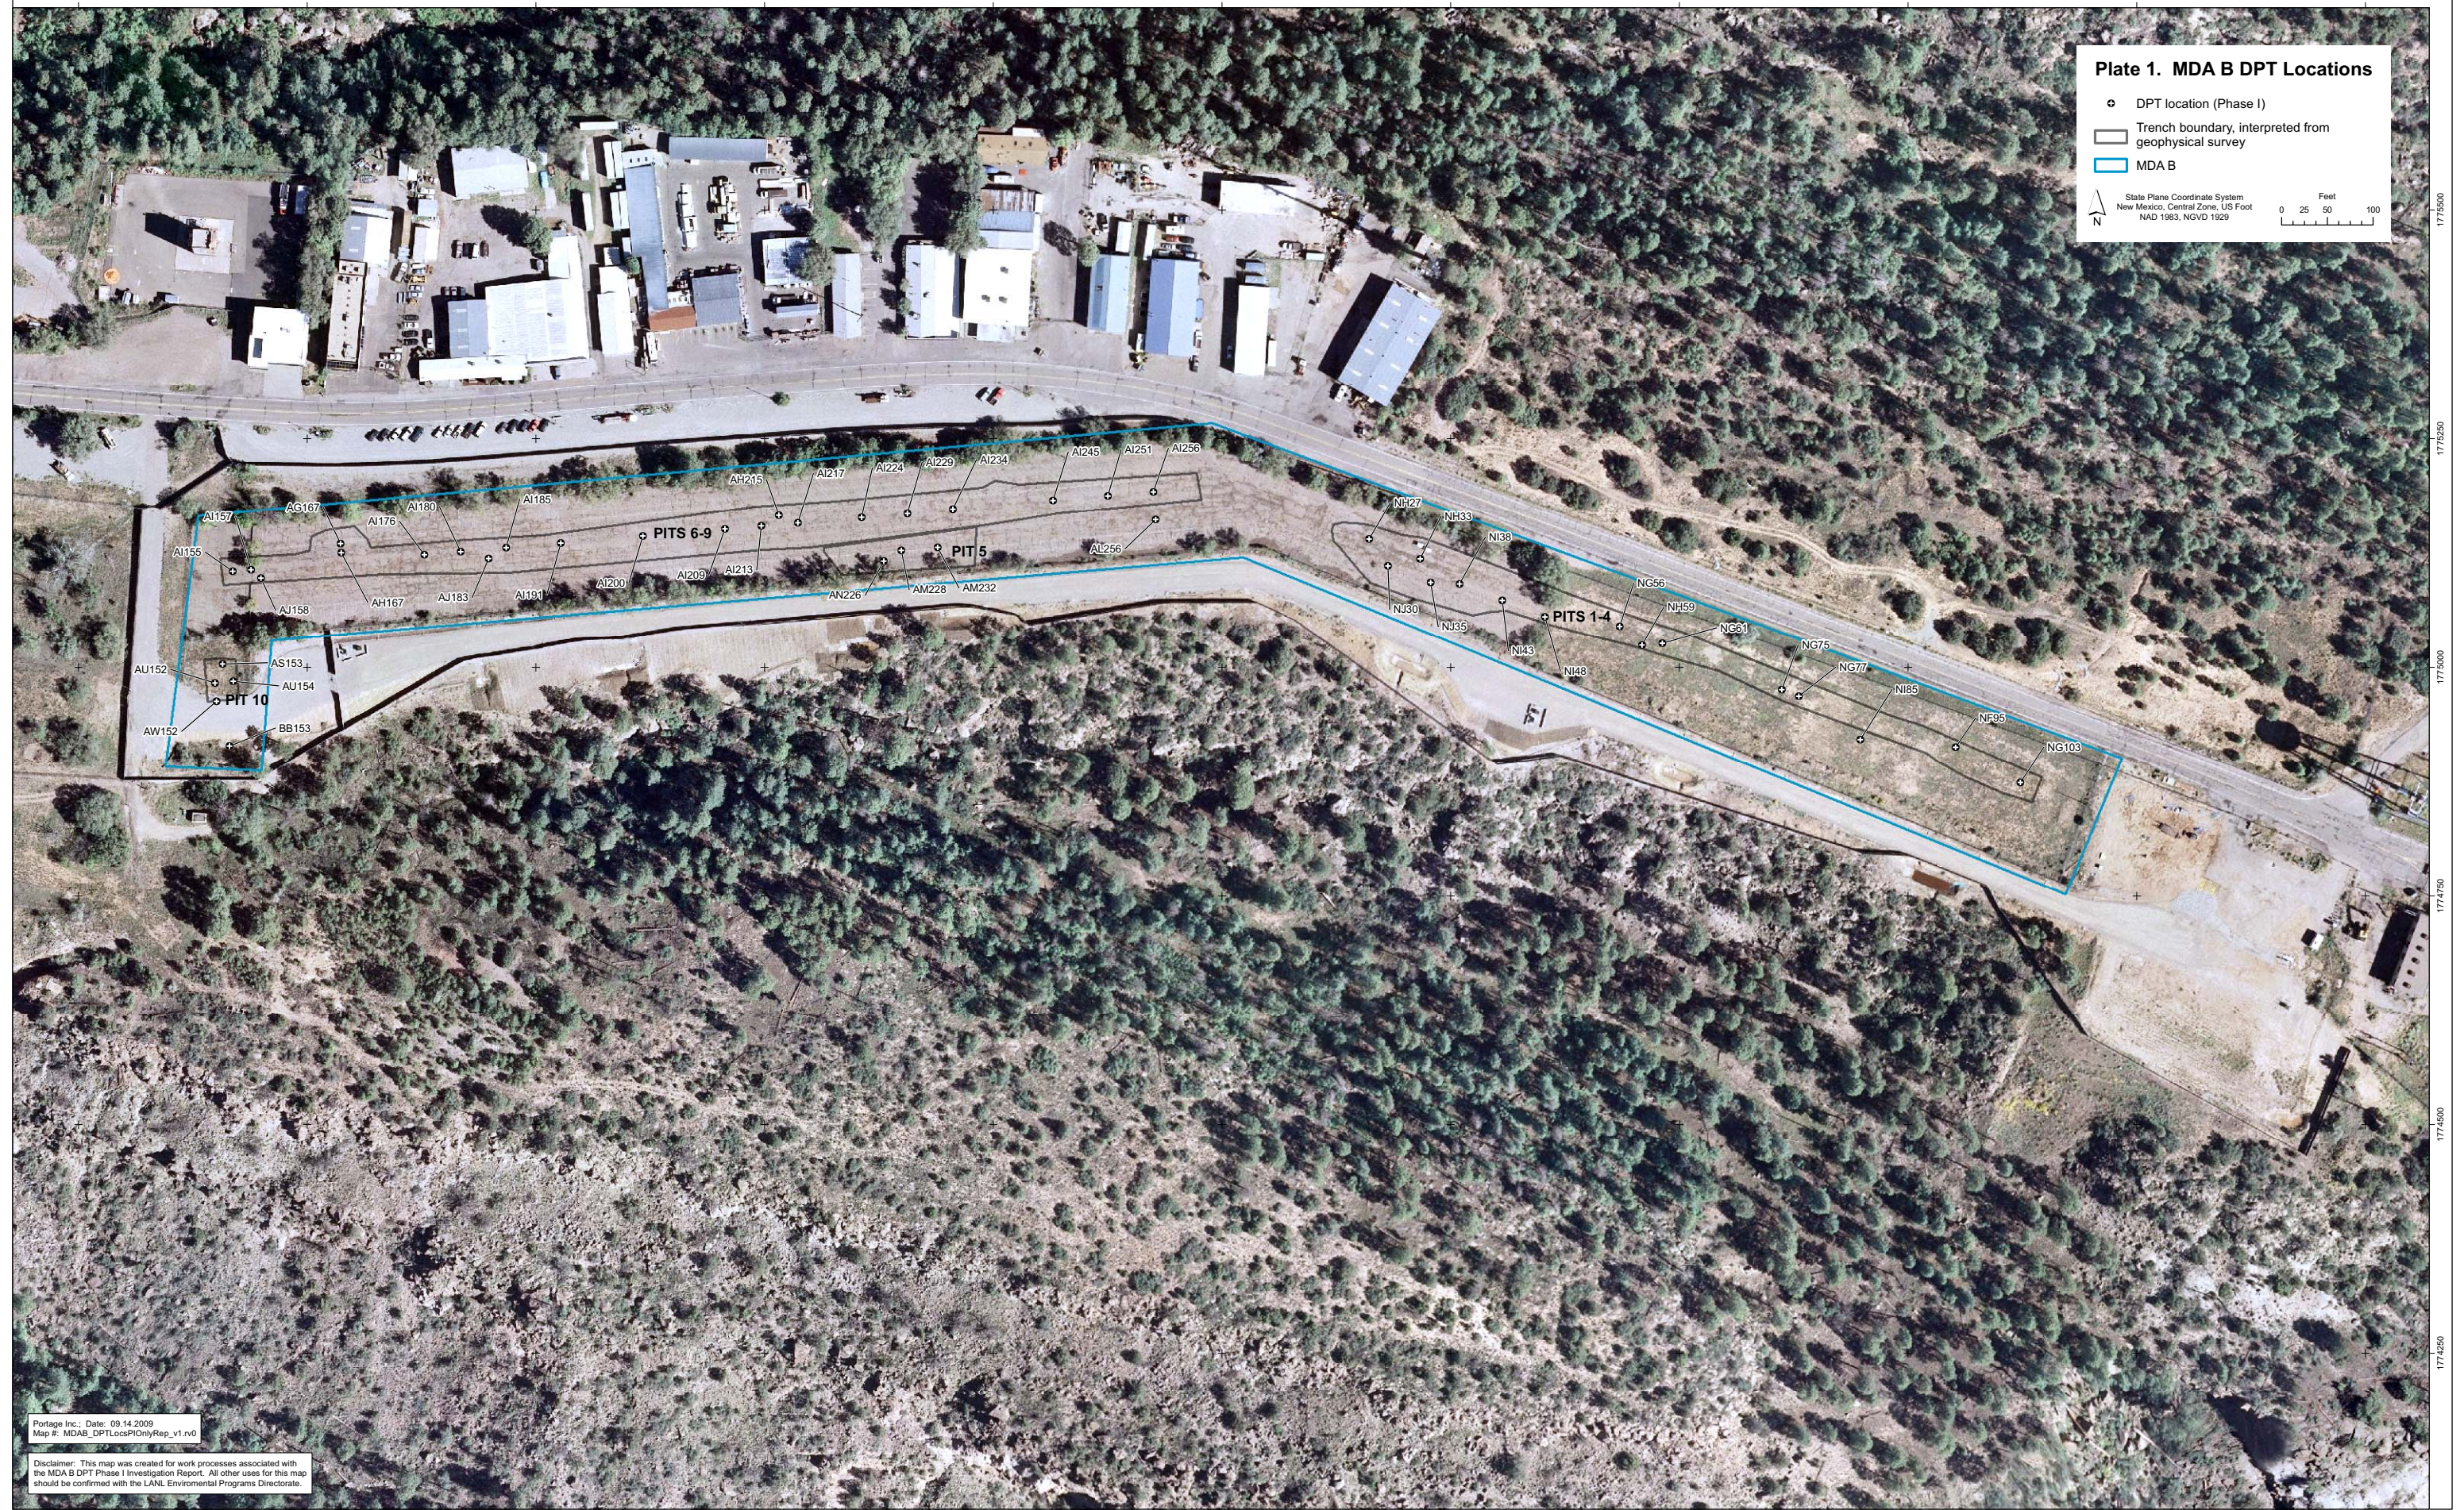
Plate 1	MDA B Direct-Push Technology Locations
---------	--

Sample locations are shown on Plate 1 and were determined with the interpreted waste zone boundary taken from geophysical survey maps. Geophysical surveys were conducted over the surface of MDA B to determine potential waste trench locations. The survey results of each campaign were color-mapped to show differences in the geophysical nature of the subsurface, and both showed an apparent signature of the location(s) of the waste zone. This outline of the apparent waste zone became the interpreted boundary within which to conduct DPT core sampling.

Results are referenced to the direct-push location IDs (AG153, AI221, etc.) and mapped on Plate 1. Results are further broken down by sample numbers (e.g., MDAB-00-04-09-177), which include indicators of the depth interval of the sample. Sample numbers that begin “MDAB-00-04-” are for the first 5-ft depth interval, those that begin “MDAB-04-08-” are for the second or 5- to 10-ft depth interval, those that begin “MDAB-08-12-” are samples taken at the 10- to 15-ft depth interval, and so on.
