LA-UR-09-8096  
December 2009  
EP2009-0648

# **Asphalt Monitoring and Removal Report for Area of Concern C-00-041, Guaje/Barrancas/Rendija Canyons Aggregate**

December 2009

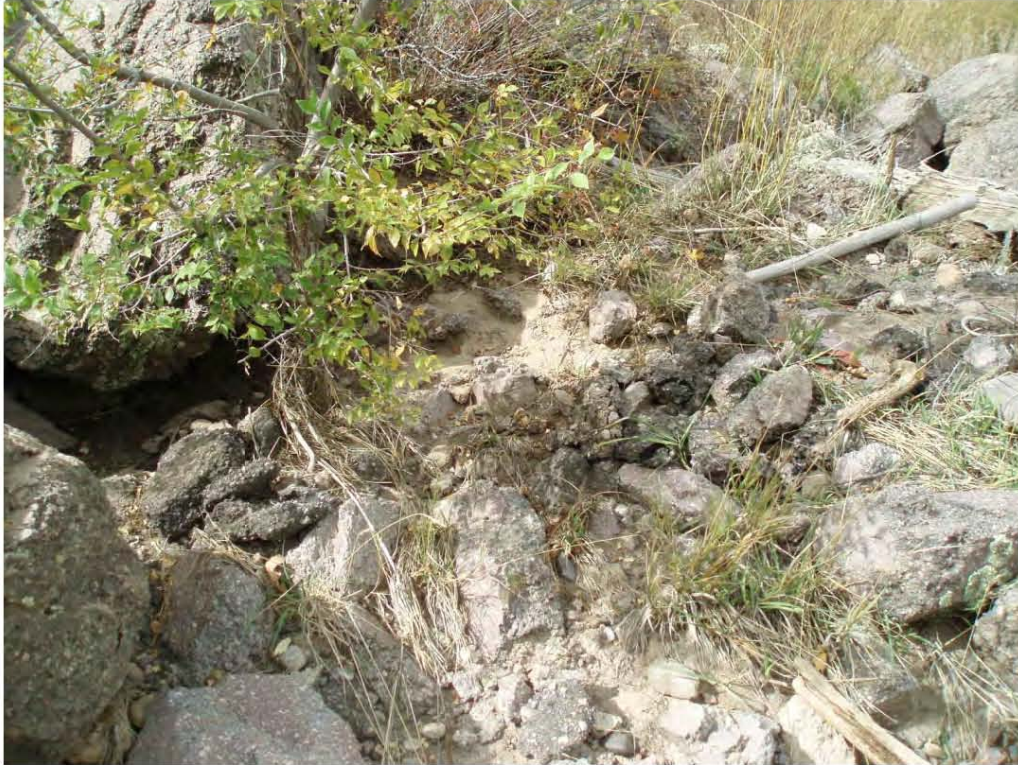
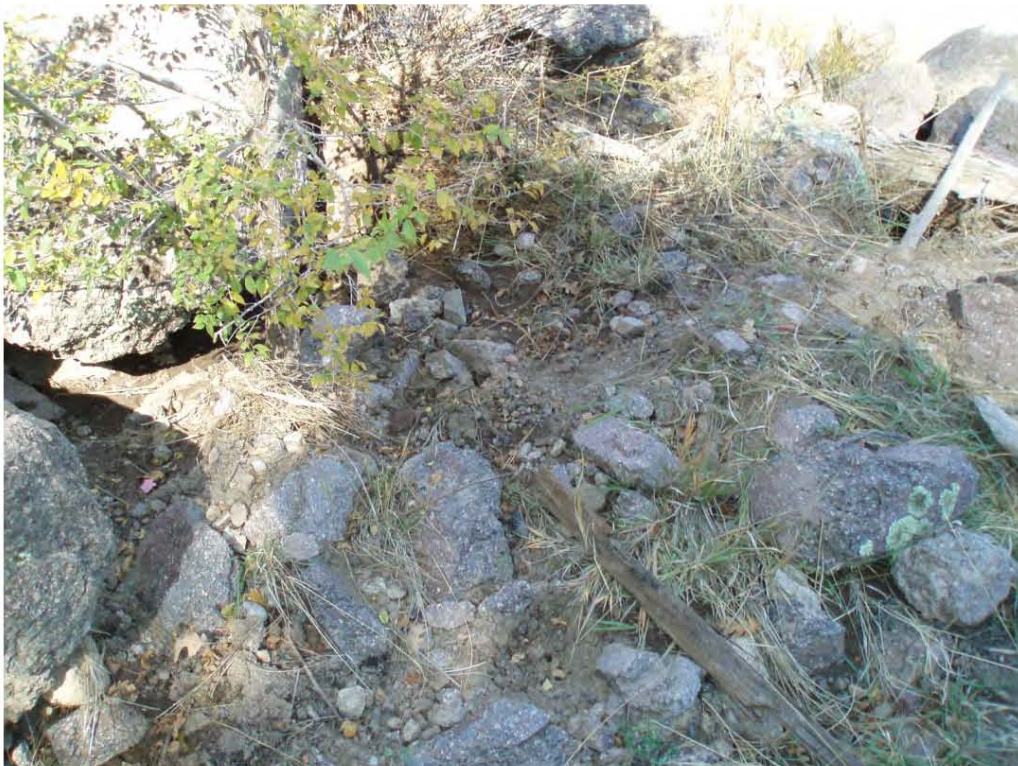
**Figure 4.2-4 Before and after photographs of asphalt removal from the drainage**

Note: The lighter gray pieces are native rock.

In October 2009, exposed asphalt fragments were found and removed during the site inspection. Asphalt was removed only if it was visible at the surface and involved no excavation or significant soil disturbance. Asphalt pieces were collected in buckets and transferred to 55-gal. drums. A total of seven drums were filled with the removed asphalt and tar from the site during this monitoring effort. Figures 4.2-1 through 4.2-5 are premonitoring and postmonitoring photographs of the site. The asphalt was recycled at the Los Alamos County Eco-Station. Management of waste is discussed in Appendix A.
