## **Documentation of Completion of Cross-Vane Structure Corrective Maintenance Actions in Pueblo Canyon**

The project to implement modifications to the three cross-vane structures located in Pueblo Canyon has been completed. As directed by the New Mexico Environment Department (NMED) in its December 3, 2009, letter, "Direction to Correct Cross-Vane Structures in Pueblo Canyon Los Alamos National Laboratory" (EPA ID# NM0890010515 LANL-HWB-08-047), this work involved the following four activities.

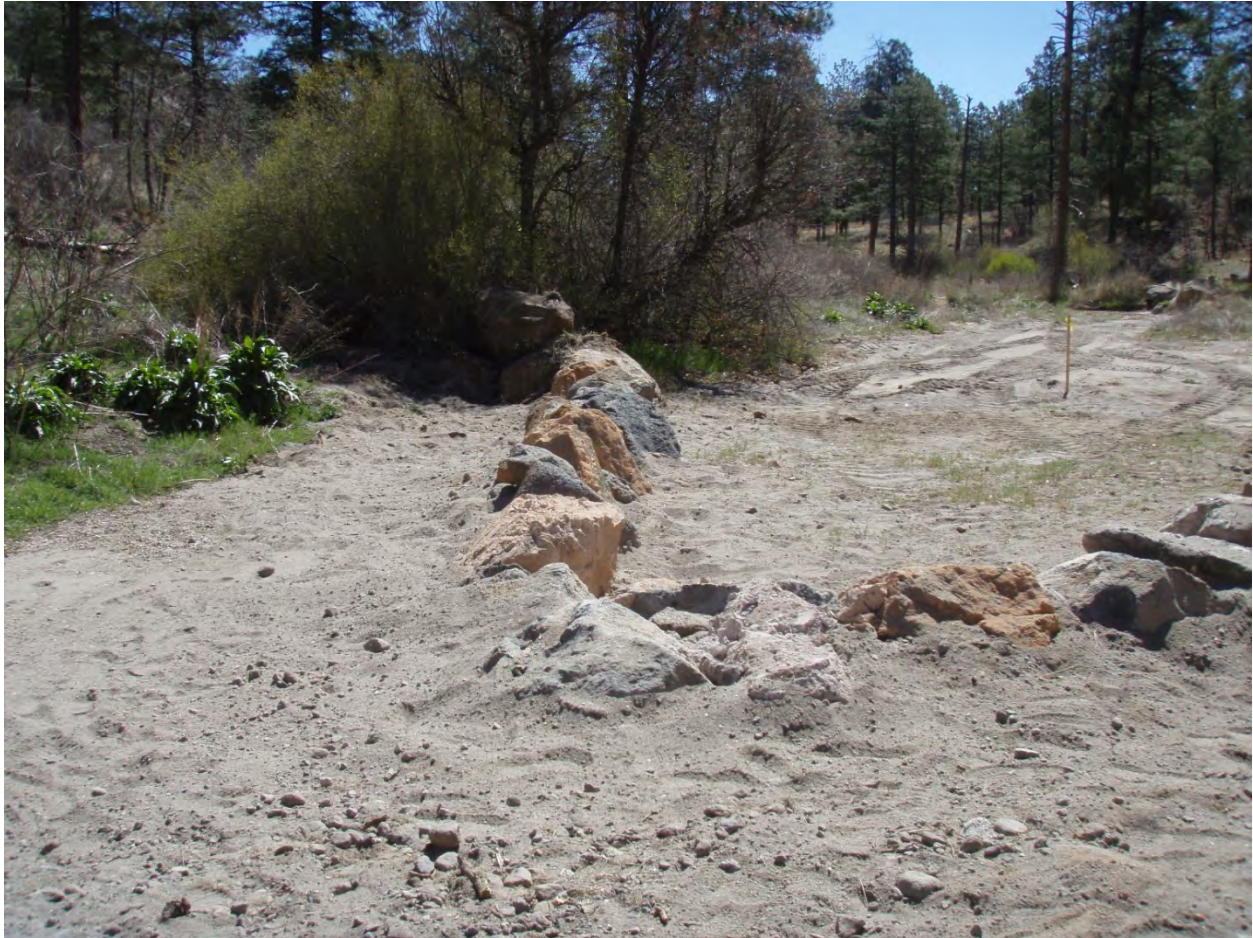
**Figure 1** Pueblo Canyon cross vane 1 looking eastward (downcanyon). Note that the vertex of the structure is at stream-bed elevation.

First, the tapers of the top surfaces of the boulders that make up the structures were adjusted so the boulders comprising the vertex of each structure are at the elevation of the existing stream channel, and the boulders anchoring the structure have been extended to the full stream bank elevation.

Finally, the vertex of each structure has been lowered by 6 in. to 1 ft, so there is an elevation difference of 1.75 to 2.50 ft between the vertex and the anchor legs of each structure, with an approximate 2% to 3% grade on each leg and less than 1 ft of elevation difference between each adjoining boulder in the structures.

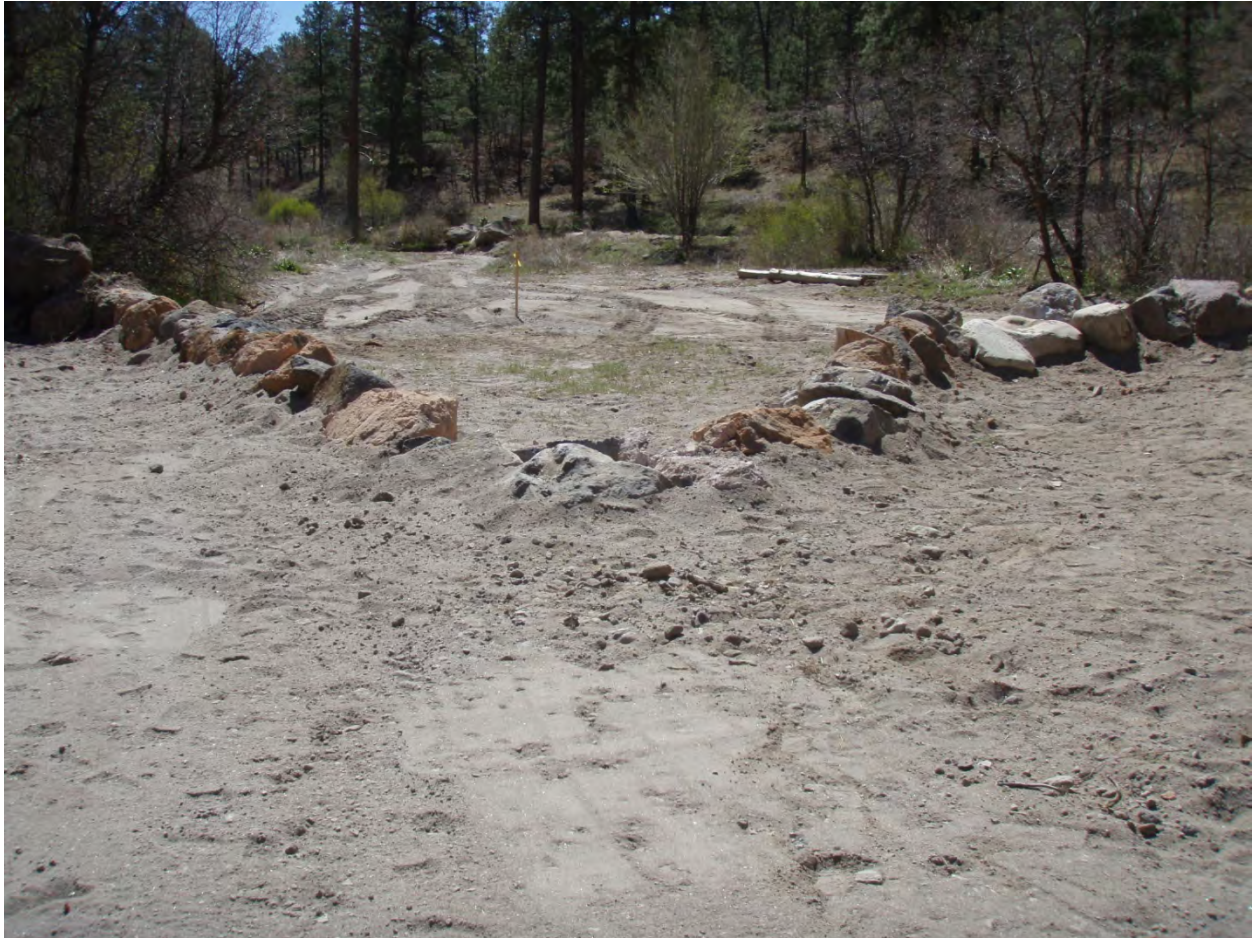
**Figure 2** Pueblo Canyon cross vane 2 looking eastward (downcanyon). Note that the vertex is at the elevation of the stream bed, and the gaps in large rocks are filled.

Third, all gaps in the structures have been filled either by adjusting the boulders and retrenching them or by trenching in smaller boulders between and in front of the existing gaps.

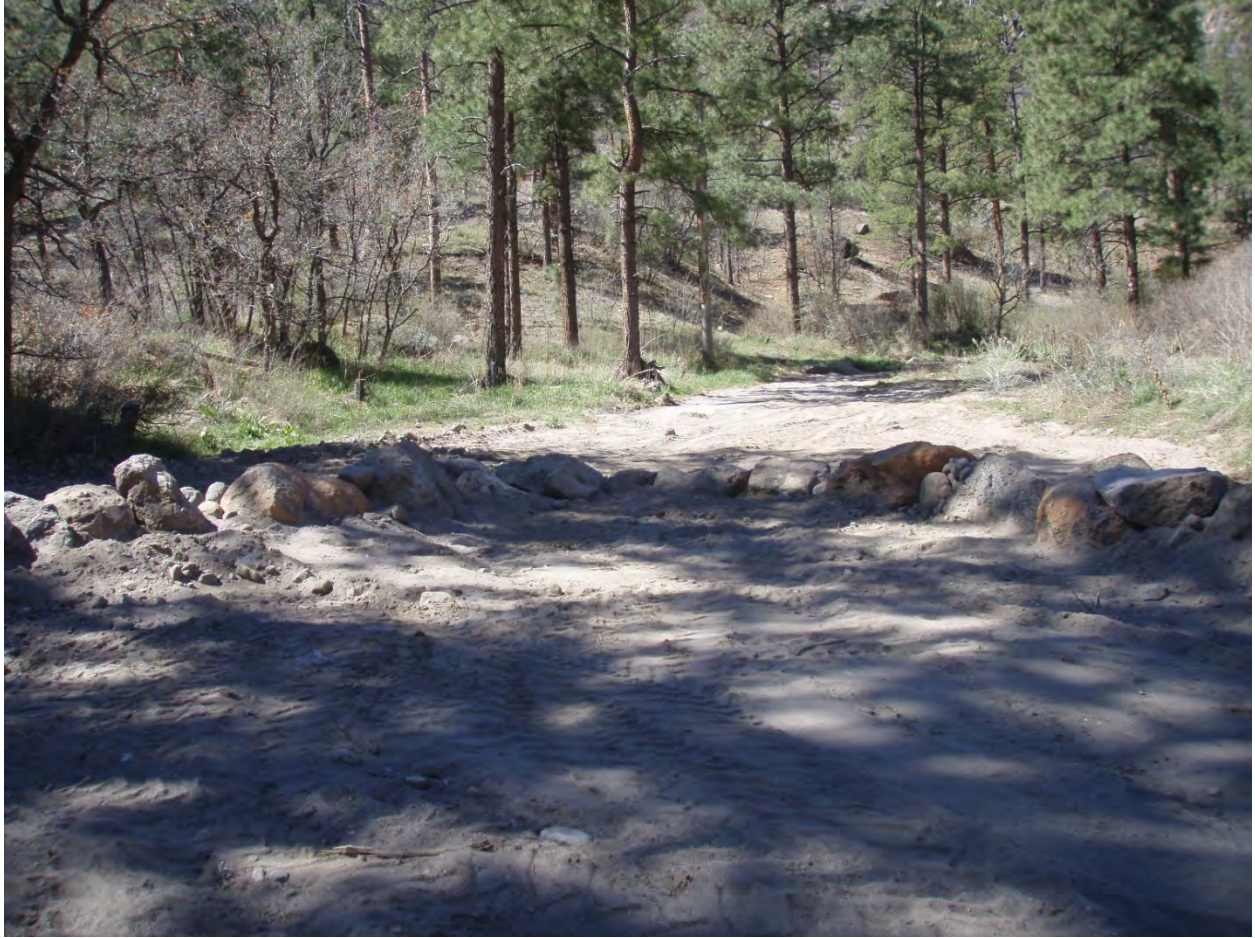
**Figure 3** Pueblo Canyon cross vane 3 looking westward (upcanyon). Note that the vertex is at the elevation of the stream bed, and the gaps in the large rocks are filled.
