Title: 2008-9 LANL Riparian Area Inventory Results

2008-9 Los Alamos National Laboratory (LANL) Riparian Area Inventory Results

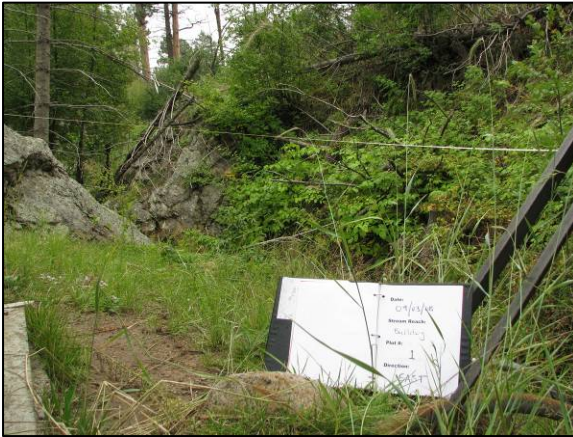
Riparian Community Occurrence Site Bulldog Gulch

Community Type: Mixed conifer / Gambel's Oak Woodland (Mixed conifer / *Quercus gambelii* Woodland)

Functional Condition: Functional

Comments: Bulldog Gulch has natural perennial stream flow. The riparian area is in excellent condition.

Recommendations: No action required.

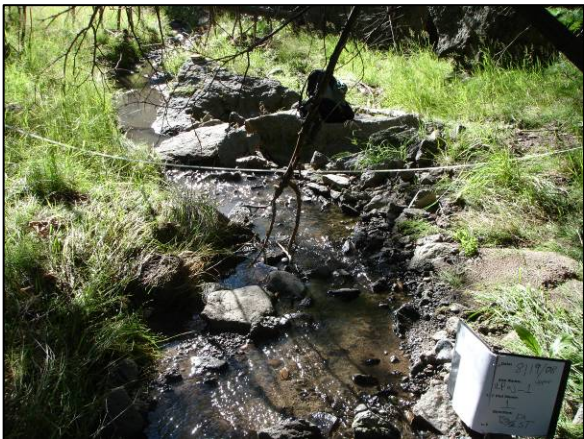
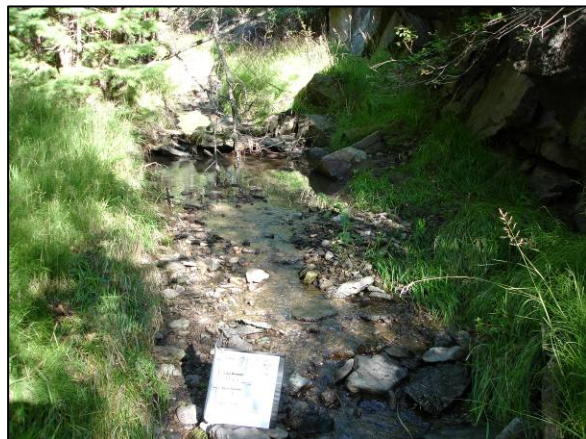
Riparian Community Occurrence Site Upper Pajarito 1

Community Type: Mixed conifer – Water Birch / Mixed Grasses Forest (Mixed conifer – *Betula occidentalis* / Mixed Grasses Forest

Functional Condition: Functional

Recommendations: No action required.

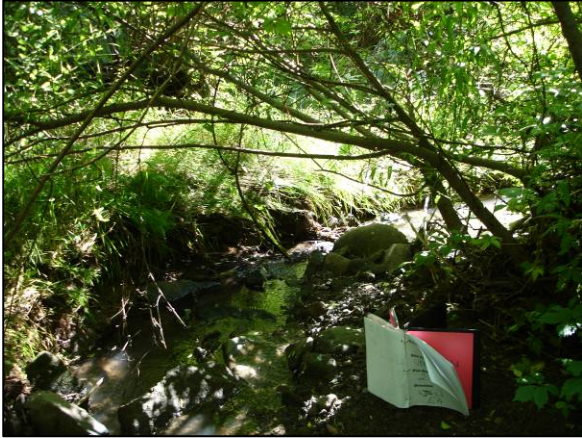
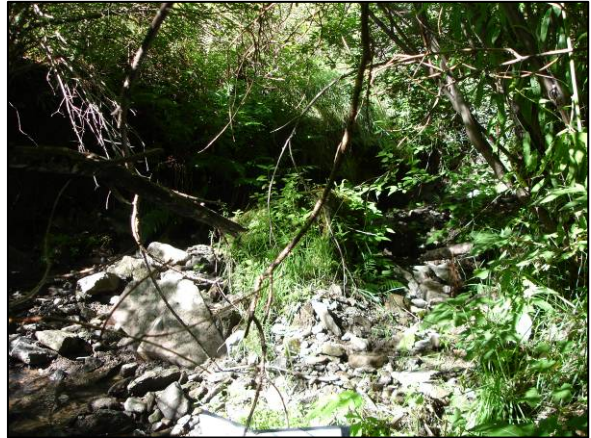
Riparian Community Occurrence Site Upper Pajarito 2

Community Type: Narrowleaf Cottonwood / Red Raspberry – New Mexico Locust Forest (*Populus angustifolia* / *Rubus strigosus* – *Robinia neomexicana* Forest)

Functional Condition: Functional

Recommendations: No action required.

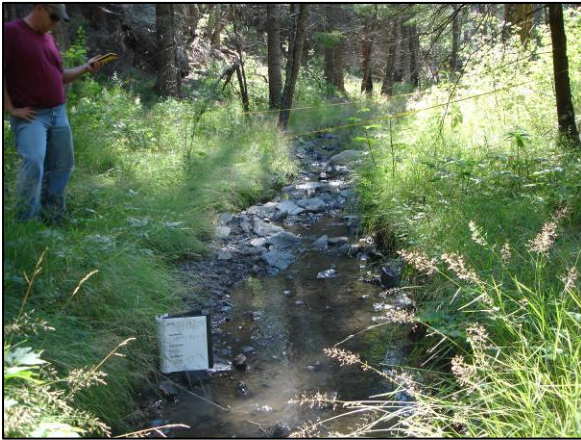
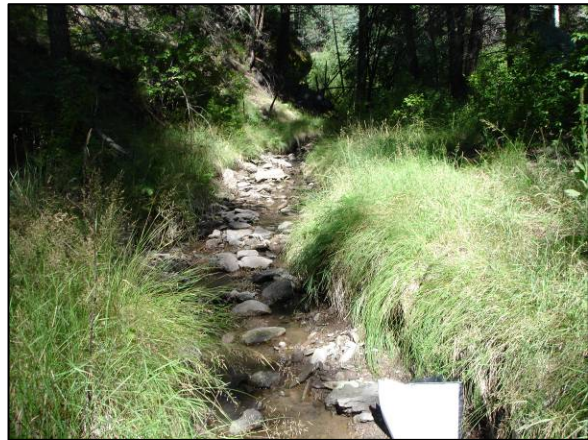
Riparian Community Occurrence Site Upper Pajarito 3

Functional Condition: Functional

Comments: Upper Pajarito has natural perennial stream flow. The riparian area is in excellent condition. Data sheets from this plot were originally labeled as Upper Starmers.

Recommendations: No action required.

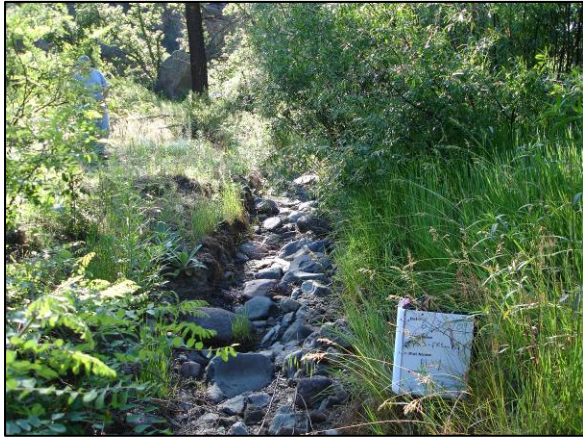
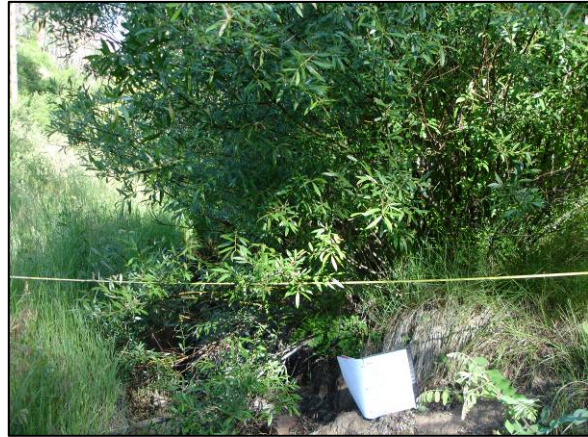
Riparian Community Occurrence Site Pajarito FRS to 18

Functional Condition: Functional

Recommendations: Restore stream conditions when the upper portion of the Flood Retention Structure is removed in accordance with the Environmental Assessment for the Proposed Future Disposition of Certain Cerro Grande Fire Flood and Sediment Retention Structures at Los Alamos National Laboratory, Los Alamos, New Mexico (DOE/EA-1408) and its Mitigation Action Plan.

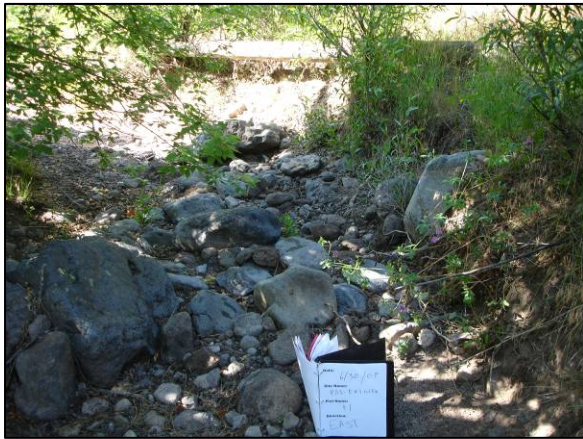
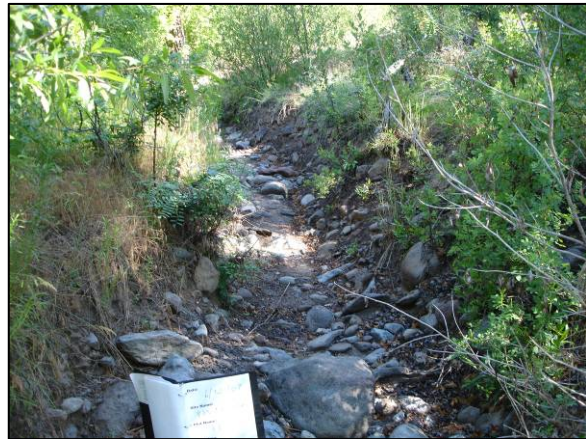
Riparian Community Occurrence Site Pajarito FRS to 18B

Functional Condition: Functional

Recommendations: To slow erosion and increase deposition, consider this riparian community occurrence for in-channel placement of mechanical obstacles (such as snags) that would reduce flow rates.

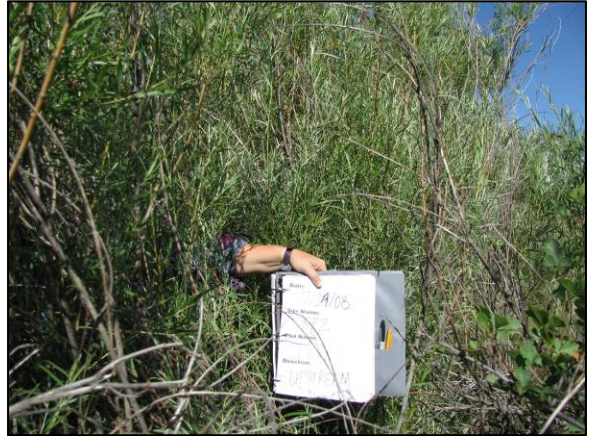
Lower Pajarito 2

Community Type: Coyote Willow / Sedge sp. Shrubland (*Salix exigua* / *Carex* sp. Shrubland)

Functional Condition: Functional

Recommendations: No action required.

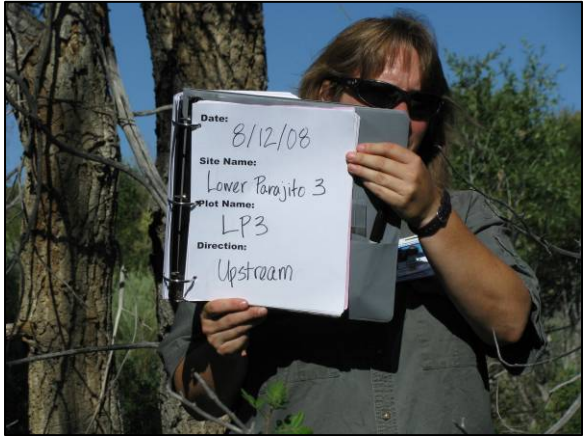
Riparian Community Occurrence Site Lower Pajarito 3

Community Type: Sedge sp. Wooded Herbaceous Vegetation (*Carex* sp. Wooded Herbaceous Vegetation)

Functional Condition: Functional

Recommendations: No action required.

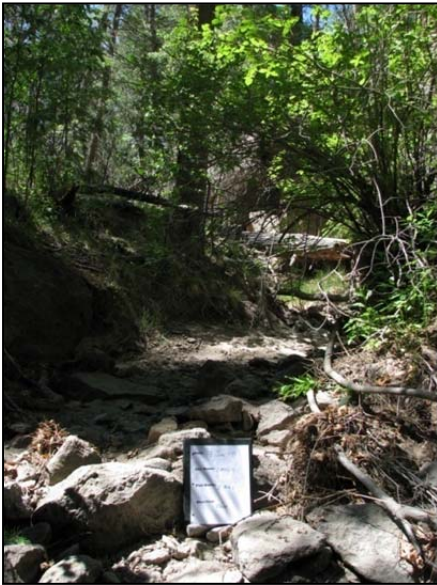
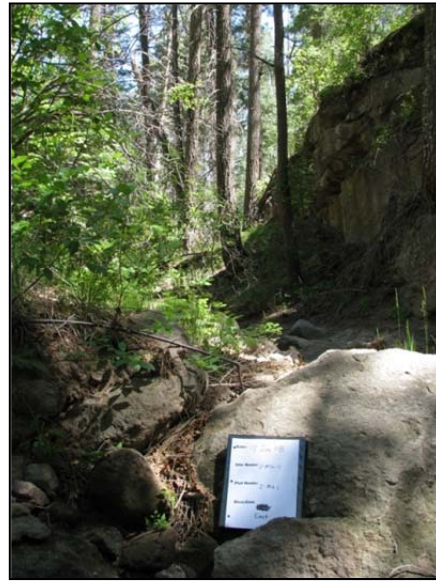
Riparian Community Occurrence Site Two-Mile 1

Functional Condition: Functional – At Risk

Comments: Excessive erosion and channel incision observed during survey. Riparian-wetland plants do not exhibit high vigor, and do not provide sufficient cover to protect banks and dissipate energy during high flows.

Recommendations: To slow erosion and increase deposition, consider this riparian community occurrence for in-channel placement of mechanical obstacles (such as snags) that would reduce flow rates.

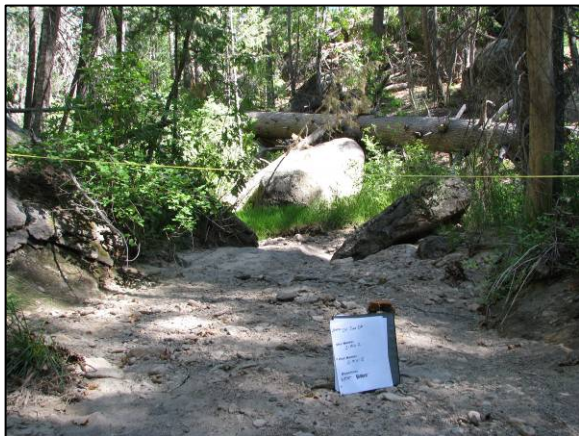
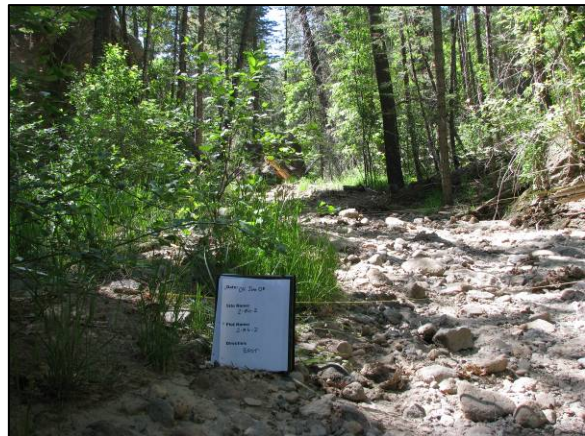
Riparian Community Occurrence Site Two-Mile 2

Functional Condition: Functional – At Risk

Comments: Erosion, soil deposition, and channelization observed during survey, probably caused by runoff and soil transport from adjacent upland watershed.

Recommendations: Consider this riparian community occurrence for in-channel placement of mechanical obstacles (such as snags) that would reduce flow rates. Consider stabilizing adjacent upland.

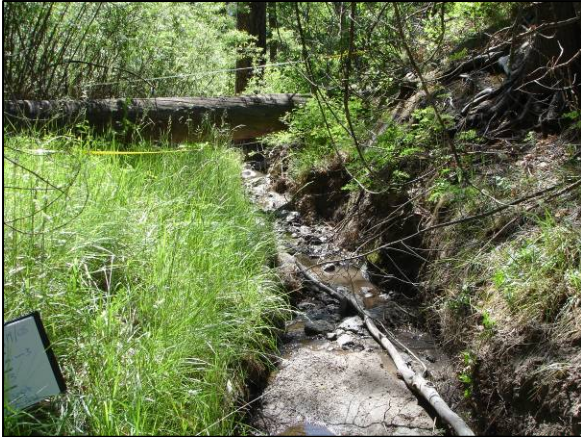
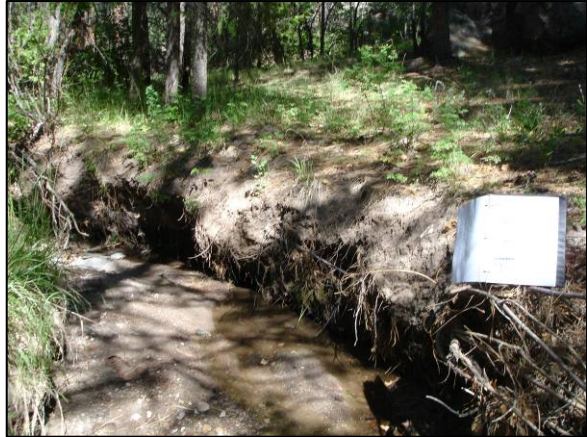
Riparian Community Occurrence Site Two-Mile 3

Functional Condition: Functional – At Risk

Comments: Soil deposition, excessive erosion, bank collapse, channelization, and channel incision observed.

Recommendations: Consider this riparian community occurrence for in-channel placement of mechanical obstacles (such as snags) that would reduce flow rates. Consider stabilizing adjacent upland.

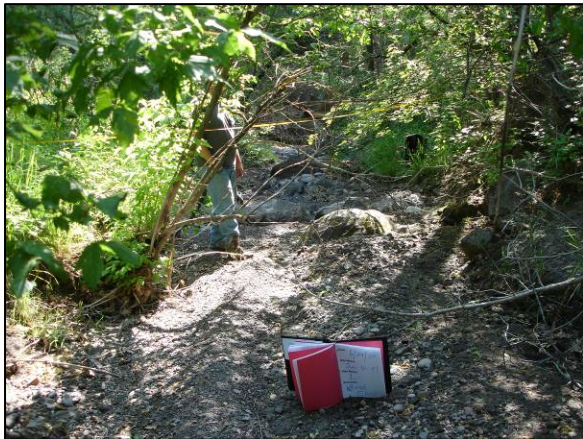
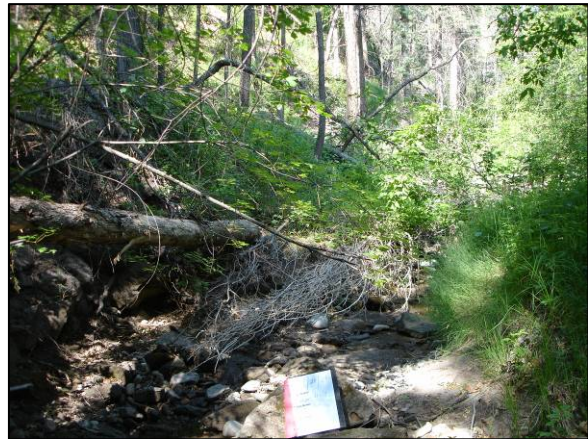
Riparian Community Occurrence Site Two-Mile 4-P1

Comments: Some soil deposition and channelization observed during survey.

Recommendations: No action required.

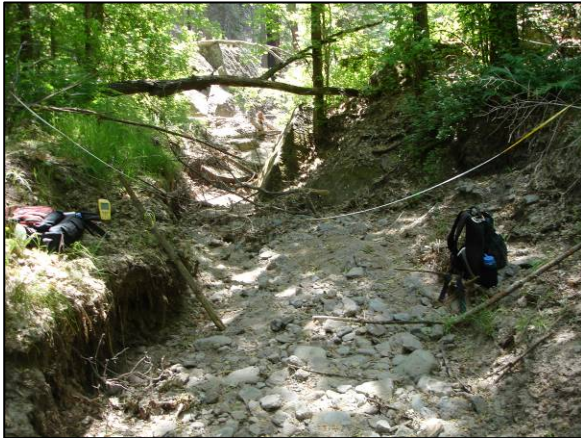
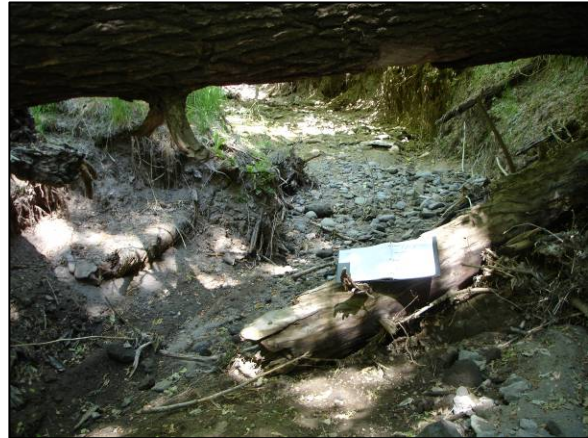
Riparian Community Occurrence Site Two-Mile 4-P2

Comments: Some soil deposition and bank collapse observed during survey.

Recommendations: Consider this riparian community occurrence for in-channel placement of mechanical obstacles (such as snags) that would reduce flow rates.

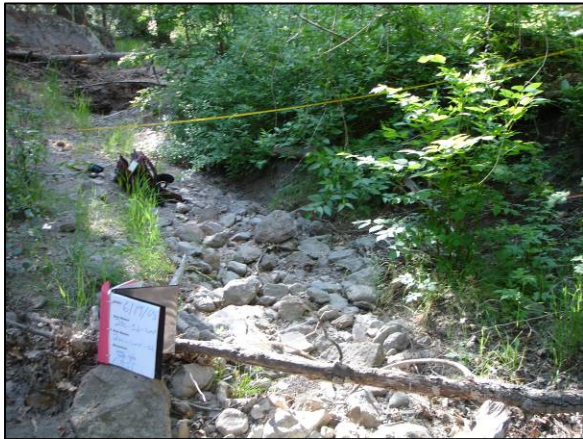
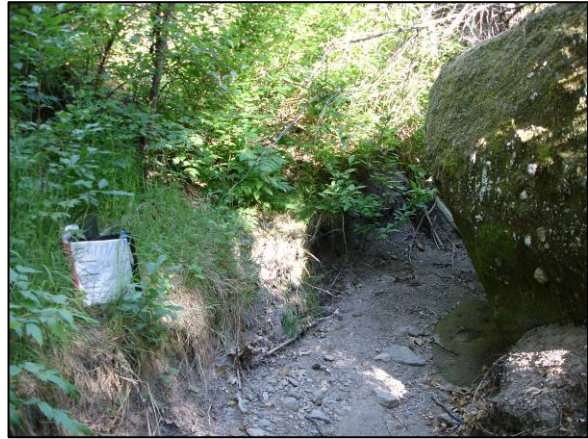
Riparian Community Occurrence Site Two-Mile – Side – West

Functional Condition: Functional – At Risk

Comments: Soil deposition, excessive erosion, bank collapse, channelization, and channel incision observed during surveys. Russian olive was present. The stream channel lacked natural sinuosity and vertical stability, however, riparian-wetland vegetation has high vigor. *Acer negundo* in overstory may have been misidentified as *Acer glabrum*.

Recommendations: Consider this riparian community occurrence for in-channel placement of mechanical obstacles (such as snags) that would reduce flow rates.

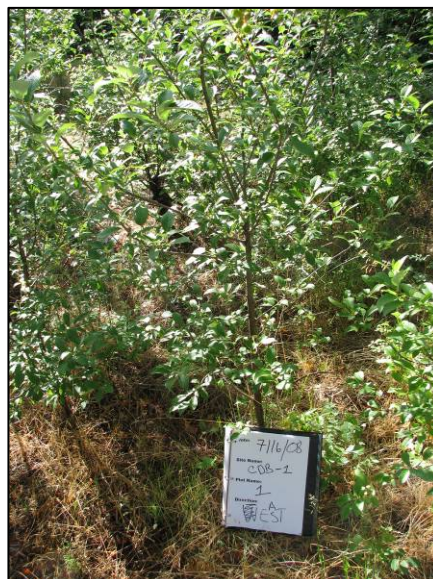
Riparian Community Occurrence Site CDB 1

Community Type: Mixed conifer / Box Elder - Chokecherry Forest (Mixed conifer / *Acer negundo* – *Prunus virginiana* Forest)

Recommendations: No action required.

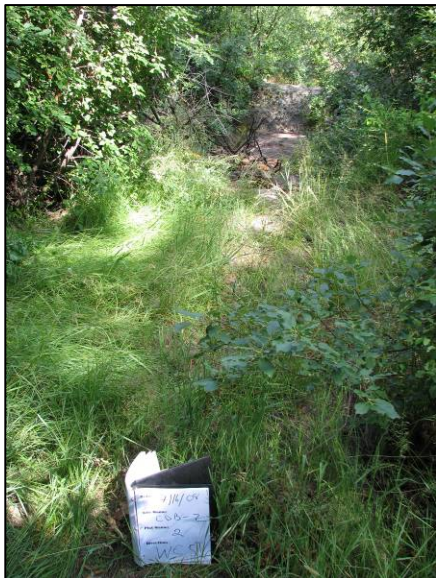
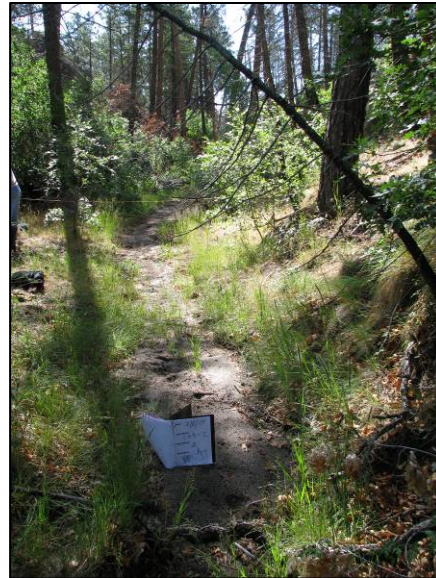
Riparian Community Occurrence Site CDB 2

Community Type: Mixed conifer / Gambel's Oak Forest (Mixed conifer / *Quercus gambelii* Forest)

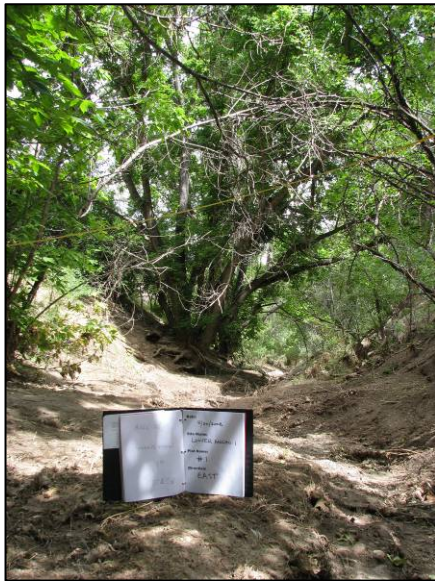
Riparian Community Occurrence Site Lower Ancho 1

Functional Condition: Functional – At Risk

Comments: Excessive erosion, head cutting, and channel incision observed during survey.

Recommendations: Consider this riparian community occurrence for in-channel placement of mechanical obstacles (such as snags) that would reduce flow rates.

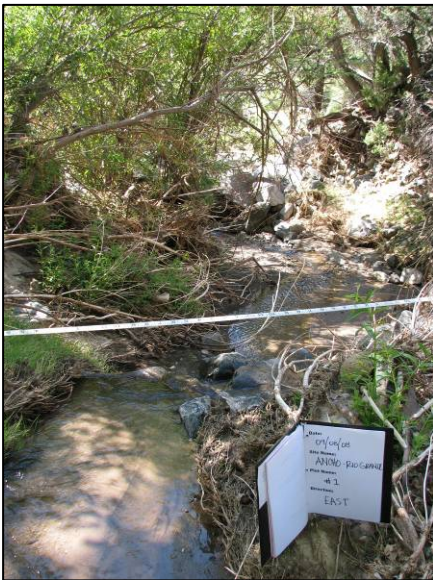
Riparian Community Occurrence Site Ancho – Rio Grande

Functional Condition: Functional – At Risk

Comments: Salt cedar and signs of feral cattle use observed during survey.

Recommendations: Consider exotic plant and feral animal removal.

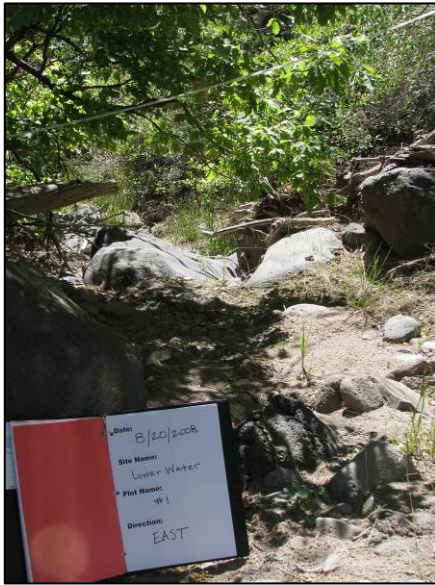
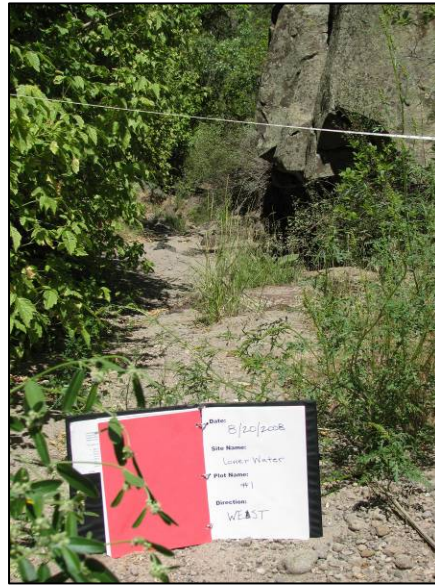
Riparian Community Occurrence Site Lower Water

Comments: Dominant stream channel bed material is boulders.

Recommendations: No action required.

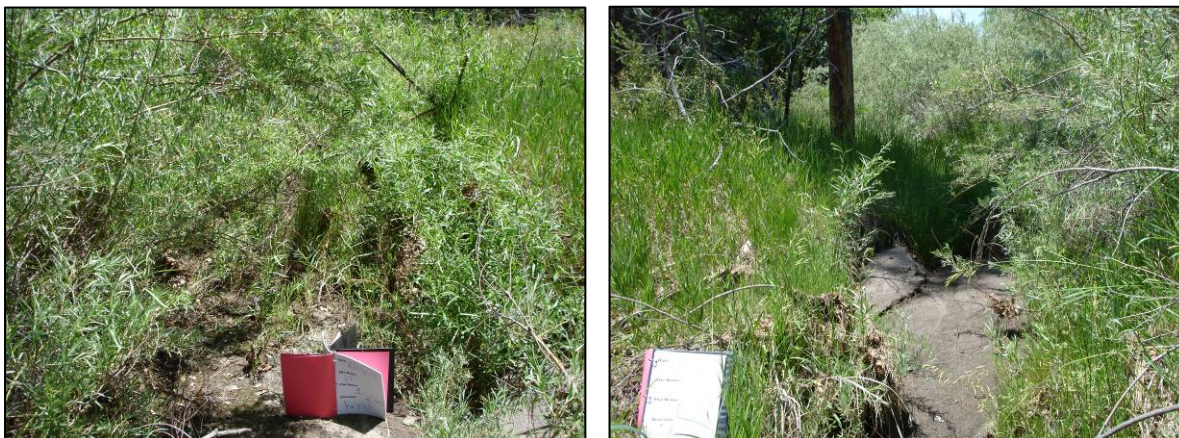
Riparian Community Occurrence Site DP - 1

Functional Condition: Functional – At Risk

Comments: Condition of adjacent uplands (developed with major roads) is contributing to augmented flows, soil deposition, and channel incision in this community occurrence. A grade control structure was recently (winter of 2009-2010) installed, and will change stream channel conditions.

Recommendations: Re-evaluate community occurrence following adjustment of the community to the grade control structure.

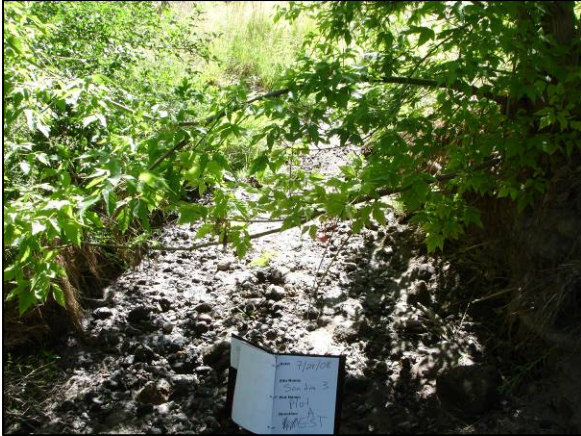
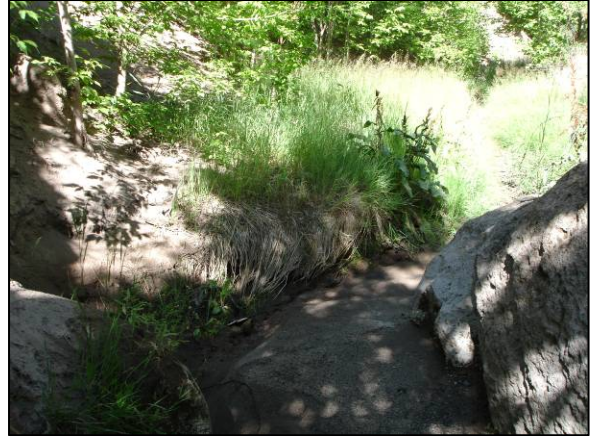
Riparian Community Occurrence Site SANDIA3

Functional Condition: Nonfunctional

Comments: This riparian community occurrence does not have sufficient hydrology to maintain healthy floodplain vegetation, protect banks, or dissipate high flows. The stream channel is experiencing excessive erosion, head cutting, soil deposition, bank collapse, channelization, and channel incision.

Recommendations: Evaluate whether to maintain or restore this area as riparian habitat. If the objective is to maintain or restore, consider in-channel placement of mechanical obstacles that would reduce flow rates.
