**FISCAL YEAR 2011 MITIGATION ACTION PLAN
ANNUAL REPORT FOR THE 2008 LOS ALAMOS
NATIONAL LABORATORY SITE-WIDE
ENVIRONMENTAL IMPACT STATEMENT**

LA-UR-11-06159

**FISCAL YEAR 2011 SITE-WIDE ENVIRONMENTAL
IMPACT STATEMENT MITIGATION ACTION PLAN
ANNUAL REPORT, FINAL**

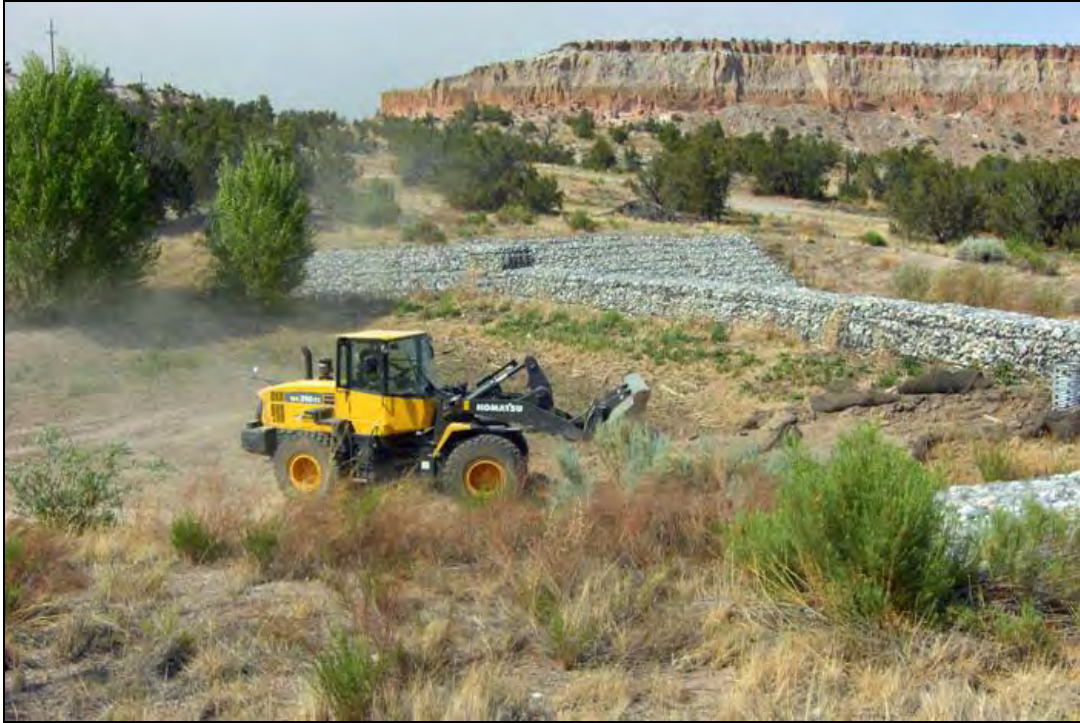
Photograph 8. Crews using heavy machinery to remove sediment from the Los Alamos Canyon Weir to restore its storage capacity.

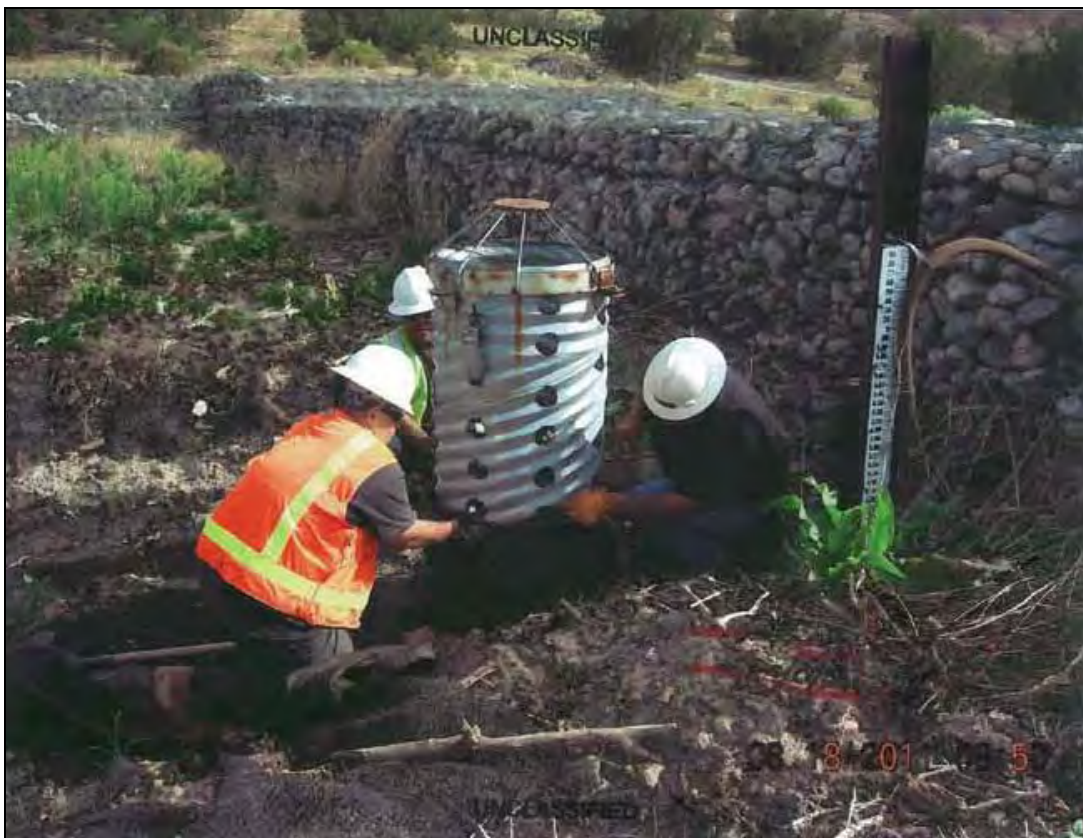
Photograph 9. Crews expose discharge standpipe and wrap it with filter fabric.

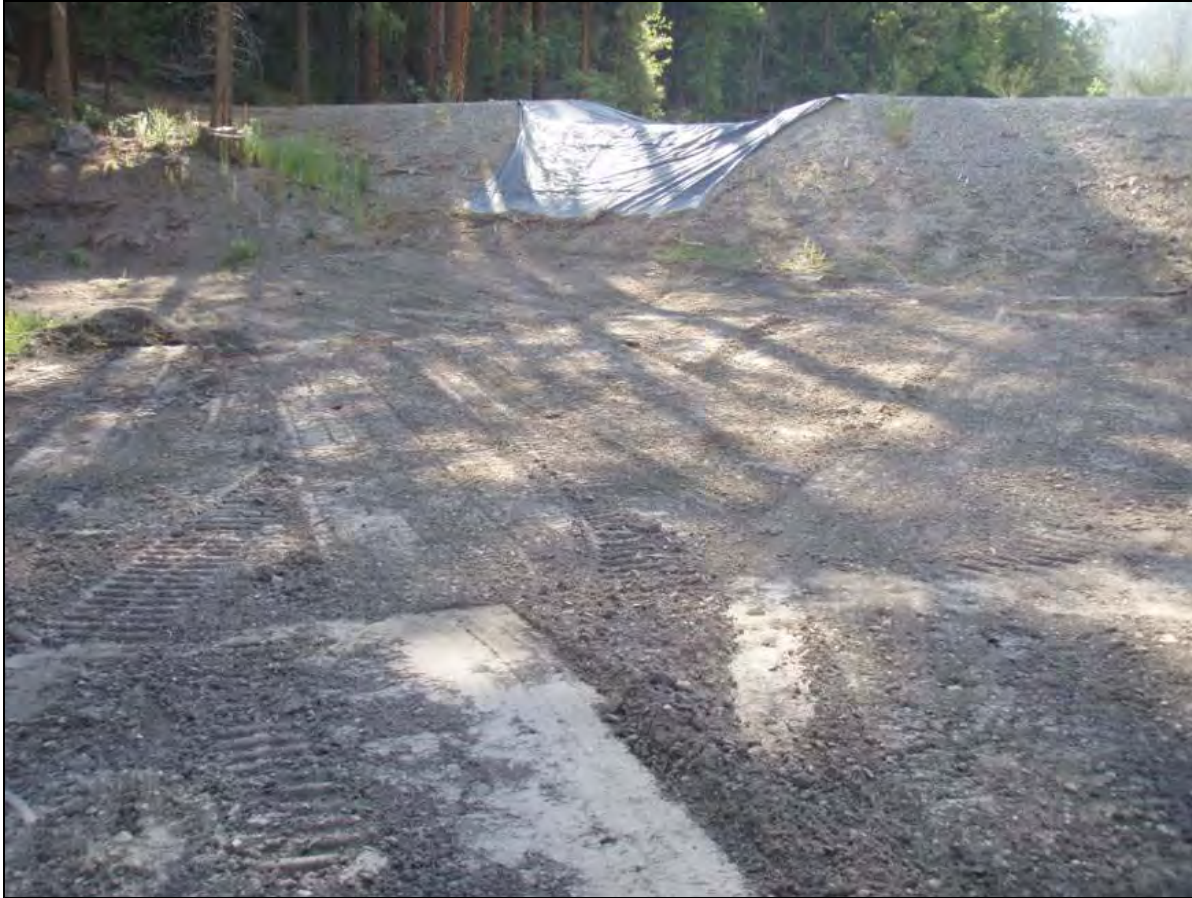
Photograph 11. Los Alamos Canyon retention basin.

In anticipation of increased sediment loads following rain events after the Las Conchas fire, sediments were removed from upper Los Alamos Canyon retention basins (Los Alamos Solid Waste Monitoring Unit (SWMU)-2, LA SMA-2) to restore their storage capacity. Crews removed and disposed of approximately 25–30 cubic yards of contaminated sediments. Sediment removal is a standard, on-going LANL activity; basins are maintained and cleaned regularly. However, the removal activity was accelerated in schedule to ensure that the maximum capacity of existing structures was available in case of post-fire flooding events (DOE 2002; DOE 2008; Photograph 11).

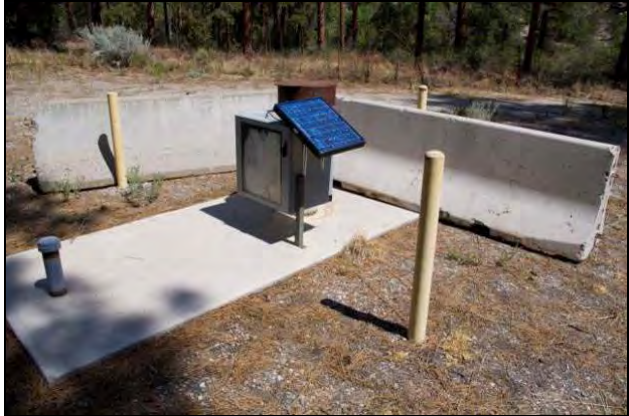
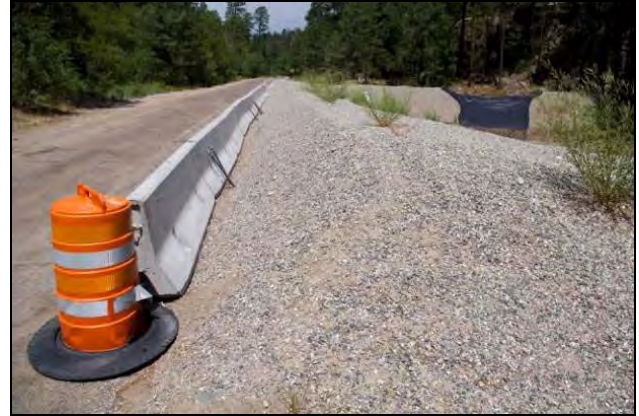
Photographs 12 and 13. Armoring at groundwater wellhead (left) and armoring of a sediment collection system (right).

LANS crews placed armoring (concrete barriers) around utility infrastructure, groundwater monitoring wells, and sediment collection systems in Los Alamos and Water Canyons as necessary, to protect these structures from potential floods and damage by floating debris (Photographs 12 and 13). Crews from Los Alamos County placed concrete barriers around the Los Alamos Ice Rink in order to protect it from the fire and associated flooding (DOE 2008; Photograph 14).

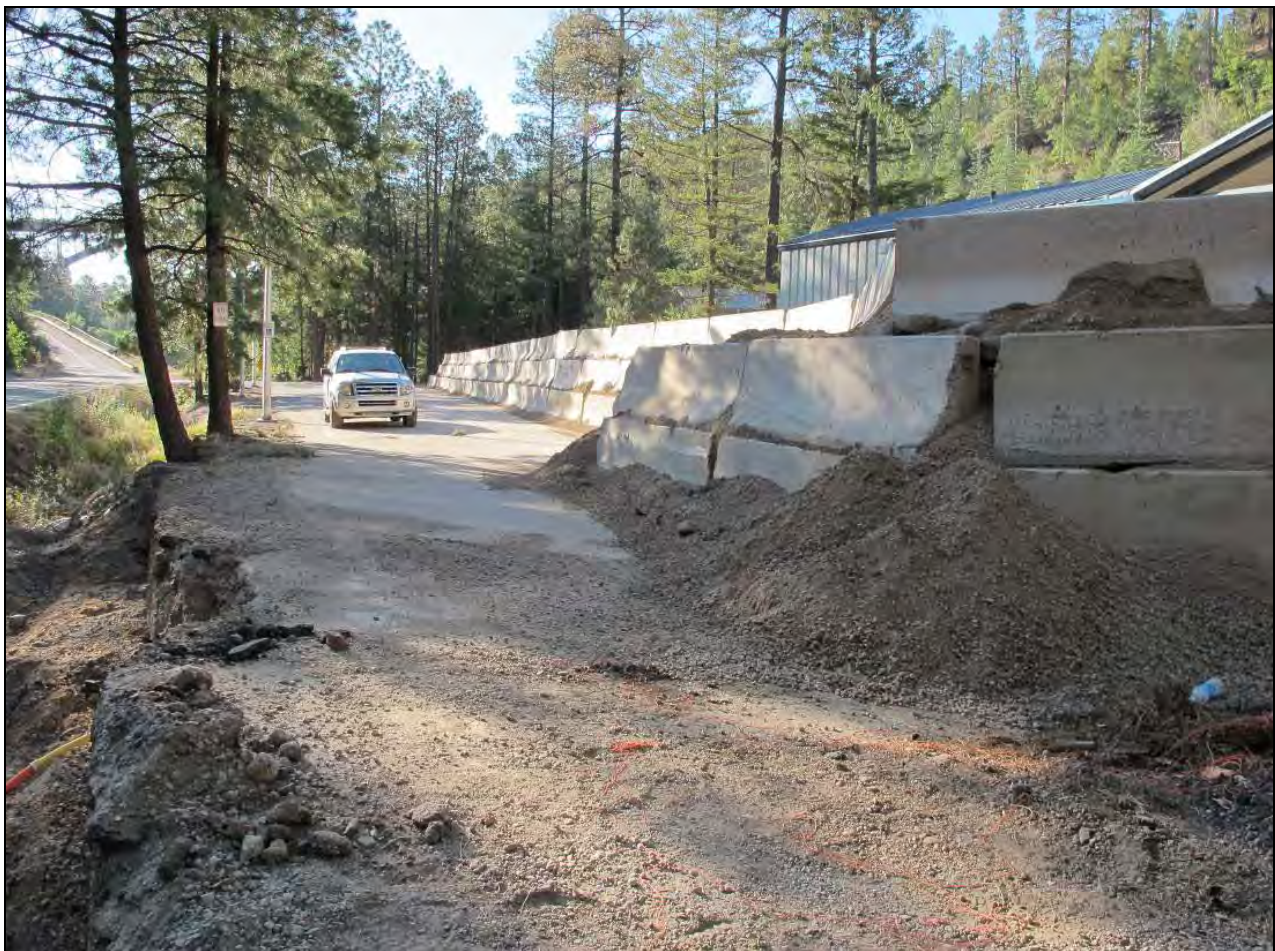
Photograph 14. Armoring at the Los Alamos County Ice Rink.

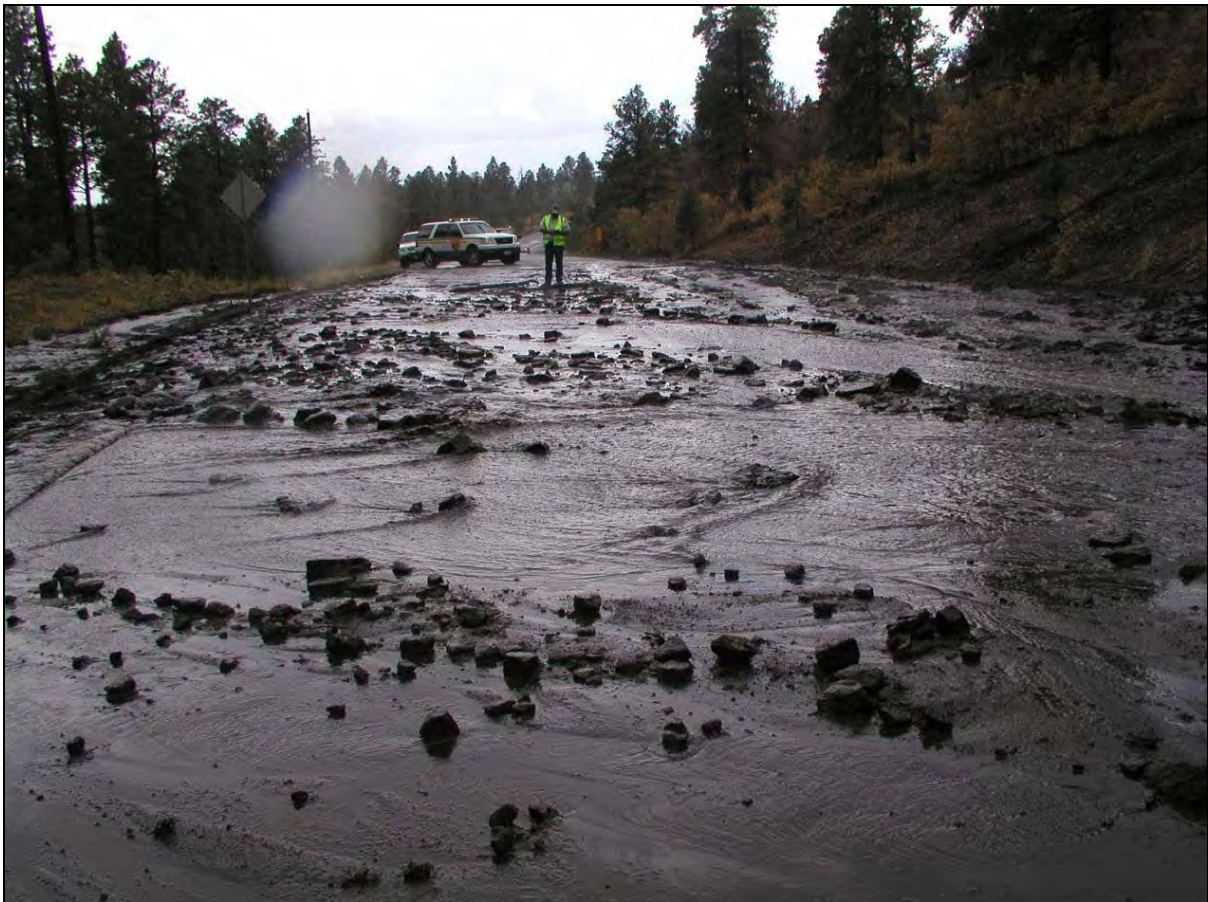
Photograph 36. Post-fire flooding effects on NM 501.

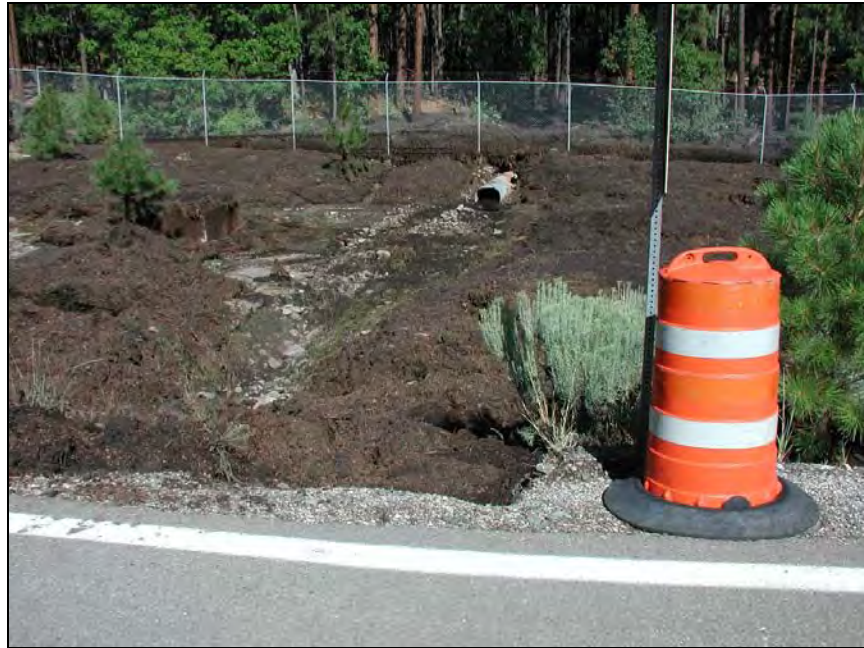
Photograph 39. Cleaned out culvert along Anchor Ranch Road.

As inspections of BMPs continue, erosion controls in Site Monitoring Areas (SMAs) are expected to need repair. As rain events persist, crews will continue to clean out culverts, as necessary, in Water Canyon, Pajarito Canyon, Cañon de Valle, and along NM 501 and Anchor Ranch Road (Photograph 39). Crews will repair roads damaged by flooding around LANL as necessary (Photograph 40).

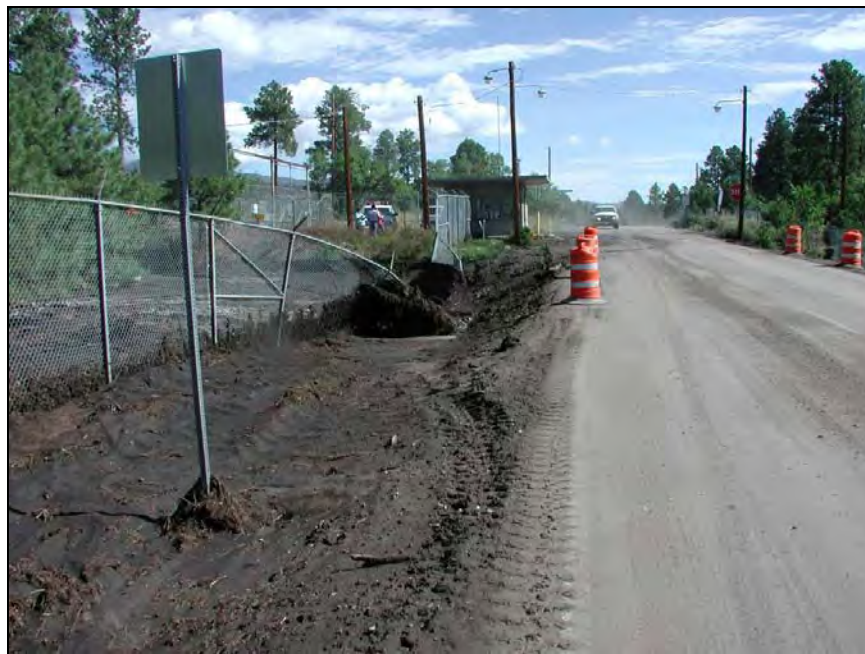
Photograph 42. Security fence at along Anchor Ranch Road damaged by flood event.

LANS crews repaired a security fence at TA-16 damaged by post-Las Conchas fire flooding in August 2011. A heavy rain event caused post-fire flooding in and around the Pajarito Canyon and Water Canyon drainages that flowed onto LANL, south of Pajarito Canyon and north of Cañon de Valle. The flow crossed Anchor Ranch Road and destroyed about 20 feet of fence (Photographs 41 and 42).

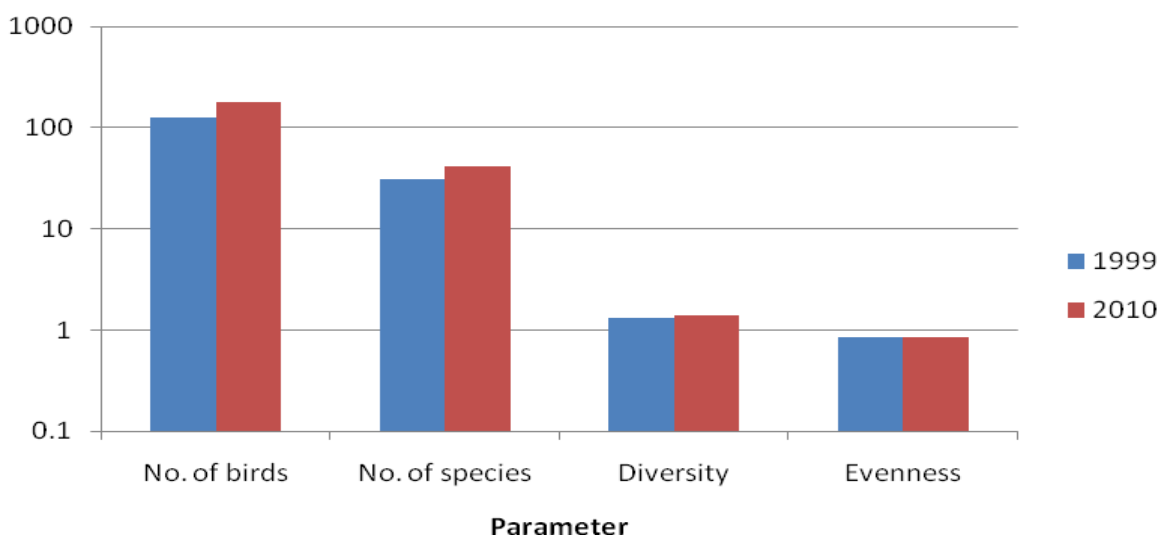
Figure 7. Populations, number of species, diversity, and evenness of birds occurring before (1999) and during (2010) operations at DARHT. Note the logarithmic scale on the vertical axis.

The number of birds, number of bird species, diversity, and evenness (distribution) collected in 2010 are similar to the same collected before the start up of operations at DARHT in 1999 (Figure 7). The most common bird species collected regardless of time periods were the chipping sparrow (*Spizella passerina*), Virginia’s warbler (*Vermivora virginiae*), western tanager (*Piranga ludoviciana*), western bluebird (*Sialia mexicana*), and the broad-tailed hummingbird (*Selasphorus platycercus*).

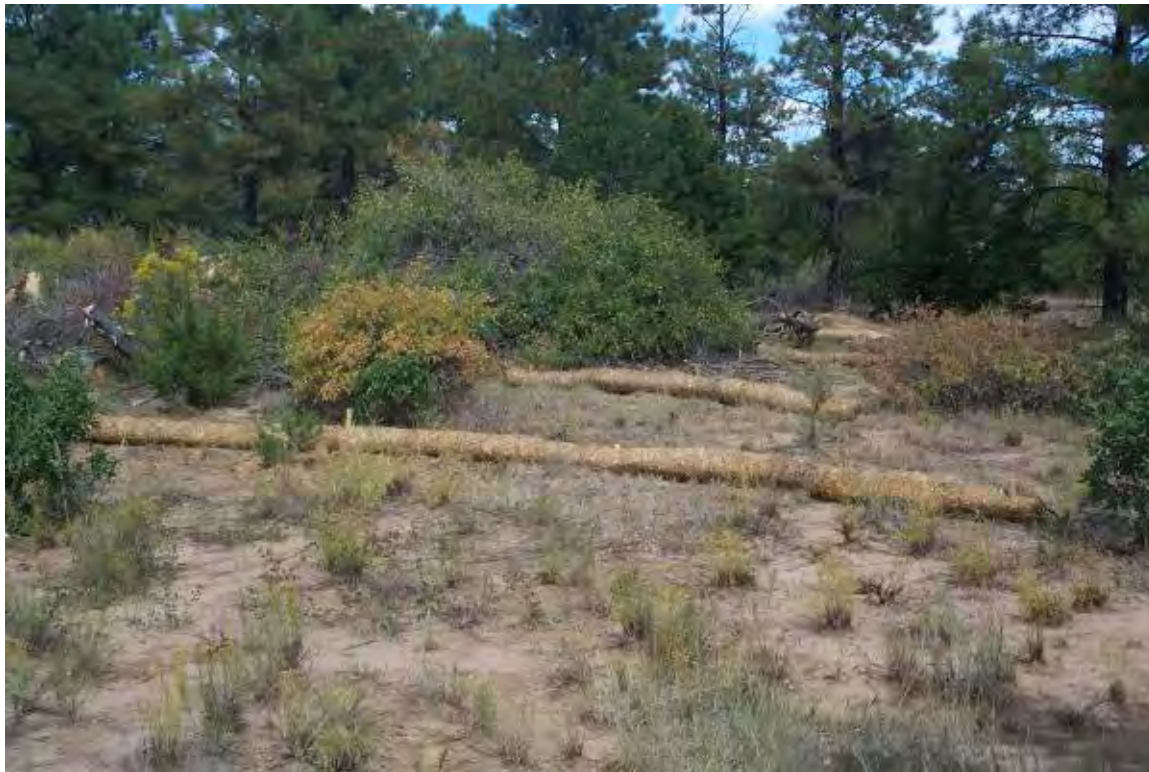
Figure 3. LA 89779, before wattle reinstatement (FY 2010).

FY 2010 SEA MAP monitoring was undertaken by a two-person team on July 31, 2010, and from August 18–25, 2010. Most of the individual site issues identified during the FY 2009 monitoring program persisted as issues in FY 2010. Altogether, 18 prehistoric sites were assessed. Two were recommended for rehabilitation measures during FY 2010, and 15 were slated for mitigations in FY 2011. These mitigations primarily consisted of fence repair, snag removal, and wattle installation (Figures 1–10).

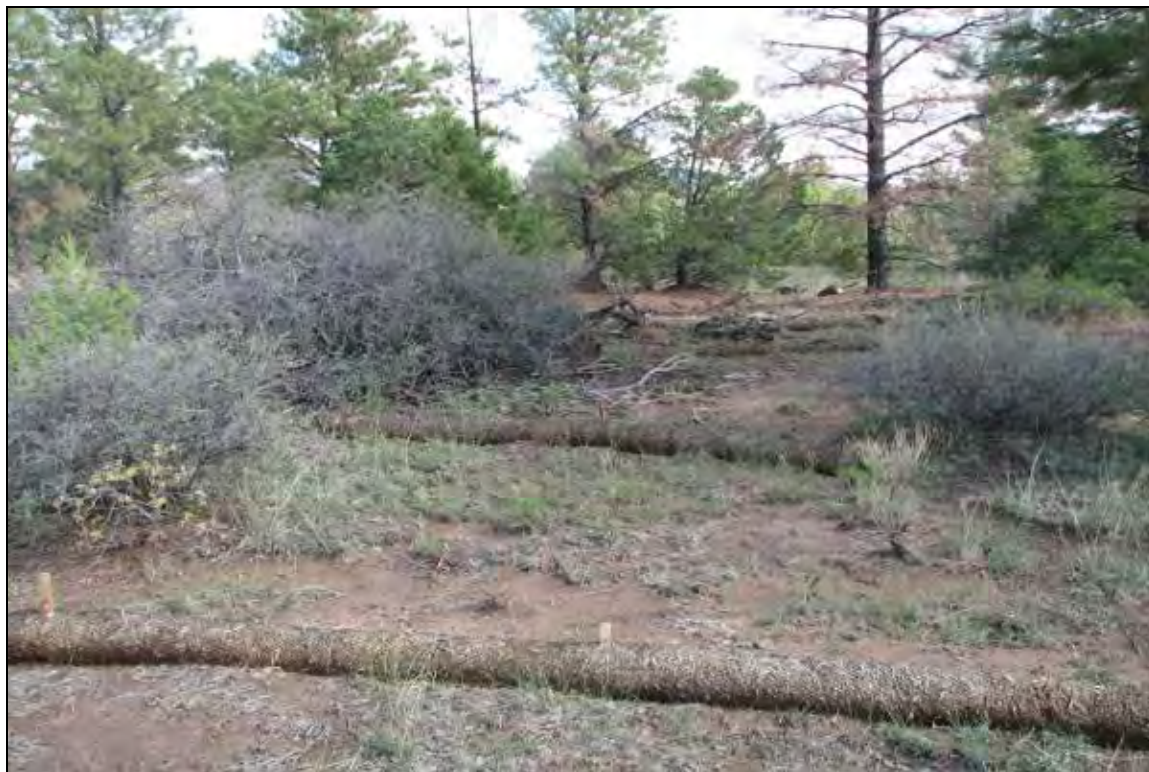
Figure 4. LA 89779, after lowering wattles (2011).

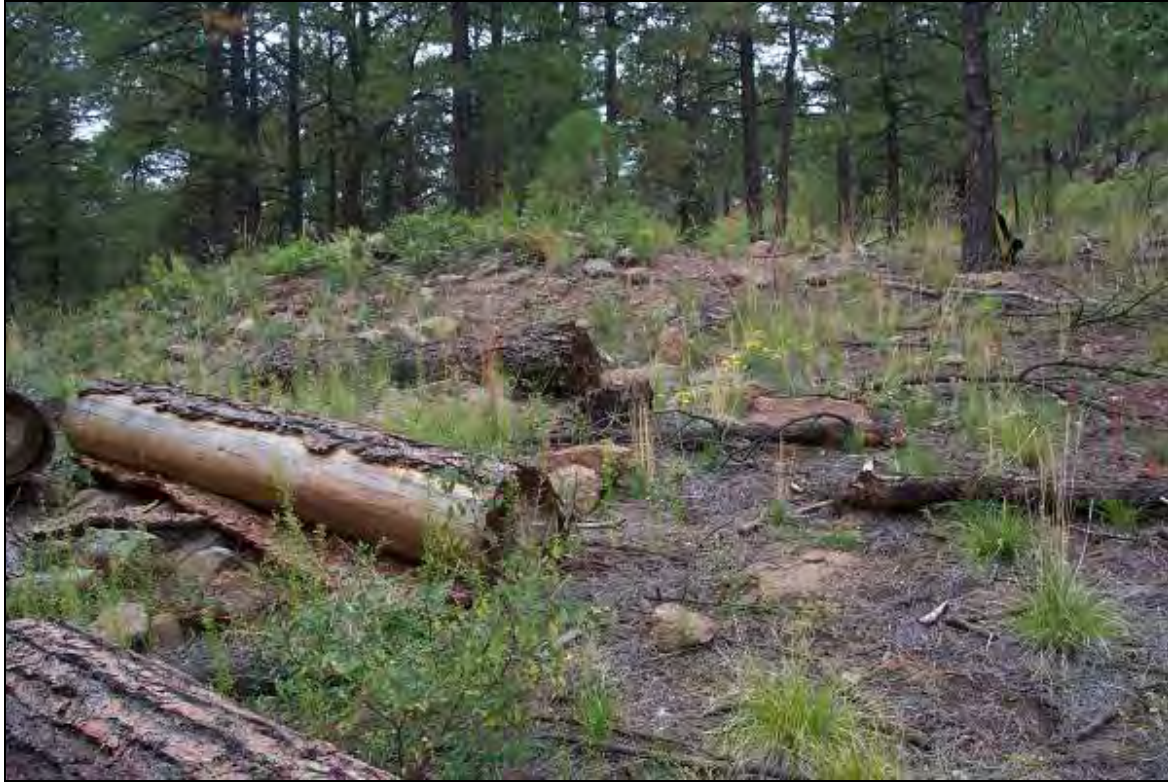
Figure 5. LA 86651, logs for erosion control (FY 2009).

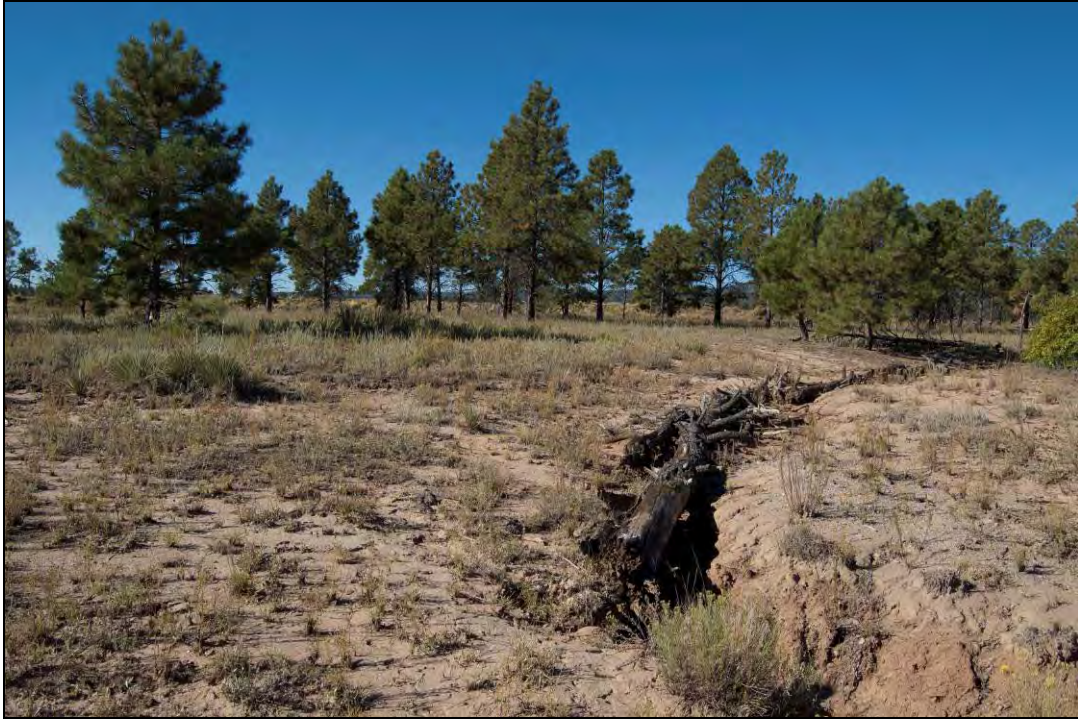
Figure 11. Detail of erosion channel, Montoya Homestead, LA 21334 (2010).

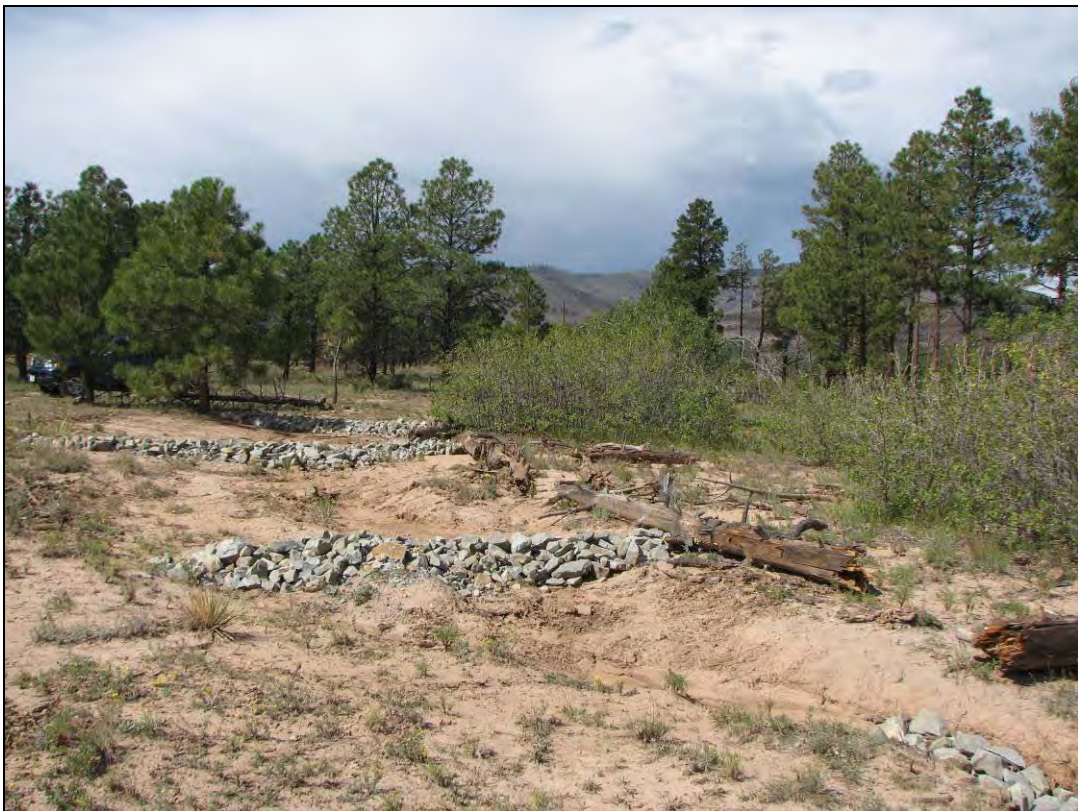
Figure 12. New rock erosion-control measures, LA 21334 (2011).

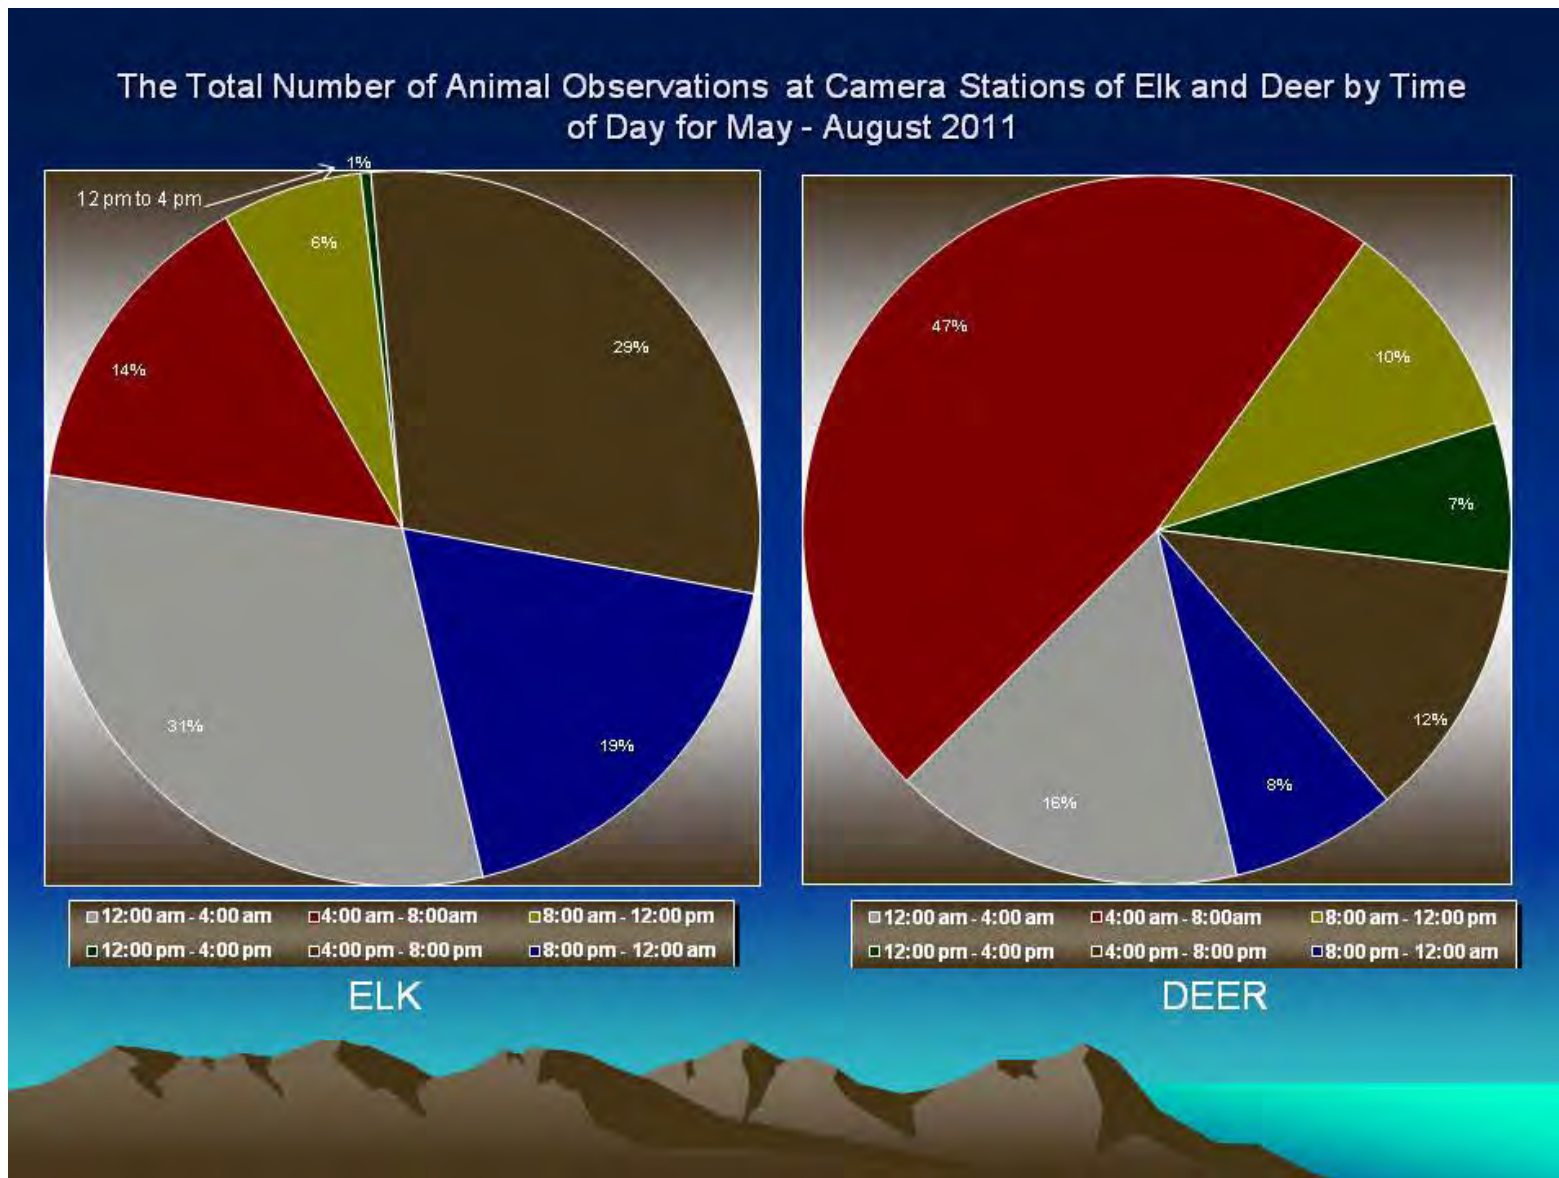
Figure 9. Percent observations of elk and deer shown by time May-August 2011.
