2015 Update to the Site Discharge Pollution Prevention Plan, Revision 1

Los Alamos National Laboratory
NPDES Permit No. NM0030759
LA-UR-16-22469 • May 1, 2016

Los Alamos/Pueblo Watershed

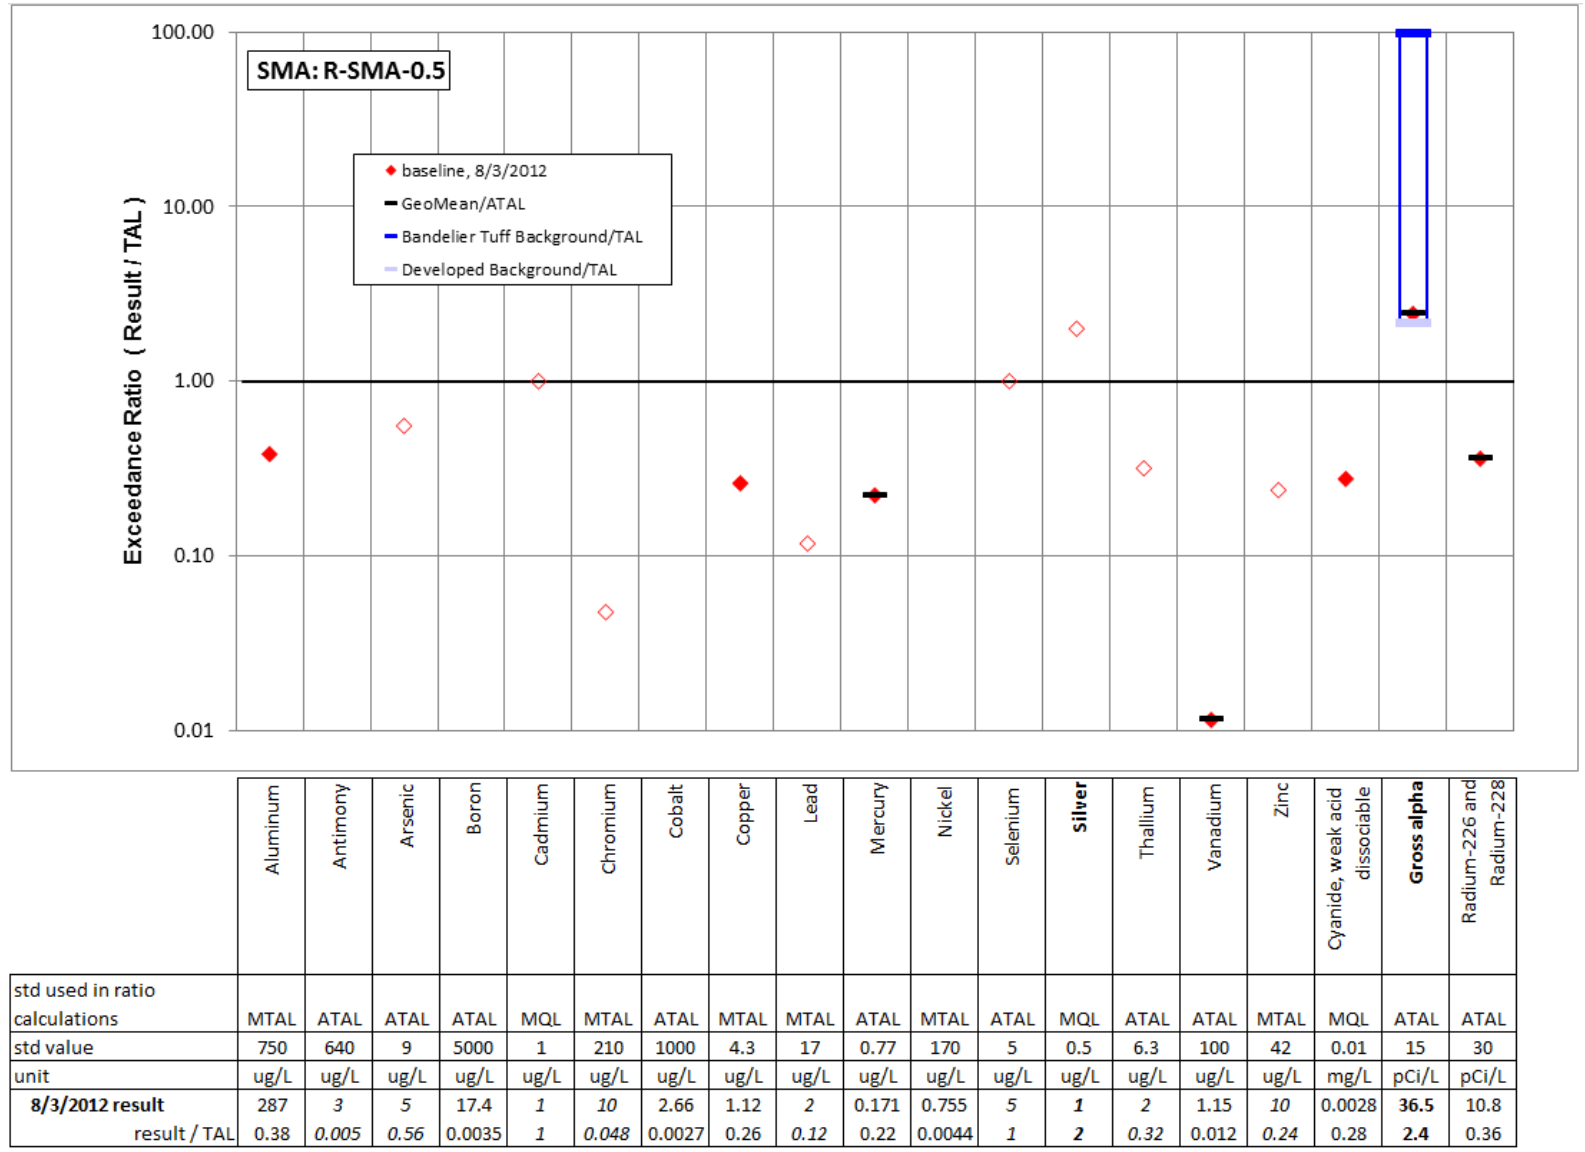
Figure 1-2 Inorganic analytical results summary plot for R-SMA-0.5

AOC C-00-020 was monitored within R-SMA-0.5. Following the installation of baseline control measures, a baseline storm water sample was collected on August 3, 2012 (Figures 1-2 and 1-3). On May 16, 2012, NMED issued a COC for AOC C-00-020. This Site is now certified as corrective action complete, and monitoring of storm water discharges has ceased at R-SMA-0.5. No further sampling is required for R-SMA-0.5 for the remainder of the IP. In Figure 1-2, cadmium, selenium, and silver are reported as nondetectable results equal to or greater than their respective TALs. These values are reported at the PQL; however, the MDLs for these analytes are below the TALs. Analytical results from this sample yielded the following TAL exceedance:

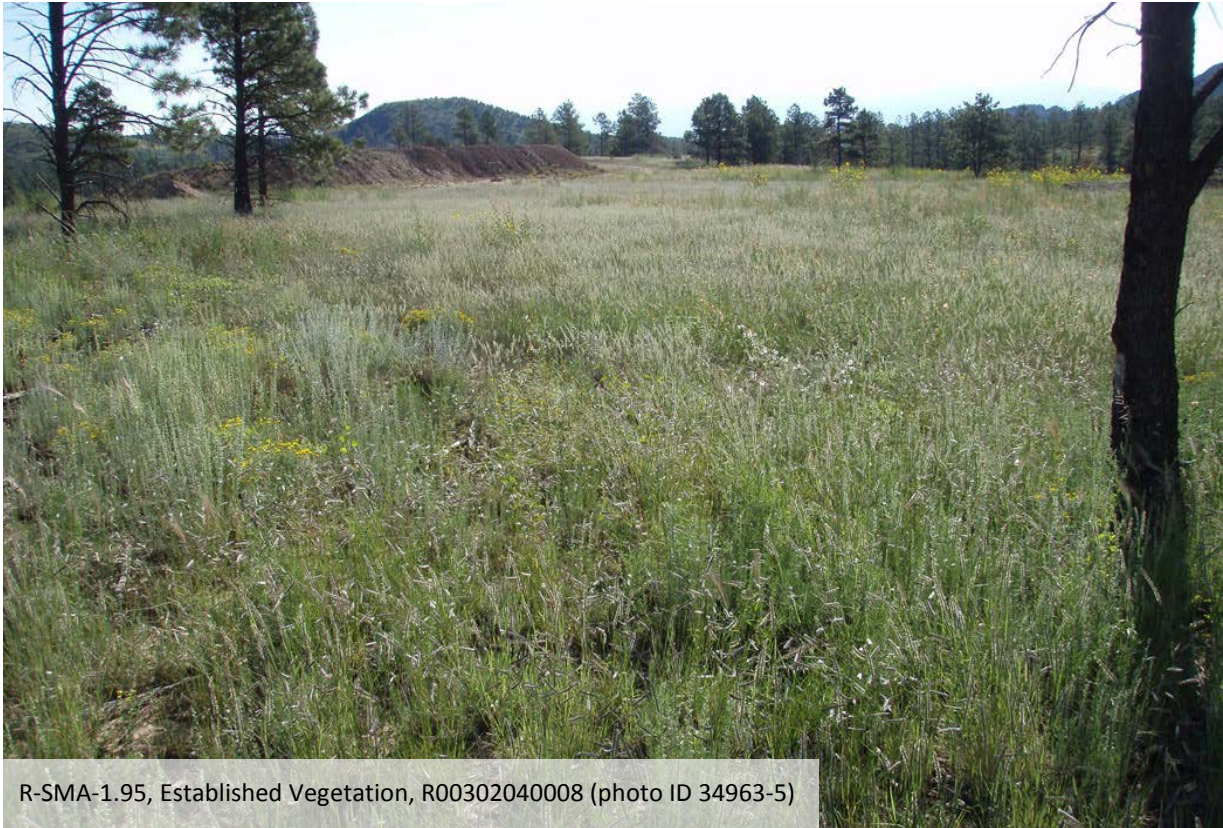
R-SMA-1.95, Established Vegetation, R00302040008 (photo ID 34963-5)

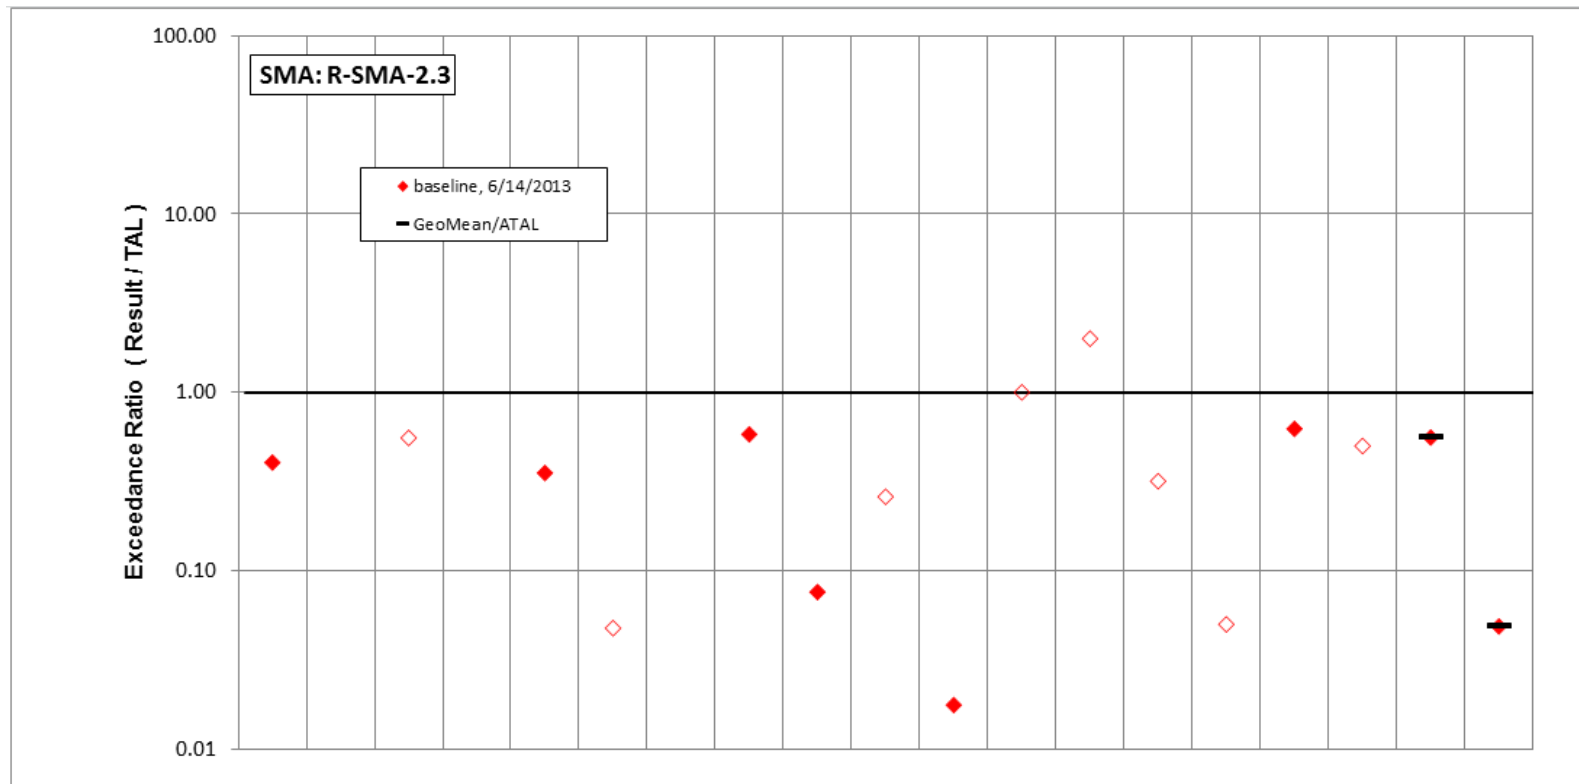
Figure 5-2 Inorganic analytical results summary plot for R-SMA-2.3

SWMU 00-011(e) is monitored within R-SMA-2.3. Following the installation of baseline control measures, a baseline storm water sample was collected on June 14, 2013 (Figures 5-2 and 5-3). In Figure 5-2, selenium and silver are reported as nondetectable results equal to or greater than their respective TALs. These values are reported at the PQL; however, the MDLs for these analytes are below the TALs. Analytical results from this sample yielded no TAL exceedances. Baseline confirmation is complete for R-SMA-2.3 and the associated SWMU 00-011(e) because all applicable sampling results are

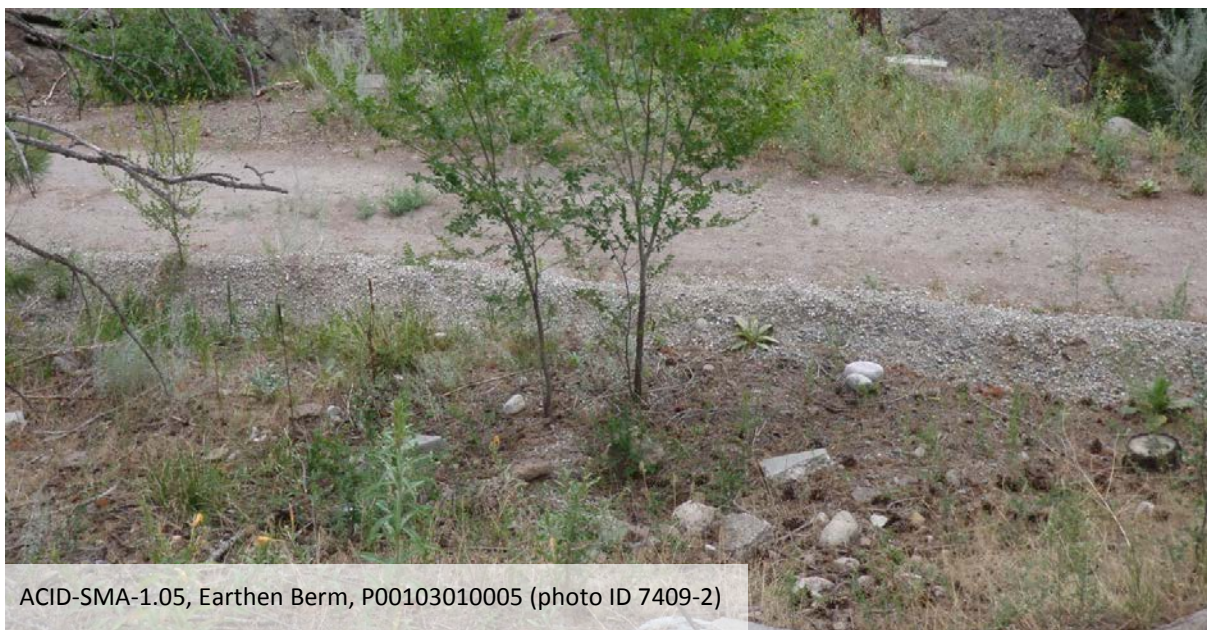
ACID-SMA-1.05, Earthen Berm, P00103010005 (photo ID 7409-2)

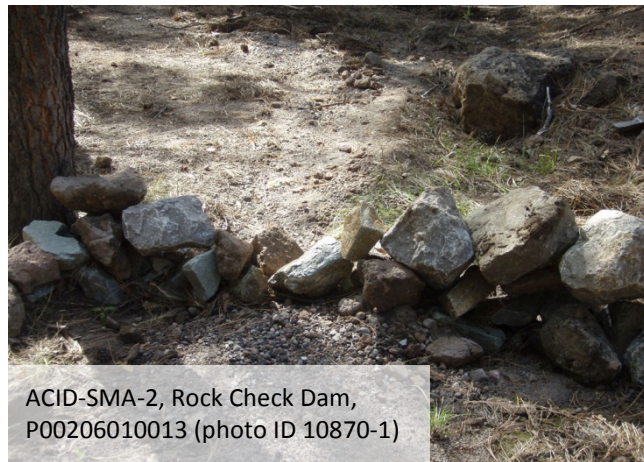
ACID-SMA-2, Rock Check Dam, P00206010013 (photo ID 10870-1)

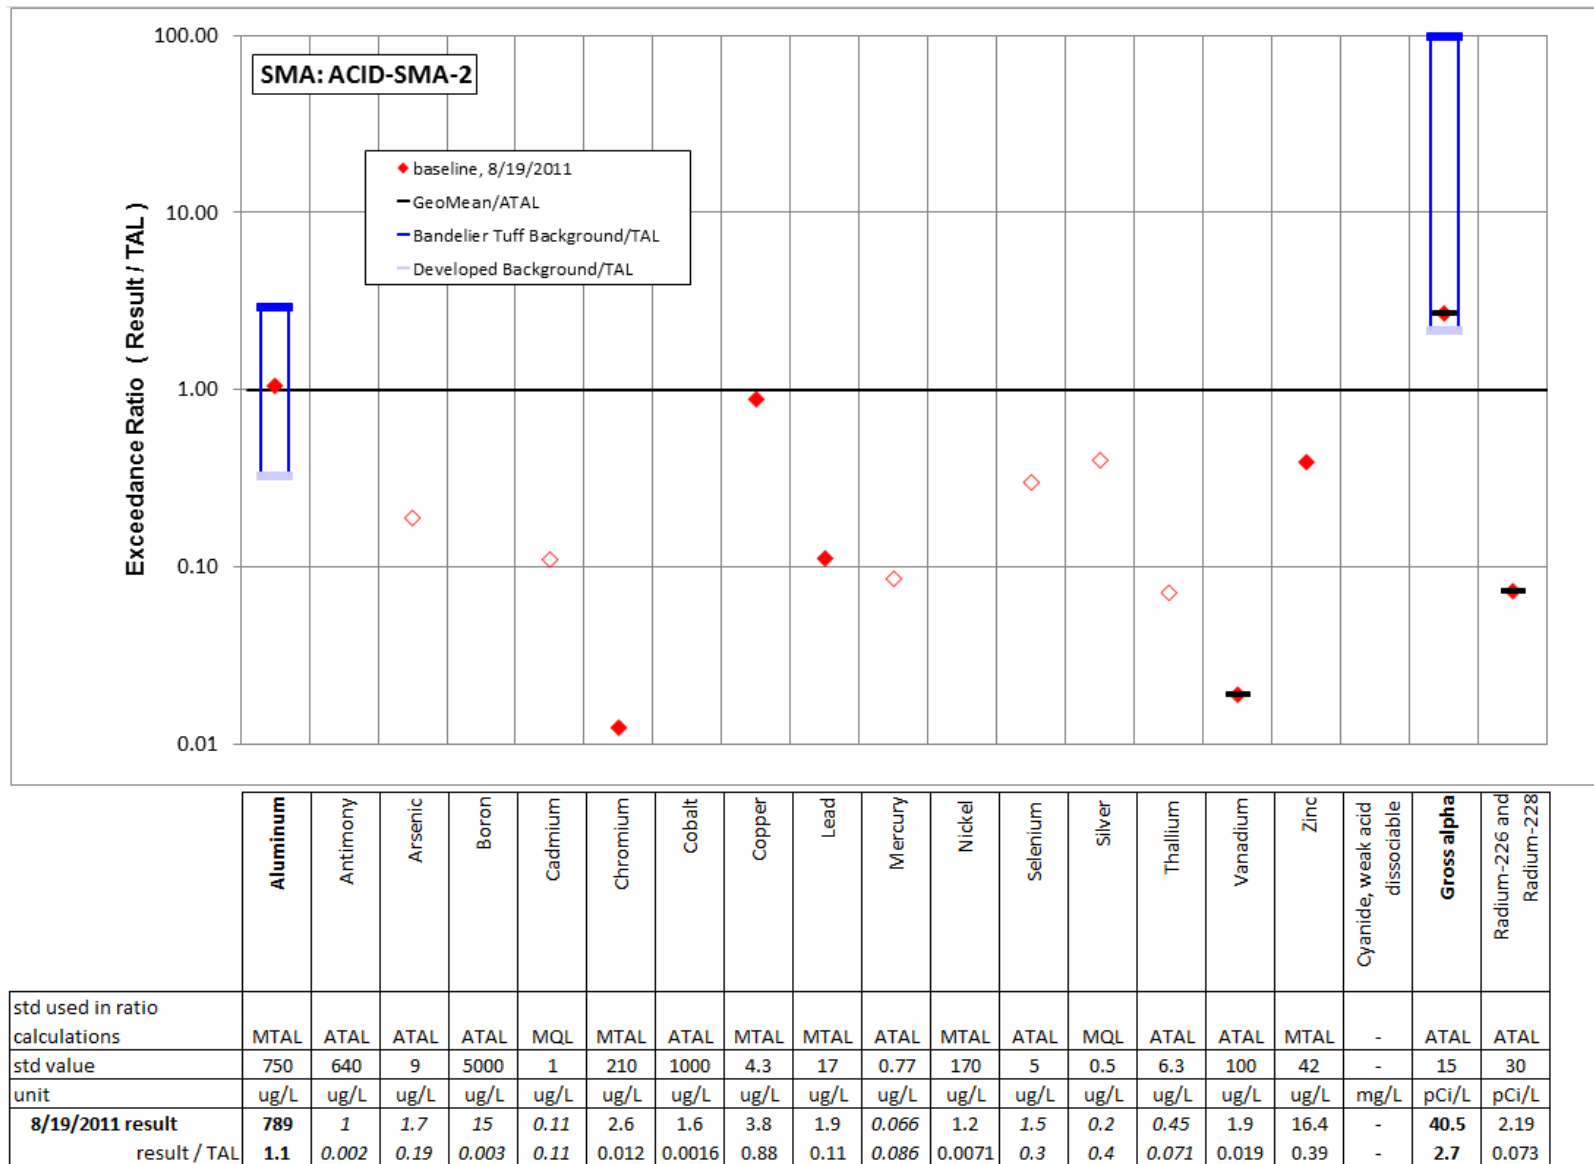
Figure 10-2 Inorganic analytical results summary plot for ACID-SMA-2

SWMUs 01-002(b)-00, 45-001, 45-002, and 45-004 are monitored within ACID-SMA-2. Following the installation of baseline control measures, a baseline storm water sample was collected on August 19, 2011 (Figures 10-2 and 10-3). Analytical results from this sample yielded the following TAL exceedances:

Monitoring location ACID-SMA-2 receives storm water run-on from developed environments, including paved parking lots, roads, and buildings, as well as landscape containing sediment derived from Bandelier Tuff. Metals including aluminum are associated with building materials, parking lots, and automobiles as well as low concentrations in the Bandelier Tuff. PCBs are associated with building materials including paint, caulking, asphalt, solvents, transformers, and cutting oils. Gross alpha in Bandelier Tuff is associated with naturally occurring radioactive uranium- and thorium-bearing minerals.

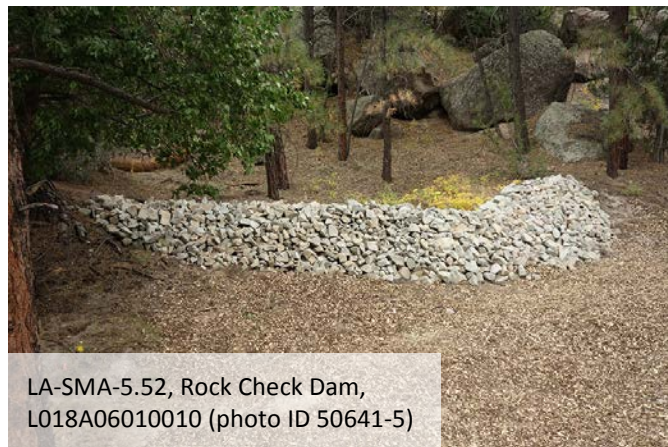
LA-SMA-5.52, Rock Check Dam, L018A06010010 (photo ID 50641-5)

Monitoring location LA-SMA-5.52 receives storm water run-on from landscapes containing sediment derived from Bandelier Tuff. Gross alpha in Bandelier Tuff is associated with naturally occurring radioactive uranium- and thorium-bearing minerals.

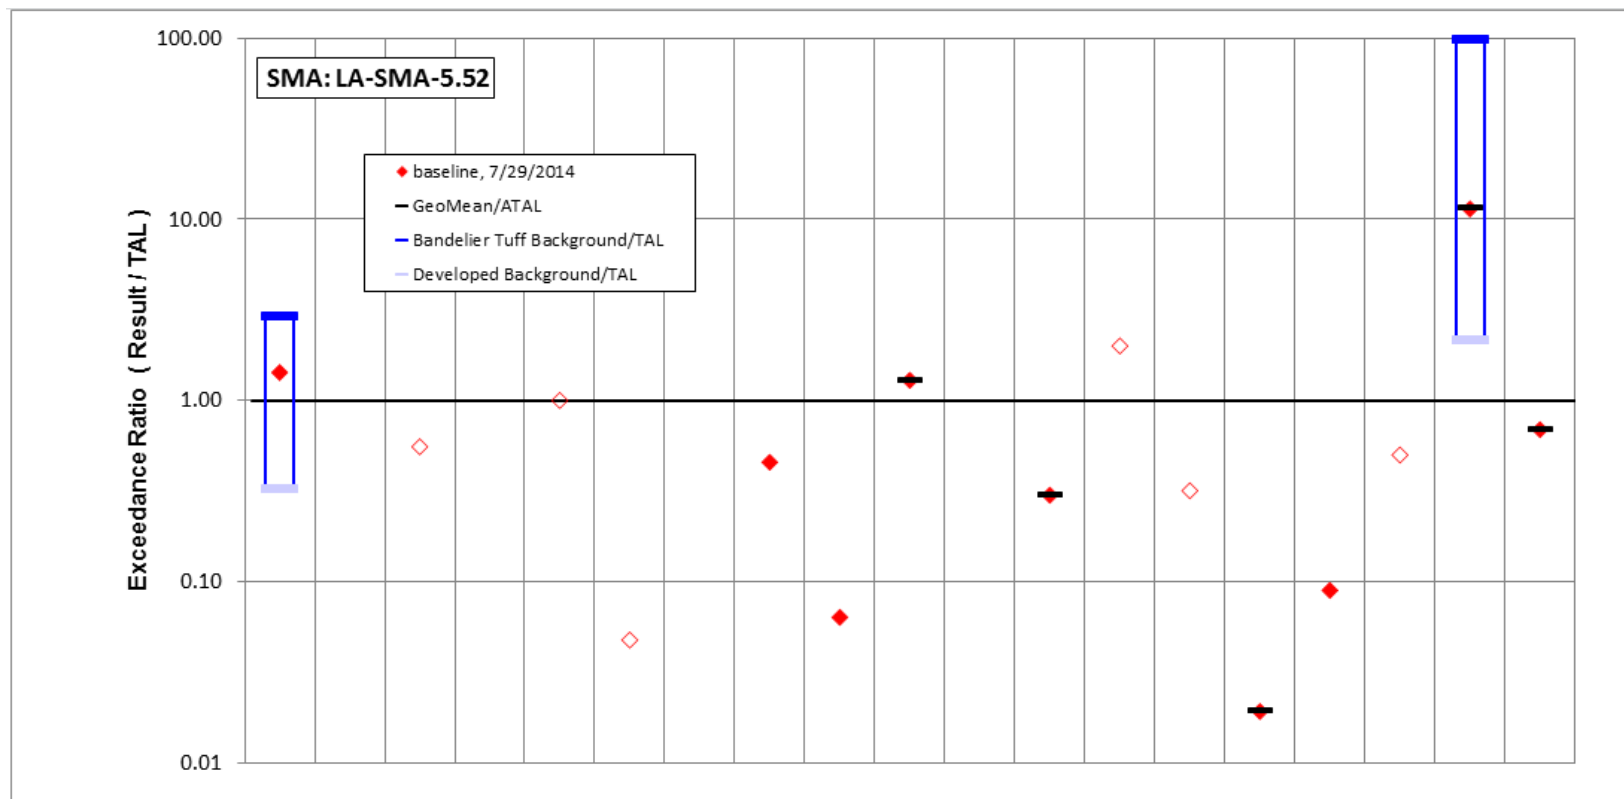
Figure 39-2 Inorganic analytical results summary plot for LA-SMA-5.52

Bold font indicates result>TAL/MQL; italic font and hollow symbols indicate undetected results; "-" is used if no analytical results were available.

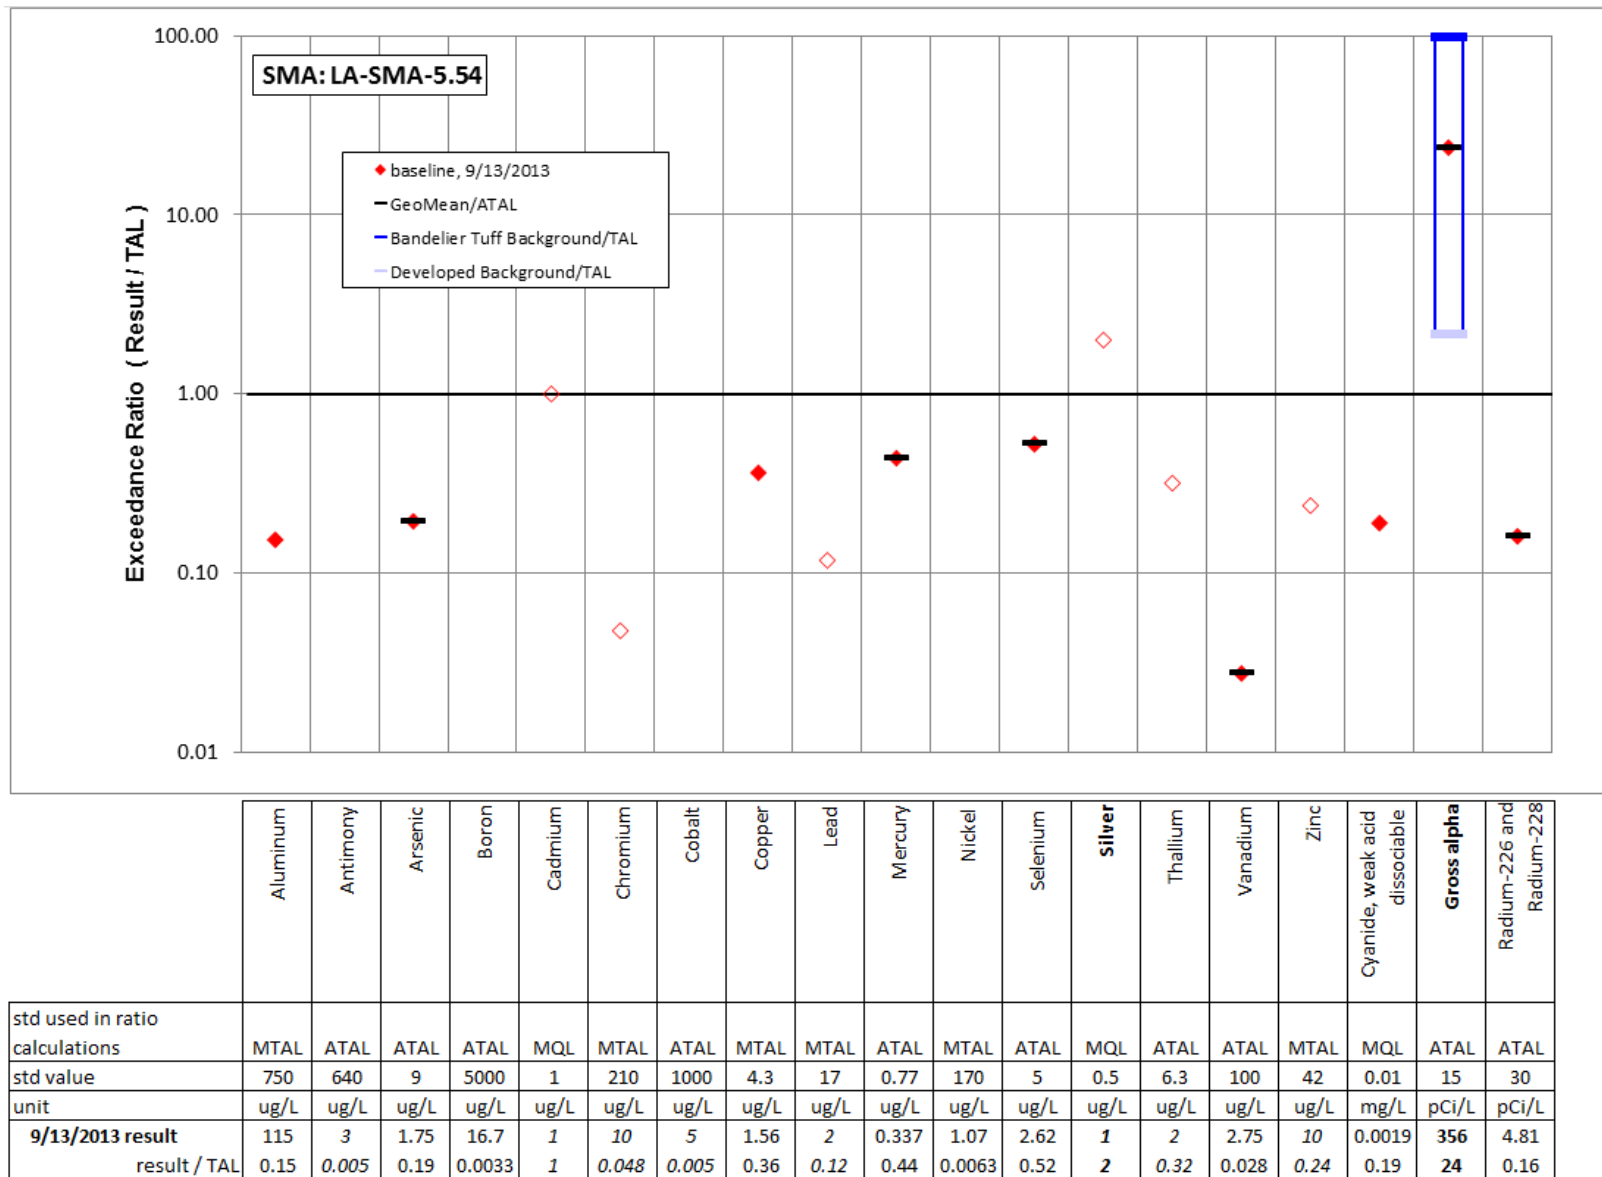
Figure 41-2 Inorganic analytical results summary plot for LA-SMA-5.54

SWMU 02-009(c) is monitored within LA-SMA-5.54. Following the installation of baseline control measures, a baseline storm water sample was collected on September 13, 2013 (Figures 41-2 and 41-3). In Figure 41-2, cadmium and silver are reported as nondetectable results equal to or greater than their respective TALs. These values are reported at the PQL; however, the MDLs for these analytes are below the TALs. Analytical results from this sample yielded the following TAL exceedances:

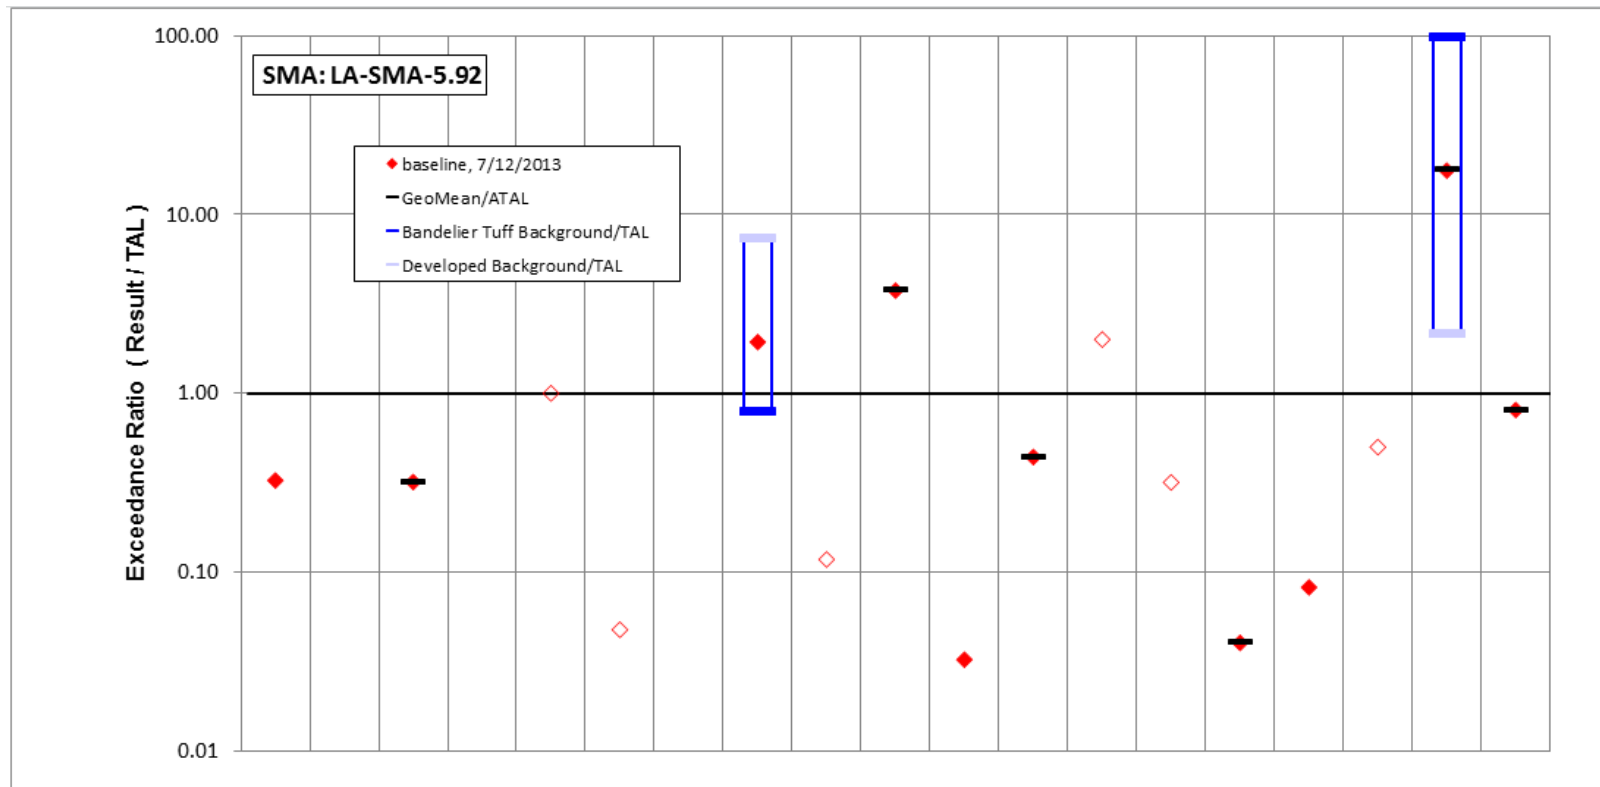
Bold font indicates result>TAL/MQL; italic font and hollow symbols indicate undetected results; "-" is used if no analytical results were available.

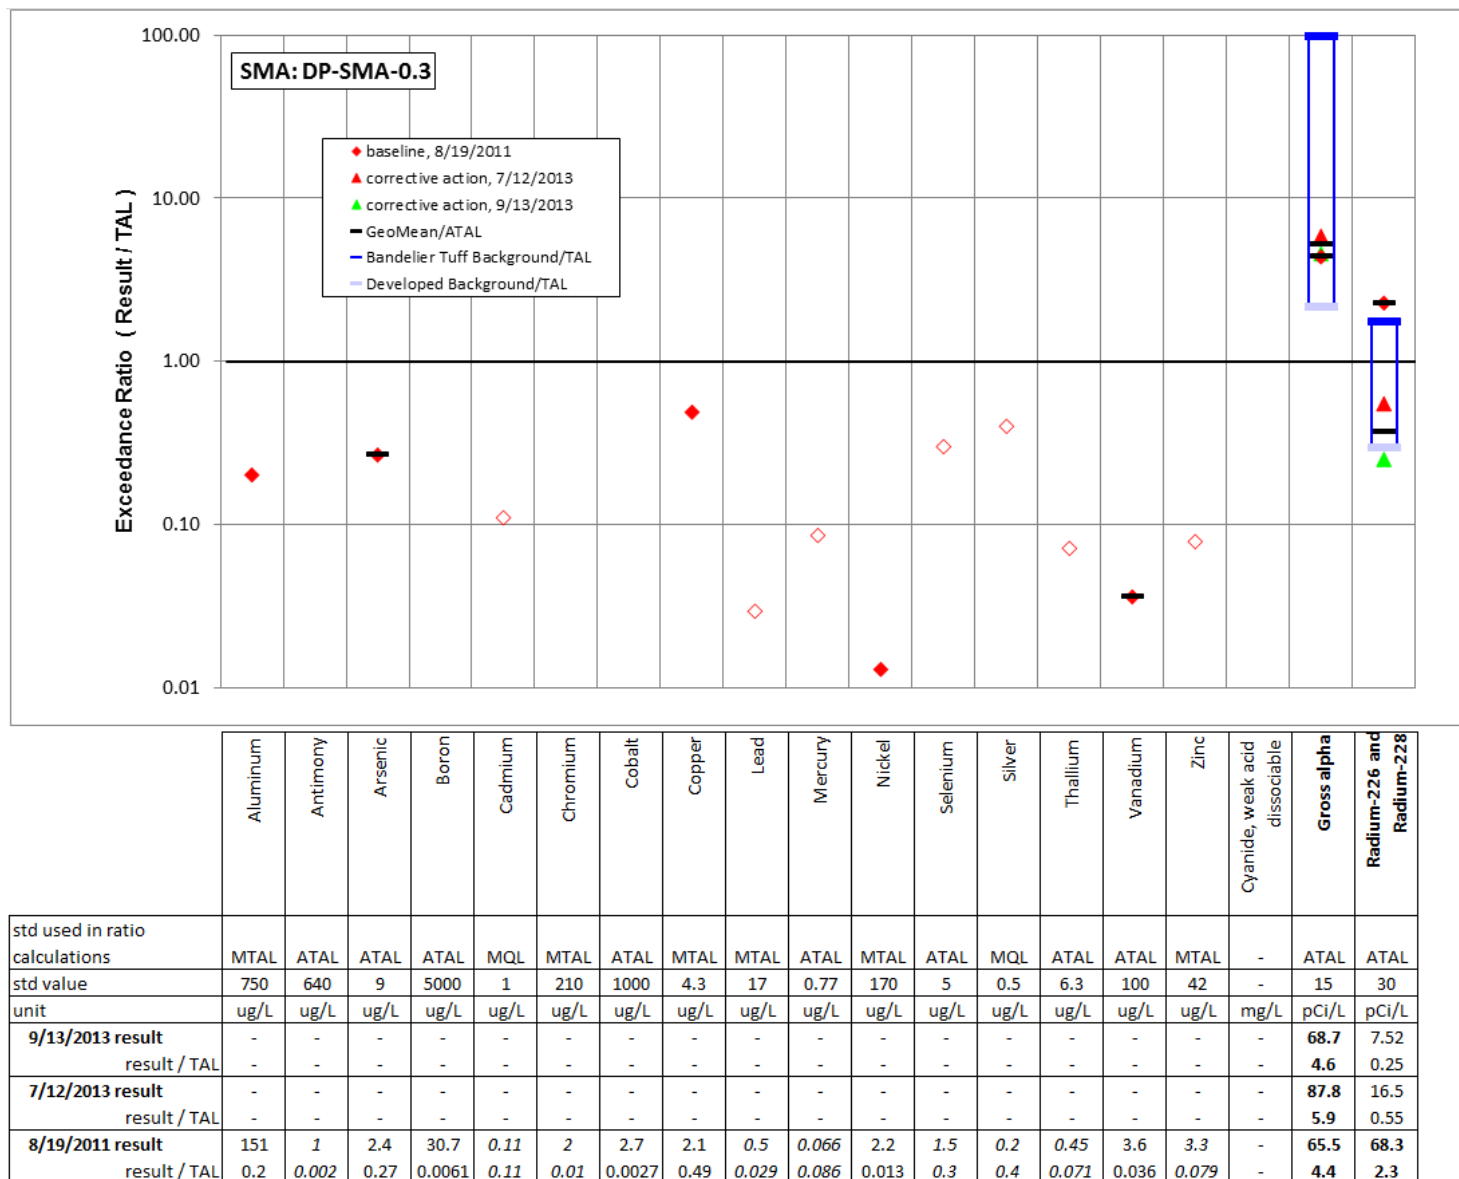
Figure 57-2 Inorganic analytical results summary plot for DP-SMA-0.3

SWMU 21-029 is monitored within DP-SMA-0.3. Following the installation of baseline control measures, a baseline storm water sample was collected on August 19, 2011 (Figure 57-2). Analytical results from this sample yielded the following TAL exceedances:

Following the installation of enhanced control measures at DP-SMA-0.3, corrective action storm water samples were collected on July 12, 2013, and September 13, 2013 (Figure 57-2). Analytical results from these corrective action monitoring samples yielded the following TAL exceedance:
