**CERRO GRANDE  
FIRE ASSESSMENT PROJECT:  
An Assessment of the Impact of the  
Cerro Grande Fire on Cultural Resources at  
Los Alamos National Laboratory, New Mexico**

Cultural Resource Report No. 211

**Los Alamos National Laboratory**

**December 2002  
Survey No. 818**

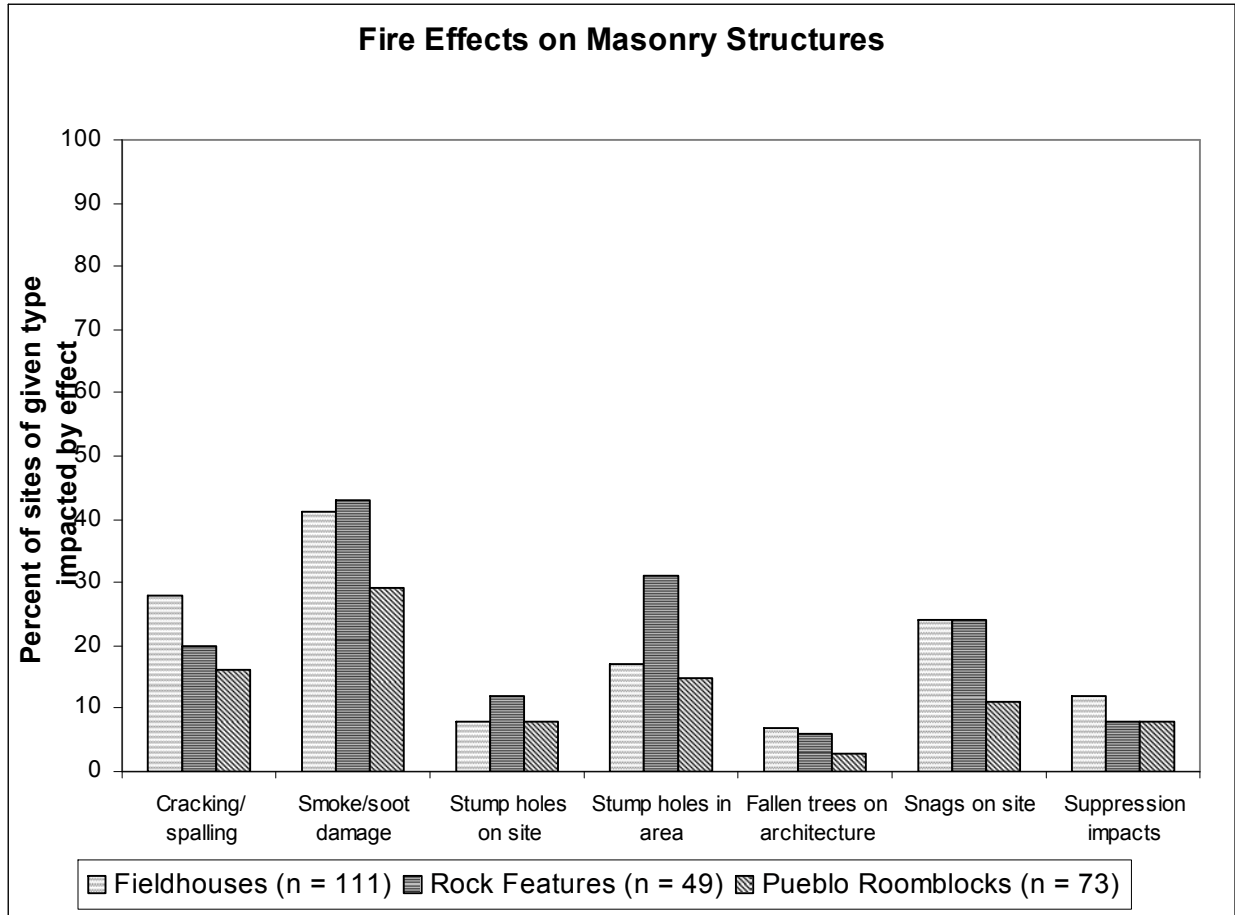
**Figure 6.1.** The effects of the Cerro Grande Fire on masonry structures at LANL.

Smoke or soot damage is the most common effect, but even this is present at less than 50% of the sites. Less common, but in fact more destructive, was the presence of cracking and spalling on masonry. When cracking and spalling did occur, usually less than a quarter of the masonry was affected, although in a few instances, virtually all of the masonry was spalled. Stump holes were particularly common in ponderosa pine areas that were subject to moderate- and severe-intensity burning. The presence of fallen trees on architecture was not common, however, snags do pose potential future threats to sites because they are fuel for future fires and because if they do fall, they create new avenues for erosion.

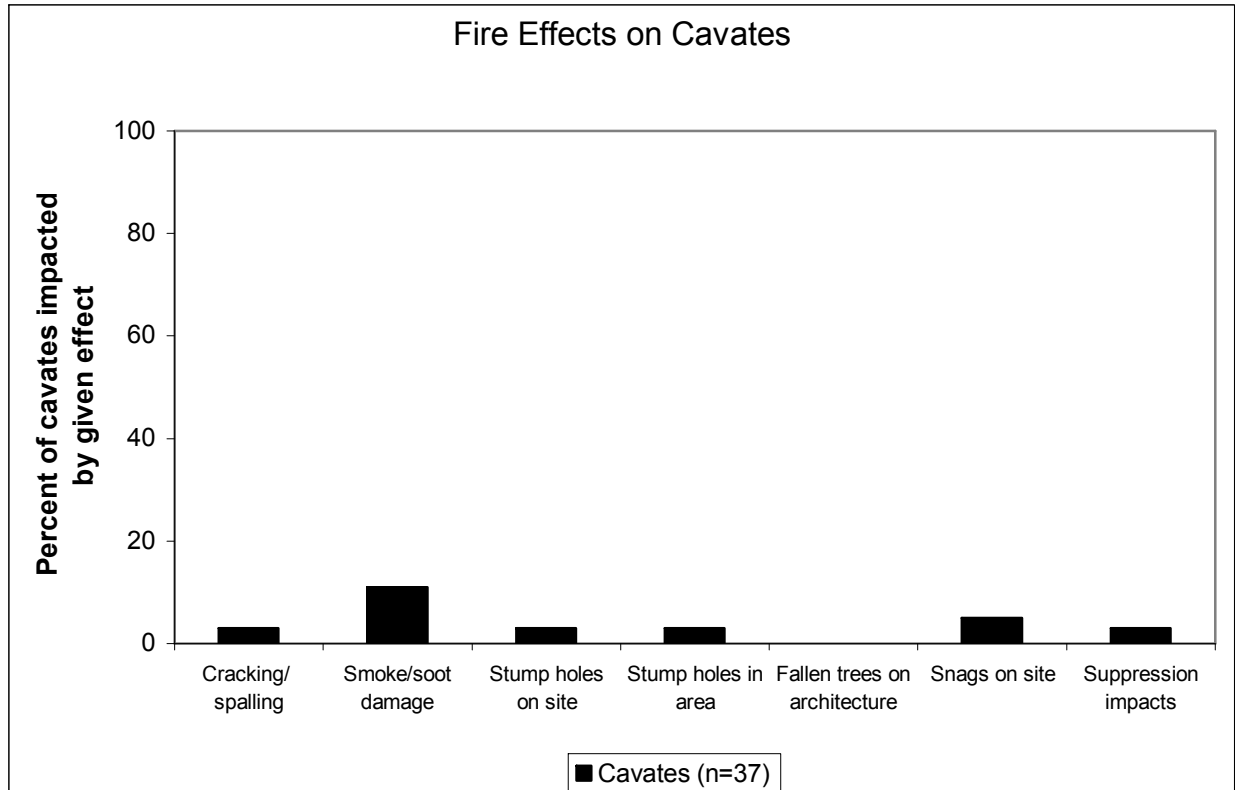
Fire damage to cavates (Figure 6.2) was infrequent and minor, and, in general, these features weathered the Cerro Grande Fire quite well. There is, however, one significant potential research issue created by the fire. The interiors of many cavates were deliberately smoke-blackened as part of their original construction. These carbon deposits have the, albeit untested, potential to yield radiocarbon dates. It is not known if soot from the Cerro Grande Fire caused contamination problems for radiocarbon dating.

**Figure 6.2.** Fire effects on cavate features at LANL.

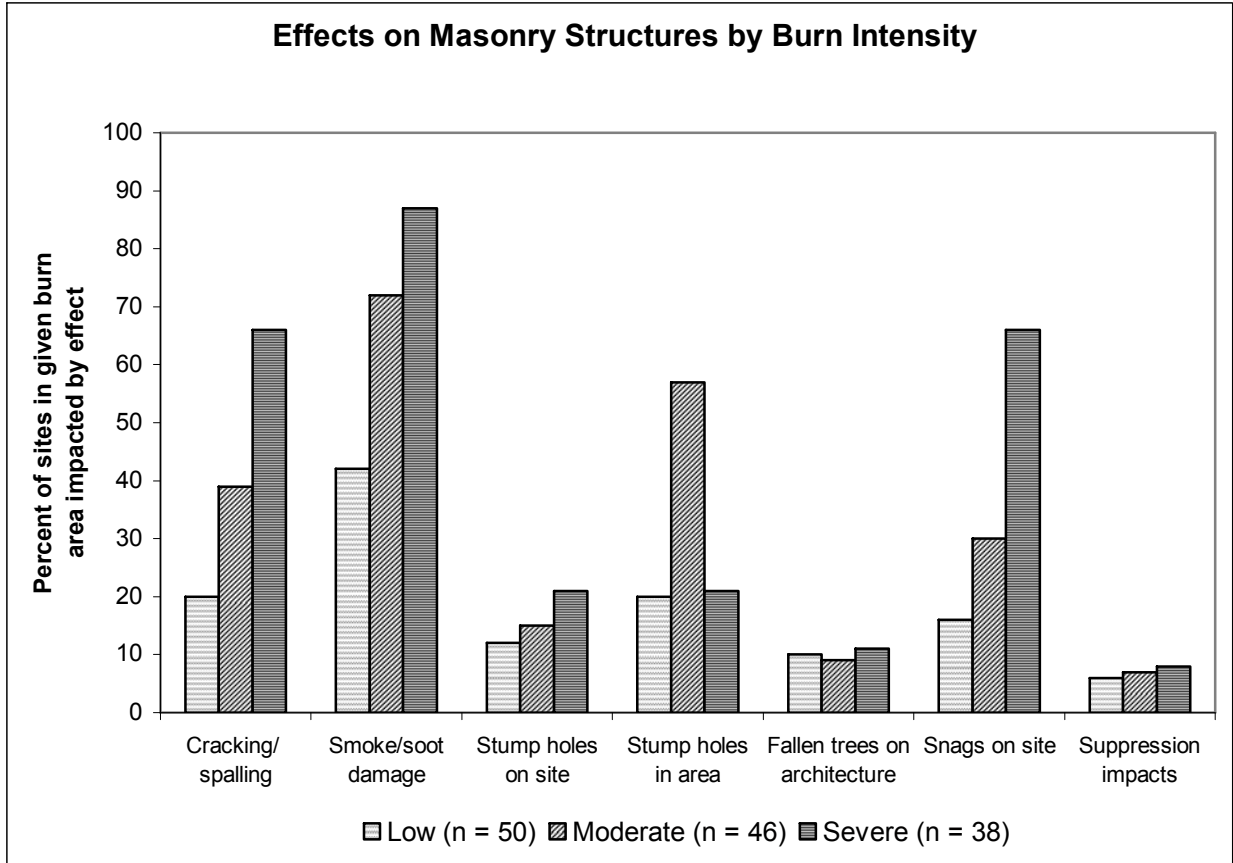
Certainly the intensity of the fire in specific areas determined how likely a given site was to suffer any given type of impact. Figure 6.3 illustrates the frequency of effects on masonry structures by burn intensity. Burn intensity, reflected in Figure 6.3, refers to our on-the-ground determination, not the burn areas depicted on the map. As can be clearly seen in this figure, the hotter the fire, the more likely a site was to be affected by any given impact. The “stump holes in the site area” category is a curious exception, and we can offer no explanation for it at the current time.

**Figure 6.3.** Burn intensity and fire effects to masonry structures.

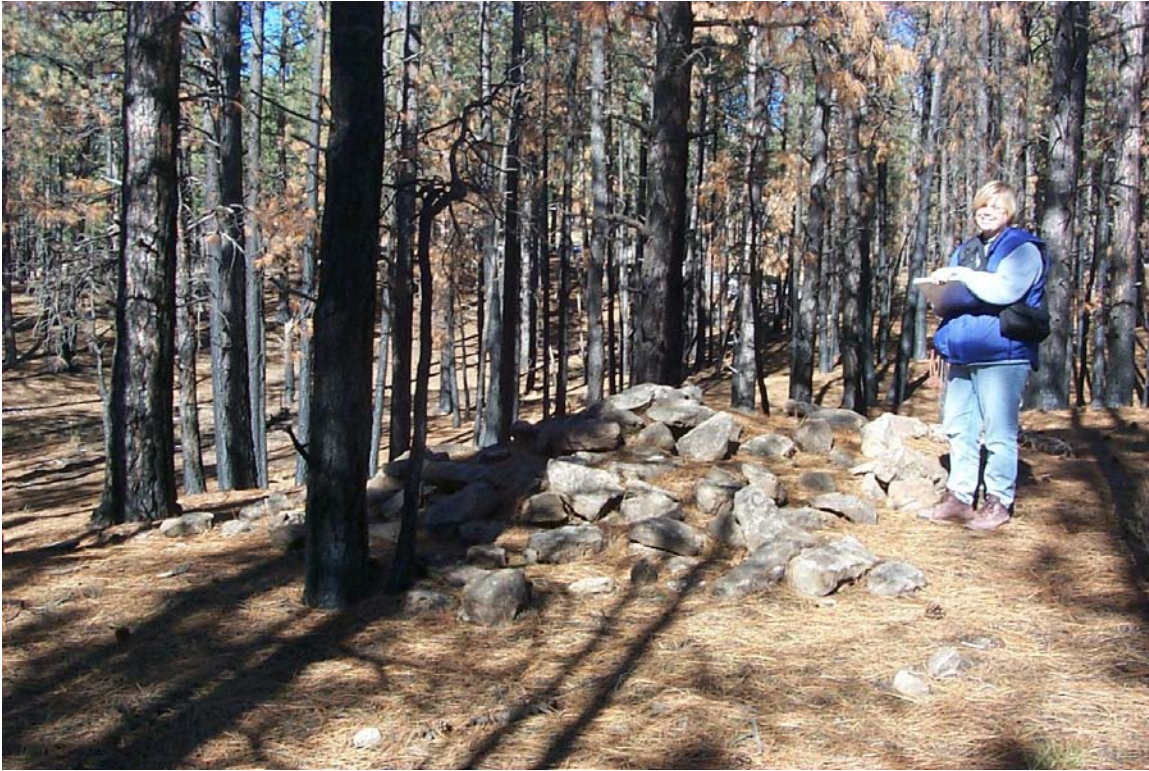
**LA 86655.** This site is a one-room structure (4 m by 3 m) of shaped tuff blocks (Figure 7.6). The site is located on a gentle south-facing slope incised by several small drainages in a ponderosa pine forest. This site is Ancestral Puebloan. The area around the site was severely burned. There are five stump holes and many snags in the site area, but they do not pose a threat to the site. Although there is minimal soot damage, 25% of the masonry is heat spalled. There is also a low erosional threat to the site.

**Figure 7.6.** General view looking north of LA 86655 with K. Schmidt.

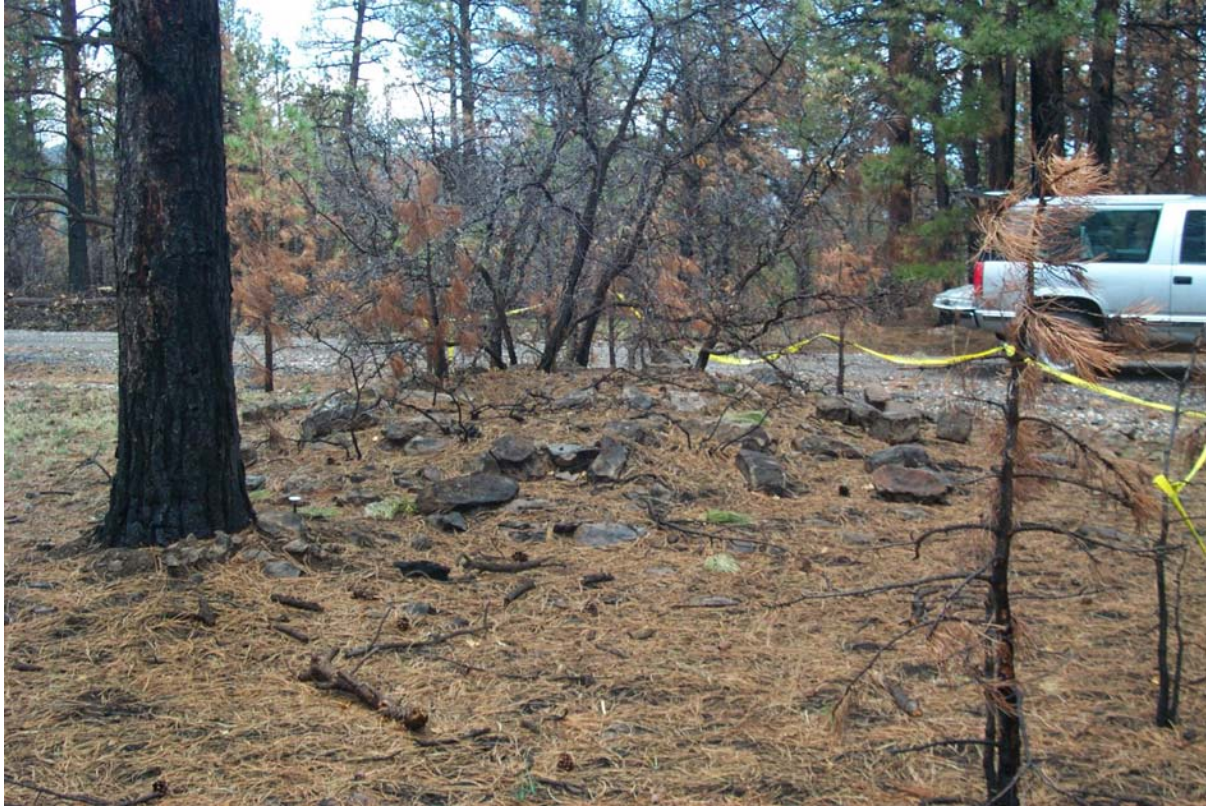
**LA 12654.** Before the Cerro Grande revisit, the site was most recently surveyed in 1993. In both visits, the site was identified as an undetermined prehistoric one- to three-room structure constructed from shaped tuff blocks and in the shape of an amorphous rubble mound (Figure 8.2). No artifacts were identified during the visit. The site is located in a piñon-juniper woodland with some scrub oak in the area. The area around the site was severely burned during the Cerro Grande Fire. Effects of this burn are evidenced by cracking, spalling, and soot and smoke damage on the masonry blocks, partially burned trees in the immediate vicinity of the site that can potentially damage the masonry further, and approximately five snags and partially burned trees in the general vicinity of the one- to three-room structure. Because of the severity of the burn, a number of trees have the potential to affect the site further. As a result, it is recommended that a large, dead tree on the south side of the mound be cut down. Despite the severe burn in the area, however, the site was not impacted by suppression or rehabilitation activities.

**Figure 8.2.** LA 12654, a one- to three-room structure after the Cerro Grande Fire.

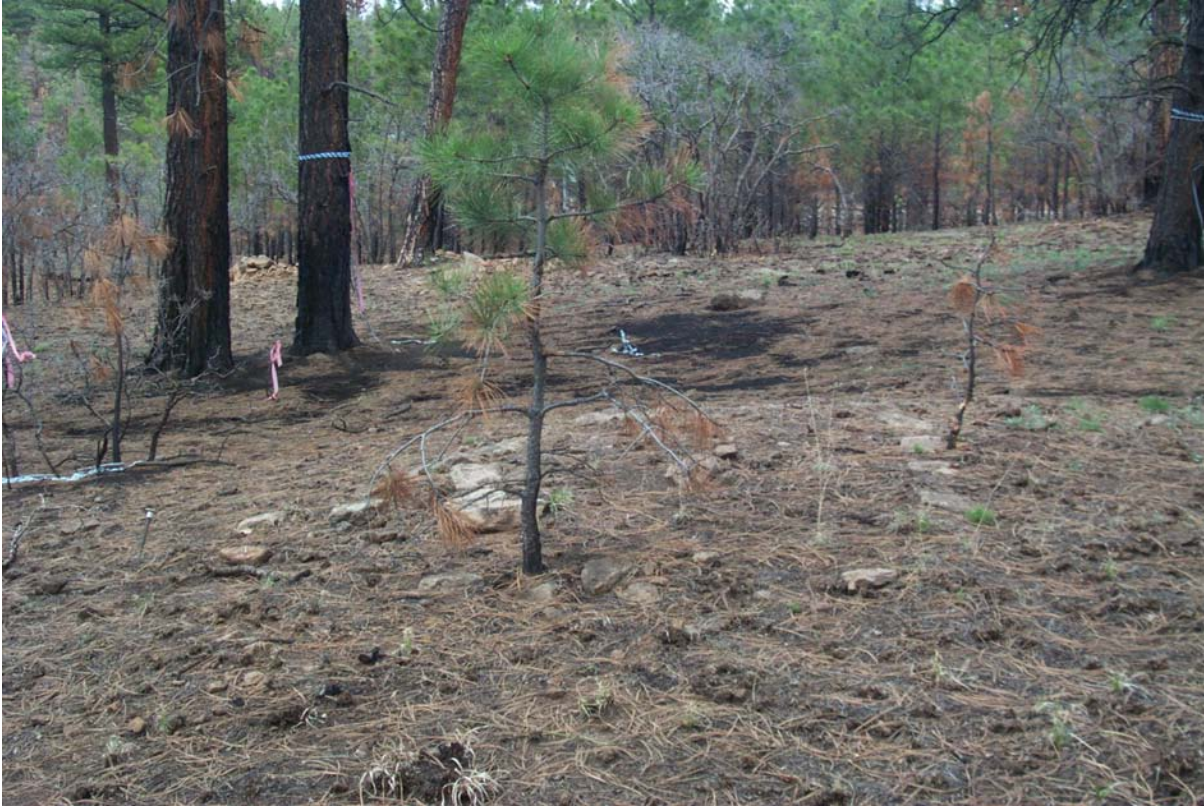
**LA 89803.** Before the Cerro Grande revisit, the site was most recently surveyed in 1992. In both visits, the site was identified as an Ancestral Pueblo period one- to three-room structure constructed from shaped tuff blocks (Figure 8.5). Two artifacts, a basalt flake and a smeared-indentured corrugated sherd, were identified during the visit. LA 89803 is located in a ponderosa pine forest. The area around the site was moderately burned during the Cerro Grande Fire. Effects of this burn are evidenced by two stump holes in the site area and five snags/partially burned trees in the vicinity of the one- to three-room structure. The site was not impacted by suppression or rehabilitation activities.

**Figure 8.5.** LA 89803, a one- to three-room structure after the Cerro Grande Fire.

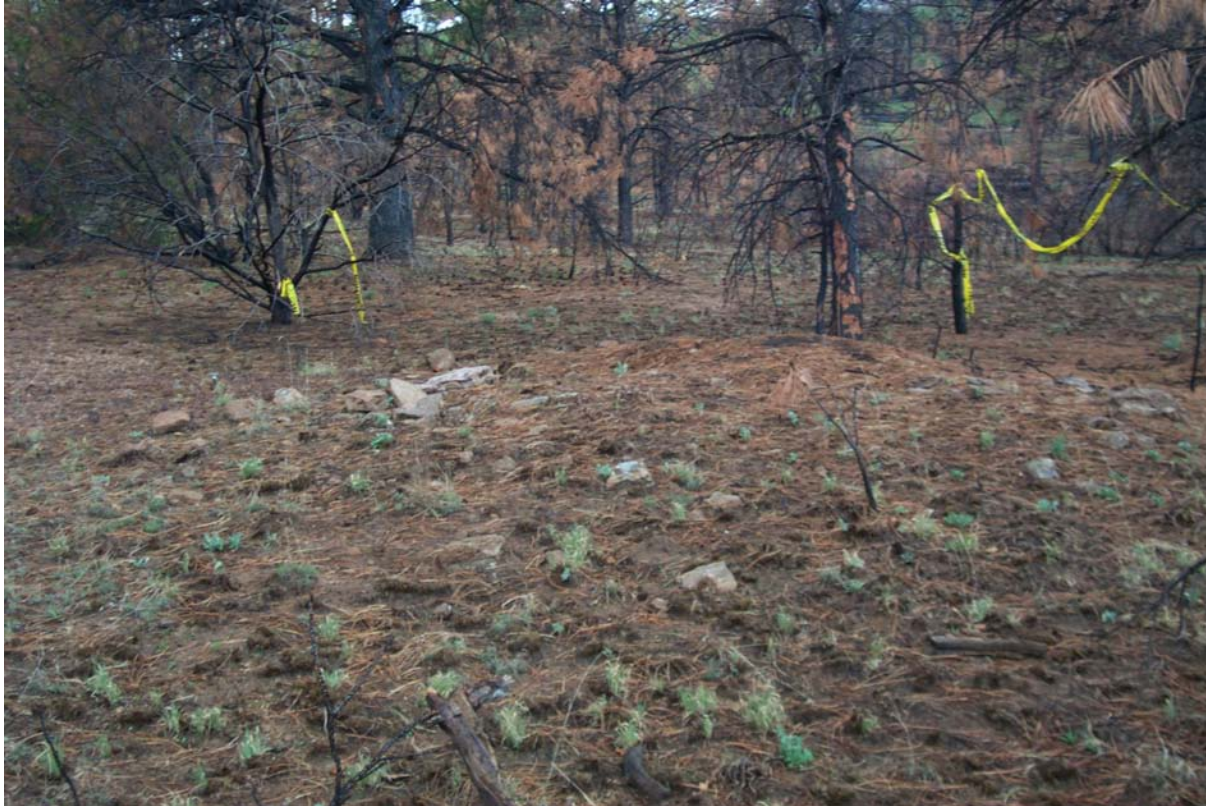
**LA 89790.** Before the Cerro Grande revisit, the site was most recently visited in 1993. In both instances, the site was identified as a one- to three-room structure that was constructed from masonry tuff blocks (Figure 8.7). Based on the presence of Wiyo Black-on-white ceramics and the shape of the masonry blocks, the site was likely occupied during the Coalition period. LA 89790 is located in a piñon-juniper woodland with some scrub oak in the area. The area around the site was severely burned during the Cerro

Grande Fire. Effects of this burn are evidenced by cracking and spalling on approximately 10% of the masonry blocks, smoke or soot damage on 80% of the masonry blocks, seven stump holes in the immediate vicinity of the one- to three-room structure, and seven snags and partially burned trees in the vicinity of the site that have the potential to damage the masonry if they fall. Because of the impacts to the site from the fire, it is recommended that a single tree on the north edge of the mound be cut down to prevent further destruction of the site. Due to heavy impacts, however, the site was not impacted by suppression or rehabilitation activities.

**Figure 8.7.** LA 89790, an ancient one- to three-room structure after the Cerro Grande Fire.

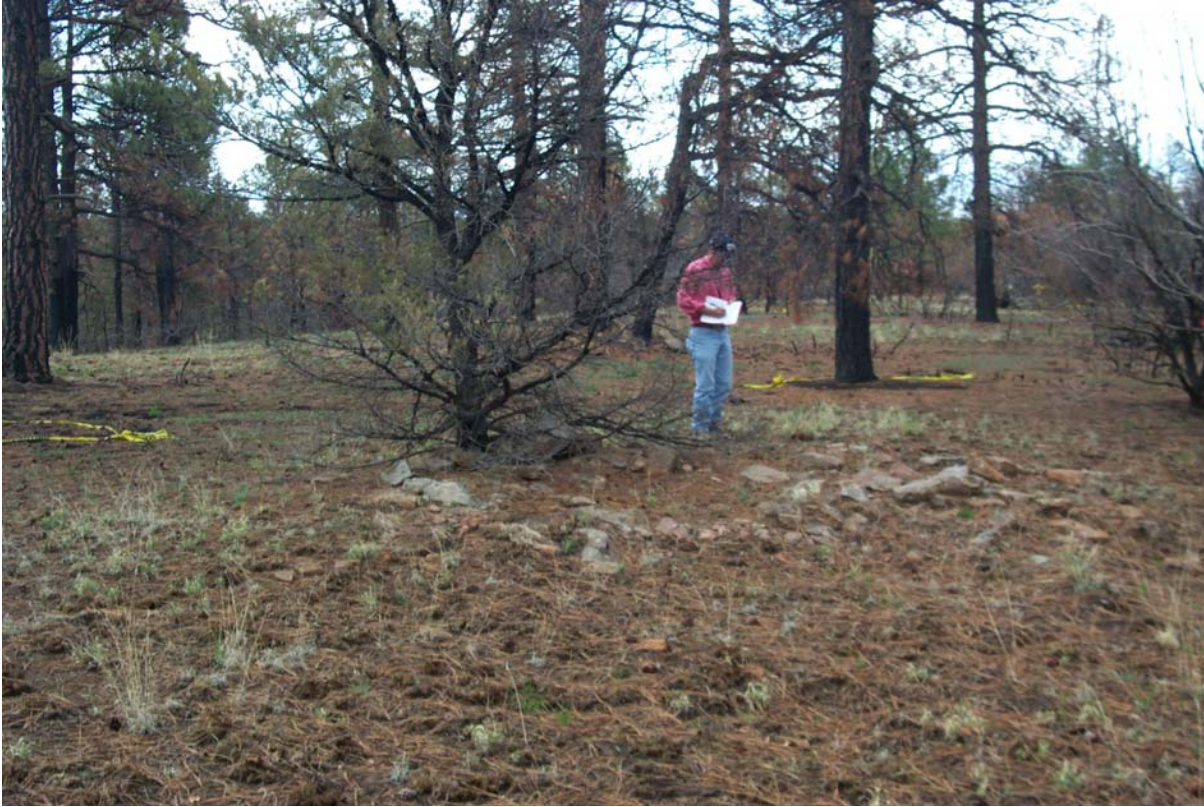
**LA 89791.** Before the Cerro Grande revisit, the site was most recently visited in 1993. In both instances, the site was identified as a one- to three-room structure that was constructed from masonry tuff blocks (Figure 8.8). Based on the presence of Biscuit B ceramics and the shape of the masonry blocks, the site was likely occupied during the Classic period. LA 89791 is located in a piñon-juniper woodland with some scrub oak in the area. The area around the site was severely burned during the Cerro Grande Fire. Effects of this burn are evidenced by cracking and spalling on approximately 10% of the masonry blocks, smoke or soot damage on 10% of the masonry blocks, 12 stump holes in the immediate vicinity of the one- to three-room structure, and a number of snags and partially burned trees in the vicinity of the site that have the potential to damage the masonry if they fall. Because of the impacts to the site from the fire, it is recommended that a single tree on the north side of the mound be cut down to prevent further destruction of the site. Despite heavy impacts from the fire, the site was not impacted by suppression or rehabilitation activities.

**Figure 8.8.** LA 89791, B. Vierra at the one- to three-room structure after the Cerro Grande Fire.

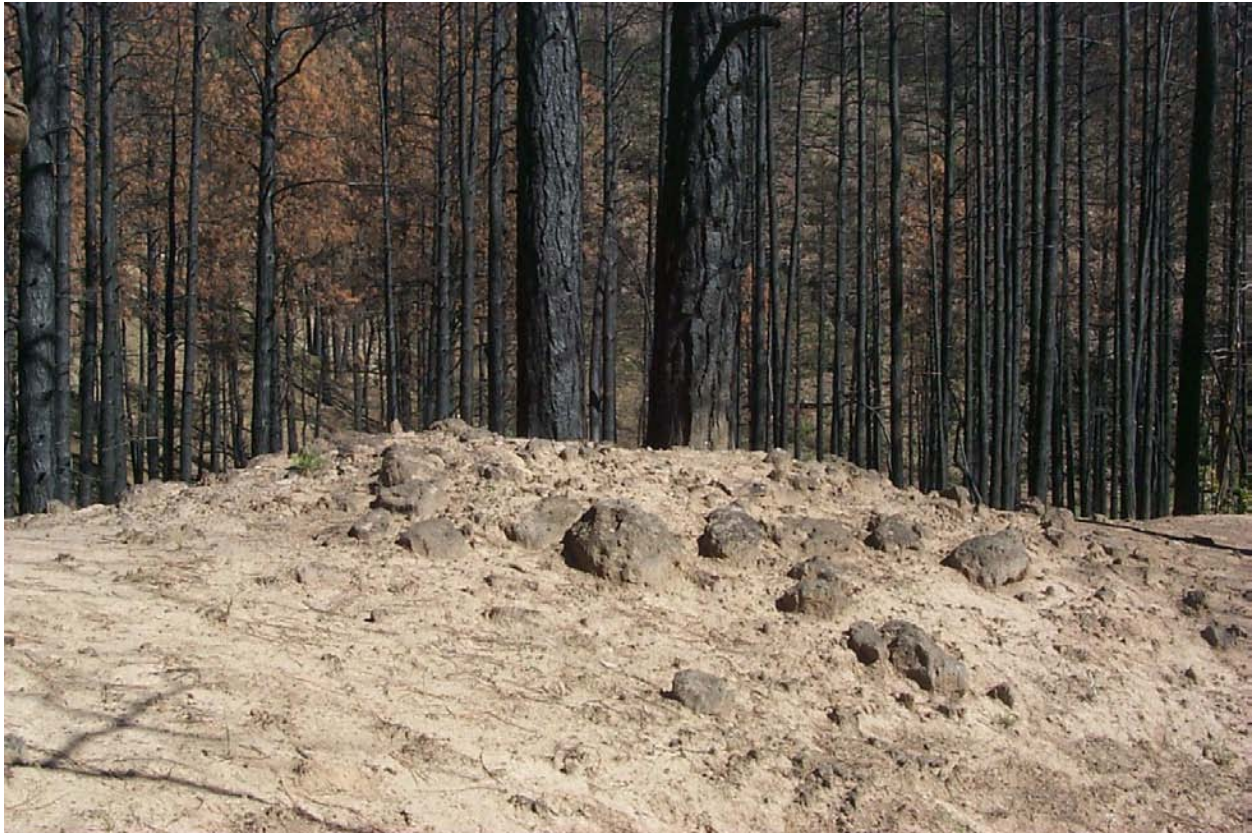
**LA 70025.** This site (Figure 10.2) was last visited in 1992 as part of a LANL Environmental Restoration Project (McGehee et al. 1993). The site consists of two one-room structures (3 m by 3 m and 2 m by 2 m) separated by 7 m. Both structures are composed of mostly unshaped tuff blocks. The site is located on the edge of a low ridge finger in western Cabra Canyon among ponderosa pine trees. Based on ceramics the site probably dates to the Late Coalition or Early Classic. The area around the site was severely burned. There are 40+ snags and partially burned trees in the area; two of these have the potential to damage the site should they fall. All of the masonry on the site is heavily soot damaged, although less than 5% is heat spalled. The duff has been burned off from around the site. As some of the tuff blocks have already started migrating downslope, the absence of duff serves to increase an already high erosional threat.

**Figure 10.2.** LA 70025, view of larger fieldhouse, facing north.

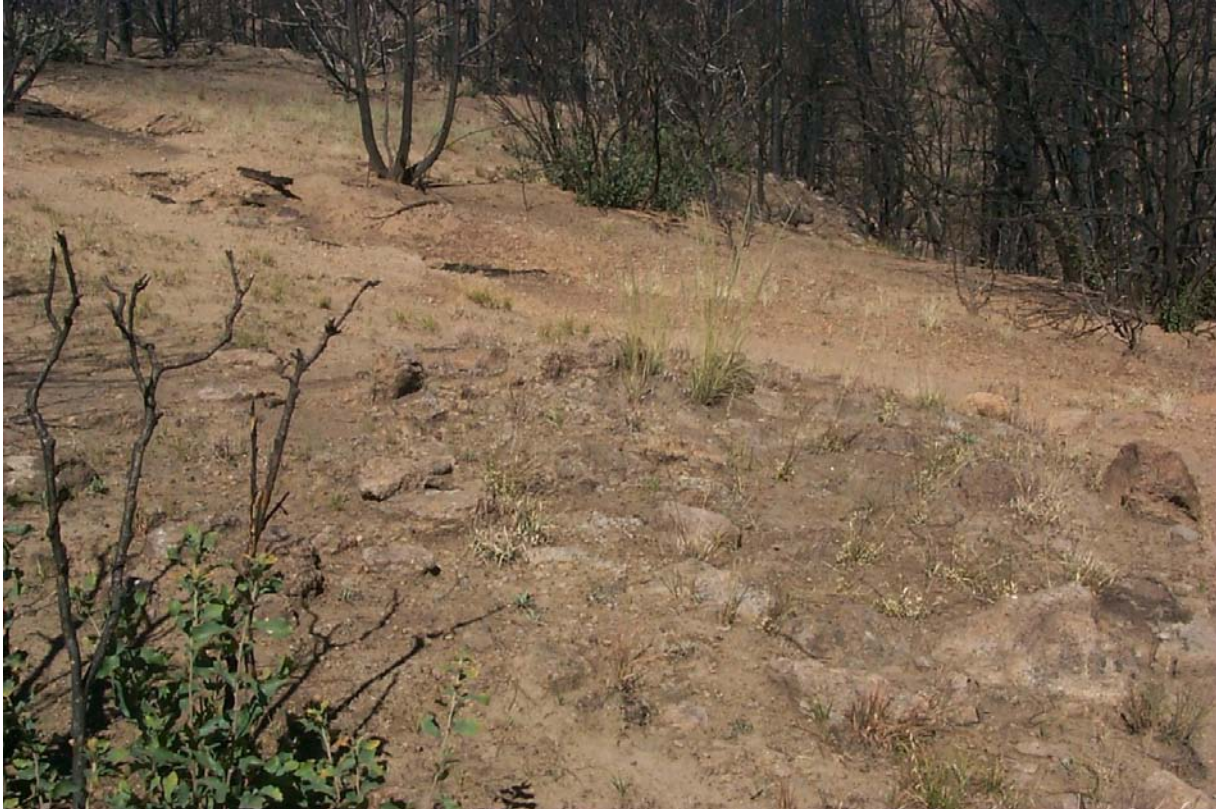
**LA 86607.** *This site (Figure 10.3) was last visited in 1992 as part of the Environmental Restoration Project. The site consists of the remains of a two- to four-room structure of tuff blocks. It is situated on top of the ridge forming the south side of Cabra Canyon. A narrow hiking trail runs through the site. Seven tuff blocks from the site were, at some time in the past (circa 5+ years ago), placed across the trail to help prevent erosion. Previous observations on the ceramics of the site indicate that it dates to the Coalition period. The area around the site was severely burned, although there is little vegetation in the immediate site vicinity. Twenty percent of the masonry was soot damaged. Due to the trail and absence of duff around the site, there is a low erosional threat.*

**Figure 10.3.** LA 86607, view of fieldhouse and modern trail, facing north.

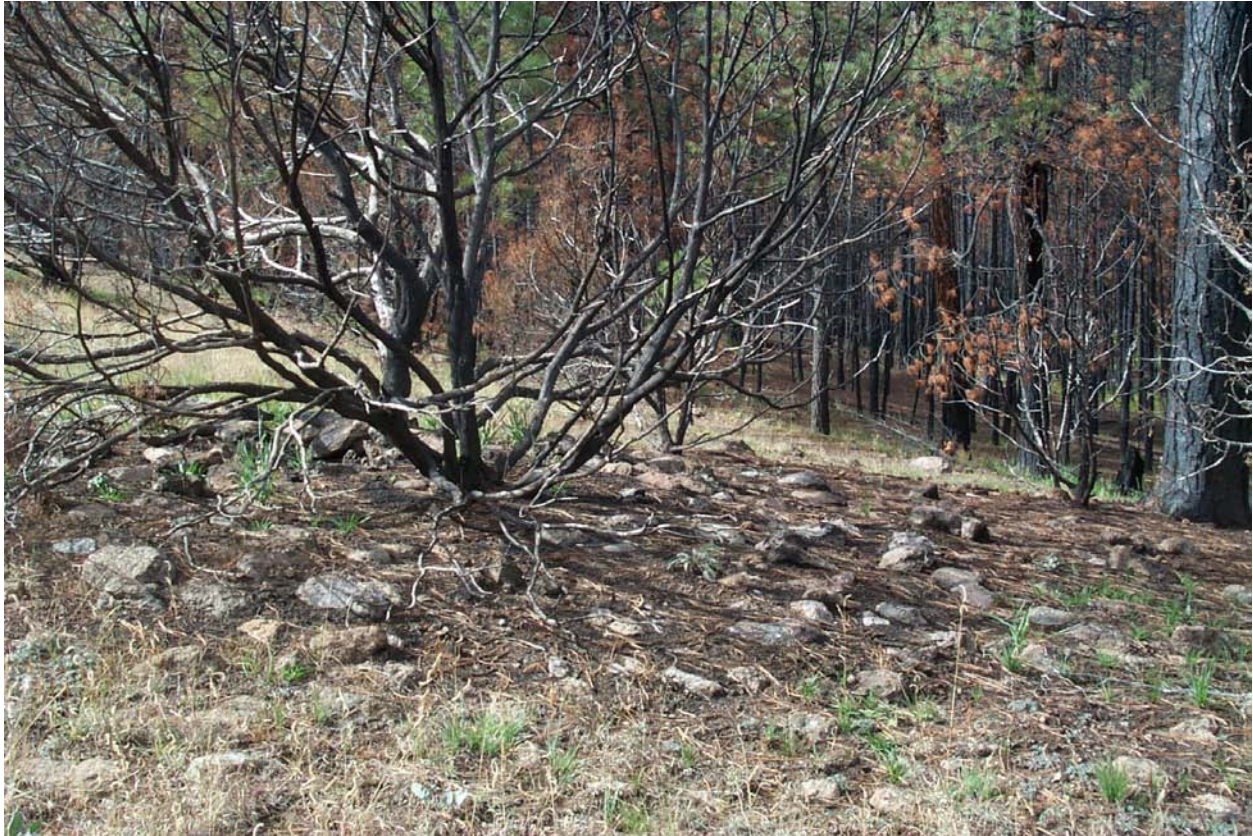
**LA 135291 (BCH-1).** This site (Figure 10.4) consists of a scatter (10 m by 10 m) of mostly unshaped tuff blocks. It is not clear if these blocks are the remains of a structure, a rock pile, or something else. The site is located just above the north-facing slope of the south bench of Rendija Canyon in a lightly forested area. Several unidentifiable sherds and one obsidian flake were found at the site. This site is probably Ancestral Puebloan. The area below the site—the bench slope and canyon bottom—suffered severe burning, and there are two junipers in the center of the tuff blocks that were burned by the fire; these

could damage the site if they fall. Otherwise, no burning occurred in the site area. Many of the masonry blocks are soot damaged.

**Figure 10.4. LA 135291, view of rock feature, facing east.**

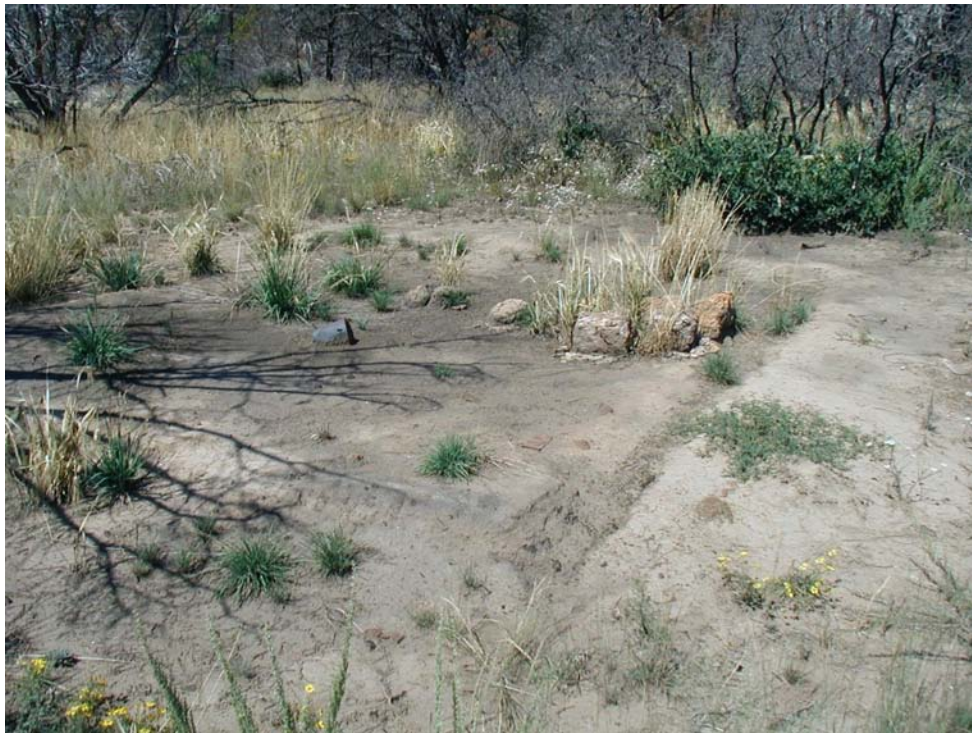
There are a number of additional Homestead period sites and features located within the burned area perimeter at LANL. These sites, discussed in greater detail in Chapter 12, include isolated trash scatters and animal pens, wagon road segments, drainage-control and water-retention features, and temporary shelters. Homestead Era wooden resources on nearby U.S. Forest Service land were also totally consumed by the fire. Forest Service losses include the Garcia cabins and the "Line Camp" cabin north of Rendija Canyon (Figures 11.3 and 11.4).

**Figure 11.4.** The “Line Camp” after the Cerro Grande Fire.

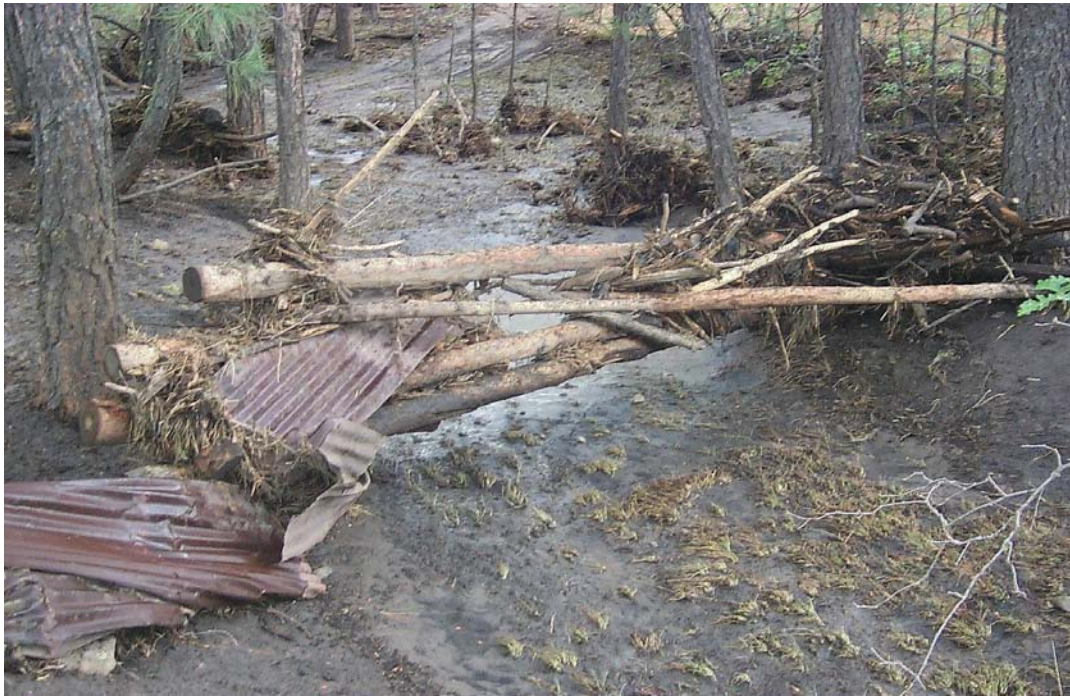
On June 28, 2000, an intense rainstorm caused significant flooding along West Jemez Road. This flooding event damaged State Route 501 in Water Canyon and destroyed the Anchor Ranch Ice House (Feature 1 of LA 16808) in TA-8. A nearby Homestead period wooden (LA 89826) appears to have been likewise destroyed by this flood (see Chapter 12). Due to the severity of this flood event (see Figures 11.5 and 11.6), which was triggered by the high severity burn on U.S. Forest Service lands upslope from TA-8, it was feared that this presaged one or more seasons of additional flood damage to facilities and cultural resources at LANL. This situation helped to spark the construction of flood retention structures in several canyons, and the placement of protective cement barriers around the historic Pond cabin (LA 21973) in Los Alamos Canyon. Fortunately, in the nearly 2.5 years since the destruction of the ice house and bridge, no other cultural resources have been impacted by fire-enhanced flooding.

**Figure 11.6.** The Ice House (post-flood and post-fire).

The site covers an area of nearly 19 ha (46 ac), and contains the remains of six structures and 24 associated discrete features. Due to the fortunate and prescient circumstance of tree thinning in and around the site in 1998, the year before the Cerro Grande Fire, the structures and features of the Anchor Ranch complex were not directly impacted by the fire itself. However, one structure, the remains of an ice storage house, was destroyed by flooding immediately after the fire (Masse 2000). Steen (1982:Fig. 8) photographed the ice storage house as it looked some twenty years ago prior to the Cerro Grande Fire. On 28 June 2000, an intense 20-minute rain cell in the burned forest upslope (to the west) and across State Route 501 from the Anchor Ranch complex, created a localized flashflood that overflowed the pond above the ice house and then demolished the ice house structure itself (see Figures 11.5 and 11.6; Masse 2000).

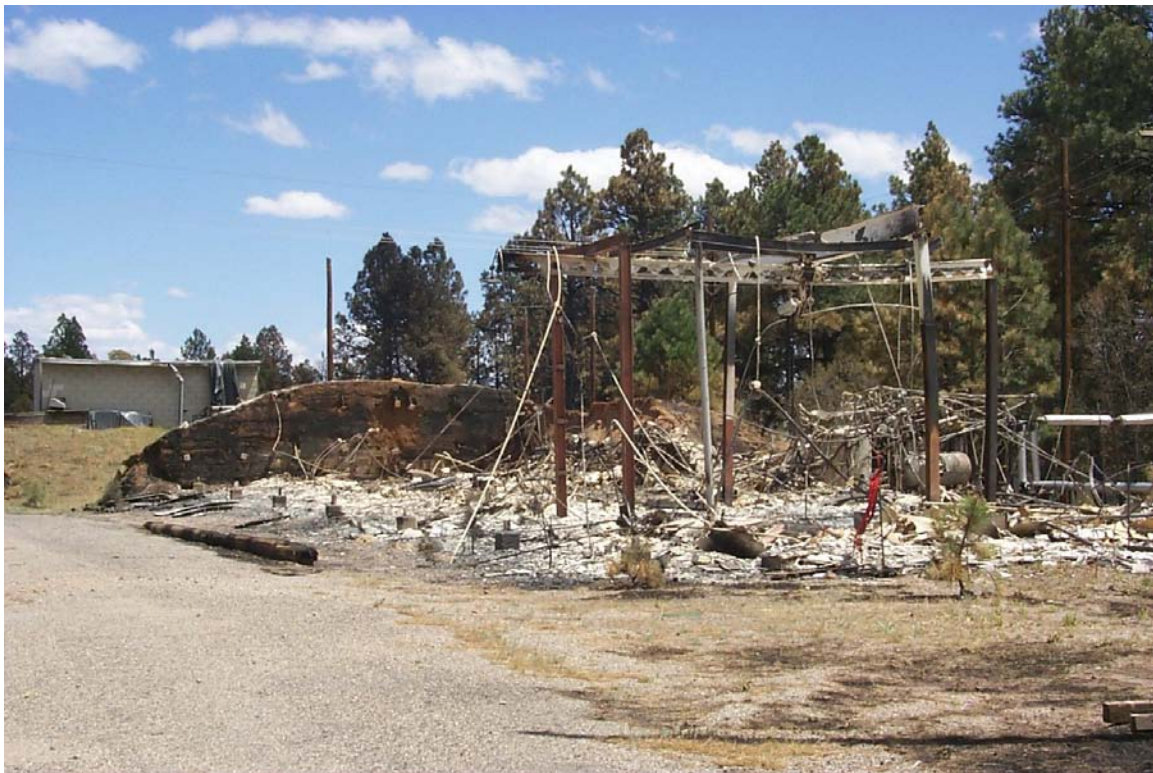
**V-Site.** TA-16-515 (originally V-1 and V-2) was built in 1944 and was completely destroyed by the fire (Figures 11.11 and 11.12). It was a wood-frame building with a low-pitched roof and a concrete foundation. There were asbestos shingles on the exterior of the building, and the south and east sides of the building were barricaded with an earthen berm. This building was a high explosives processing building (McGehee 1995).

**Figure 11.12.** TA-16-515 after the Cerro Grande Fire.

A decision was ultimately made to leave the ruins of TA-16-515 in a post-fire state (see Figure 11.12) and to rebuild the original courtyard area around TA-16-516, the intact assembly building. To date, the remains of TA-16-515 have been decontaminated of asbestos-containing material, and a large crane, associated earthen berms, and the foundation have been left in place.

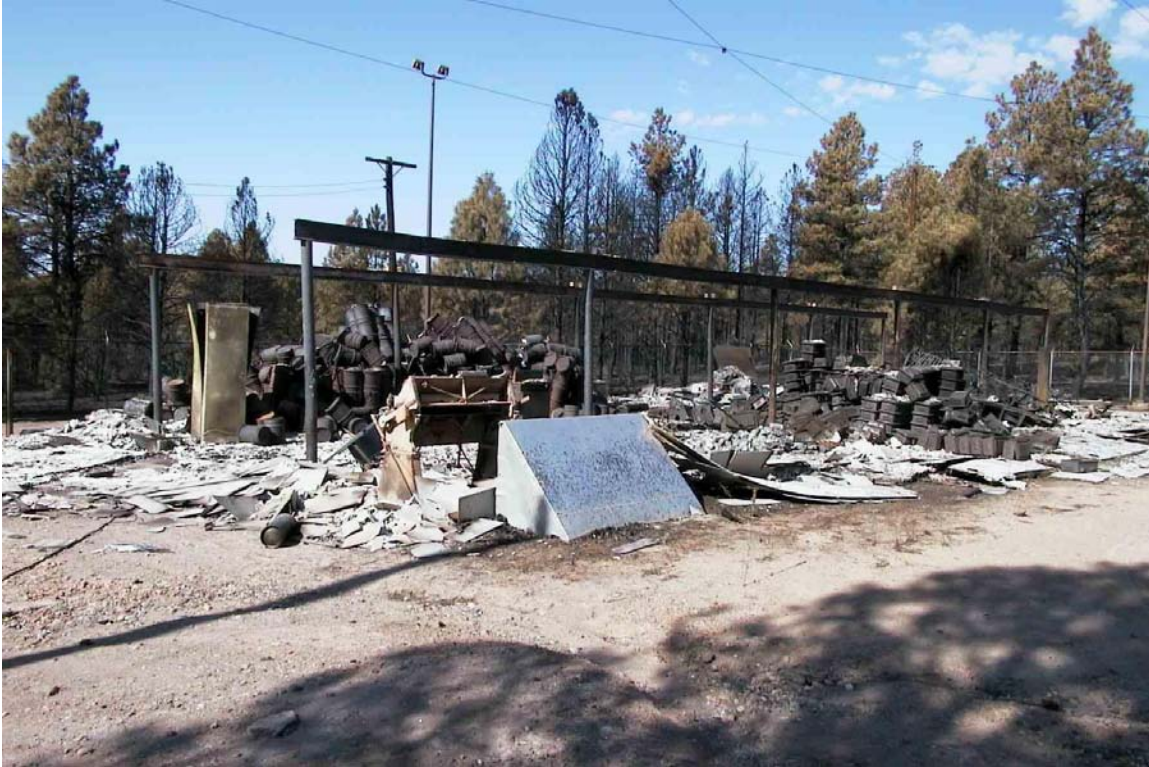
**TA-40.** TA-40-72 and TA-40-73 (originally TD-2 and TD-3) were completely destroyed in the fire (Figures 11.13 and 11.14). These two identical buildings were built in 1945 from the same plans and were used as general storage buildings. However, they were also identified as “magazines” on a 1955 Laboratory Structure Location Map and probably functioned at one time as explosives support buildings. They were wood frame with 2-in. by 4-in. studs and bracing set on reinforced concrete floors and appear to have had asbestos siding or shingles.

**Figure 11.13.** TA-40-72 after the Cerro Grande Fire.

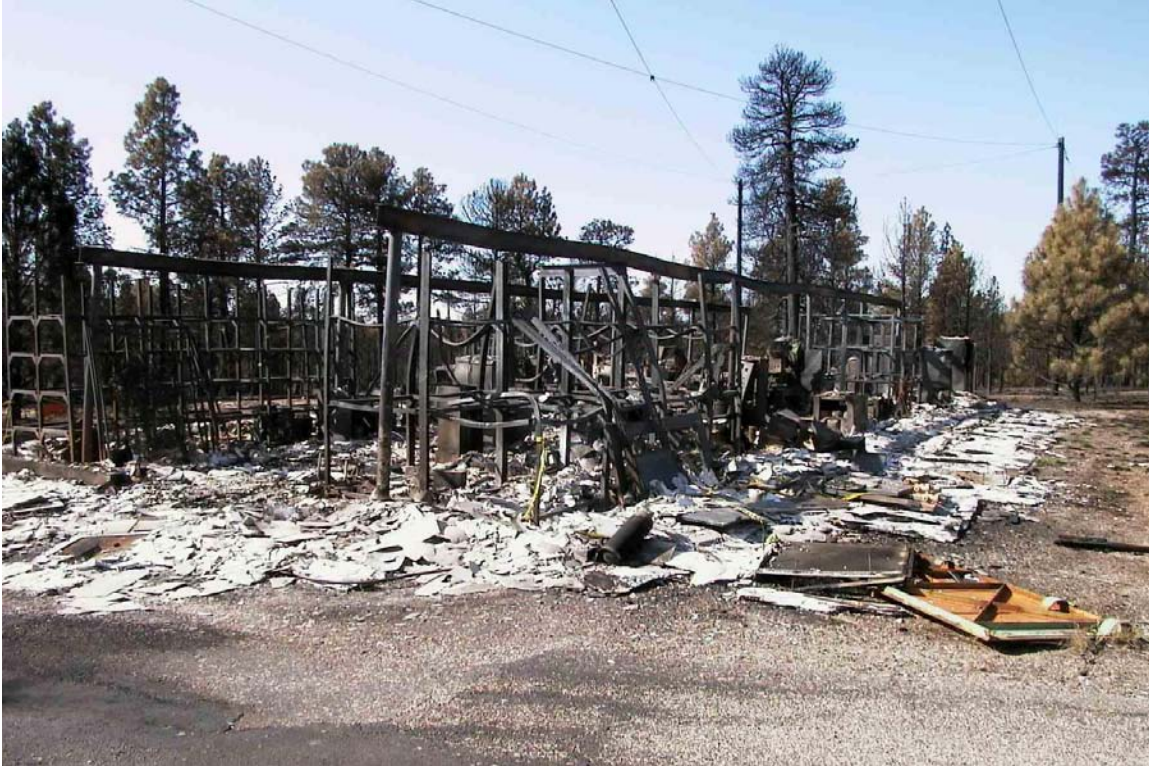
**Figure 11.14.** TA-40-73 after the Cerro Grande Fire.

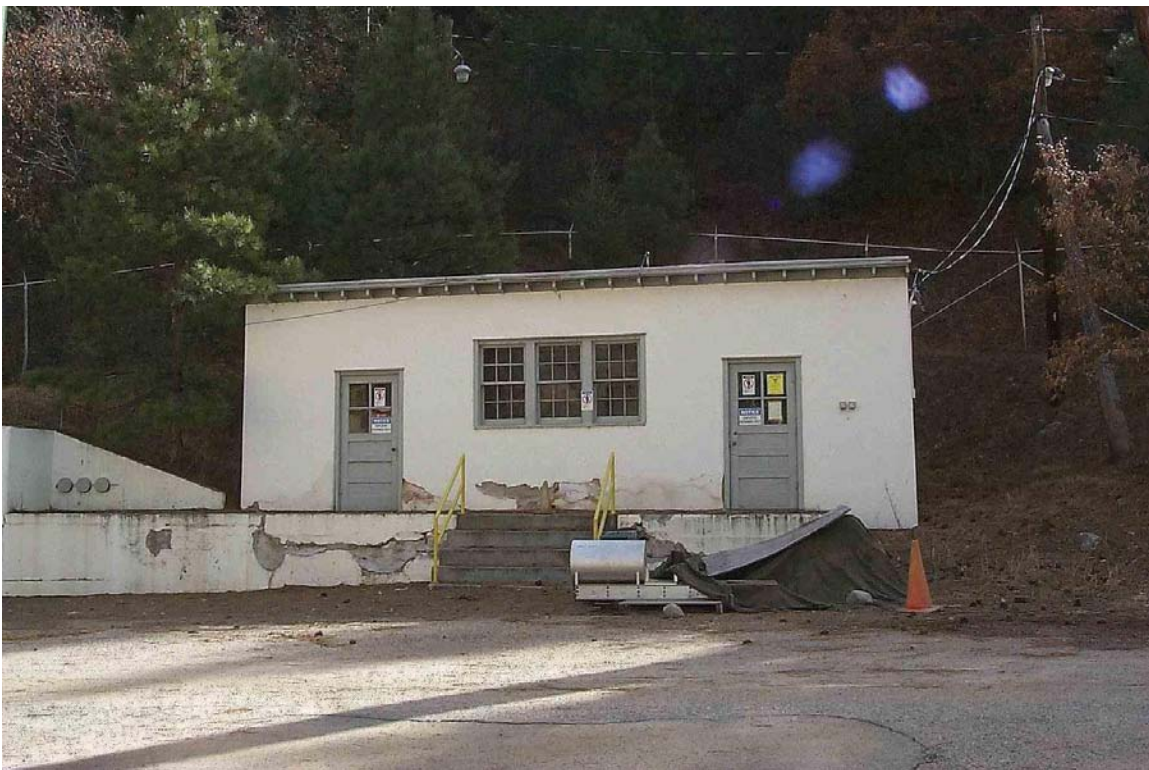
**TA-2.** The elevated risk of flooding in Los Alamos Canyon necessitated the emergency removal of TA-2-4, a small building at the historic Omega West Reactor facility (Figure 11.15). This building was built in 1947, and, although used primarily as a guard station, was once used to store radioactive material associated with the Omega West Research Reactor (McGehee 2000).

**Figure 11.15.** TA-2-4 in Los Alamos Canyon.

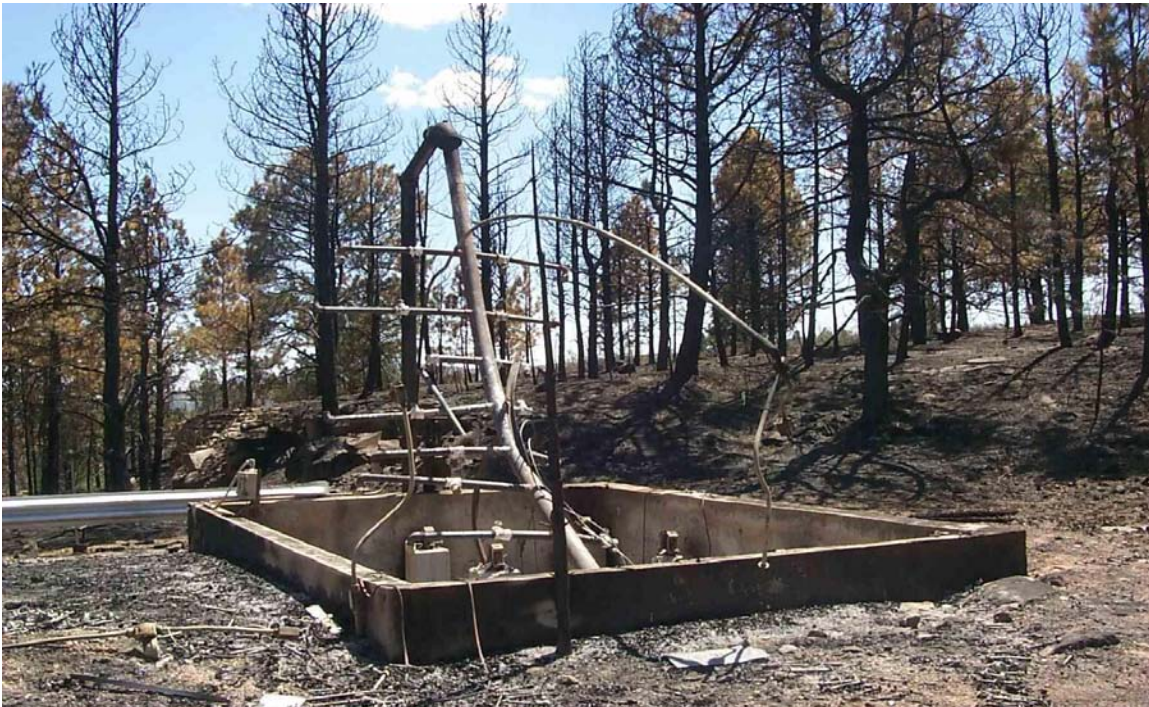
**TA-16.** TA-16-372 was a wooden cooling tower built in 1953 (McGehee 1995). It was located near TA-16-390 and was completely destroyed by the fire (Figures 11.16 and 11.17).

**Figure 11.17.** TA-16-372 after the Cerro Grande Fire.

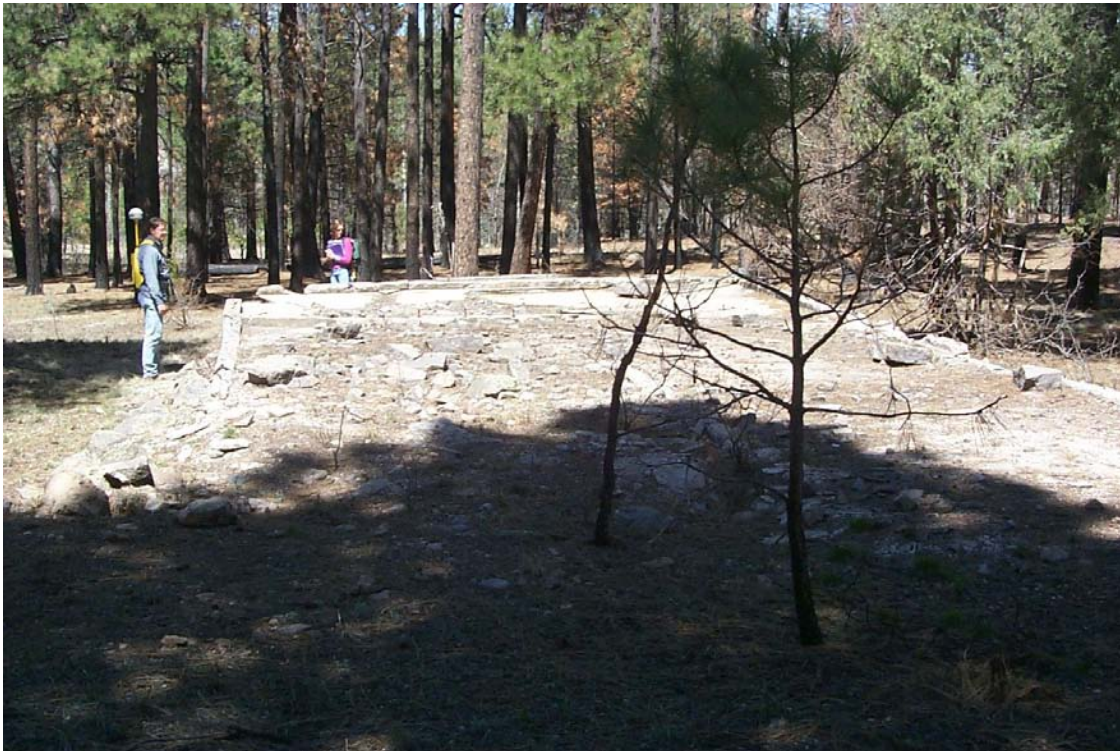
**Figure 12.1.** General view looking northwest of a historic foundation at LA 21369B with B. Harmon (left) and J. Nisengard.

seven structures, tuff blocks, and concrete. These features represent the remains of a pre-World War II Civilian Conservation Corps (CCC) construction camp associated with the building of State Route 4. Together these components measure approximately 100 m north-south by 20 m east-west. The site has been extensively bulldozed and is disturbed by two roads running north-south and parallel to one another. This site is fairly disturbed, a great deal of gravel litters the site and there are several large holes between the small mounds; the mounds consist of concrete and tuff blocks. Some bent metal is also present. A small concrete structure is associated with a can scatter to the north of the concentration of the structure mounds. The site burn severity is moderate. Stump and root holes exist adjacent to masonry and in the site, and additional snags are in the site area. No treatment is recommended for this site.
