**CERRO GRANDE  
FIRE ASSESSMENT PROJECT:  
An Assessment of the Impact of the  
Cerro Grande Fire on Cultural Resources at  
Los Alamos National Laboratory, New Mexico**

Cultural Resource Report No. 211

**Los Alamos National Laboratory**

**December 2002  
Survey No. 818**

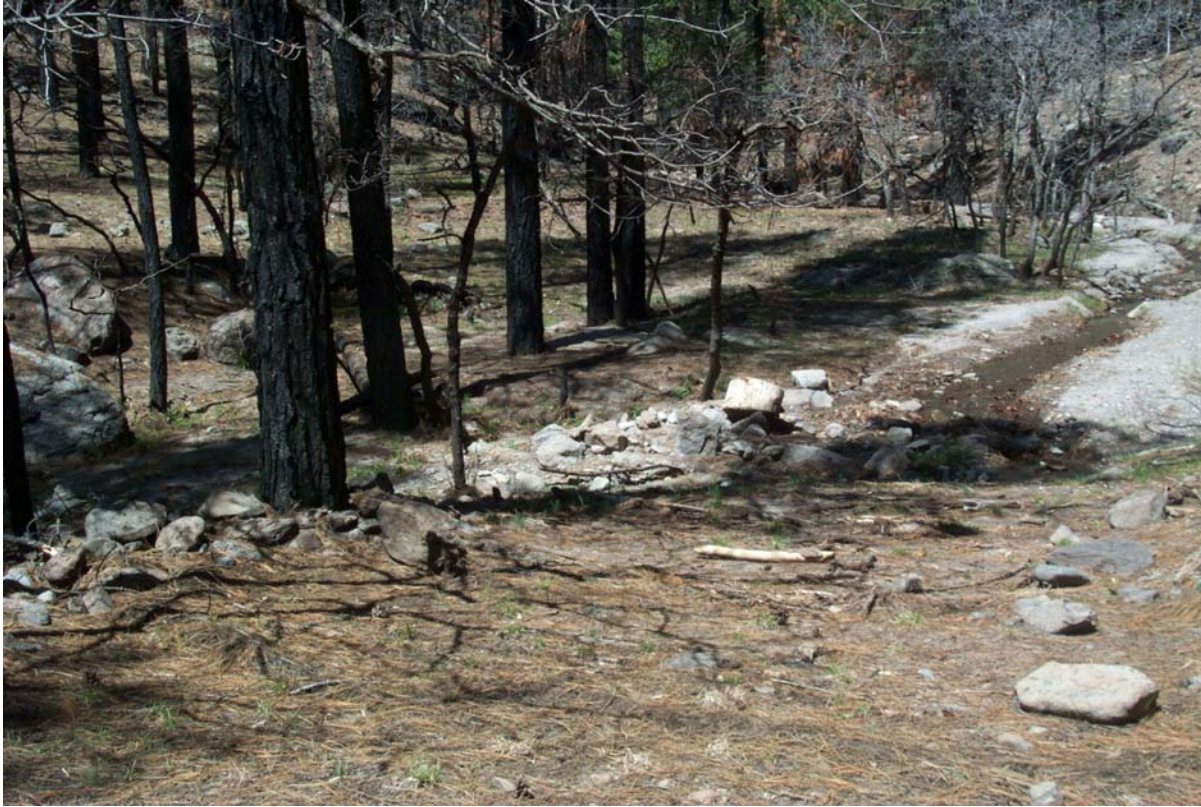
**Figure 12.2. LA 89826, a Homestead period structure after the Cerro Grande Fire.**

**LA 89826.** Before the Cerro Grande revisit, the site was most recently surveyed in 1993. In both visits, the site was identified as a Homestead period structure. The site consists of the collapsed portions of a wooden bridge over a segment of LA 89825 (Figure 12.2), a Homestead period wagon road. Nothing remains of the wooden structure as it appears to have washed away. There is a single piece of burned wood lodged between two rocks on the south side of the crossing. It is probable that this is the only piece of wood remaining. No artifacts were identified during either visit. LA 89826 was located in a mixed ponderosa pine forest and piñon-juniper woodland. The area around the site was minimally burned during the Cerro Grande Fire. In addition to the destruction of the wooden bridge, the fire also affected the site in the form of 10 partially burned trees in the immediate site vicinity. The site was not impacted by suppression or rehabilitation activities. Dendrochronological dating of bridge specimens proved unsuccessful, however one element could be matched with the Anchor Ranch Ice House (see Appendix I).

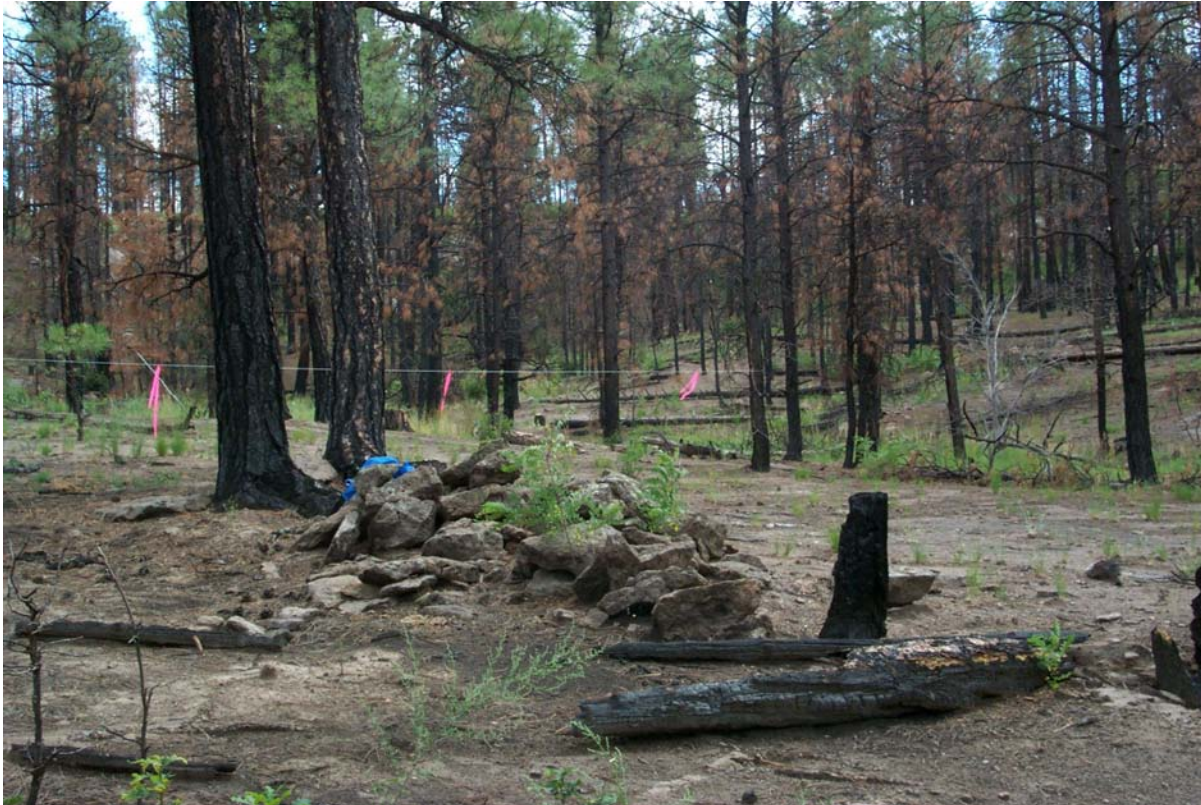
**Figure 12.3. LA 21298, a Historic period structure after the Cerro Grande Fire.**

**LA 21298.** Before the Cerro Grande revisit, the site was most recently surveyed in 1979. In both visits, the site was identified as a historic structure dating to the Homestead period. The site consists of a rock pile that may have been a windbreak or structure foundation and an associated can scatter (Figure 12.3). A wooden ramada was identified during the 1979 visit, but the ramada was seemingly destroyed during the fire since no traces of it were visible during the Cerro Grande revisit. LA 21298 is located in a mixed

ponderosa pine forest and piñon-juniper woodland, with a fairly high density of scrub oak in the area. The area around the site was severely burned as is evidenced by cracking, spalling, and soot damage on the masonry blocks; stump and root holes on the site itself as well as in the surrounding area; snags and

partially burned trees in both the immediate and general vicinity of the site; and the loss of architectural wood in the form of a ramada. The site was not impacted by suppression or rehabilitation activities, but because of the extensive damage, it is suggested that potentially threatening trees in the area be removed.

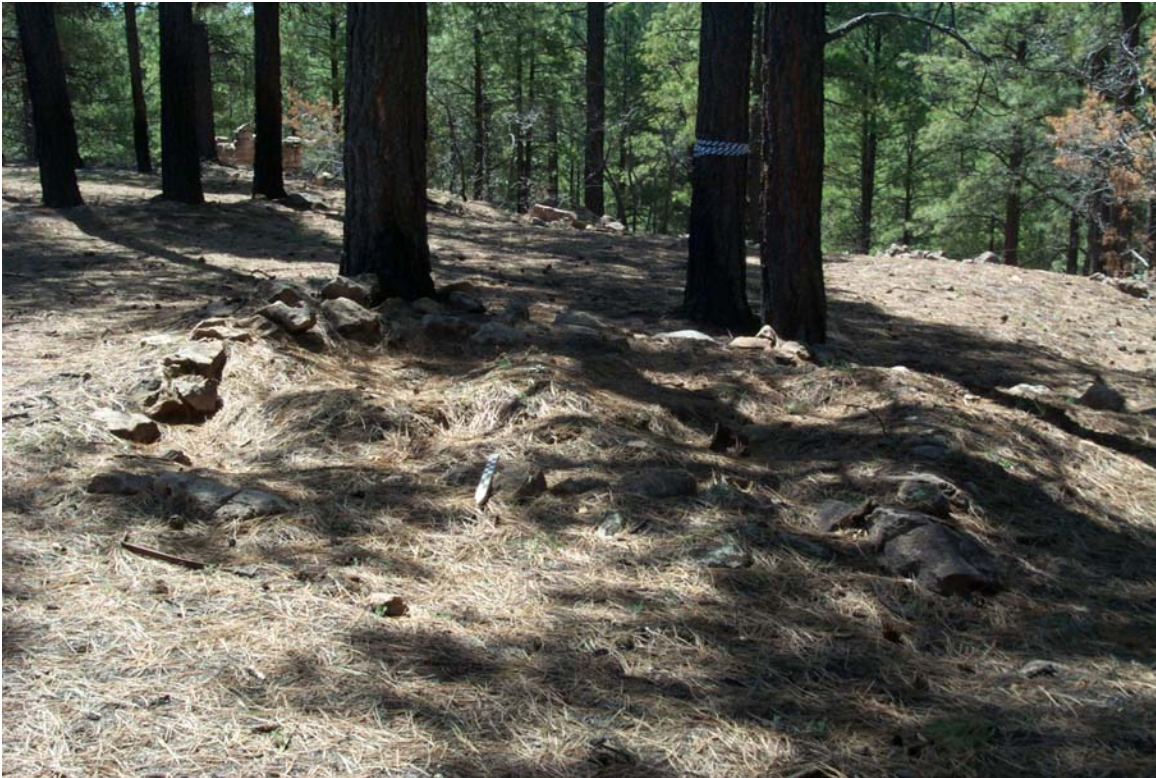
**LA 86643.** Before the Cerro Grande revisit, the site was most recently surveyed in 1991. The site is the remains of the Gomez Homestead. It contained the following features: a cabin foundation (Figure 12.4) and roof beams, corrugated roof material, a stone structure, a corral (Figure 12.5), a historic trash dump, an horno, and a fence line. The site is located in ponderosa pine forest, and the area was moderately impacted by the fire. Many of the features mentioned above were burned during the Cerro Grande Fire, although nothing was completely destroyed. The cabin foundation area was burned; only one wood roof beam remains. The corrugated roof material associated with the cabin is burned but intact (in four pieces).

**Figure 12.4.** LA 86643, the cabin foundation after the Cerro Grande Fire.

Several of the cabin foundation blocks have been discolored by smoke damage. The corral area is burned with trees being burned at the base. The northwest section of the masonry wall of the corral is most heavily burned. Remnants of a burned post are present in the north-central sections of the corral, and about 10 pieces of corrugated metal are also burned. The trash dump area was heavily burned, and while the artifacts suffered damage, they are all still intact. The area around the fence line was also burned, but there are still about 30 wooden fence posts present, five of which are still upright. The stone structure and the horno were not burned during the fire. In addition to these effects, evidence of the burn is also present in the form of approximately 20 partially burned trees in the site area that have the potential to further damage the structures. Architectural wood was also lost. Because of the heavy damage the site sustained, especially the corral, it is recommended that the burned trees in the corral be cut down to prevent further damage. The site was not impacted by suppression or rehabilitation activities. An attempt was made to

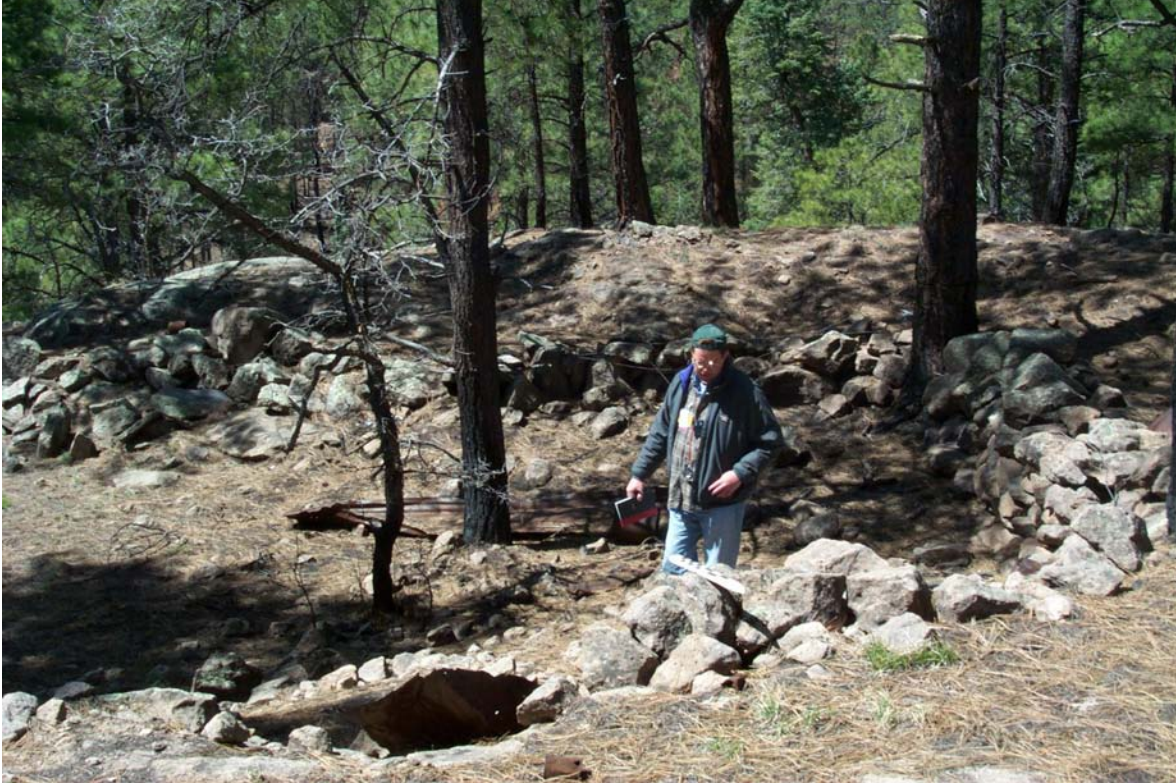
dendrochronologically date the Gomez homestead fenceline, however this proved unsuccessful due to the erratic nature of the ring series of the juniper posts (see Appendix I).

**Figure 12.5.** LA 86643, B. Harmon at the corral after the Cerro Grande Fire.

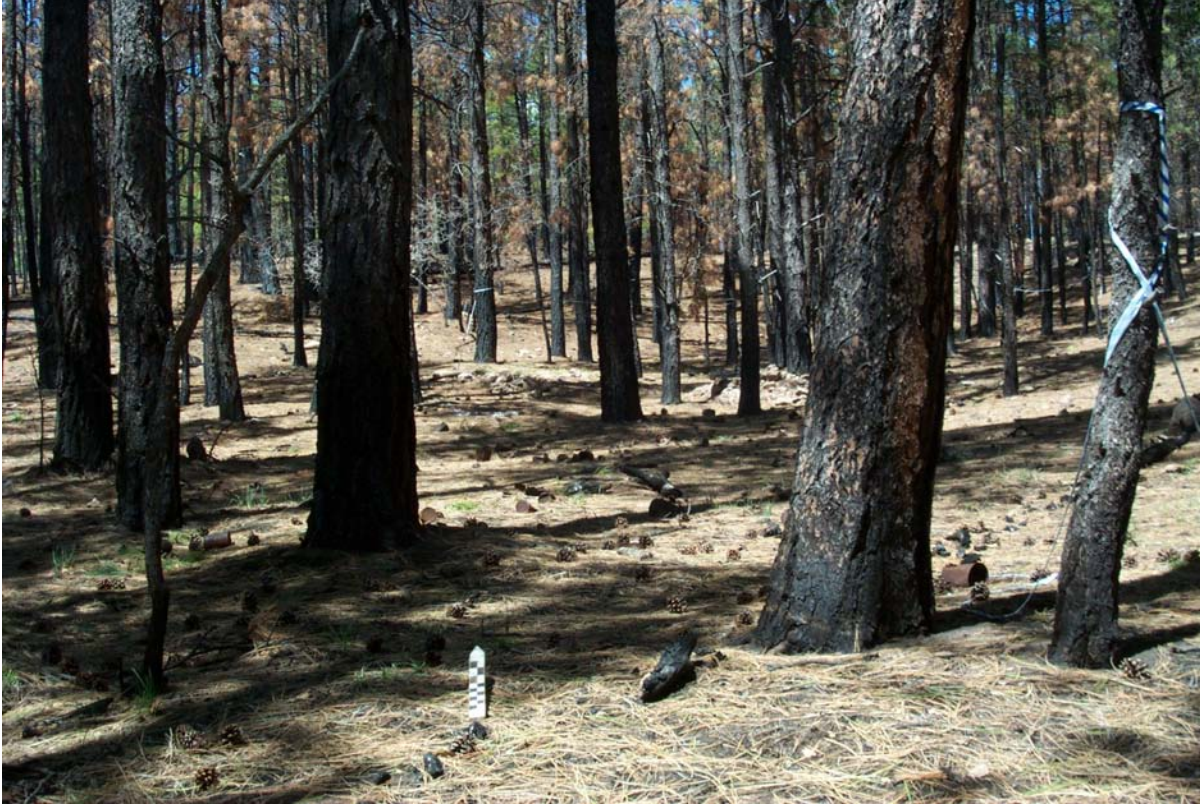
**LA 89769.** Before the Cerro Grande revisit, the site was most recently surveyed in 1992. In both visits, the site was identified as a Homestead period artifact scatter (Figure 12.6). Items at the site include approximately 120 metal cans, three glass shards, and three broken bottles. The cans were burned during the fire but remain intact. Heavy pine duff obscures the ground surface, and more trash could be present below the duff level. LA 89769 is located in a mixed ponderosa pine and piñon-juniper area. The area around the site was severely burned during the fire. The effects are evidenced by approximately five stump holes in the site area and over 30 partially burned trees. Because of the severe burn, most of the duff is gone. As a result, it is recommended that two wattles be placed upslope and downslope (one each) of the trash scatter. The site was not impacted by suppression or rehabilitation activities.

**Figure 12.6.** LA 89769, an artifact scatter after the Cerro Grande Fire.

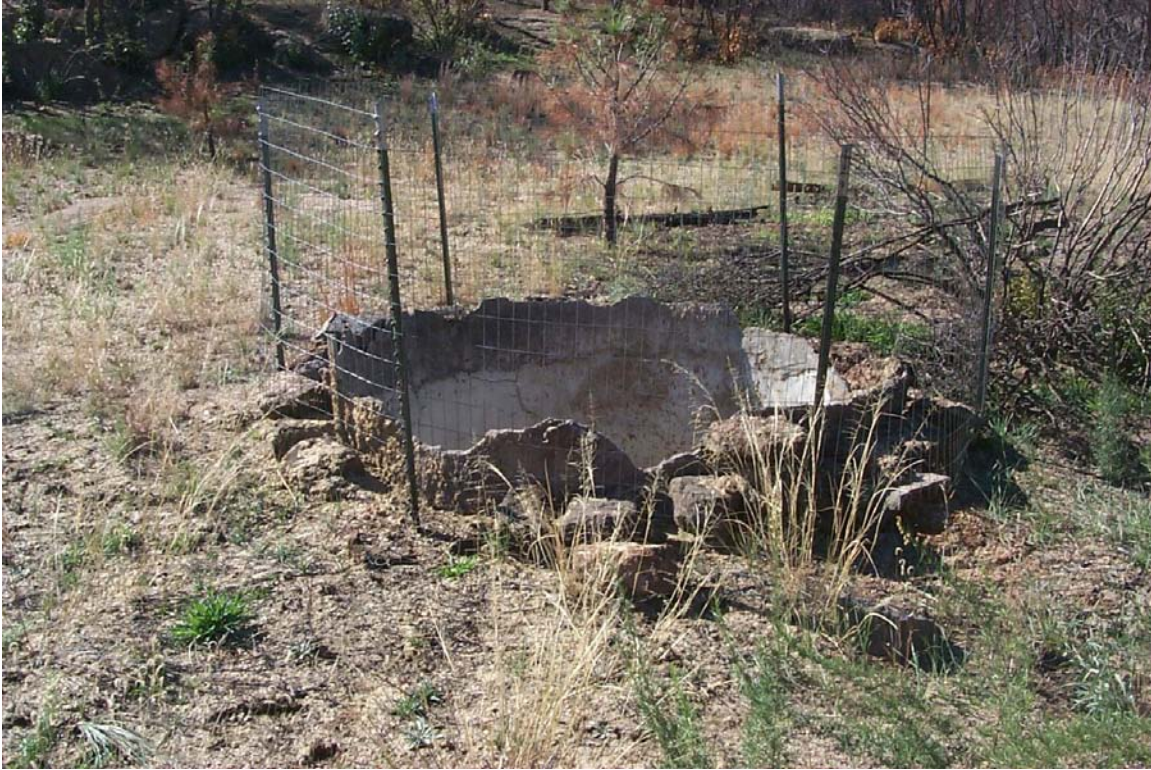
**LA 30638.** Before the Cerro Grande revisit, the site was most recently surveyed in 1998. During this inspection, the site was identified as part of the Fermin Vigil homestead, with a cement-lined cistern (Figure 12.7) and historic trash scatter present. During the Cerro Grande revisit, the site was identified as a historic cistern and associated trash scatter dating to the Homestead period. The site is located in the bottom of Mortandad Canyon and was severely impacted by the fire. The severity of the burn is evidenced by the destruction of wooden structures (fence posts) associated with the site, as well as by cracking, spalling, and soot damage on the cistern itself and the presence of numerous partially burned trees in the site area. The snags pose a potential threat to the cistern, especially if they fall and further damage the masonry structure. In addition to impacts from the fire itself, the site has also been impacted by several rehabilitation activities, including the felling of a single tree, the placement of mulch across the site, and a fence around the cistern. The site was not impacted by suppression activities.

**Figure 12.7. LA 30638, a cistern with associated masonry.**

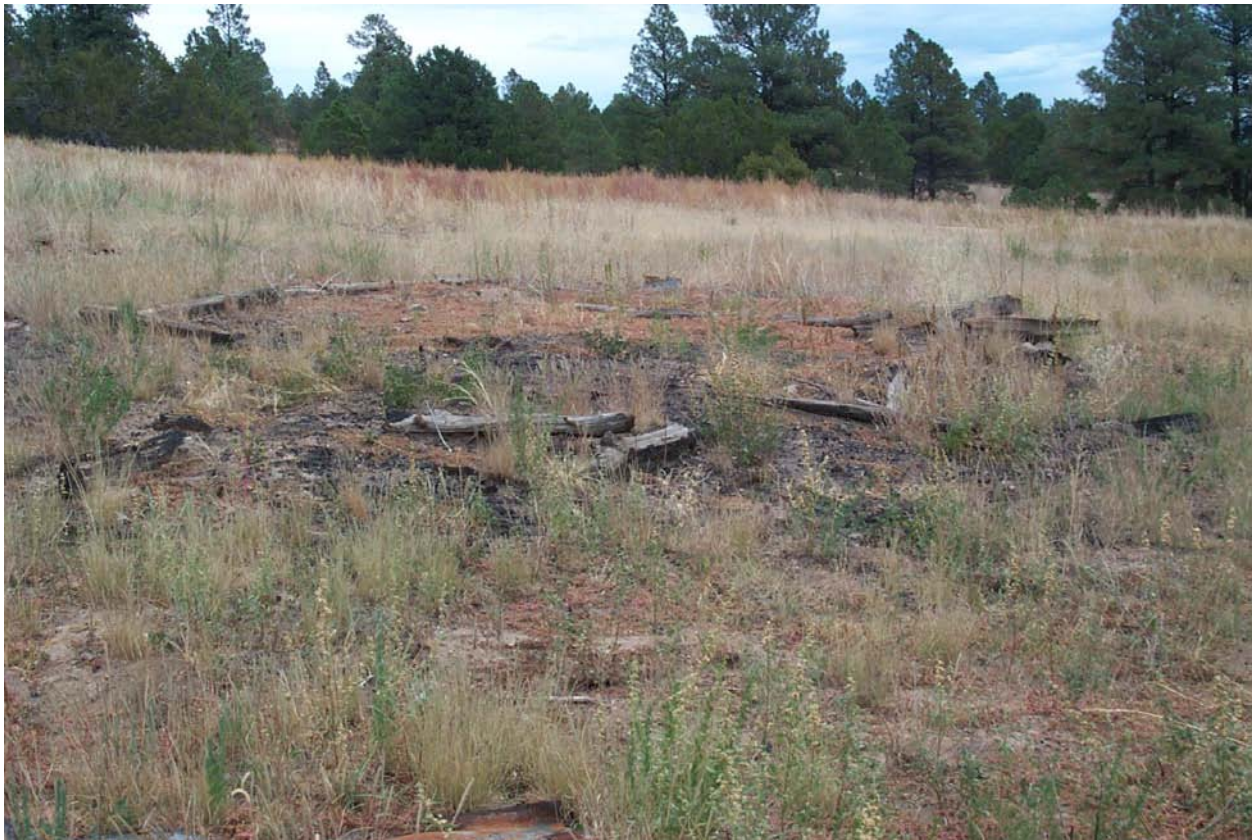
**LA 85407.** This site (Figure 12.8) was last visited in 1992 as part of the Bason Land Exchange. The site is part of the historic Serna homestead consisting of the remains of a log cabin, a second possible log structure of unknown use, a corral, a fence line, a trash scatter, and two rock features (possible hornos). While the site itself measures 100 m by 90 m, the entire homestead tract covered a little over 60 ac. Artifacts in the trash scatter and on other parts of the site include lard, sardine, coffee, kerosene, and condensed milk cans, galvanized metal, and purple glass fragments. The homestead was inhabited by the family of Fidel Serna, and later the family of José María Serna, from the early 1900s to 1942 or 1943 (Peterson and Nightengale 1993:50–57). There is also a very light scatter of prehistoric artifacts on the site consisting of several obsidian flakes, one Biscuit B sherd, and two Kapo Black sherds. The site is located on a small bench to the north of the canyon. Vegetation consists mostly of short grasses and small stands of piñon and juniper. The area in general is moderately burned, although most of the wood from the cabin, the possible structure, and corral was destroyed. The fence posts also suffered some damage although many of them are still present. Attempted dendrochronological dating of four log specimens from the site proved unsuccessful (see Appendix I).

**Figure 12.8.** LA 85407, view of cabin remains, facing northeast.

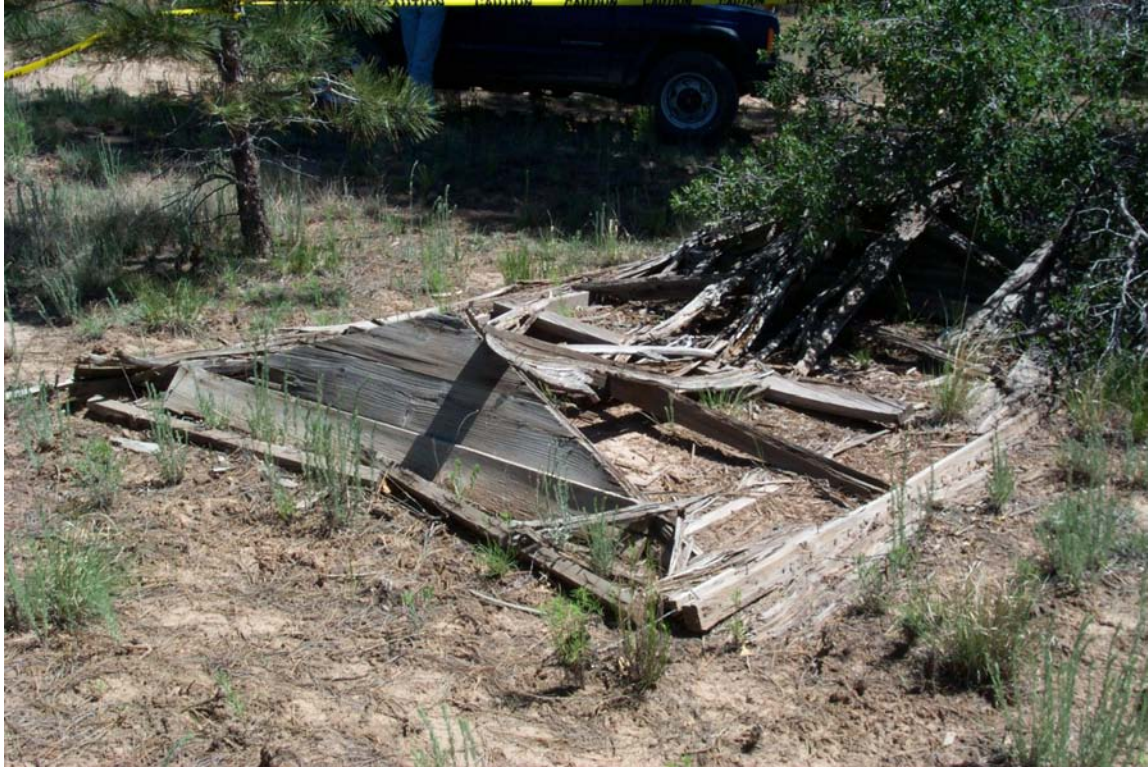
**LA 131234.** Before the Cerro Grande revisit, the site was most recently surveyed in March 2000 (Masse et al 2001). In this visit, as well as the Cerro Grande Fire revisit, the site was identified as consisting of three historic storage structures dating to the Manhattan Project period. These structures are identified as “bomb huts”—that is, wooden storage structures that contained casings and other such components of nuclear weapons prior to their assembly. These three storage units are referred to as Structures A, B, and C. Structures A and B were completely burned during the Cerro Grande Fire, and only small, isolated portions remain. Structure C escaped direct fire effects and appears to be mostly undisturbed (Figure 12.9). The structures are located in the ponderosa pine forest, and there is some scrub oak in the area. The area around the site was moderately burned during the fire, and a significant amount of architectural wood was lost, specifically that associated with Structures A and B (Figure 12.10). Despite significant losses from the fire itself, the site was not impacted by suppression or rehabilitation activities.

**Figure 12.9. LA 131234, Structure C after the Cerro Grande Fire.**

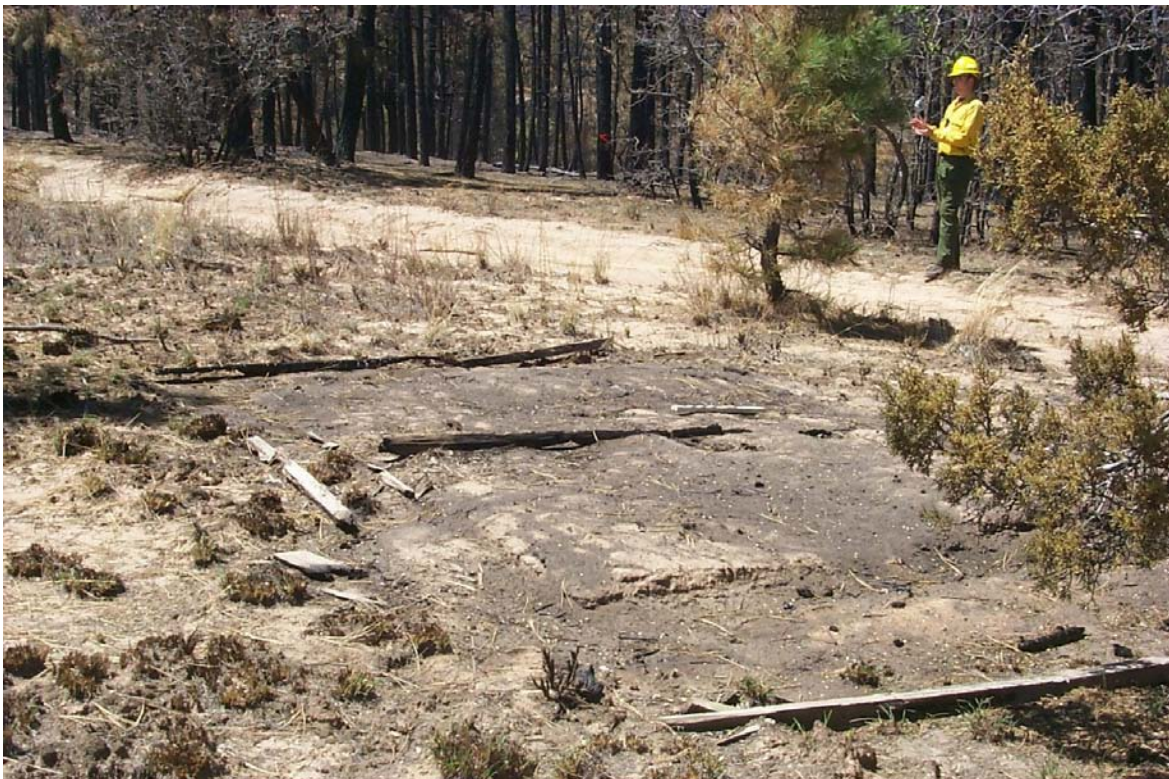
**Figure 12.10. LA 131234, A. Madsen at Structure B after the Cerro Grande Fire.**

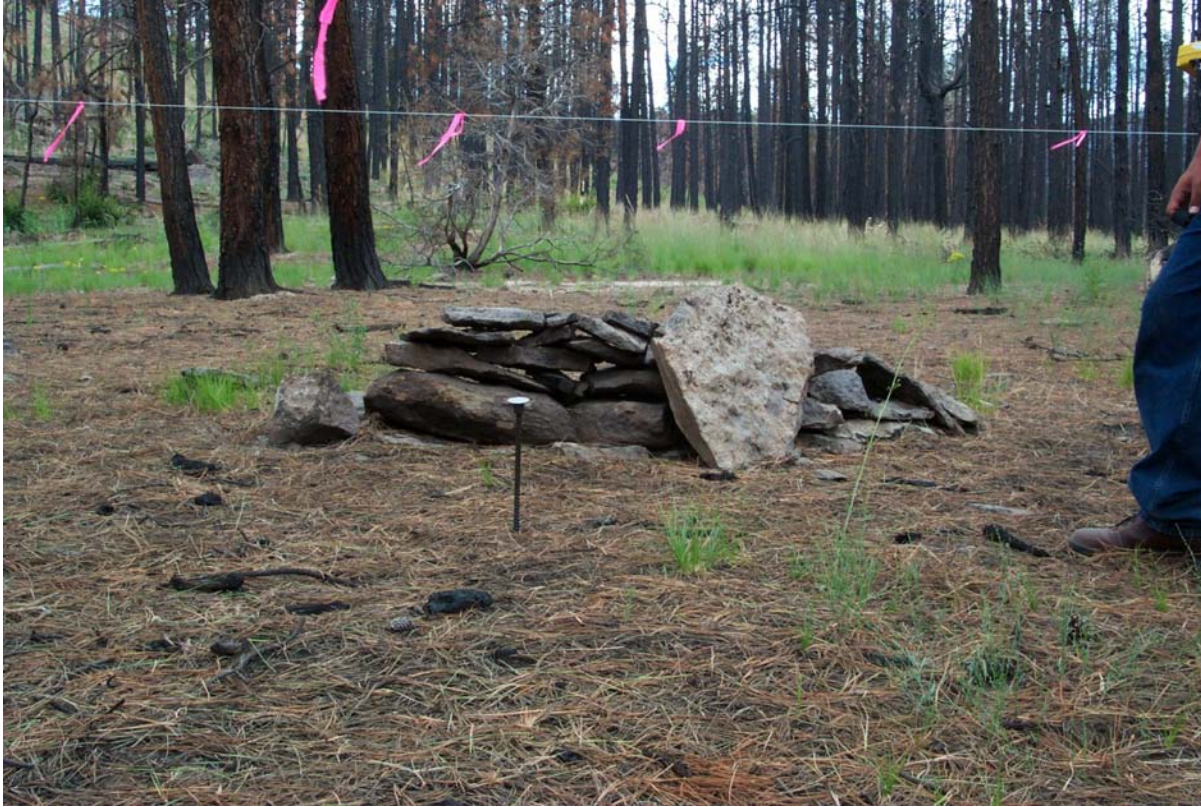
**LA 89838.** Before the Cerro Grande revisit, the site was most recently surveyed in 1996. In both visits, the site was identified as a Historic period rock feature consisting of a small, somewhat curved alignment of flat, tabular, rhyolitic slabs piled four courses high (Figure 12.11). The alignment appears to represent some sort of hunting blind or windbreak. Based on the presence of axe cut timbers, the site was assigned to the Historic period. The site is located in a mixed ponderosa pine and piñon-juniper woodland area. The area around LA 89838 was severely burned during the Cerro Grande Fire as is evidenced by cracking, spalling, and soot staining on a large percentage of the masonry blocks; stump and root holes both on the site itself and in the immediate area around the site; the loss of architectural wood that was referenced in the 1996 visit; and partially burned trees both on the site itself and in the general site area. Despite the severe burn, however, the site was not impacted by suppression or rehabilitation activities.

**Figure 12.11.** LA 89838, a Historic period rock feature after the Cerro Grande Fire.
