Title **Final Progress Report on Los Alamos National Laboratory
Cerro Grande Fire Rehabilitation Activities**

Prepared by **Kevin J. Buckley and Jeffrey C. Walterscheid,
Water Quality and Hydrology Group
Samuel R. Loftin, Ecology Group
Gregory A. Kuyumjian, USDA Forest Service**

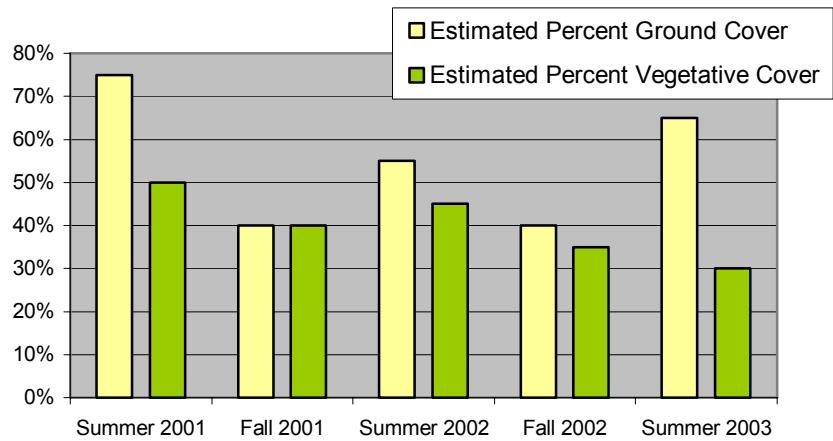
Changes in Vegetation Over Three Years on BART Unit 2, LANL TA-06

The following pages illustrate some of the post-fire changes in vegetation on BART units over the past three years. BART units 1, 2, 22, and 33 were chosen as a representative sample of the rehab units. Changes in vegetation are apparent in the photos. Units 1, 22, and 33 were located in areas that the CGRP thinned for fire protection. The figures on each page show results of BART vegetation and total cover sampling. There are no cover data for the summer 2000 photos. Because most BART units are in high-burn severity, it is assumed that vegetative and ground cover were near zero in 2000.
