# Historic Preservation Assessment and Recommendation Report for the Gun Site Restoration Project

# **Historic Preservation Assessment and Recommendation Report for the Gun Site Restoration Project**

August 7, 2008

Historic Building Report No. 281

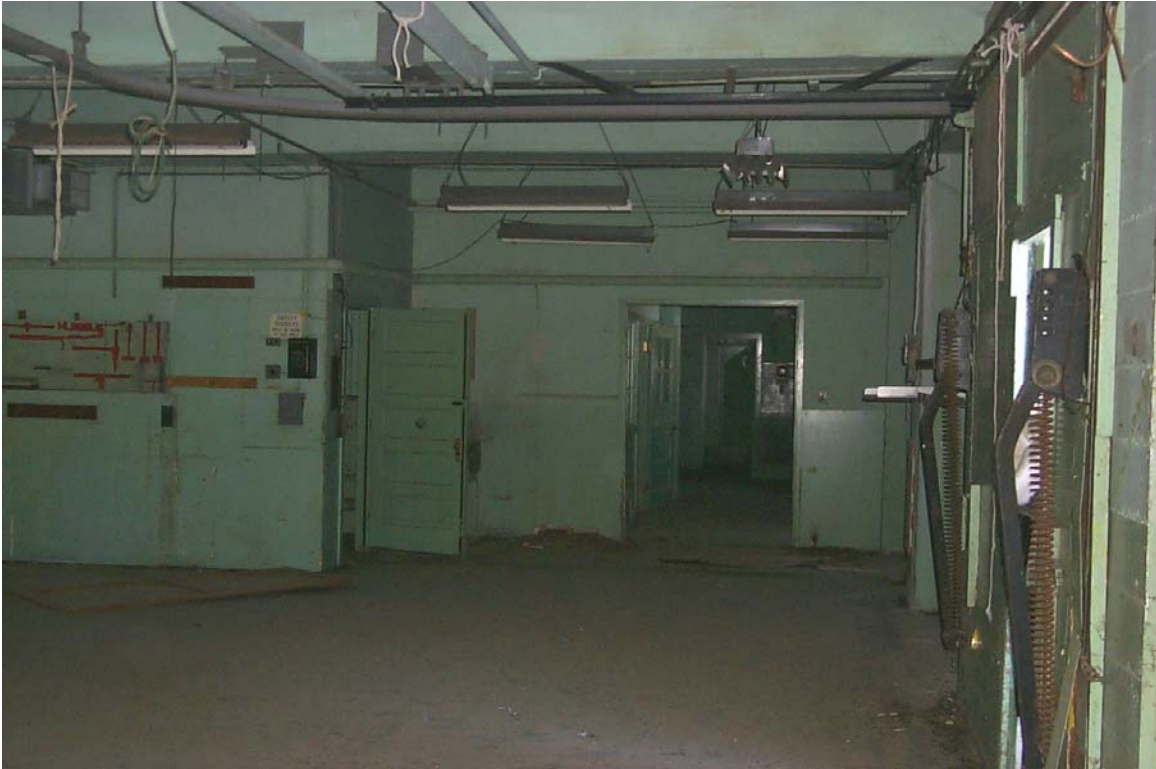
Figure 5a. Interior TA-8-1, current Room 5 looking west towards current Room 3

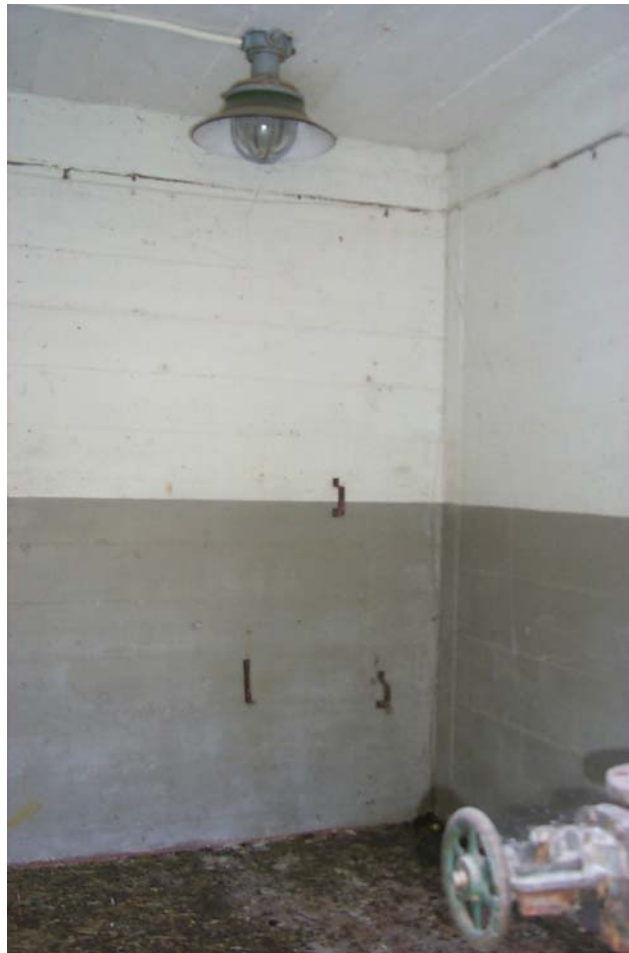
- Room 1 and Room 2 both contain deluge sprinkler hydrants as well as a few vents and indications of previously installed electrical equipment. Lighting fixtures are also intact in both rooms.

Figure 6a. Interior TA-8-2

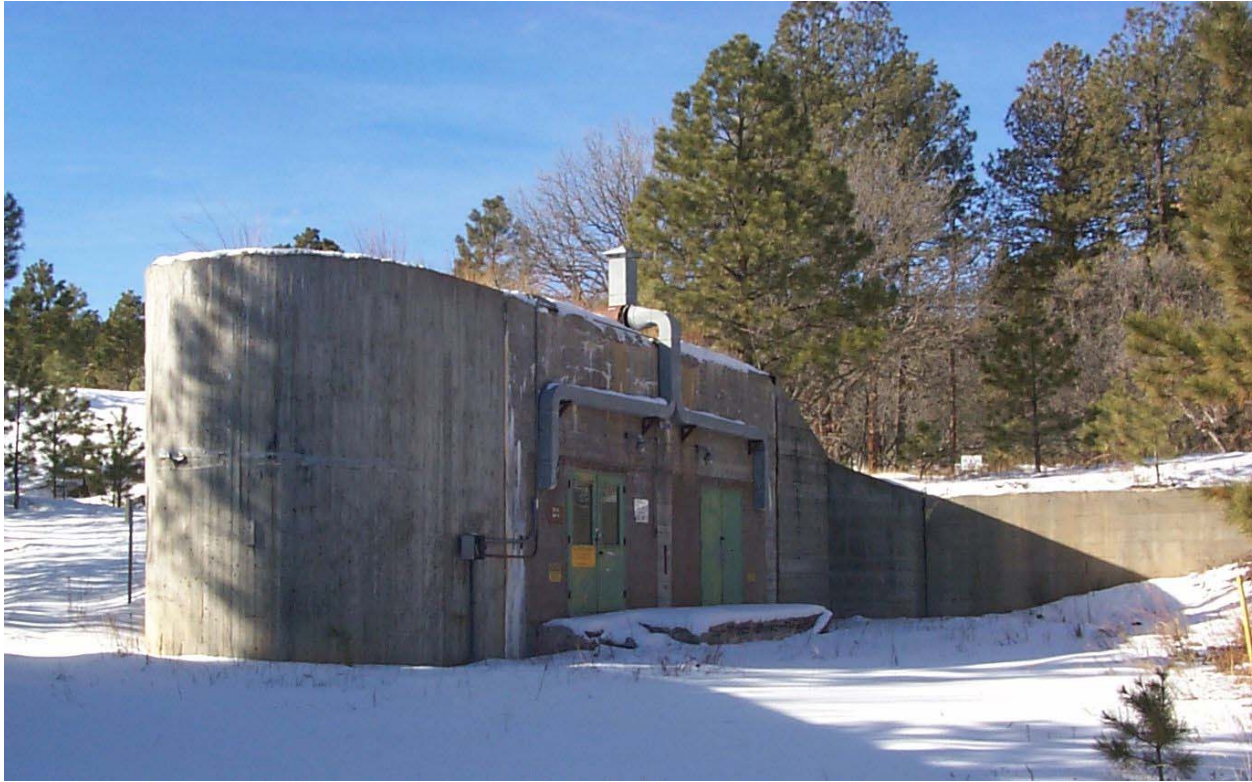
Figure 6b. Exterior TA-8-2

The drawings specify that the double doors on each room were originally built-up diagonal plank (similar to original doors found at V-Site buildings TA-16-516 and TA-16-517). The current doors in Building 2 are steel slab. Another significant alteration appears to be the framed walls. These were originally specified as “triple sealed gypsum,” as match the construction at V-Site. These walls have been removed and are currently replaced with CMU block. Two shed additions were constructed on the east, rounded face of the building sometime between 1947 and 1949. In 1949, an addition enclosed the concrete pad that separated the two small equipment and storage sheds. These sheds were removed at some unknown date.

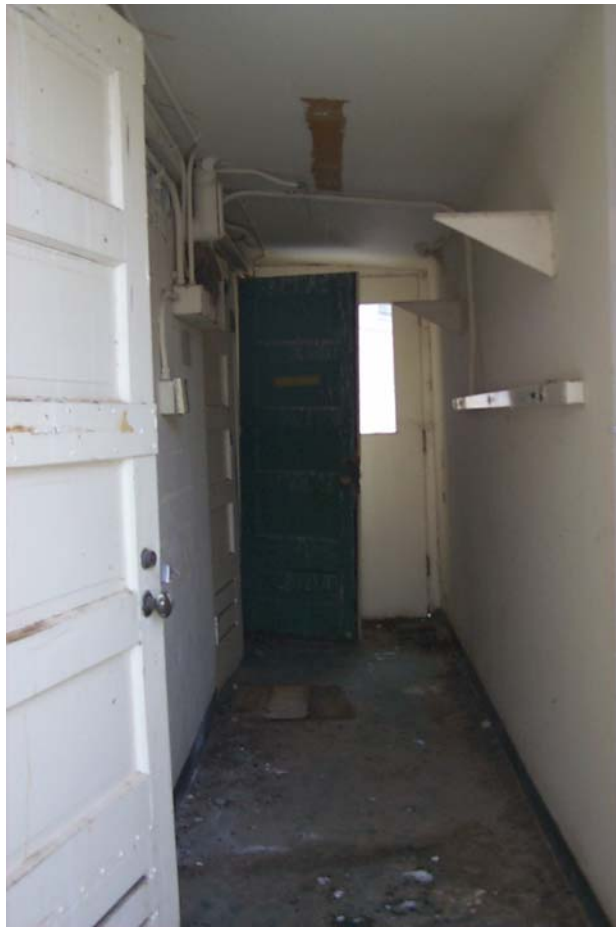
Figure 7a. Interior TA-8-3, enclosed dock

Further alterations to the exterior occurred in 1966 with the addition of a “dock enclosure” that currently exists (ENG-C 34041 April 6, 1966). These additions are considered non-contributing and are recommended for removal.

**Additions:** As recommended on Building 1, all non-historic additions addressed earlier should be removed. These include the barricade, the dock enclosure, the existing platform with the exception of the foundation, and the wooden steps leading up to the east (Figure 10).

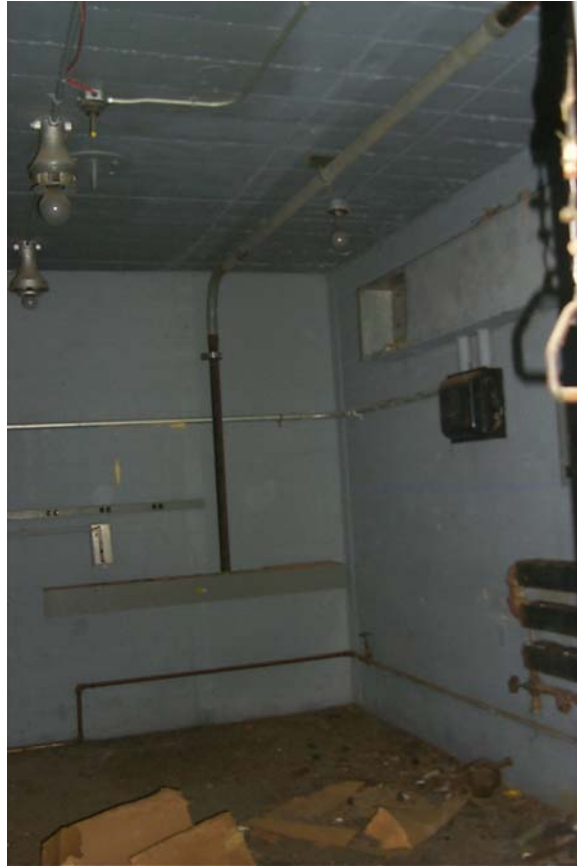
The interior of Building 3 is not accessible because of health safety concerns, so condition and as-built status have not been assessed.

Figure 7b. Interior TA-8-3

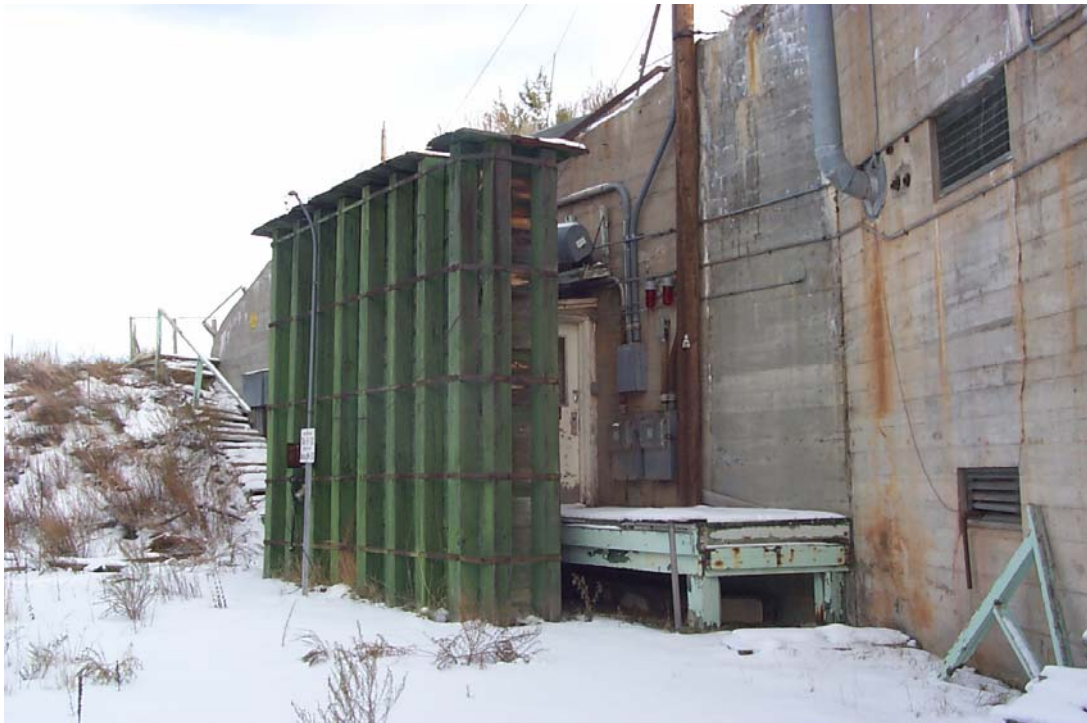
Figure 7c. Exterior TA-8-3
