2012 Update to the Site Discharge Pollution Prevention Plan, Revision 1

Los Alamos National Laboratory
NPDES Permit No. NM0030759
LA-UR-13-21503 • May 1, 2013

Water/Cañon de Valle Watershed

Volume 4

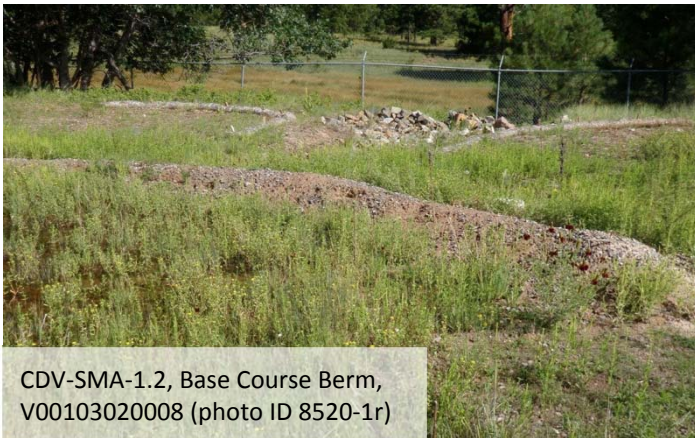
CDV-SMA-1.2, Base Course Berm, V00103020008 (photo ID 8520-1r)

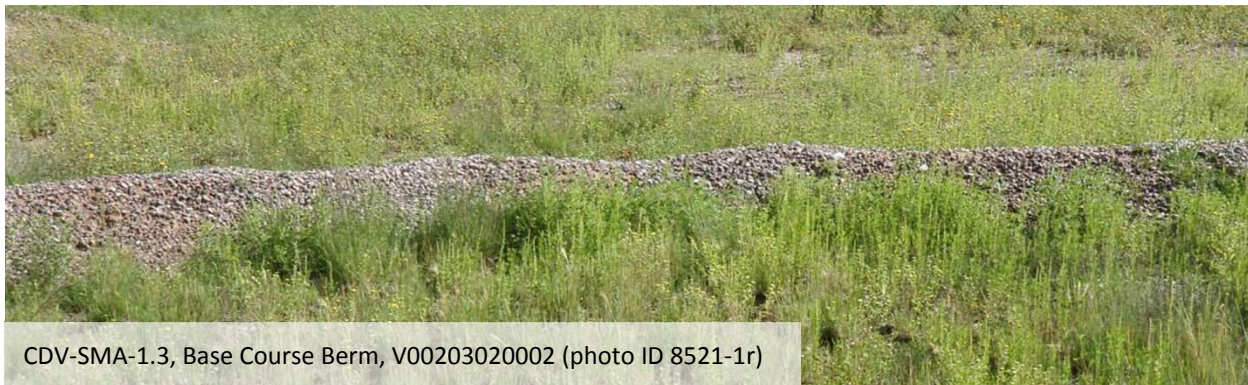
CDV-SMA-1.3, Base Course Berm, V00203020002 (photo ID 8521-1r)

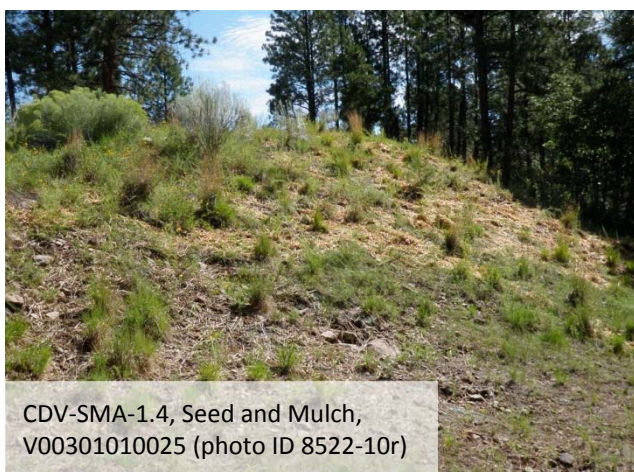
CDV-SMA-1.4, Seed and Mulch, V00301010025 (photo ID 8522-10r)

Maintenance Reference	Maintenance Conducted	Maintenance Date	Response Time	Response Discussion
BMP-23594	Repaired seed/mulch V00301010025 and adjacent area with additional seed/mulch.	05-24-2012	9 day(s)	Maintenance conducted in timely manner.
BMP-25442	Added rock to check dam V00306010012 to increase height and width.	07-24-2012	12 day(s)	Maintenance conducted in timely manner.
BMP-26666	Repaired rock check dam V00306010044.	08-30-2012	0 day(s)	Maintenance conducted upon inspection.

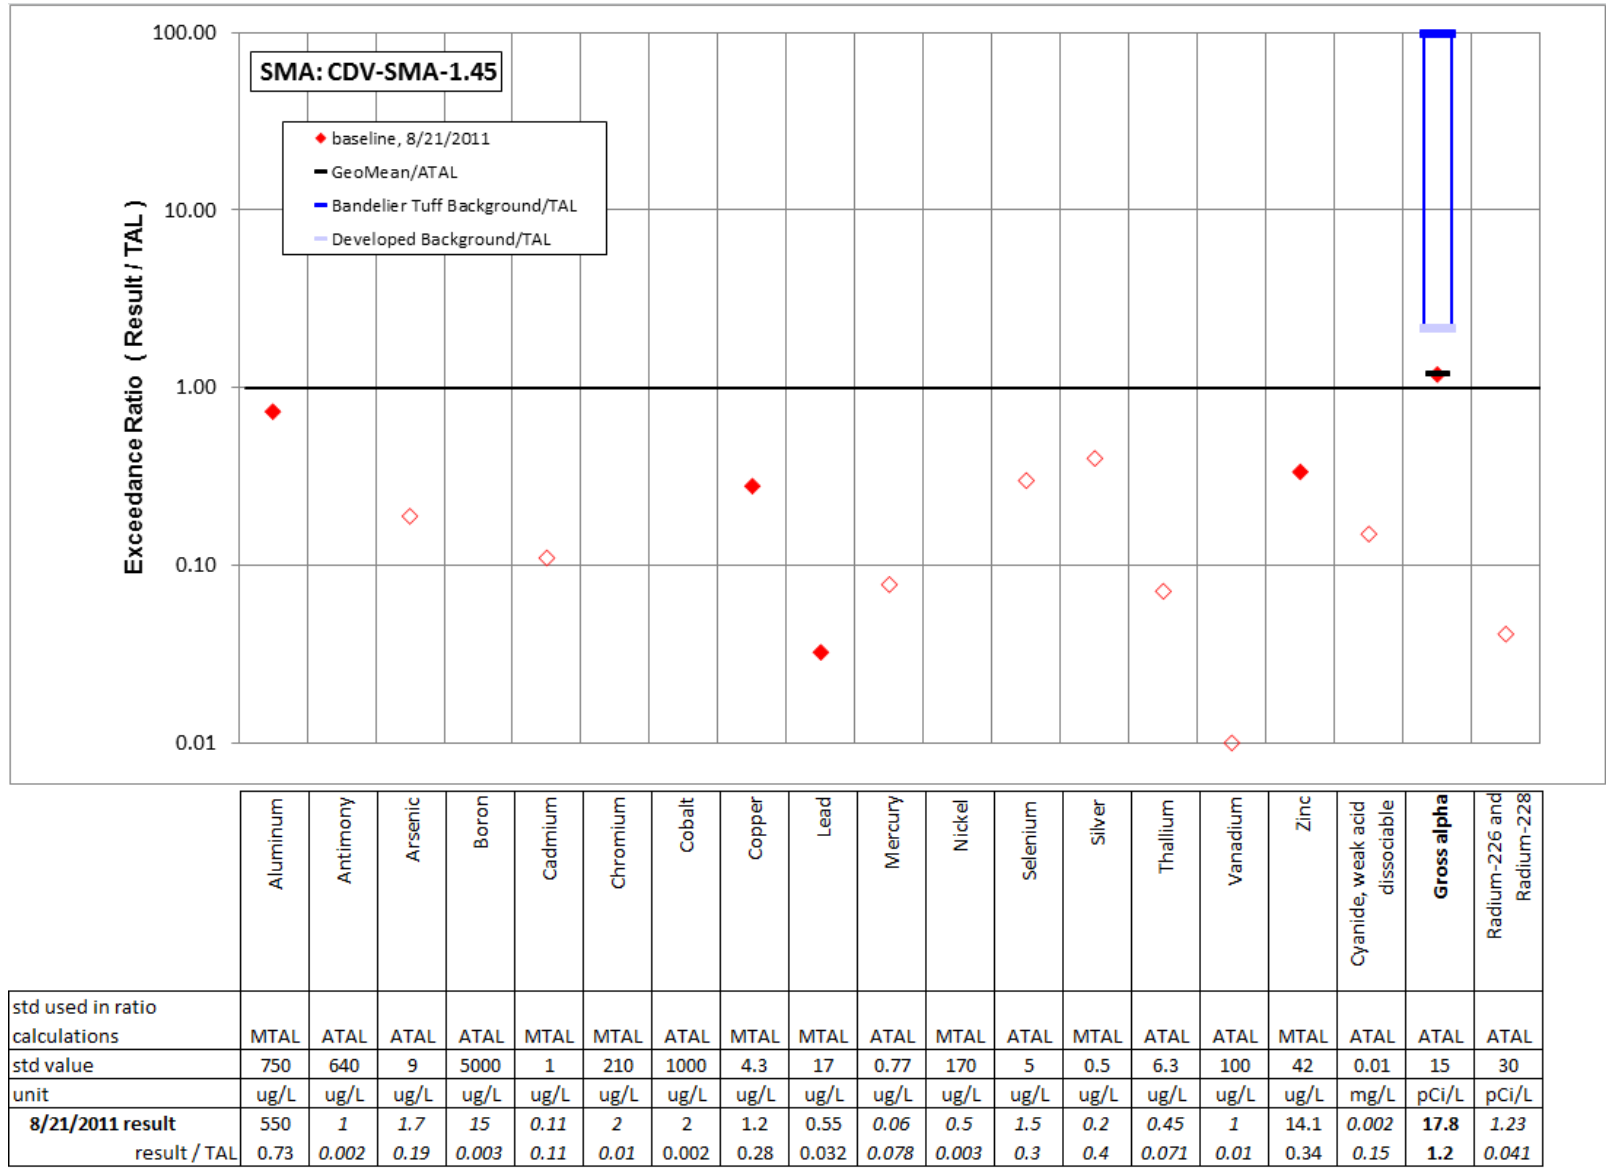
Figure 183-2 Inorganic analytical results summary plot for CDV-SMA-1.45

SWMU 16-026(i) is monitored within CDV-SMA-1.45. Following the installation of baseline control measures, a baseline confirmation sample was collected on August 21, 2011 (Figure 183-2). Inorganic analytical results from this baseline sample yielded one TAL exceedance:

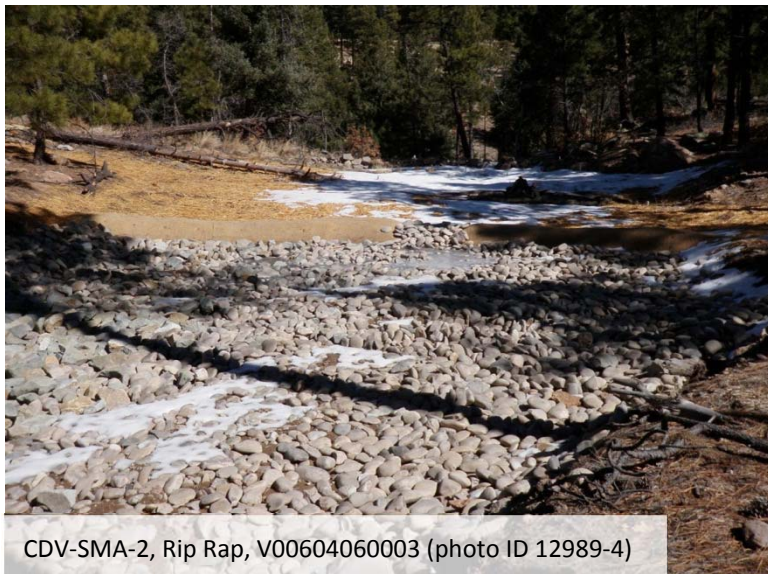
CDV-SMA-2, Rip Rap, V00604060003 (photo ID 12989-4)

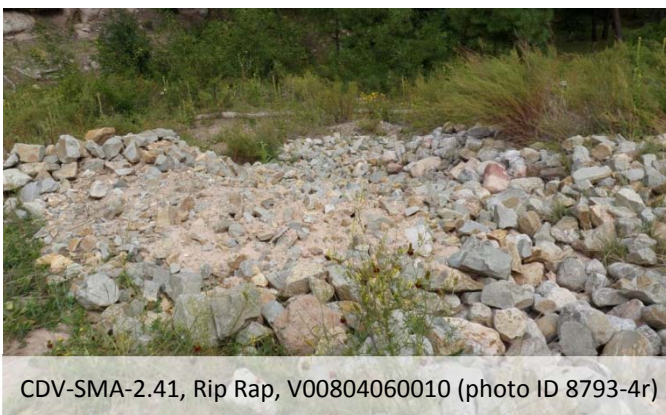
CDV-SMA-2.41, Rip Rap, V00804060010 (photo ID 8793-4r)

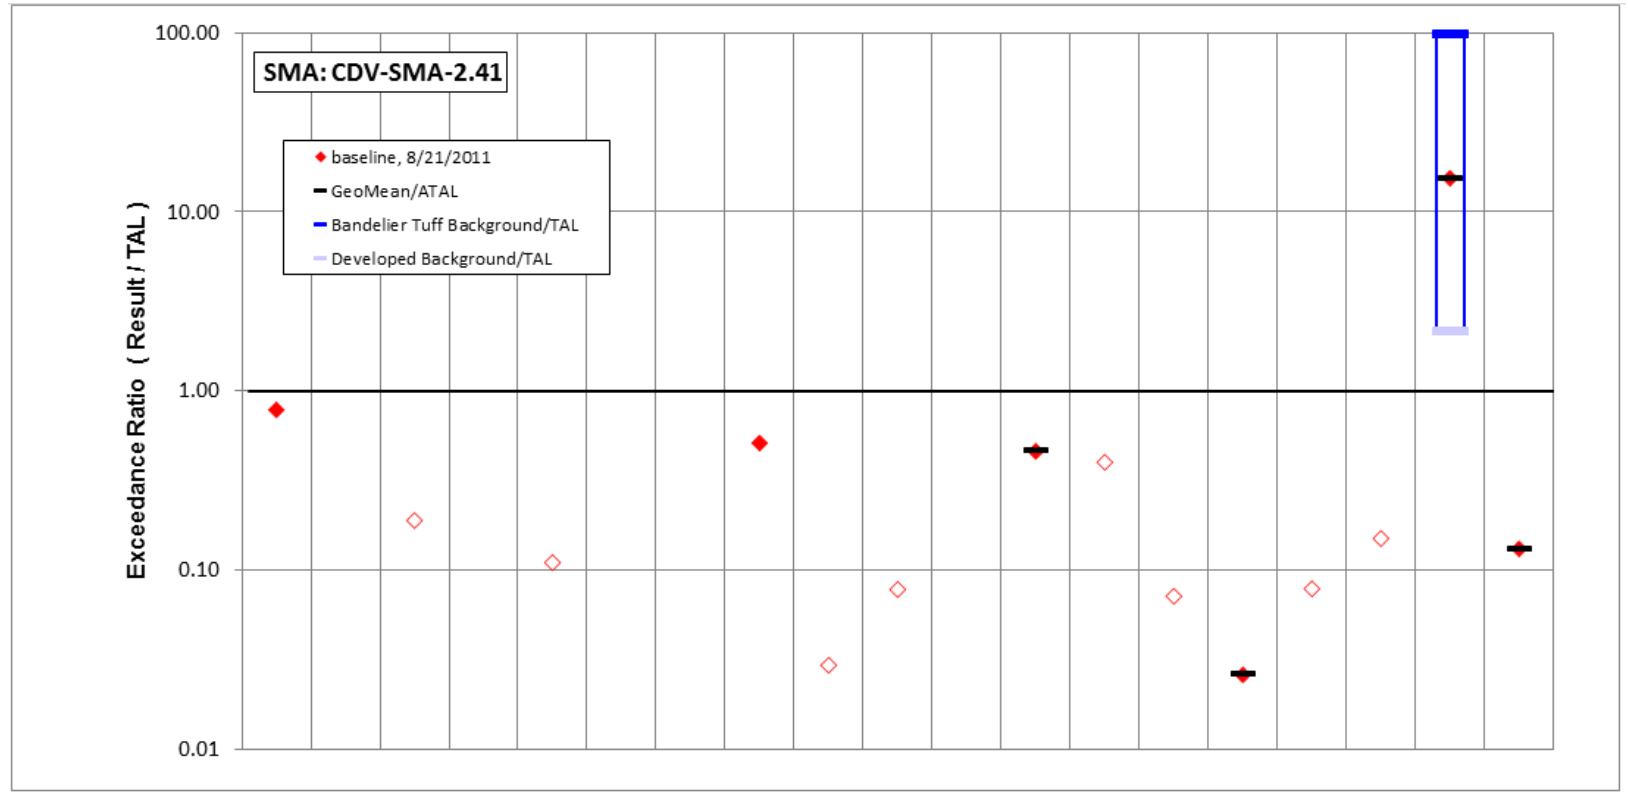
Figure 187-2 Inorganic analytical results summary plot for CDV-SMA-2.41

SWMU 16-018 is monitored within CDV-SMA-2.41. Following the installation of baseline control measures, a baseline confirmation sample was collected on August 21, 2011 (Figures 187-2 and 187-3). Analytical results from this baseline sample yielded two TAL exceedances:

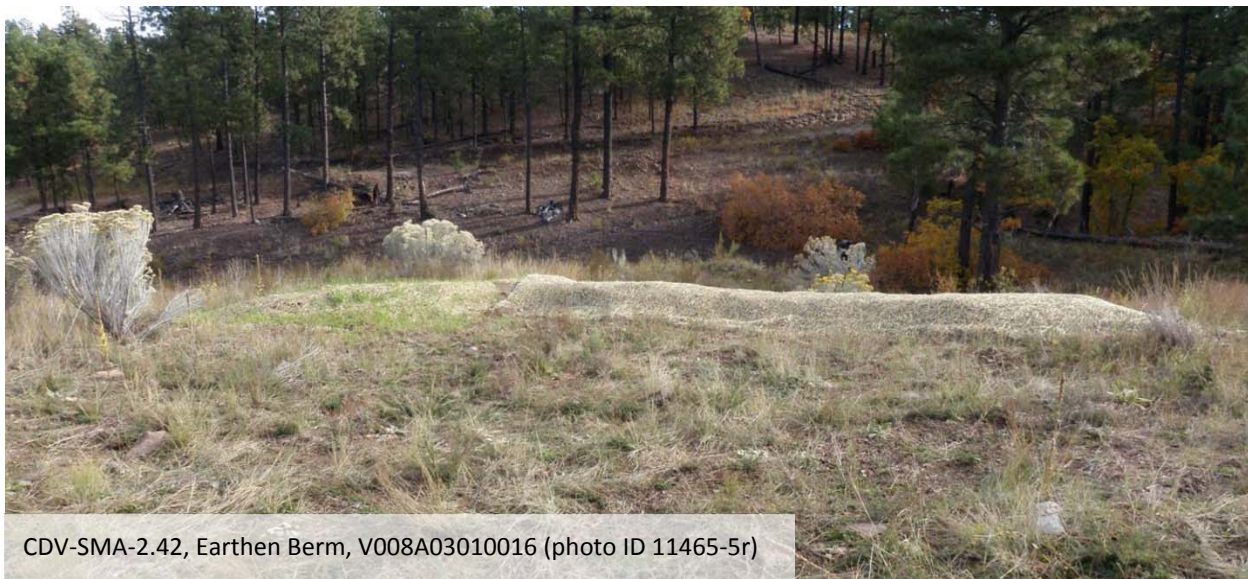
CDV-SMA-2.42, Earthen Berm, V008A03010016 (photo ID 11465-5r)

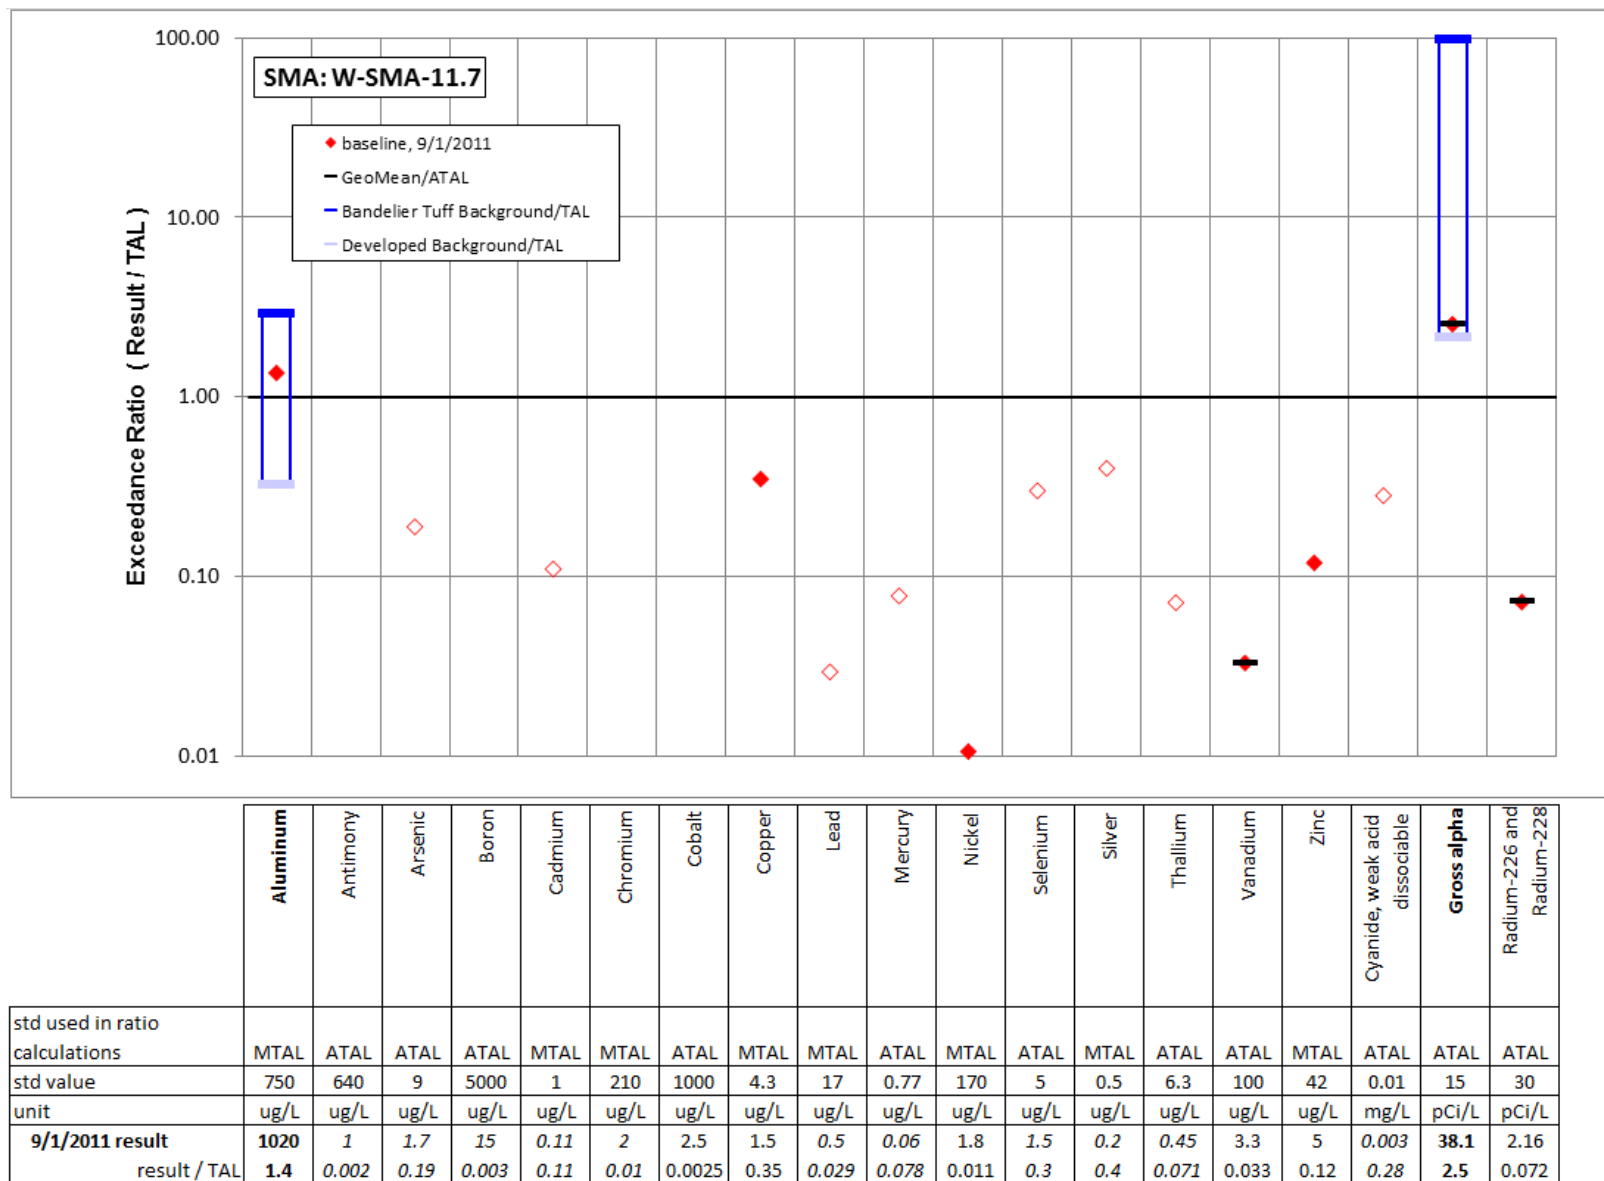
Figure 226-2 Inorganic analytical results summary plot for W-SMA-11.7

AOC 49-008(c) is monitored within W-SMA-11.7. Following the installation of baseline control measures, a baseline storm water sample was collected on September 1, 2011 (Figure 226-2). Analytical results from this sample yielded two TAL exceedances:

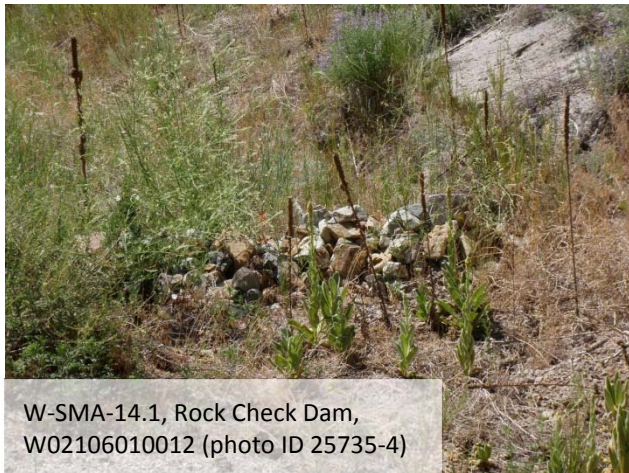
W-SMA-14.1, Rock Check Dam,
W02106010012 (photo ID 25735-4)

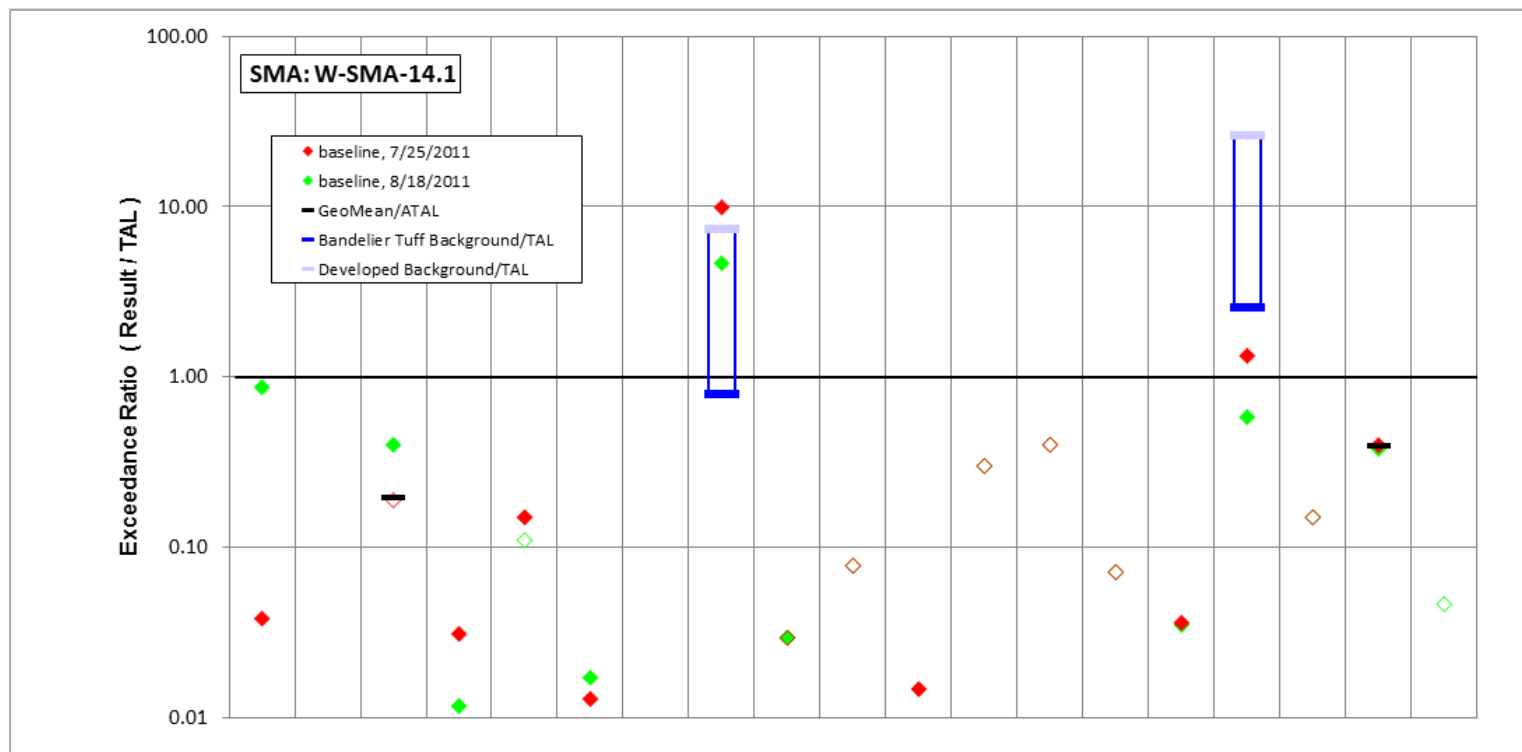
Figure 228-2 Inorganic analytical results summary plot for W-SMA-14.1

SWMU 15-014(l) and AOC 15-004(h) are monitored within W-SMA-14.1. Following the installation of baseline control measures, two baseline storm water samples were collected on July 25, 2011, and August 18, 2011 (Figures 228-2 and 228-3). Analytical results from these samples yielded two TAL exceedances:

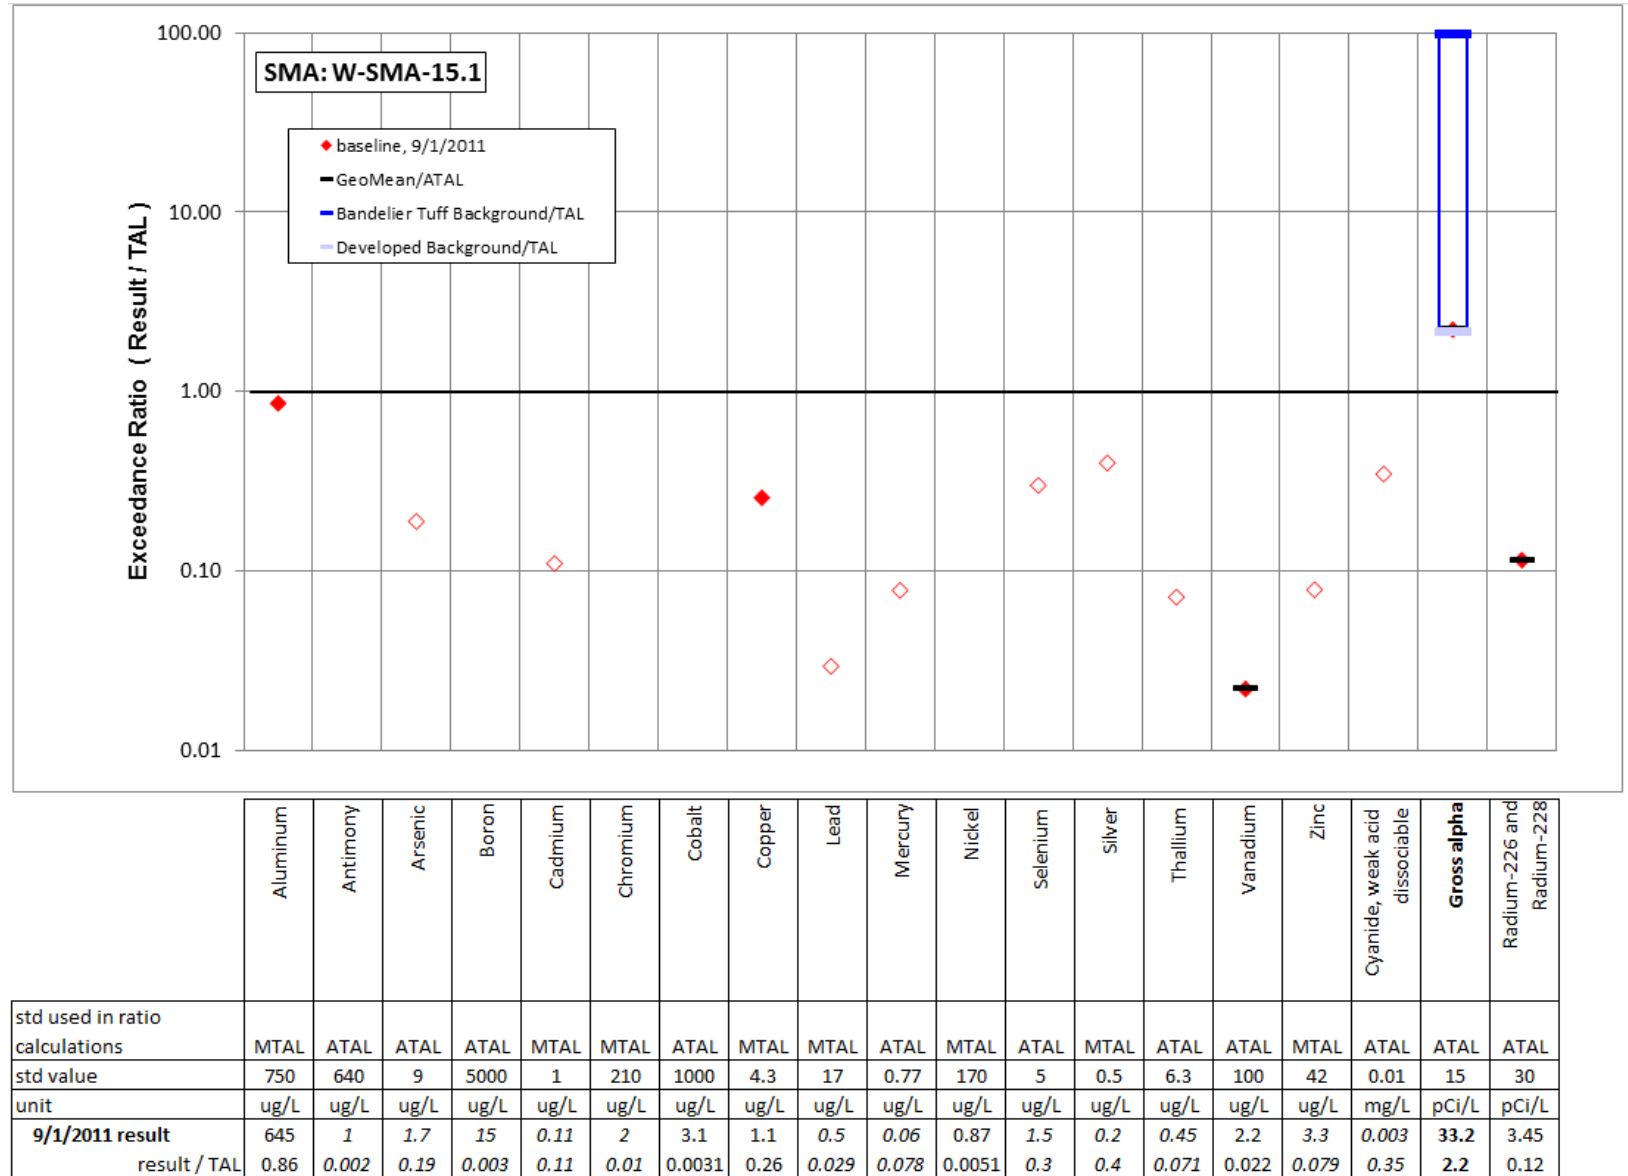
Figure 229-2 Inorganic analytical results summary plot for W-SMA-15.1

SWMU 49-005(a) is monitored within W-SMA-15.1. Following the installation of baseline control measures, a baseline confirmation sample was collected on September 1, 2011 (Figure 229-2). Inorganic analytical results from this baseline sample yielded one TAL exceedance:
