Subject: Submittal of the Long Term Monitoring Plan for Los Alamos County Airport  
Landfill Replacement, Solid Waste Management Units 73-001(a) Technical Area 73

Enclosed, please find two hard copies in addition to the electronic version of the Long Term Monitoring Plan for the Los Alamos County Airport Landfill Replacement, Solid Waste Management Units 73-100(a) Technical Area 73.

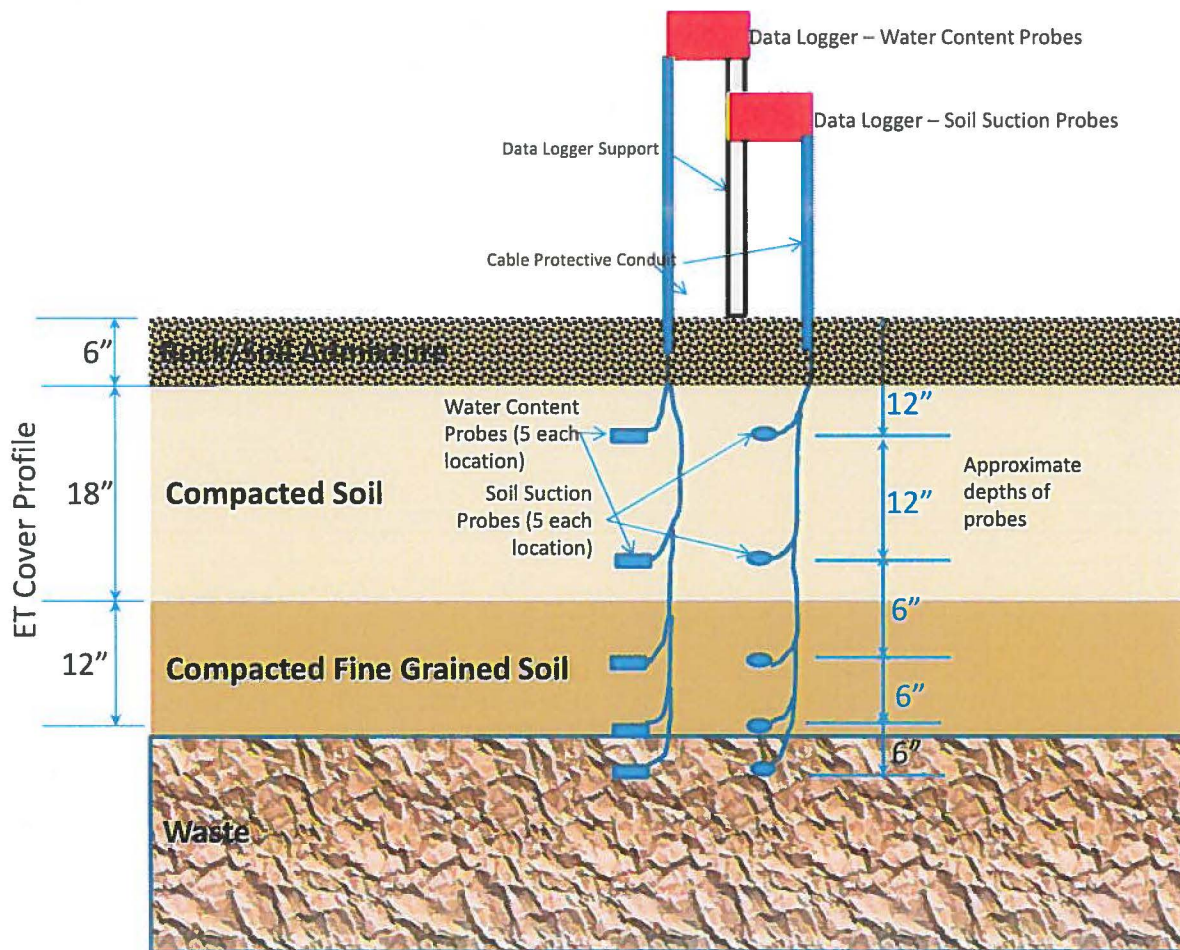
Figure 1. Water Balance Monitoring Typical Equipment

Monitoring Equipment at each location (2 locations) includes:

- 5 each – 5TM water content probes by Decagon Devices Inc.
- 5 each – MPS-2 water potential probes by Decagon Devices, Inc.
- 2 each – EM50 data loggers by Decagon Devices Inc.

Water balance monitoring of the ET Cover shall be performed on a quarterly basis. The monitoring equipment shall be installed within three months after the completion of the cover construction. This monitoring will include the monitoring of water content and soil suction within the cover profile. There shall be two locations within the cover system to be monitored (Figure 2). The two locations are to be used to provide duplication in case of instrumentation or software errors. Each location has five water content probes and five soil suction probes

installed within the profile to measure the respective parameters on a continual basis (Figure 1). Each set of probes are connected to on-site data loggers that will compile the data to be downloaded by the Inspection Engineer on a quarterly basis. The summary and analysis of the data shall be submitted with each quarterly inspection report.

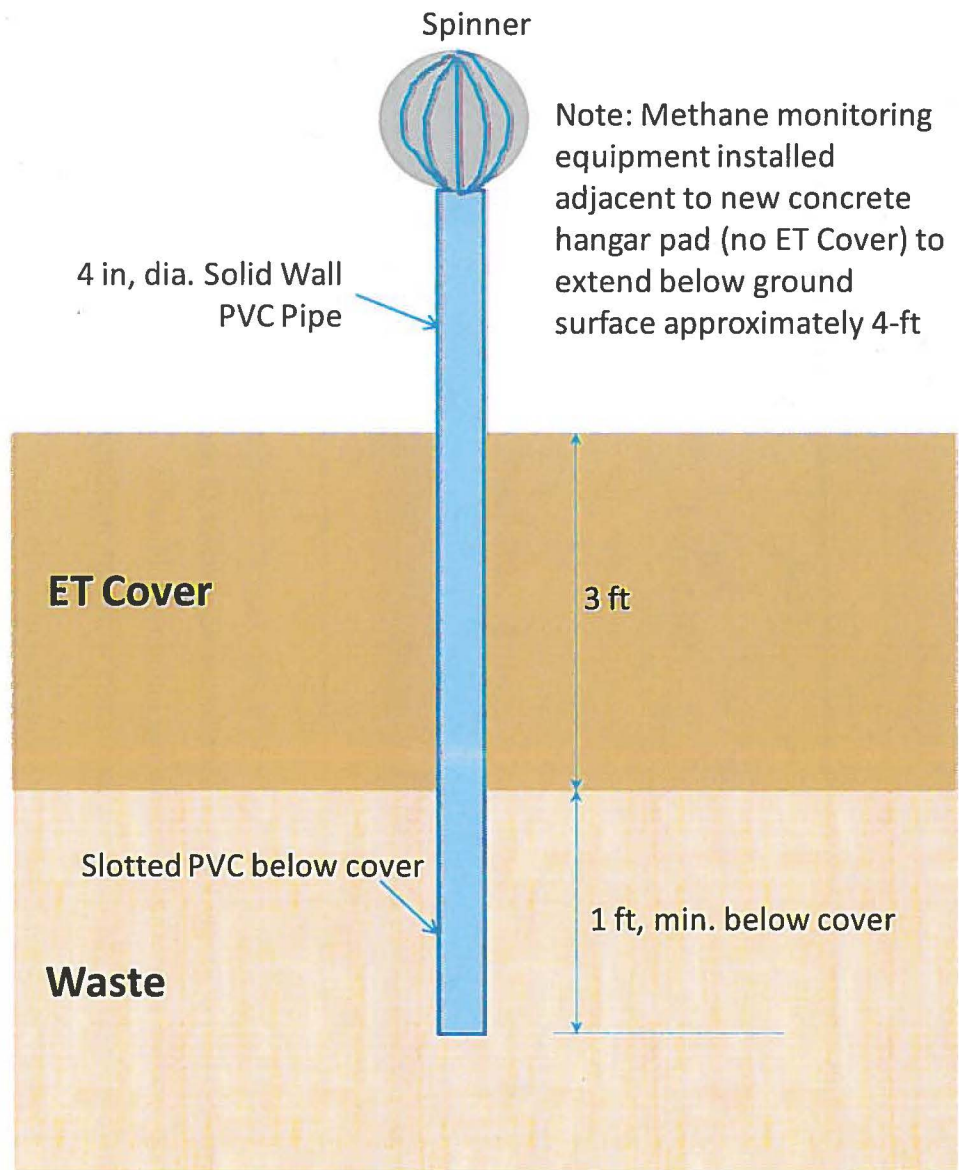
*Figure 3. Methane Monitoring Vent*

Methane monitoring shall be performed at four locations (Figures 2 and 3). The monitoring equipment shall be installed within three months after the completion of the cover construction. The monitoring shall include the installation of the four passive vent locations. Each location shall include a vertical riser installed into the underlying waste that rises above ground level where measurements can be made (Figure 3). The methane will be measured at the exit point of each methane riser on the established periodic basis to quantify methane release from the landfill. The values will be compared to the lower explosive limit (LEL).
