LA-UR-08-6891 EP2008-0578

## Los Alamos Site Monitoring Area 2 Interim Measure and Monitoring Plan

November 2008

Prepared by the Environmental Programs Directorate

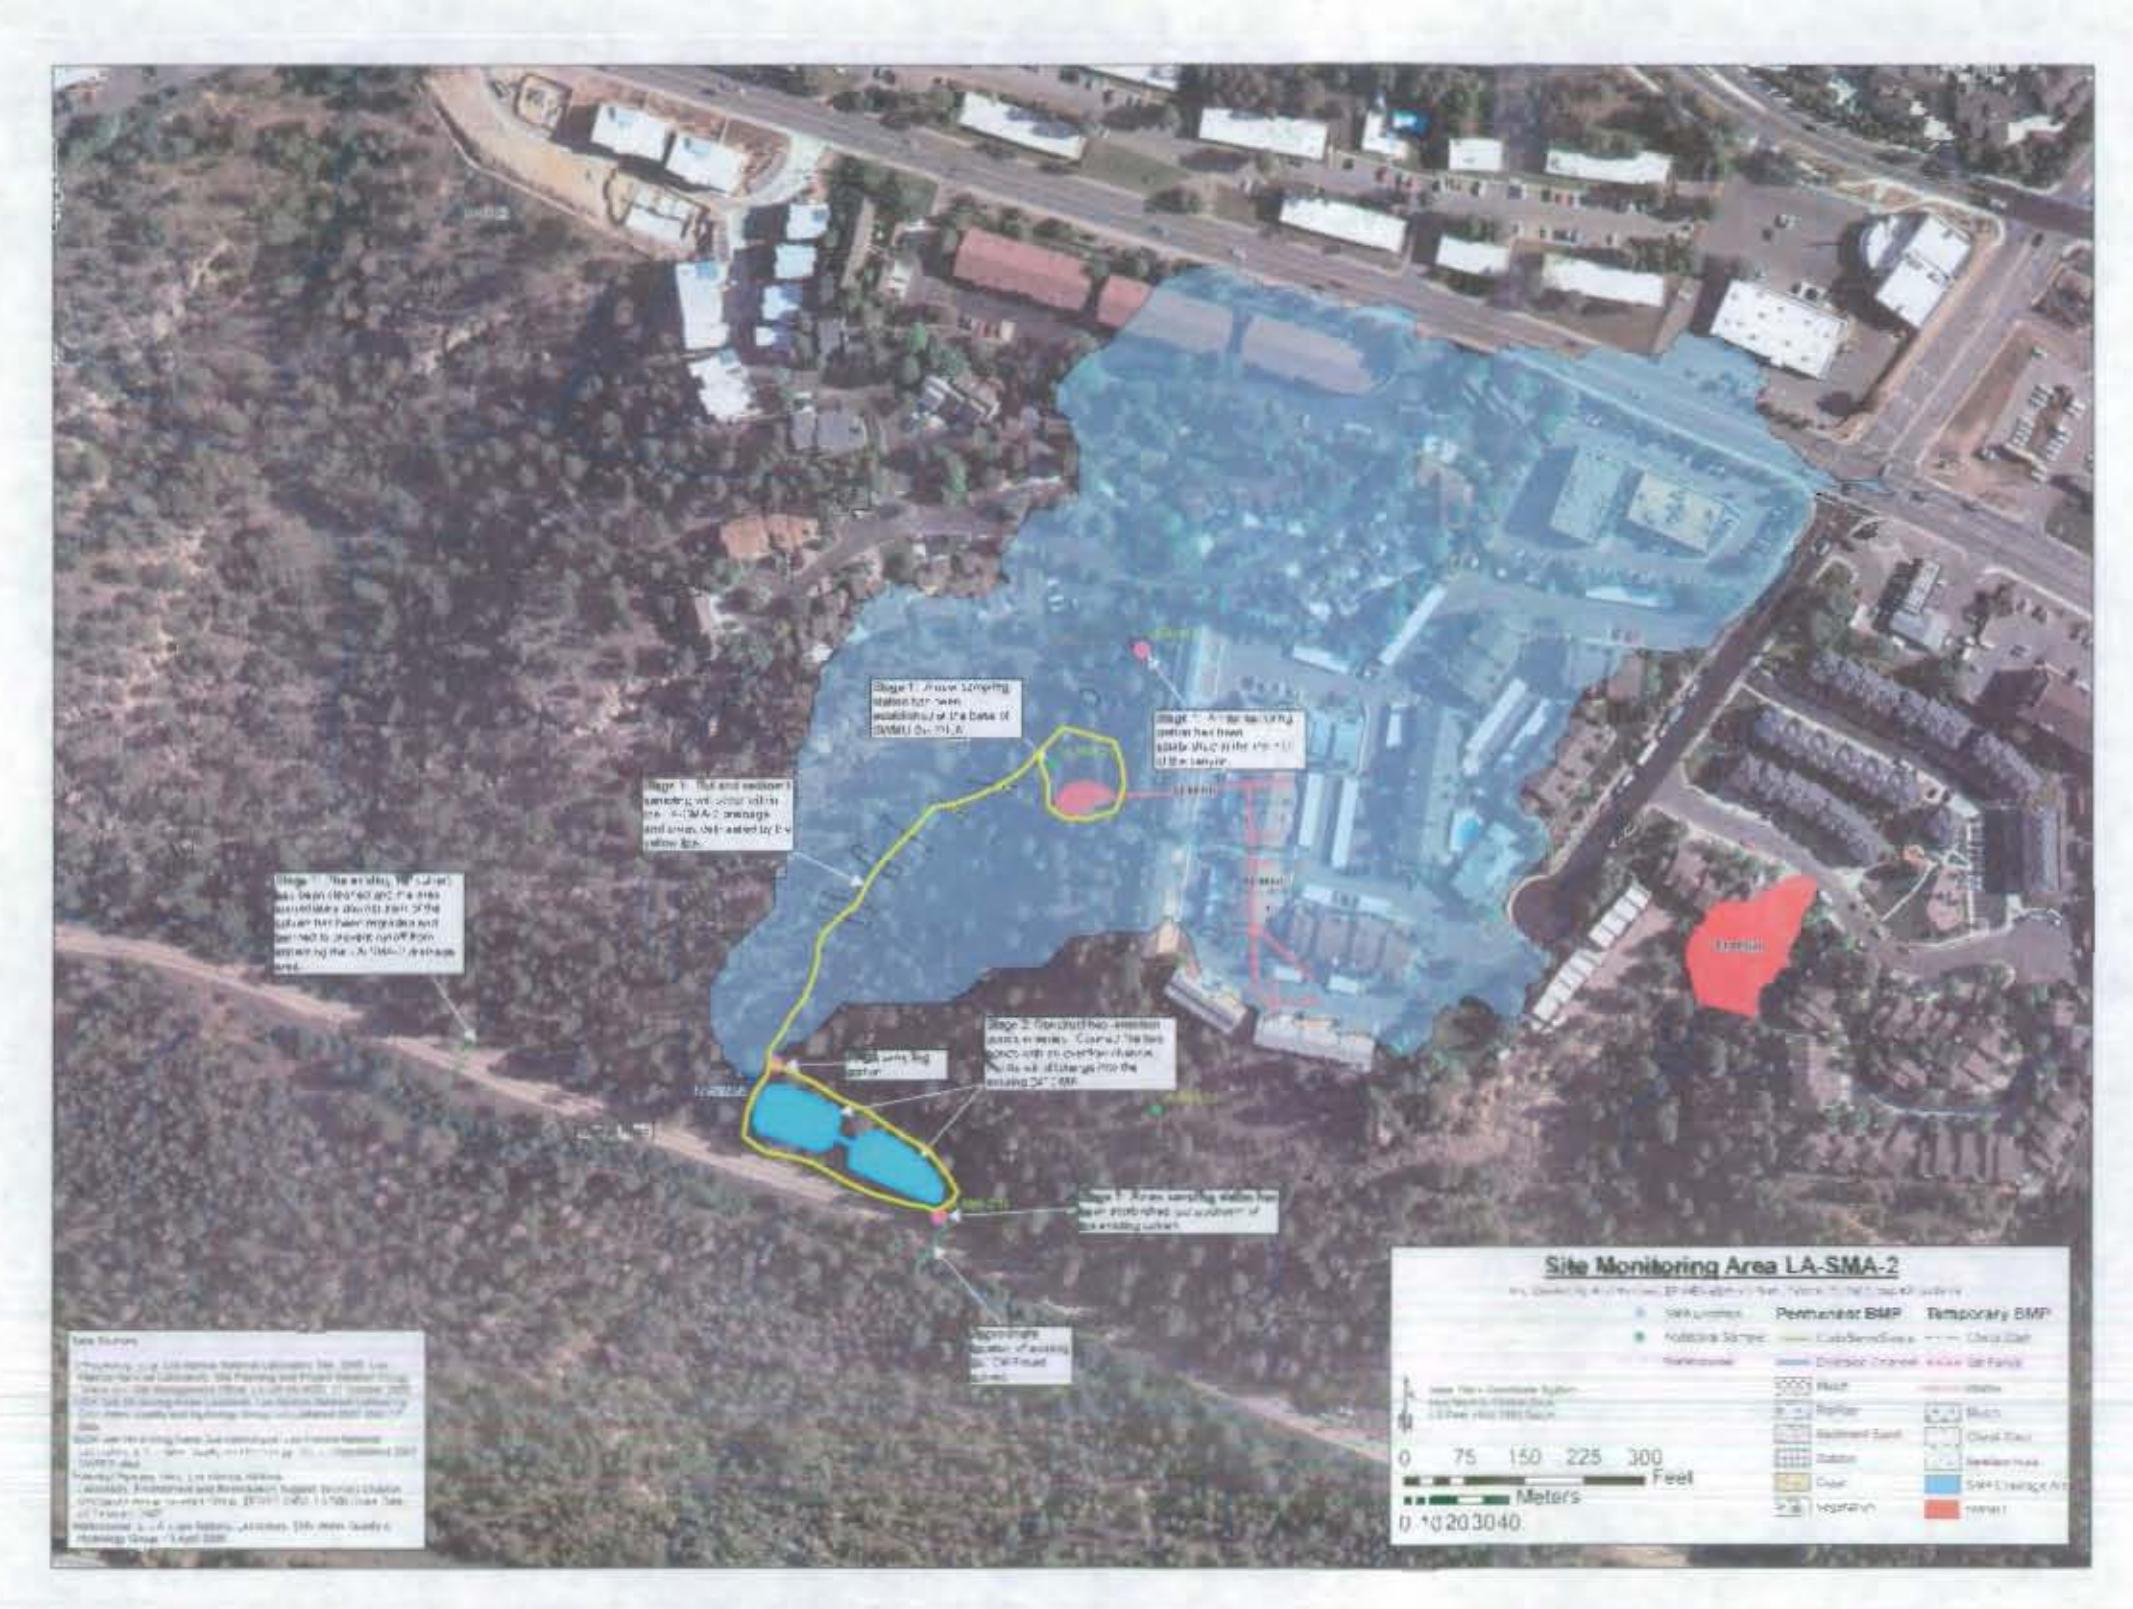
Note: The magenta dots represent non-IP sampling locations.

Figure 1.0-1 Aerial photograph of Stage 1 and 2 activities in LA-SMA-2

Solid Waste Management Unit (SWMU) 01-001(f) is within Los Alamos Site Monitoring Area 2 (LA-SMA-2) and is located in Technical Area 01 (TA-01), mostly on the mesa above Los Alamos Canyon (Figure 1.0-1). SWMU 01-001(f) is the location of a former septic tank and outfall that served HT and FP Buildings. The HT Building was used to heat-treat and machine natural and enriched uranium, and the FP Building was a foundry for nonradioactive and nonferrous metals. Stormwater runoff from this site is currently regulated under the Federal Facility Compliance Agreement (FFCA), which will terminate upon issuance of an individual permit (IP), expected by January 2009.

Figure 1.0-1 shows an aerial photograph of LA-SMA-2, with Stage 1 and recommended Stage 2 BMPs and sampler locations. If implementation of Stage 2 BMPs is necessary, detailed engineering drawings will be required.

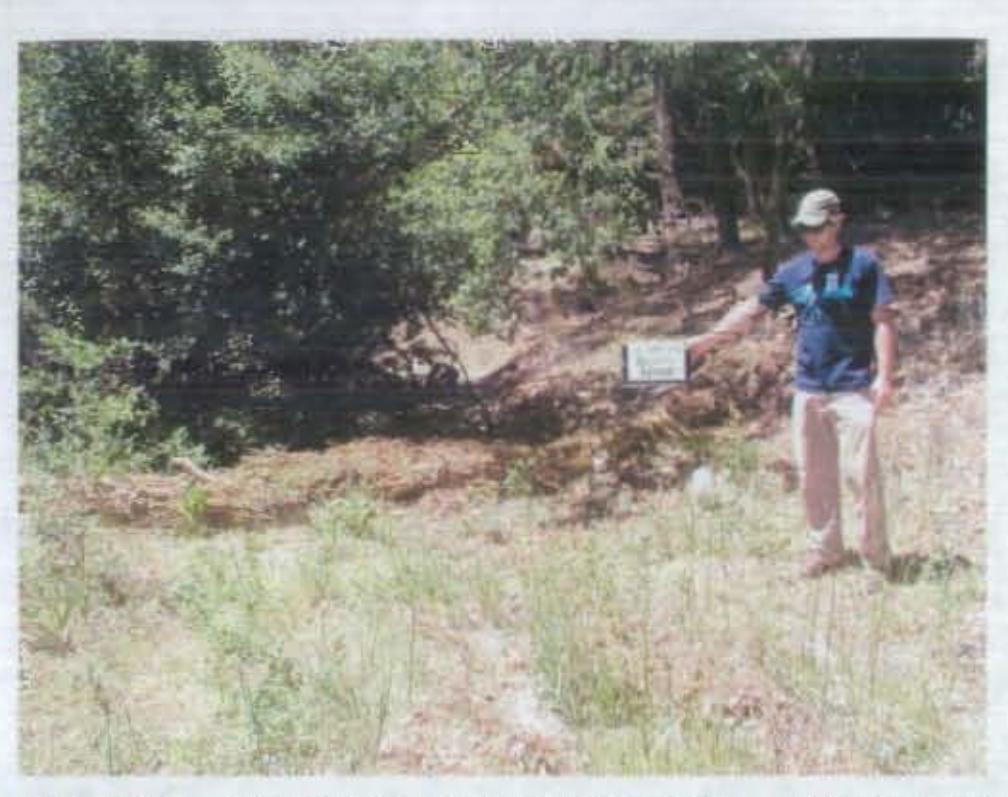
Example of juniper bates placed below LA-SMA-2 FFCA sampler and above the LA-SMA-2.15 sampler Figure 3.1-1

Immediately below the sampler at LA-SMA-2, there is an area of sediment deposition that is approximately 300 ft long  $\times$  50 ft wide. Water that drains out of the LA-SMA-2 tributary must flow through this area and under Omega Road through a 24-in. culvert to reach the Los Alamos Canyon waterway. Substantial vegetation and downed woody debris on the surface of this area slow runoff and trap sediments. This capacity has been augmented by the installation of a series of juniper bales to trap sediments from larger flows (Figure 3.1-1).

Stage 1 BMPs and sampler implementation have been completed. Stormwater samplers have been installed at three locations. Three rows of juniper bales have been installed above the most downgradient sampler. The 18-in. culvert has been cleaned, and a berm has been constructed to divert run-on from the sediment retention area.

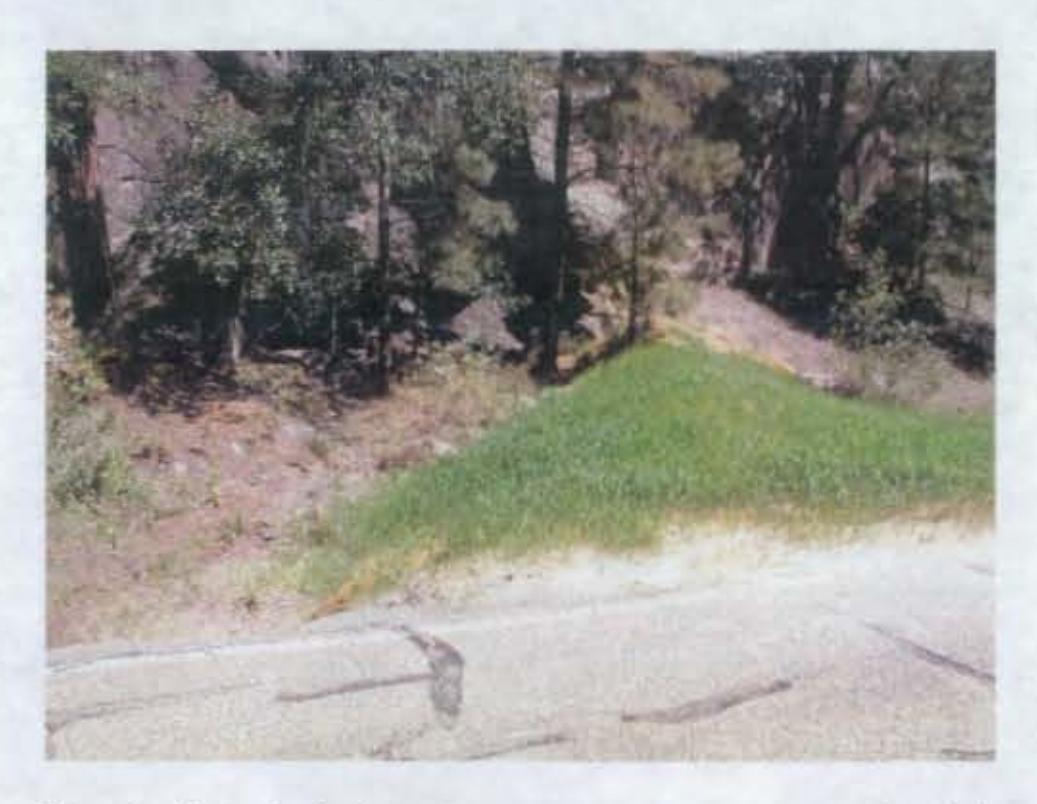
Figure 3.1-2

Earthen berm that routes stormwater under paved road through 18-in. culvert and away from LA-SMA-2 drainage

Los Alamos Canyon waterway. Until recently, the 18-in. culvert was plugged with debris, and there was evidence that past runoff had been forced to the southeast, across the depositional area below the LA-SMA-2 tributary, and into the 24-in. roadway culvert described above. The 18-in. culvert has been cleaned, and the drainage just downstream of the existing 18-in. culvert has been bermed to ensure that runoff does not bypass the culvert (Figure 3.1-2). It is estimated that run-on to the sediment deposition area has been reduced by approximately 30%.

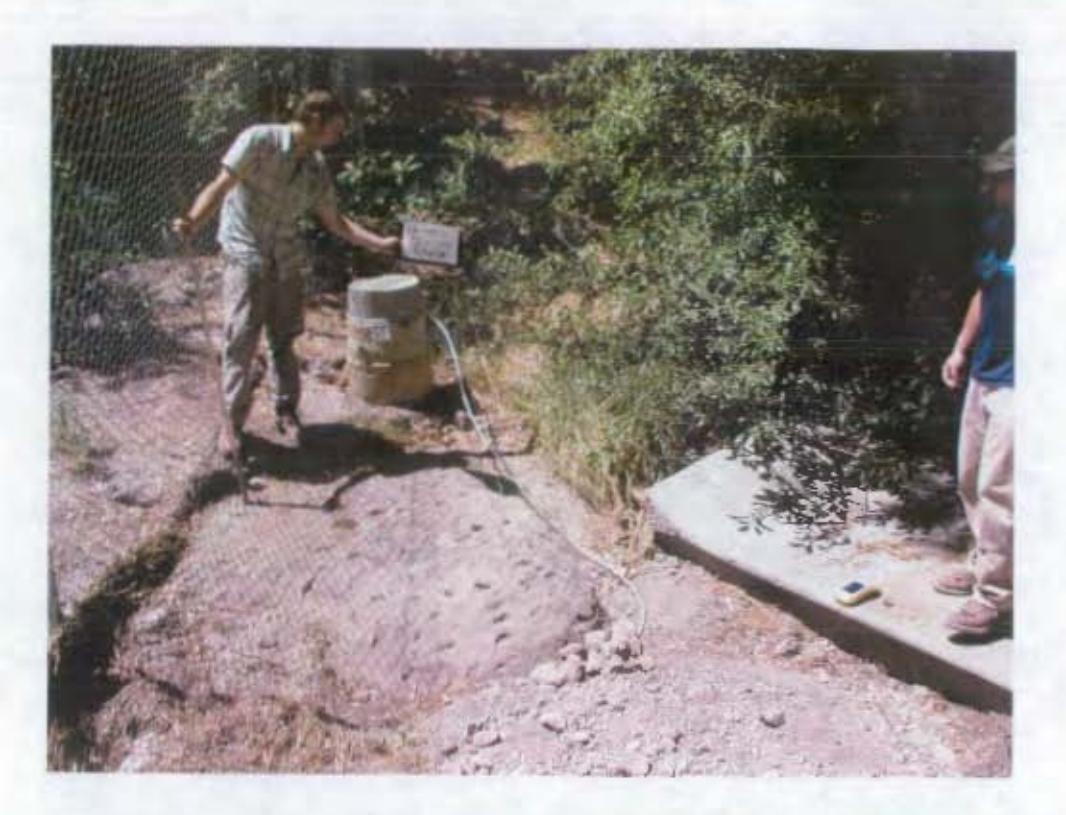
Figure 3.1-3 LA-SMA-2, the run-on sampler located at the upstream end of the tributary canyon and just upgradient of the SWMU

In addition to the existing LA-SMA-2 sampling location, three additional ISCO automated samplers have been installed to better understand potential contaminant dynamics in this drainage (see Figures 3-1-3 to 3.1-6). The locations for sampling are as follows:

A sampling station at the upstream end of the tributary canyon will provide a greater understanding of the source of pollutants, including PCBs, in run-on from non-Laboratory property on the mesa top. For example, if the sampling data show PCBs present at the upstream end of the tributary canyon, then more work could be done to identify the source of PCBs on the mesa, and BMPs could be designed and installed that would prevent the transport of PCBs from the tributary into the canyon.

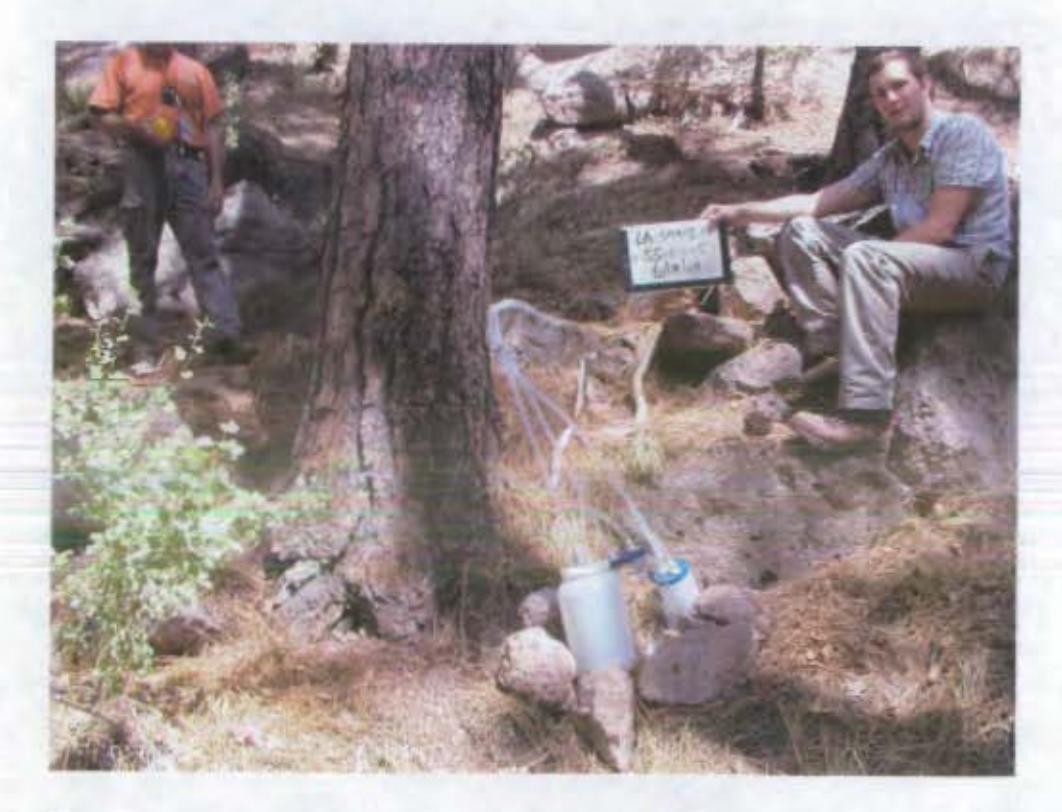
Figure 3.1-4 LA-SMA-2.1, the existing sampler at the outfall of SWMU 01-001(f)

The sampler below the former outfall of SWMU 01-001(f) will demonstrate compliance with the IP and assess BMP effectiveness in preventing runoff or sediment migration from the SWMU.

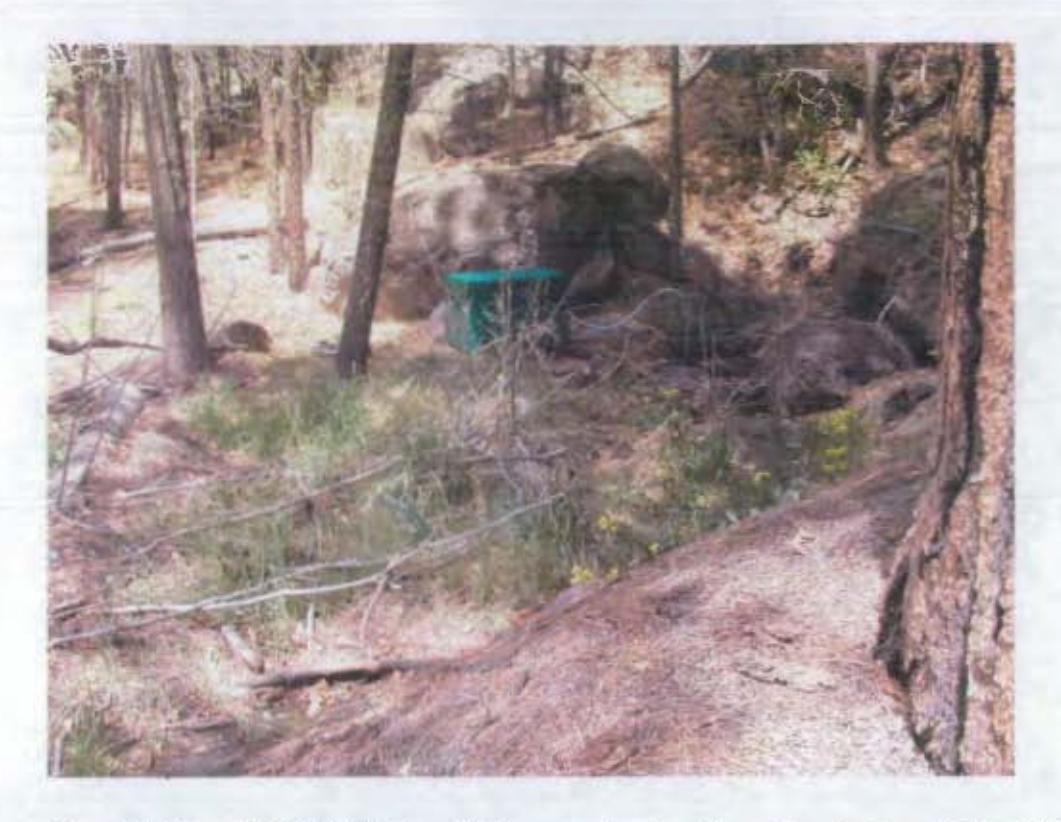
Figure 3.1-5 LA-SMA-2, the existing sampler location at the bottom of the SMA

The current sampling location at the bottom of LA-SMA-2 will be relocated below the sediment deposition area and above the Omega Road culvert following authorization of the IP.

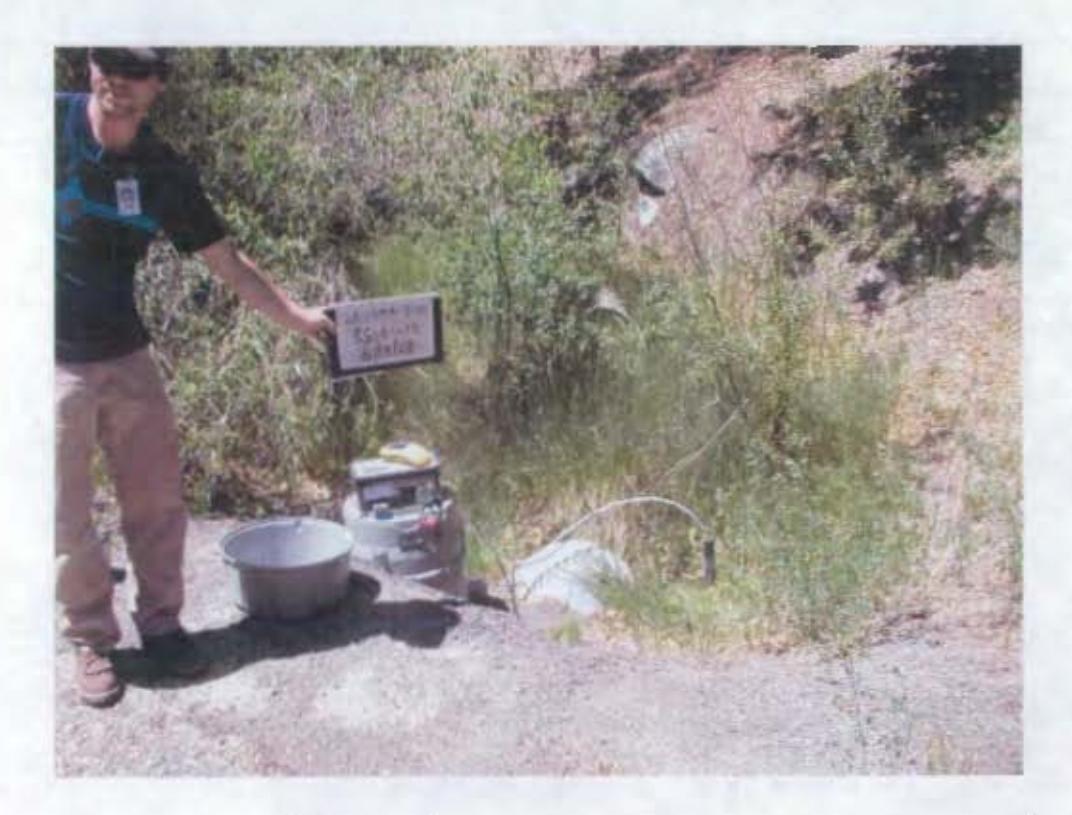
Figure 3.1-6 LA-SMA-2.15, just upstream of the existing 24-in.-diameter culvert at Omega Road

As described earlier, it was observed that sediment has been deposited in the LA-SMA-2 drainage and surrounding overbank just downstream of the existing sampler and just upstream of the existing 24-in. culvert under Omega Road. It is possible that PCB-laden sediments are depositing in this location and not entering the waterway in Los Alamos Canyon. If this is the case, current sampling data acquired upstream of this location may not be indicative of the potential for contaminants to enter the receiving waters in Los Alamos Canyon. By collecting stormwater-runoff samples just upstream of the 24-in. culvert under Omega Road, a better understanding can be obtained of the impacts of the sediment deposition area. If it is found that significant benefits are being derived from the retention of sediment in this area, BMPs could be designed to enhance the detention of stormwater and the retention of sediment.
