**Geophysical Survey of the Wetland Area of Upper Sandia Canyon**

# Final Report

Prepared for:  
TerranearPMC

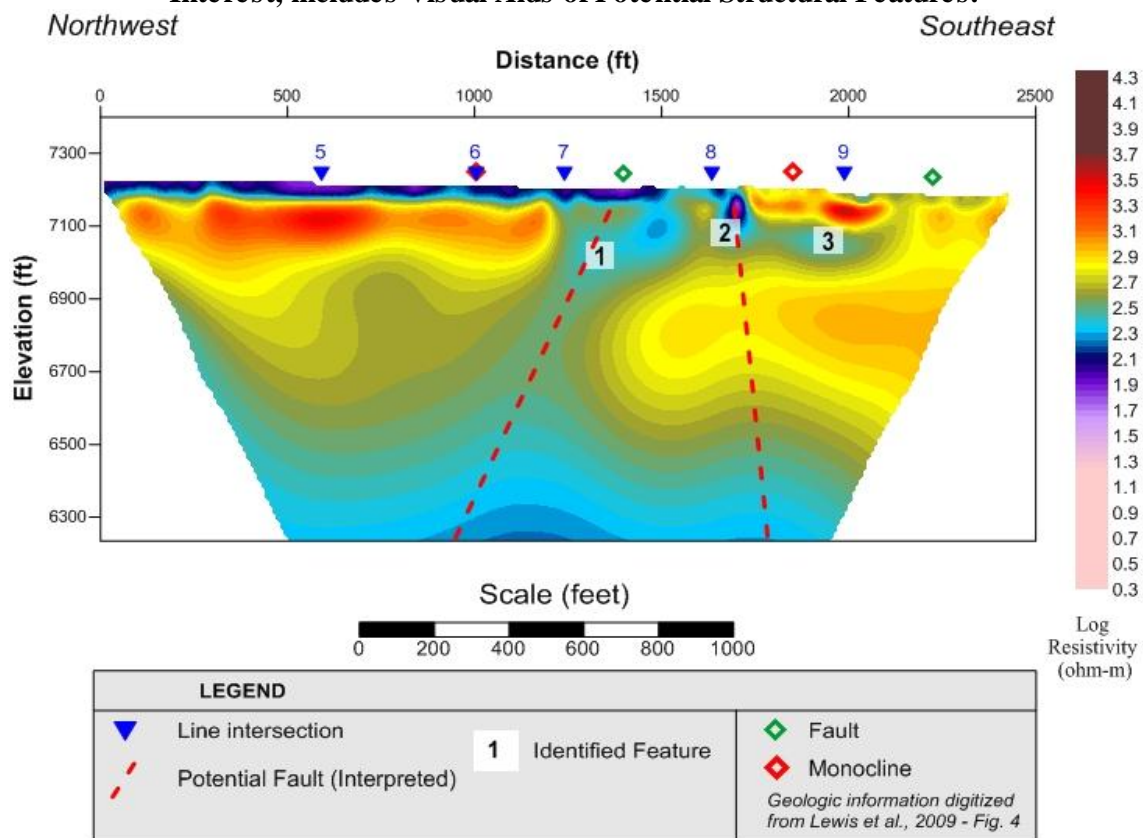
**Figure 5. Profile 2 Model Resistivity Results - Identifying Electrical Resistivity Features of Interest, includes Visual Aids of Potential Structural Features.**

Figure 5 displays the modeled resistivity results for profile 2, acquired parallel to and to the north of profile 1. The near-surface conductive layer discussed previously extends between 0 and 1700 feet along the profile, located within the canyon-floor flood plain and southern margin of the wetland, displaying an average thickness of 25 feet. East of 1700 feet, the near-surface rocks are resistive where the canyon becomes incised and the line crosses bedrock exposures of welded tuff. The main anomaly in this profile is a conductive linear feature, labeled (1), at

approximately 1400 feet along the profile. This feature dips toward the west and extends down to the underlying conductive layer at approximately 6600 feet elevation. A clear offset in the resistivity model contours can be observed for this feature, potentially indicating a fault structure. Even though profile 2 is more proximal to the canyon axis the resistivity values of this feature are higher than those discussed for profile 1, possibly suggesting a lower degree of saturation or less clay content along the potential fault. The conductive feature labeled (2), located at the eastern terminus of the wetland, extends down from the ground surface to the 7000 feet elevation contour. A slight offset in the underlying model resistivity contours could indicate a fault at this location. The final conductive feature in this profile, labeled (3), which corresponds to the general location along the profile of the feature labeled (6) in profile 1. In this case the feature is not associated with significant offsets in the model resistivity contours and may represent enhanced water or clay contents in an east-dipping stratigraphic unit.

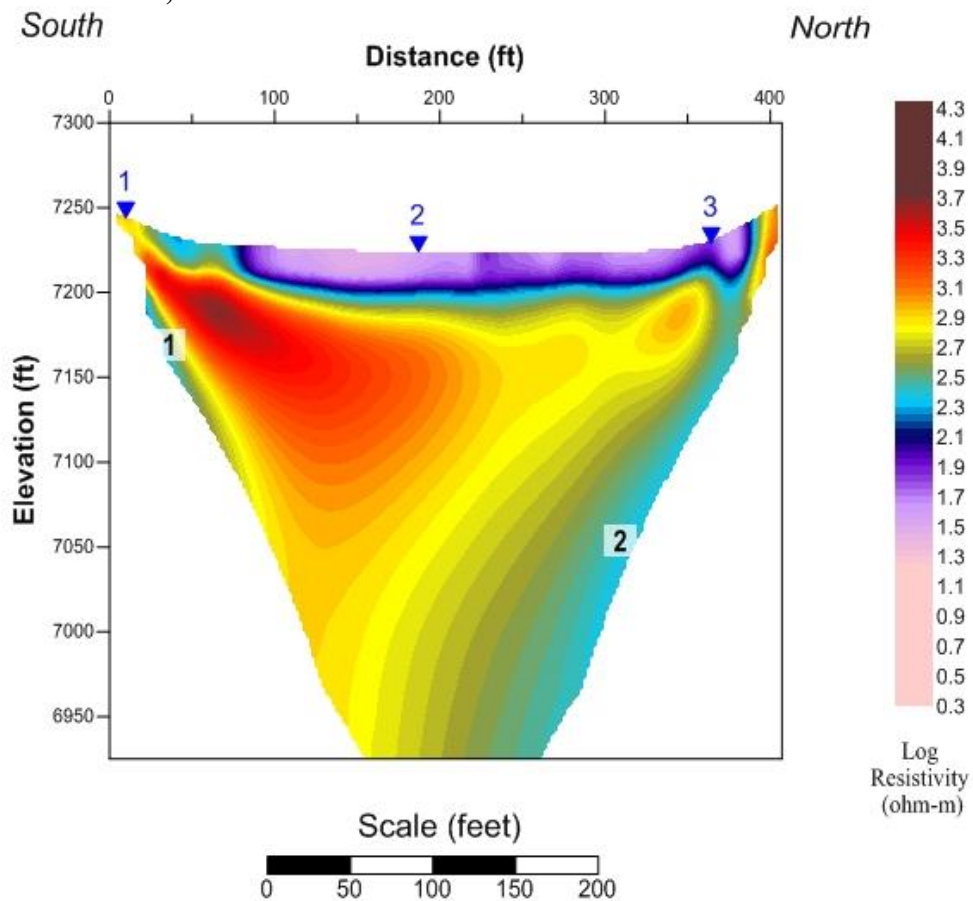
**Figure 8. Profile 5 Model Resistivity Results - Identifying Electrical Resistivity Features of Interest, includes Visual Aids of Potential Structural Features.**

Figure 8 displays the modeled resistivity results for profile 5, acquired perpendicular to profiles 1 through 4. The dominant feature in this profile is the near-surface conductive layer discussed previously, which extends across the majority of the profile with an average thickness of 20 feet. Although the wetland occurs between approximately 180 and 375 feet along the profile, the near-surface conductive layer is uniformly conductive as far south as about 75 feet along the profile. This may indicate that alluvial groundwater beneath the canyon floor floodplain extends south beneath the adjacent alluvial slope or that the near-surface conductive layer is mapping silt- and

clay-rich alluvial deposits. Deep resistivity values can be observed becoming more conductive at the edges of the model; between 7200 and 7100 feet elevation on the southern edge, labeled (1), and quite clearly at all depths on the northern edge, labeled (2). The feature on the southern edge of the model coincides well with the location of the conductive feature labeled (1) in profile 1, although unfortunately there is little overlap of these regions of the two models. These are regions of the model where we have the lowest sensitivity and hence it is difficult to draw any reasonable conclusions as to the origin of such features.

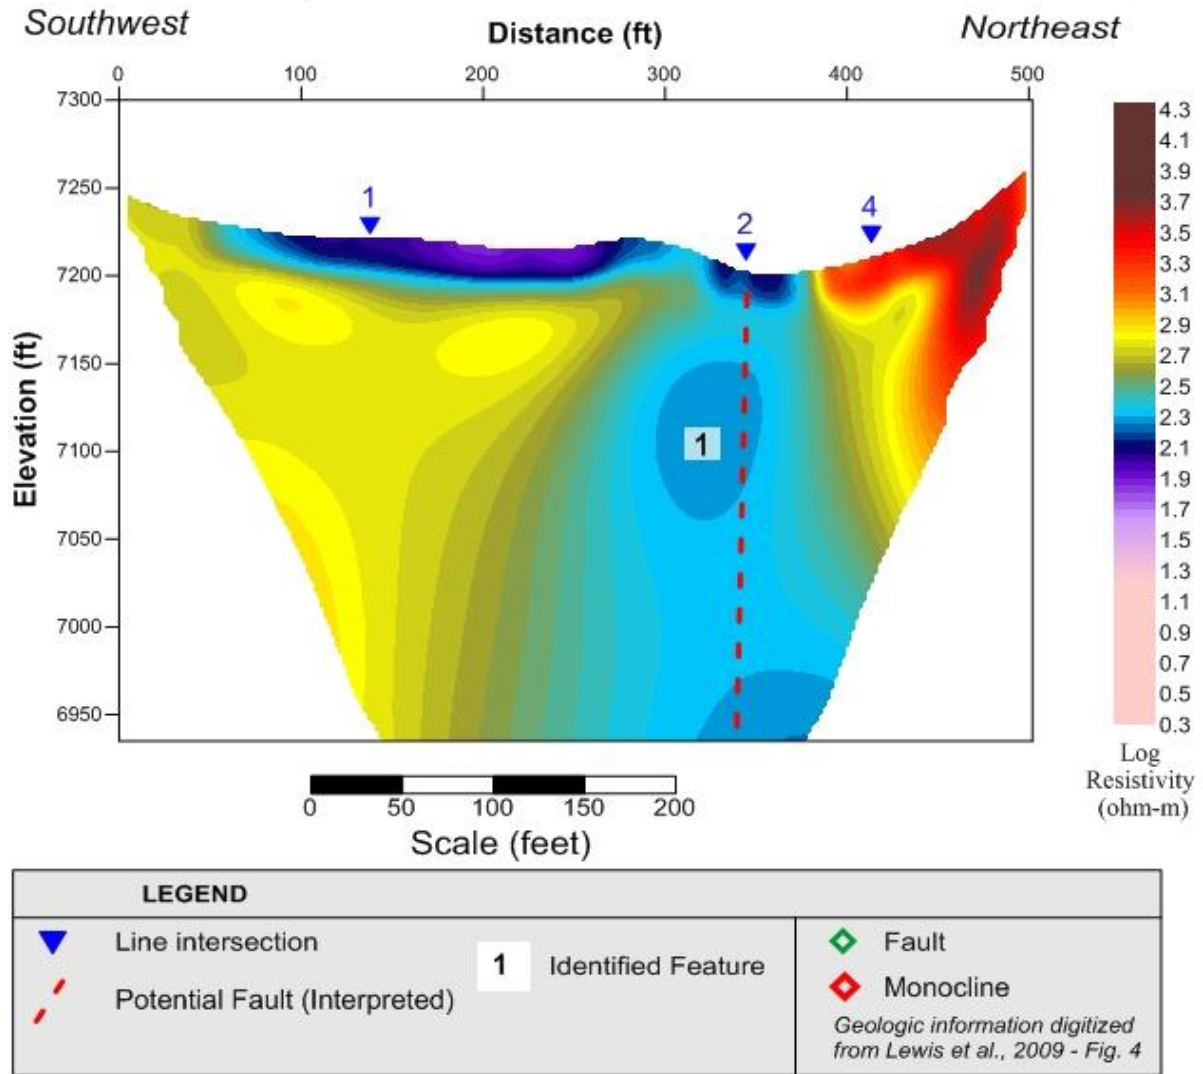
**Figure 11. Profile 8 Model Resistivity Results - Identifying Electrical Resistivity Features of Interest, includes Visual Aids of Potential Structural Features.**

Figure 11 displays the modeled resistivity results for profile 8, acquired parallel to and to the southeast of profile 7. The near-surface conductive layer discussed previously extends between 50 and 380 feet along the profile, with an average thickness of 25 feet. The profile crosses the eastern end of the wetland, which occurs between approximately 310 and 365 feet along the profile. South of 310 feet, the near-surface conductive layer may represent silt- and clay-rich alluvial deposits. At depth we observe one significant conductive feature, labeled (1). This feature is centered under the wetlands and is associated with a clear offset in the model resistivity contours, with the conductive feature extending unbroken from the near-surface to the penetration depth limit of the resistivity model. The feature may represent a fault running through this profile.

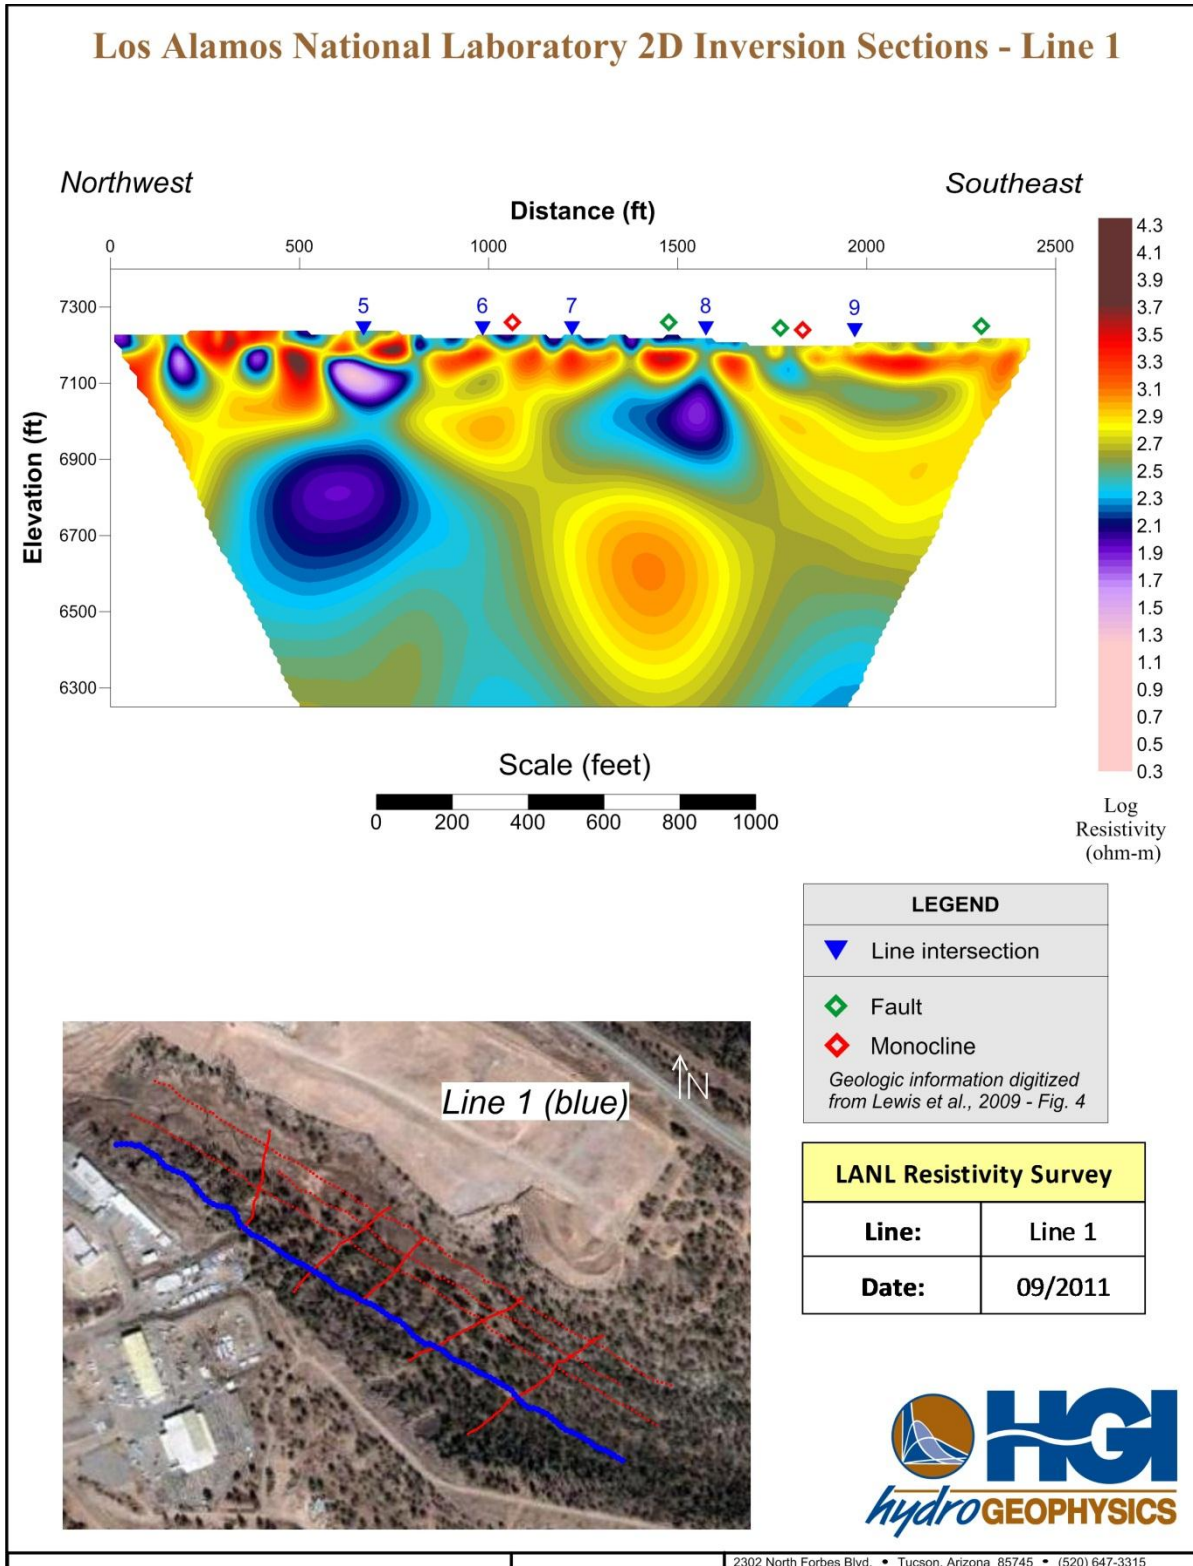
## Plate 1 Profile 1 - Two-dimensional Model Resistivity Results

The 2D resistivity model results are presented as 2D profiles in Plates 1 through 11 found in Appendix A at the end of this report. Common color contouring scales were used throughout and there is no vertical exaggeration in the 2D profile figures. Electrically conductive (low resistivity) subsurface regions are represented by cool hues (purple to green) and electrically resistive regions are represented by warm hues (orange to red). To help emphasize particular features in each section a log scale of model resistivity is used in the profile figures. When data span multiple orders of magnitude, it is appropriate to display a log transformation. Table 3 lists the data statistics for each profile.

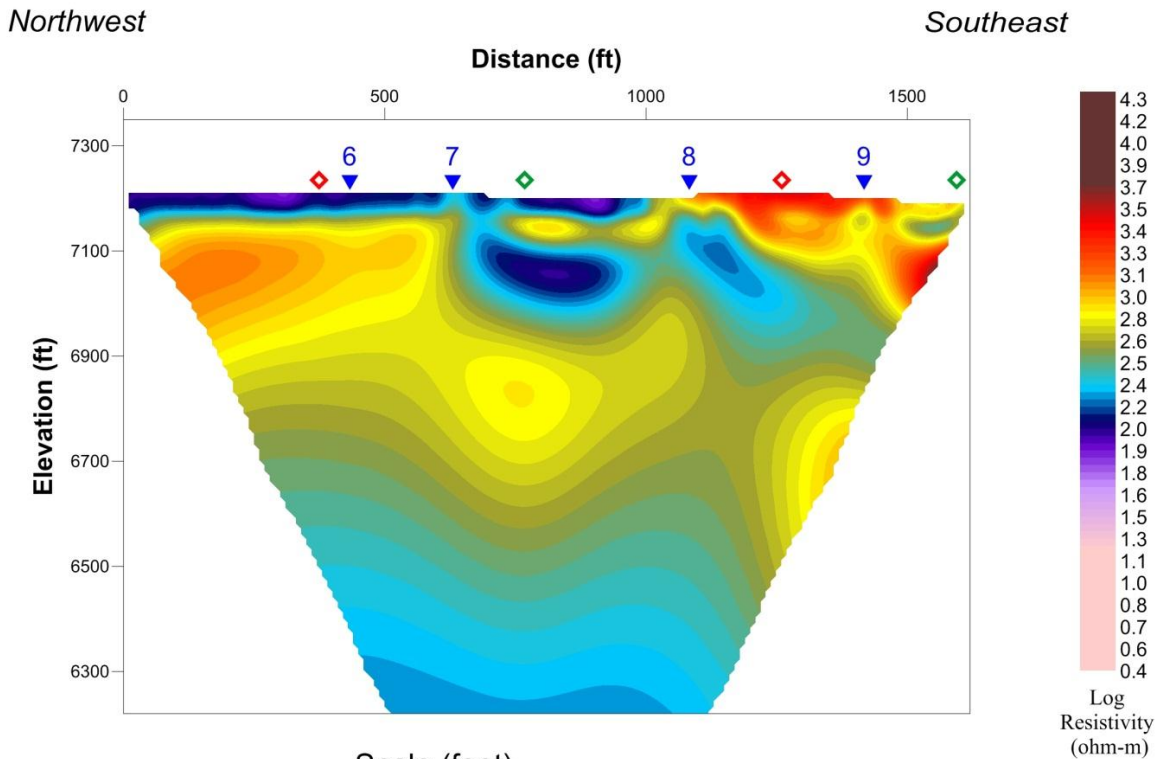
Plate 4 Profile 4 - Two-dimensional Model Resistivity Results

Los Alamos National Laboratory 2D Inversion Sections - Line 4

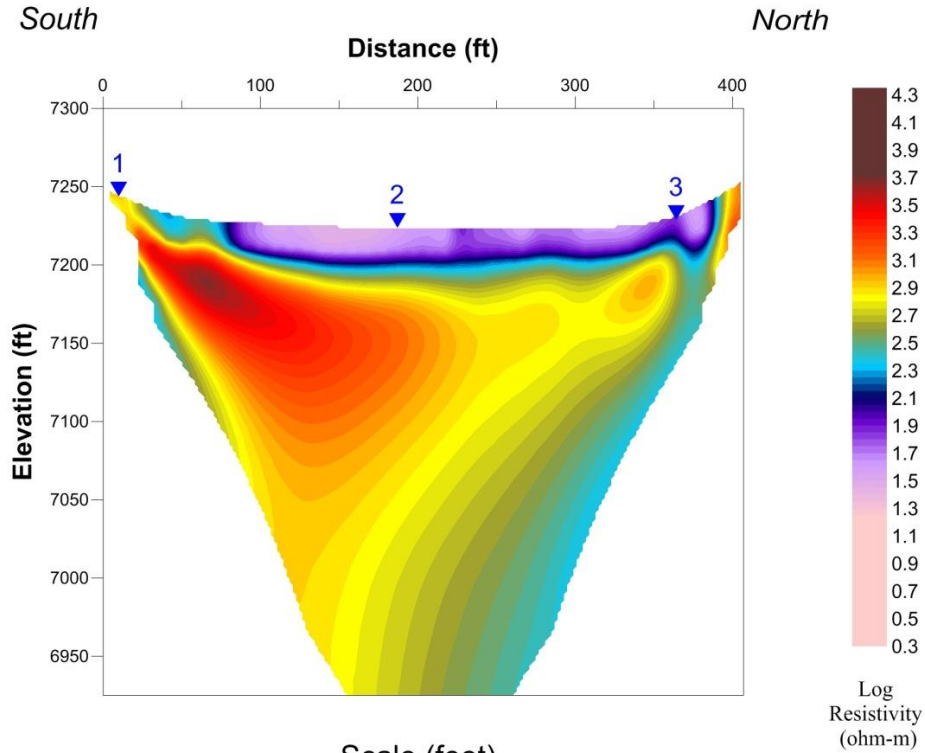
Plate 6 Profile 5 - Two-dimensional Model Resistivity Results

Los Alamos National Laboratory 2D Inversion Sections - Line 5

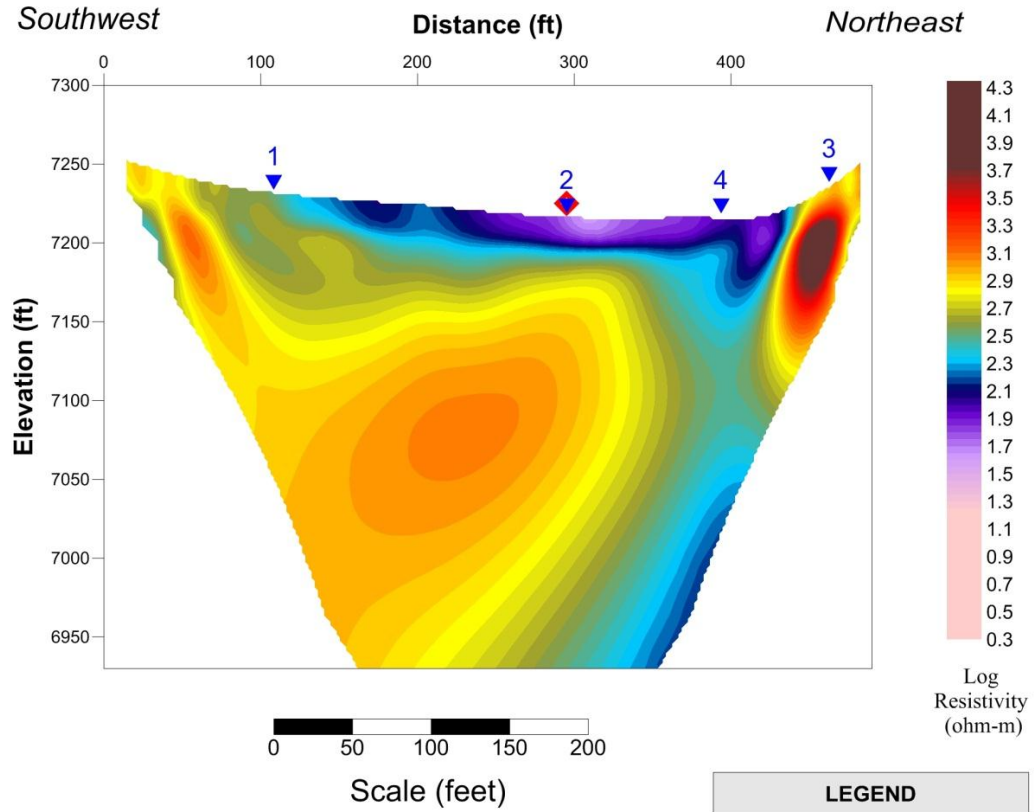
Plate 7 Profile 6 - Two-dimensional Model Resistivity Results

Los Alamos National Laboratory 2D Inversion Sections - Line 6

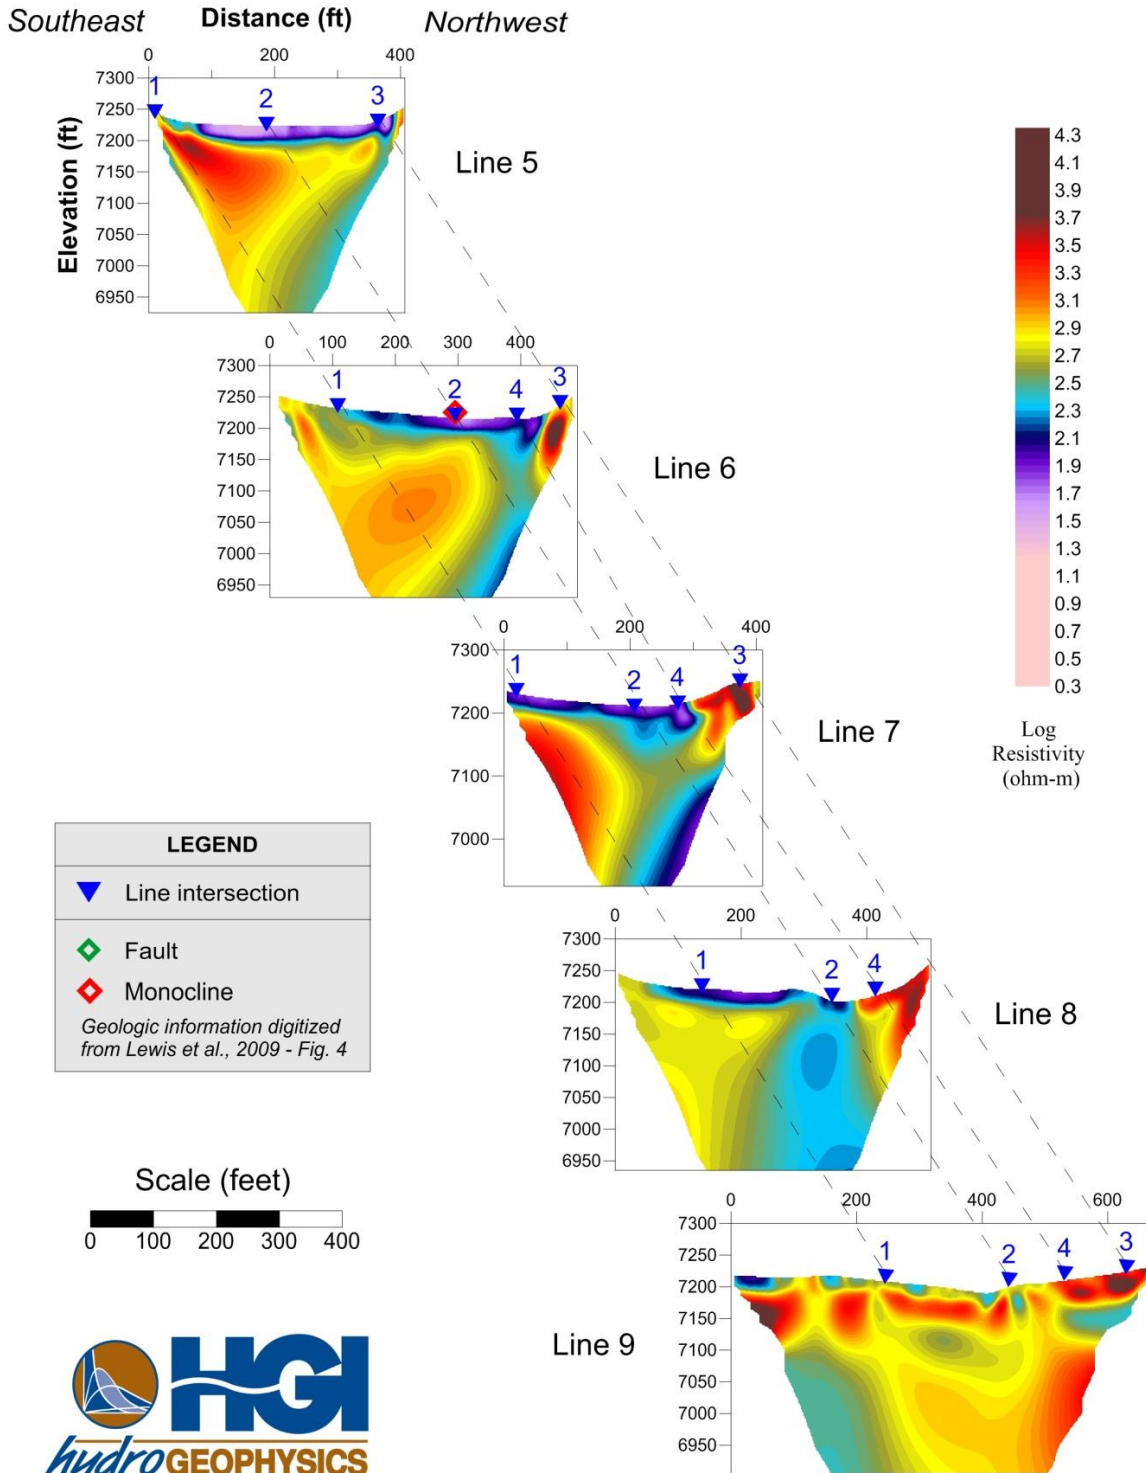
### Los Alamos National Laboratory 2D Inversion Sections - Lines 5-9
