LA-UR-15-22213  
May 2015  
EP2015-0062

# **Alternative Compliance Request for 52 Site Monitoring Area/ Site Combinations Exceeding Target Action Levels from Nonpoint Sources**

Prepared by the Environmental Programs Directorate

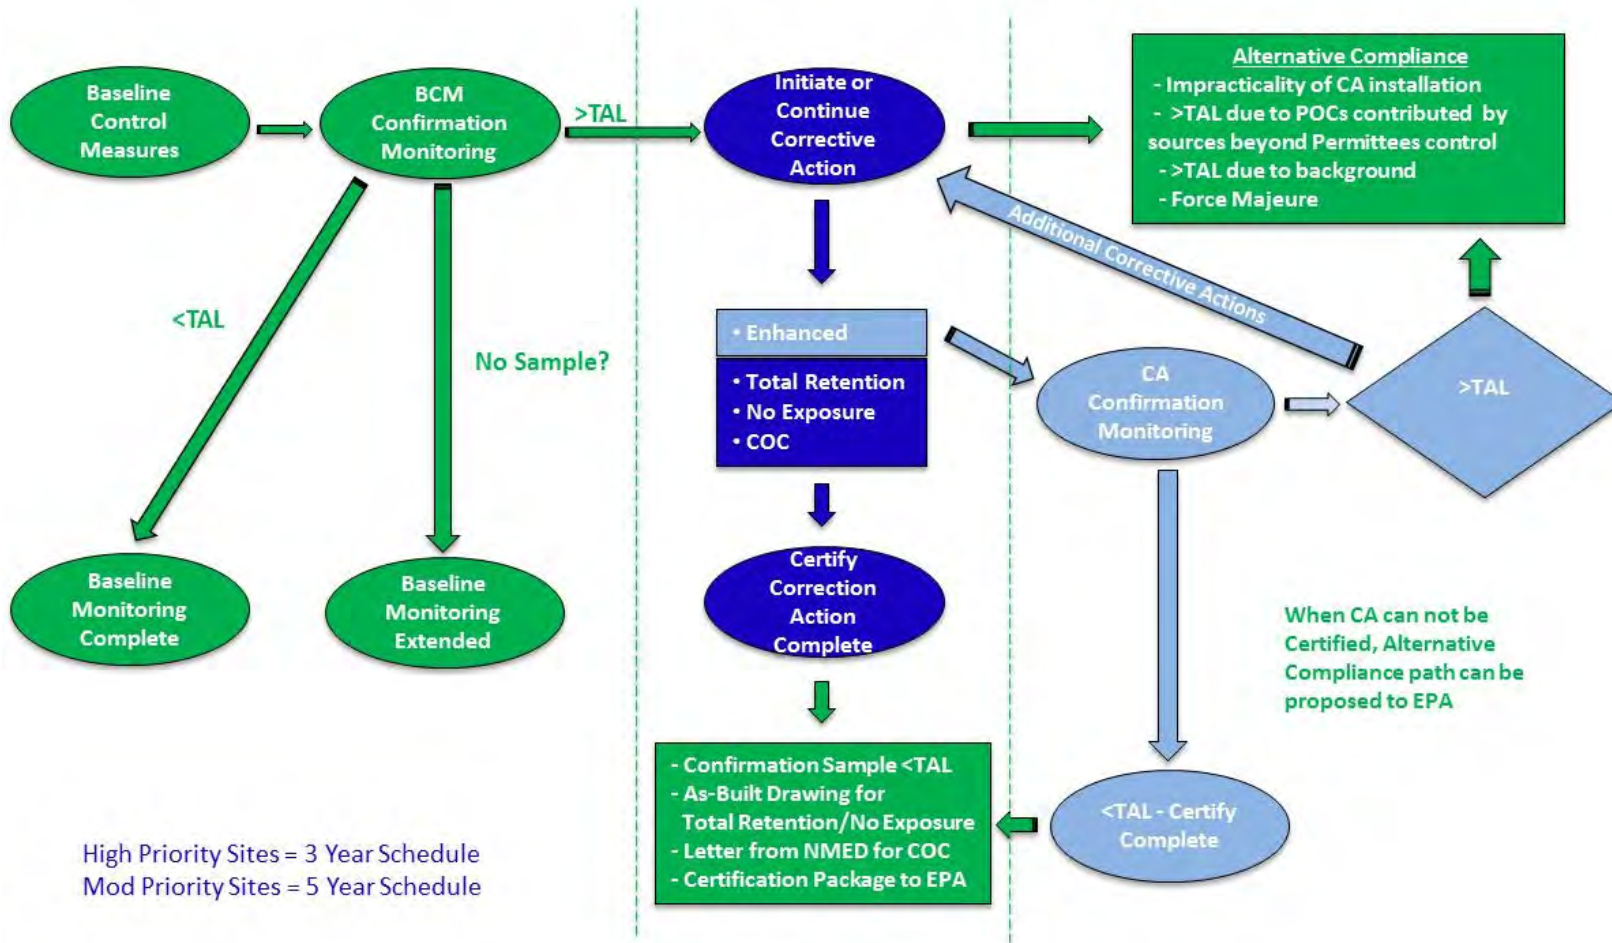
**Figure 2.0-1 Flow chart of the corrective action process/alternative compliance**

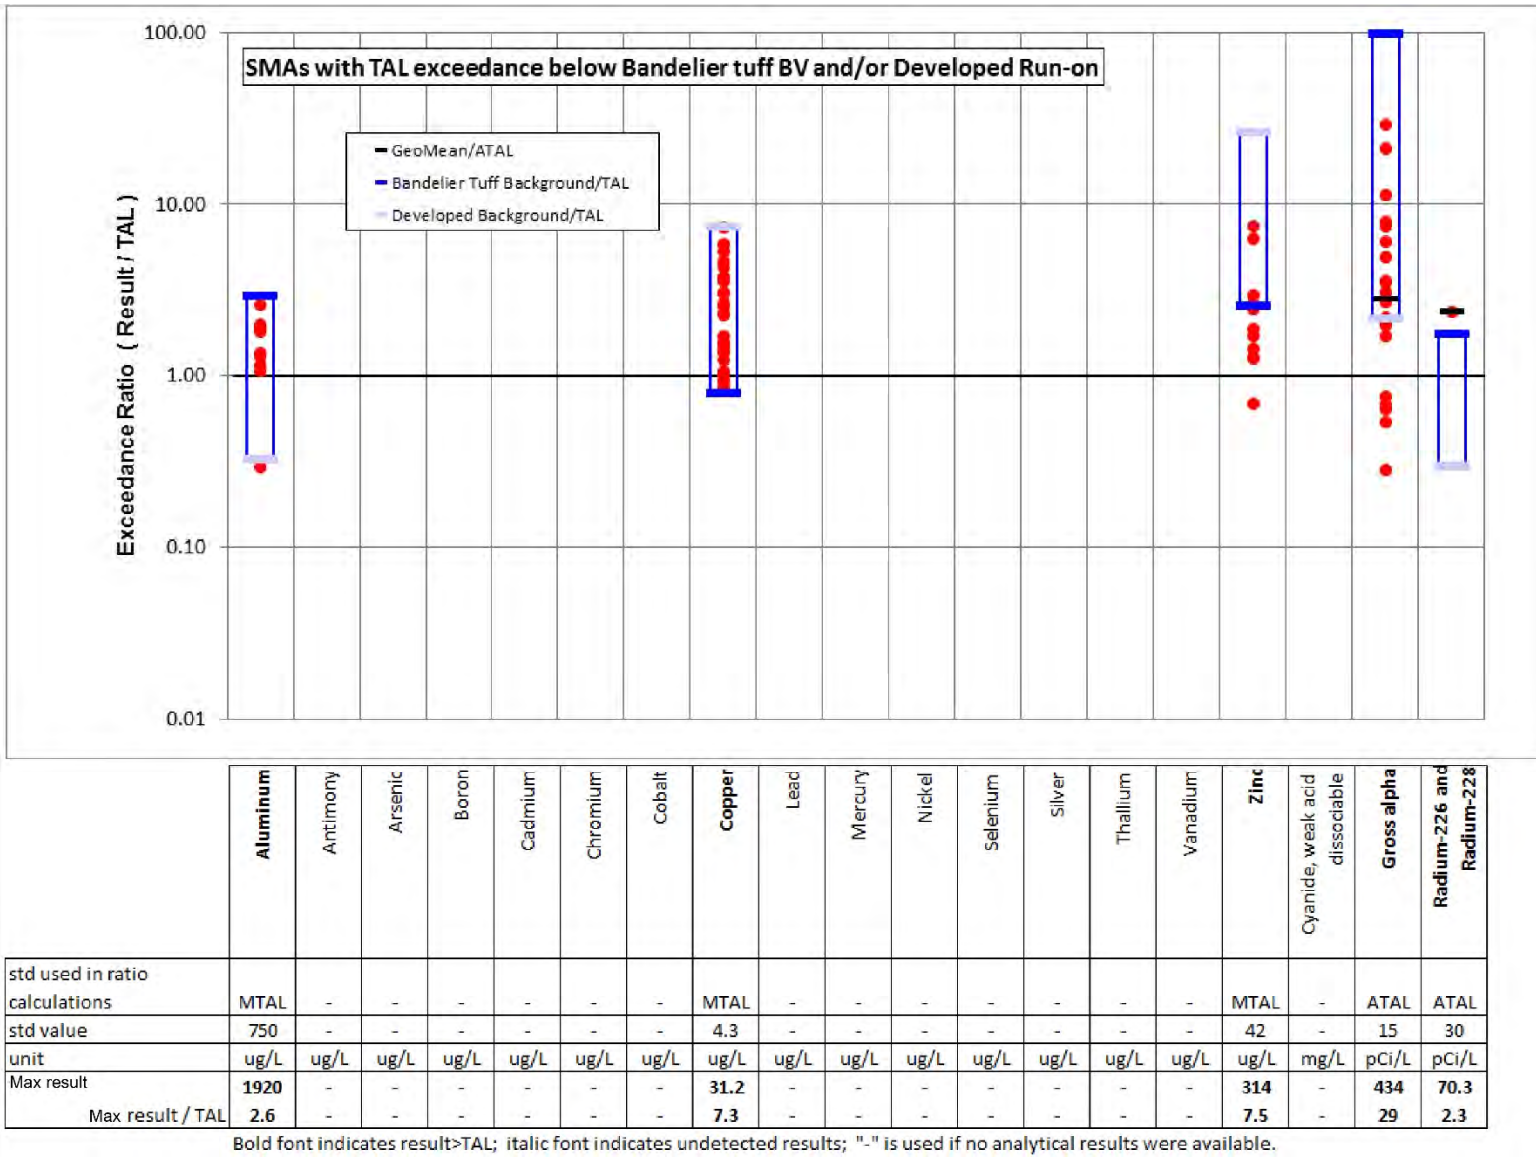
Figure 5.1-1 Storm water monitoring exceedance plot for metals and radionuclides

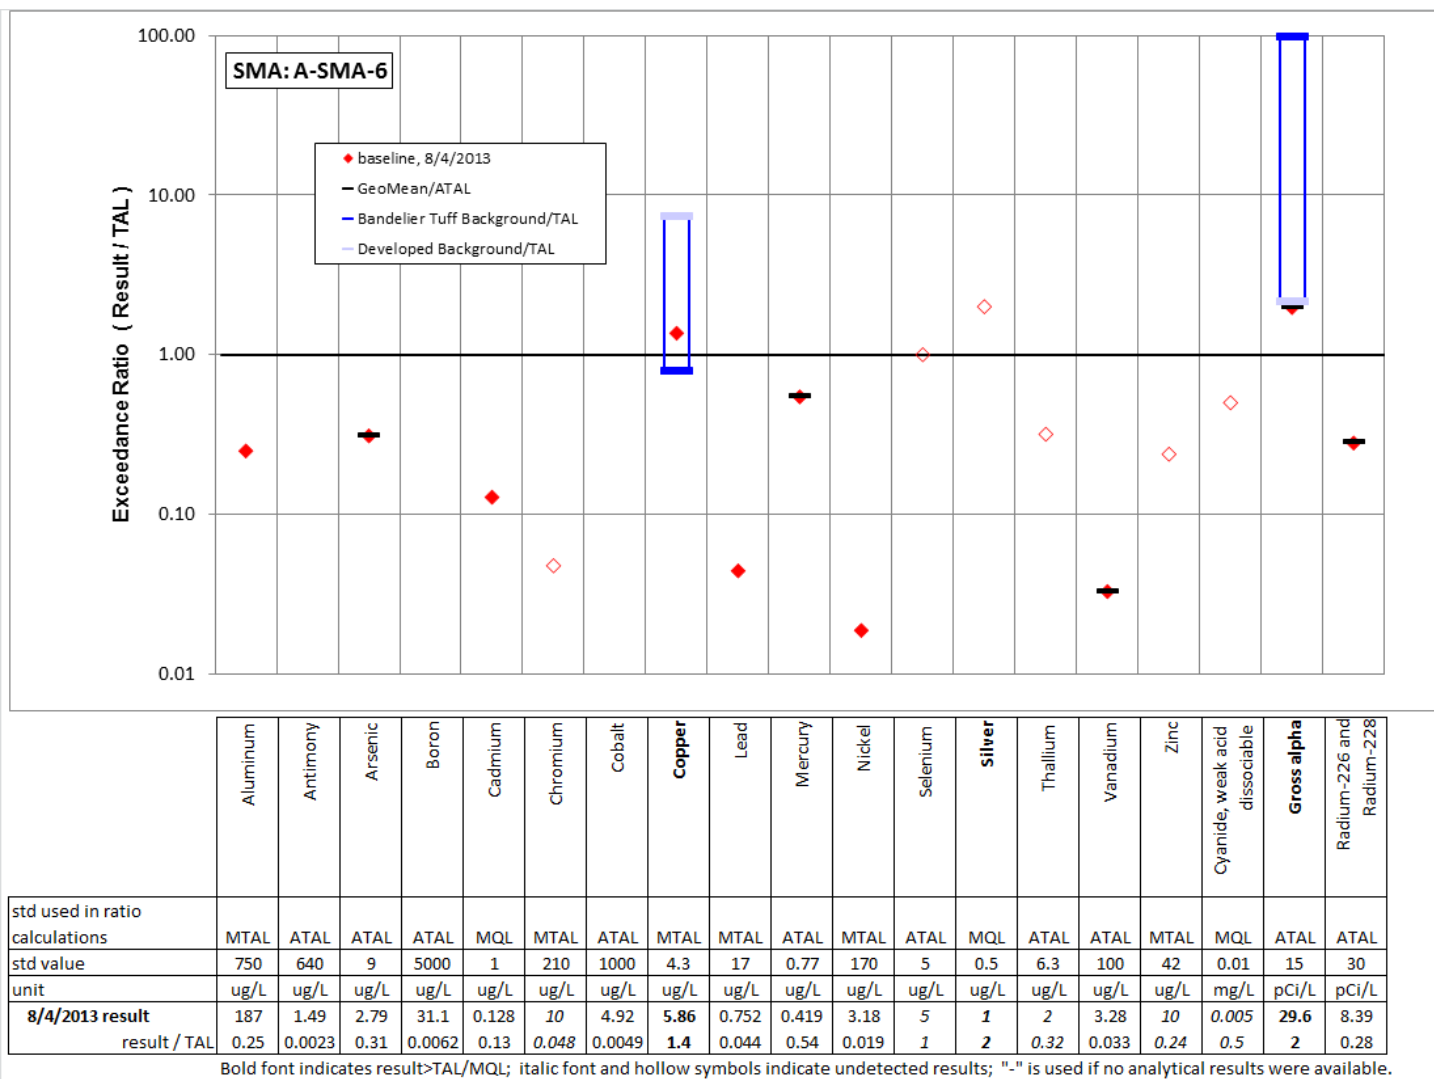
Figure A-9.2-1 TAL exceedance plot for A-SMA-6

- Copper is not known to have been associated with industrial materials historically managed at this Site. Copper was not detected above BVs in the 8 shallow RFI samples collected at the Site. The 1994 RFI data are screening level only.
- Gross alpha-emitting radionuclides are not known to have been associated with industrial materials historically managed at this Site. Alpha-emitting radionuclides managed by the Permittees are exempt from regulation under the CWA and are excluded from the definition of adjusted gross-alpha radioactivity.

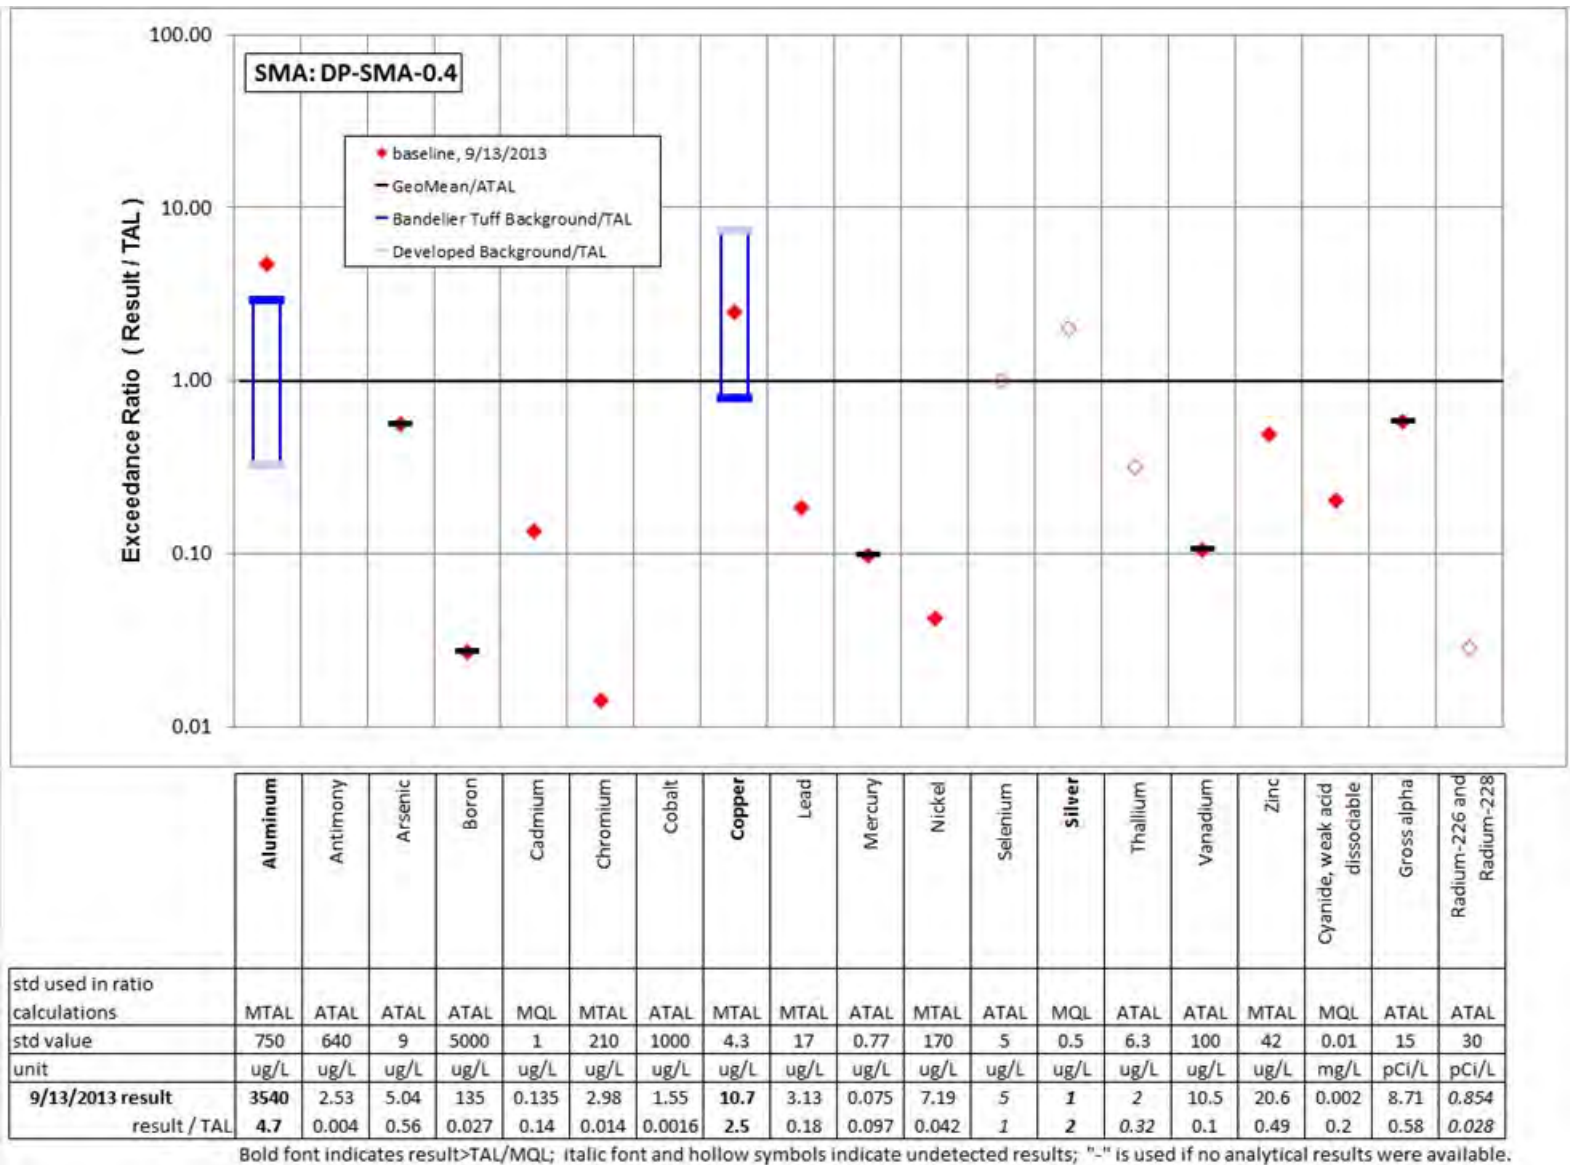
Figure A-14.2-1 TAL exceedance plot for DP-SMA-0.4

The Site history and lack of detections of TAL exceedance constituents within or near the SMA indicate the Site is not the source of the TAL exceedances.
