# **DP West Building 21-002 Footprint Letter Work Plan**

# DP West Building 21-002 Footprint Letter Work Plan

January 2011

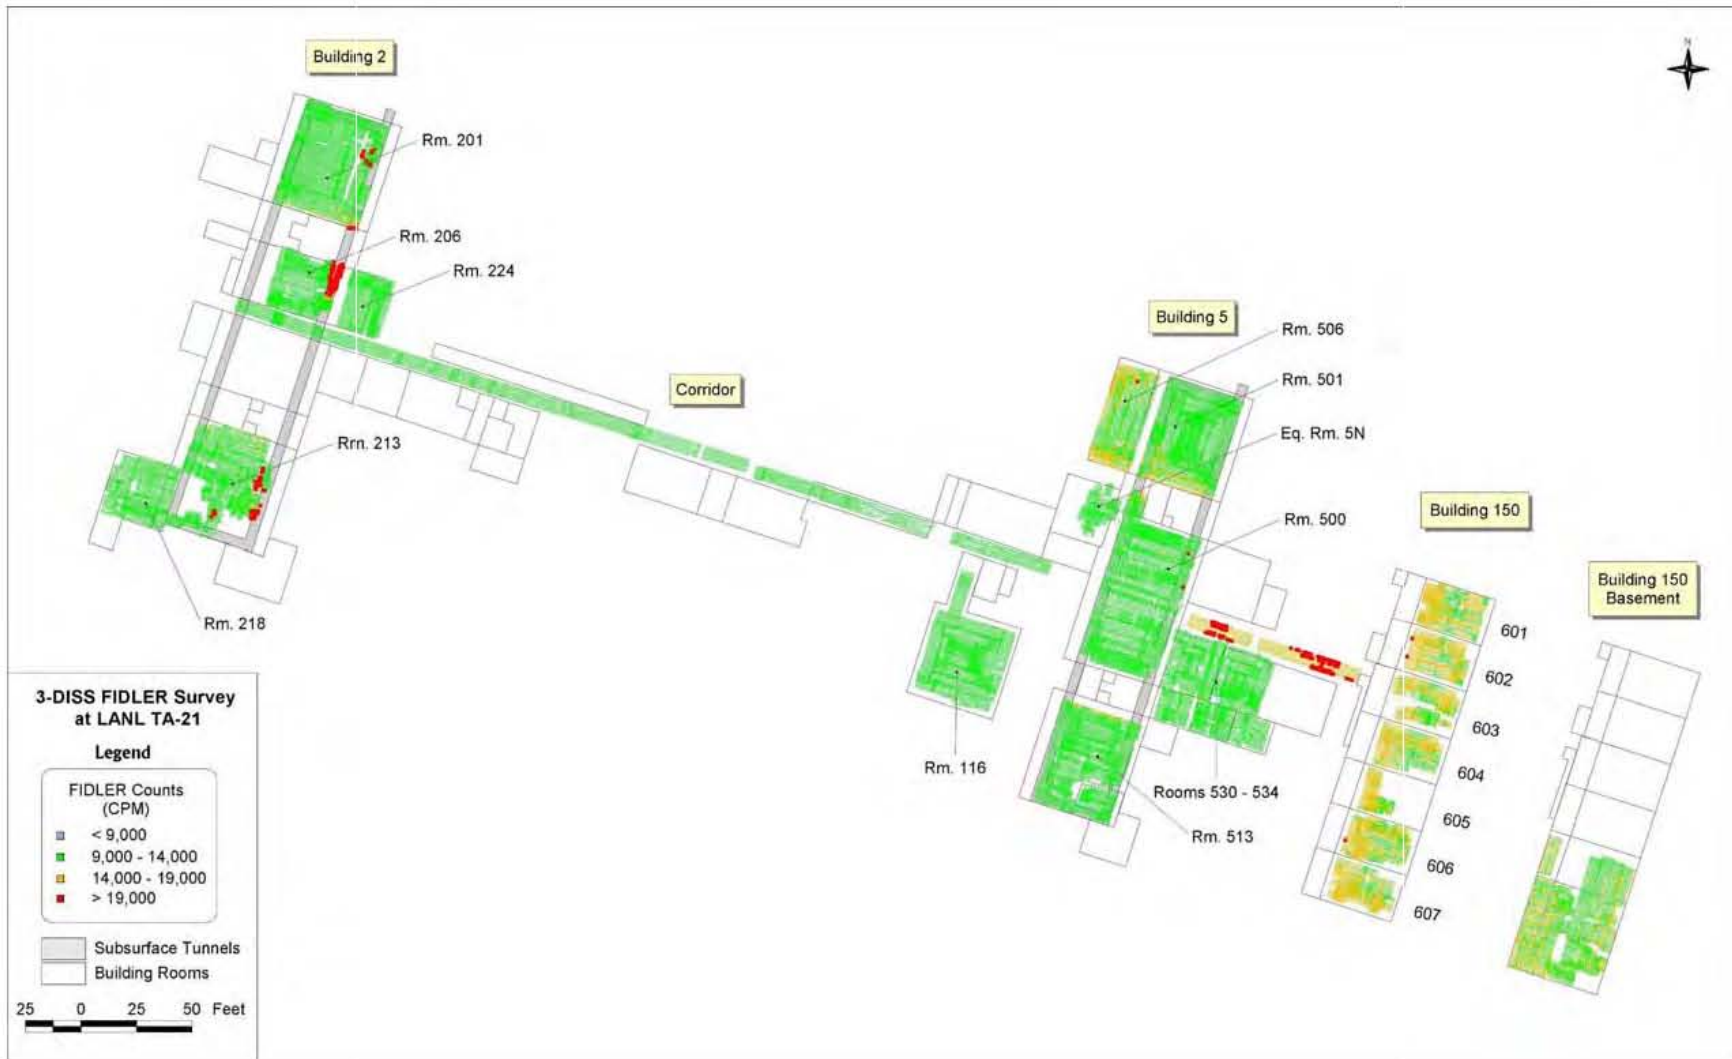
Figure 2.2-1 Low-energy photon distribution measured over DP West building floors

Source: (LANL 2006, 094351).

In 2006, the reconnaissance-level characterization plan (LANL 2006, 111467) focused primarily on defining the physical, radiological, and chemical condition of the facilities that could affect future D&D activities. According to the subsequent "Report on Characterization of Above-Grade Delta Prime West Structures at Technical Area 21," subsurface spaces were not inspected due to potential exposure risks posed by radioactively-contaminated surfaces in these spaces (LANL 2006, 094351, pp. 6 and 25). Additionally, three samples (two surface and one volumetric) were collected from equipment room 2B pumps, piping, and sump [SWMU 21-022(i)], analyzed for PCBs (LANL 2006, 094351, p. 31), and classified as not PCB-contaminated (LANL 2006, 094351, p. 17). FIDLER low-energy photon radiation detectors were used to determine the distribution of low-energy photons emitted by radionuclides in or beneath the accessible floor areas (Figure 2.2-1), particularly the contribution of anomalies caused by decaying americium-241 and plutonium isotopes. Elevated counts in rooms 206, 213, and 219 (located

along the east side of room 213) were attributed to uncontrolled releases of radioactive liquids into the pipe troughs and utility tunnels (LANL 2006, 094351, p. 22).
