LA-UR-11-2186
May 2011
EP2011-0062

Interim Measures Work Plan for Stabilization of the Sandia Canyon Wetland

Prepared by the Environmental Programs Directorate

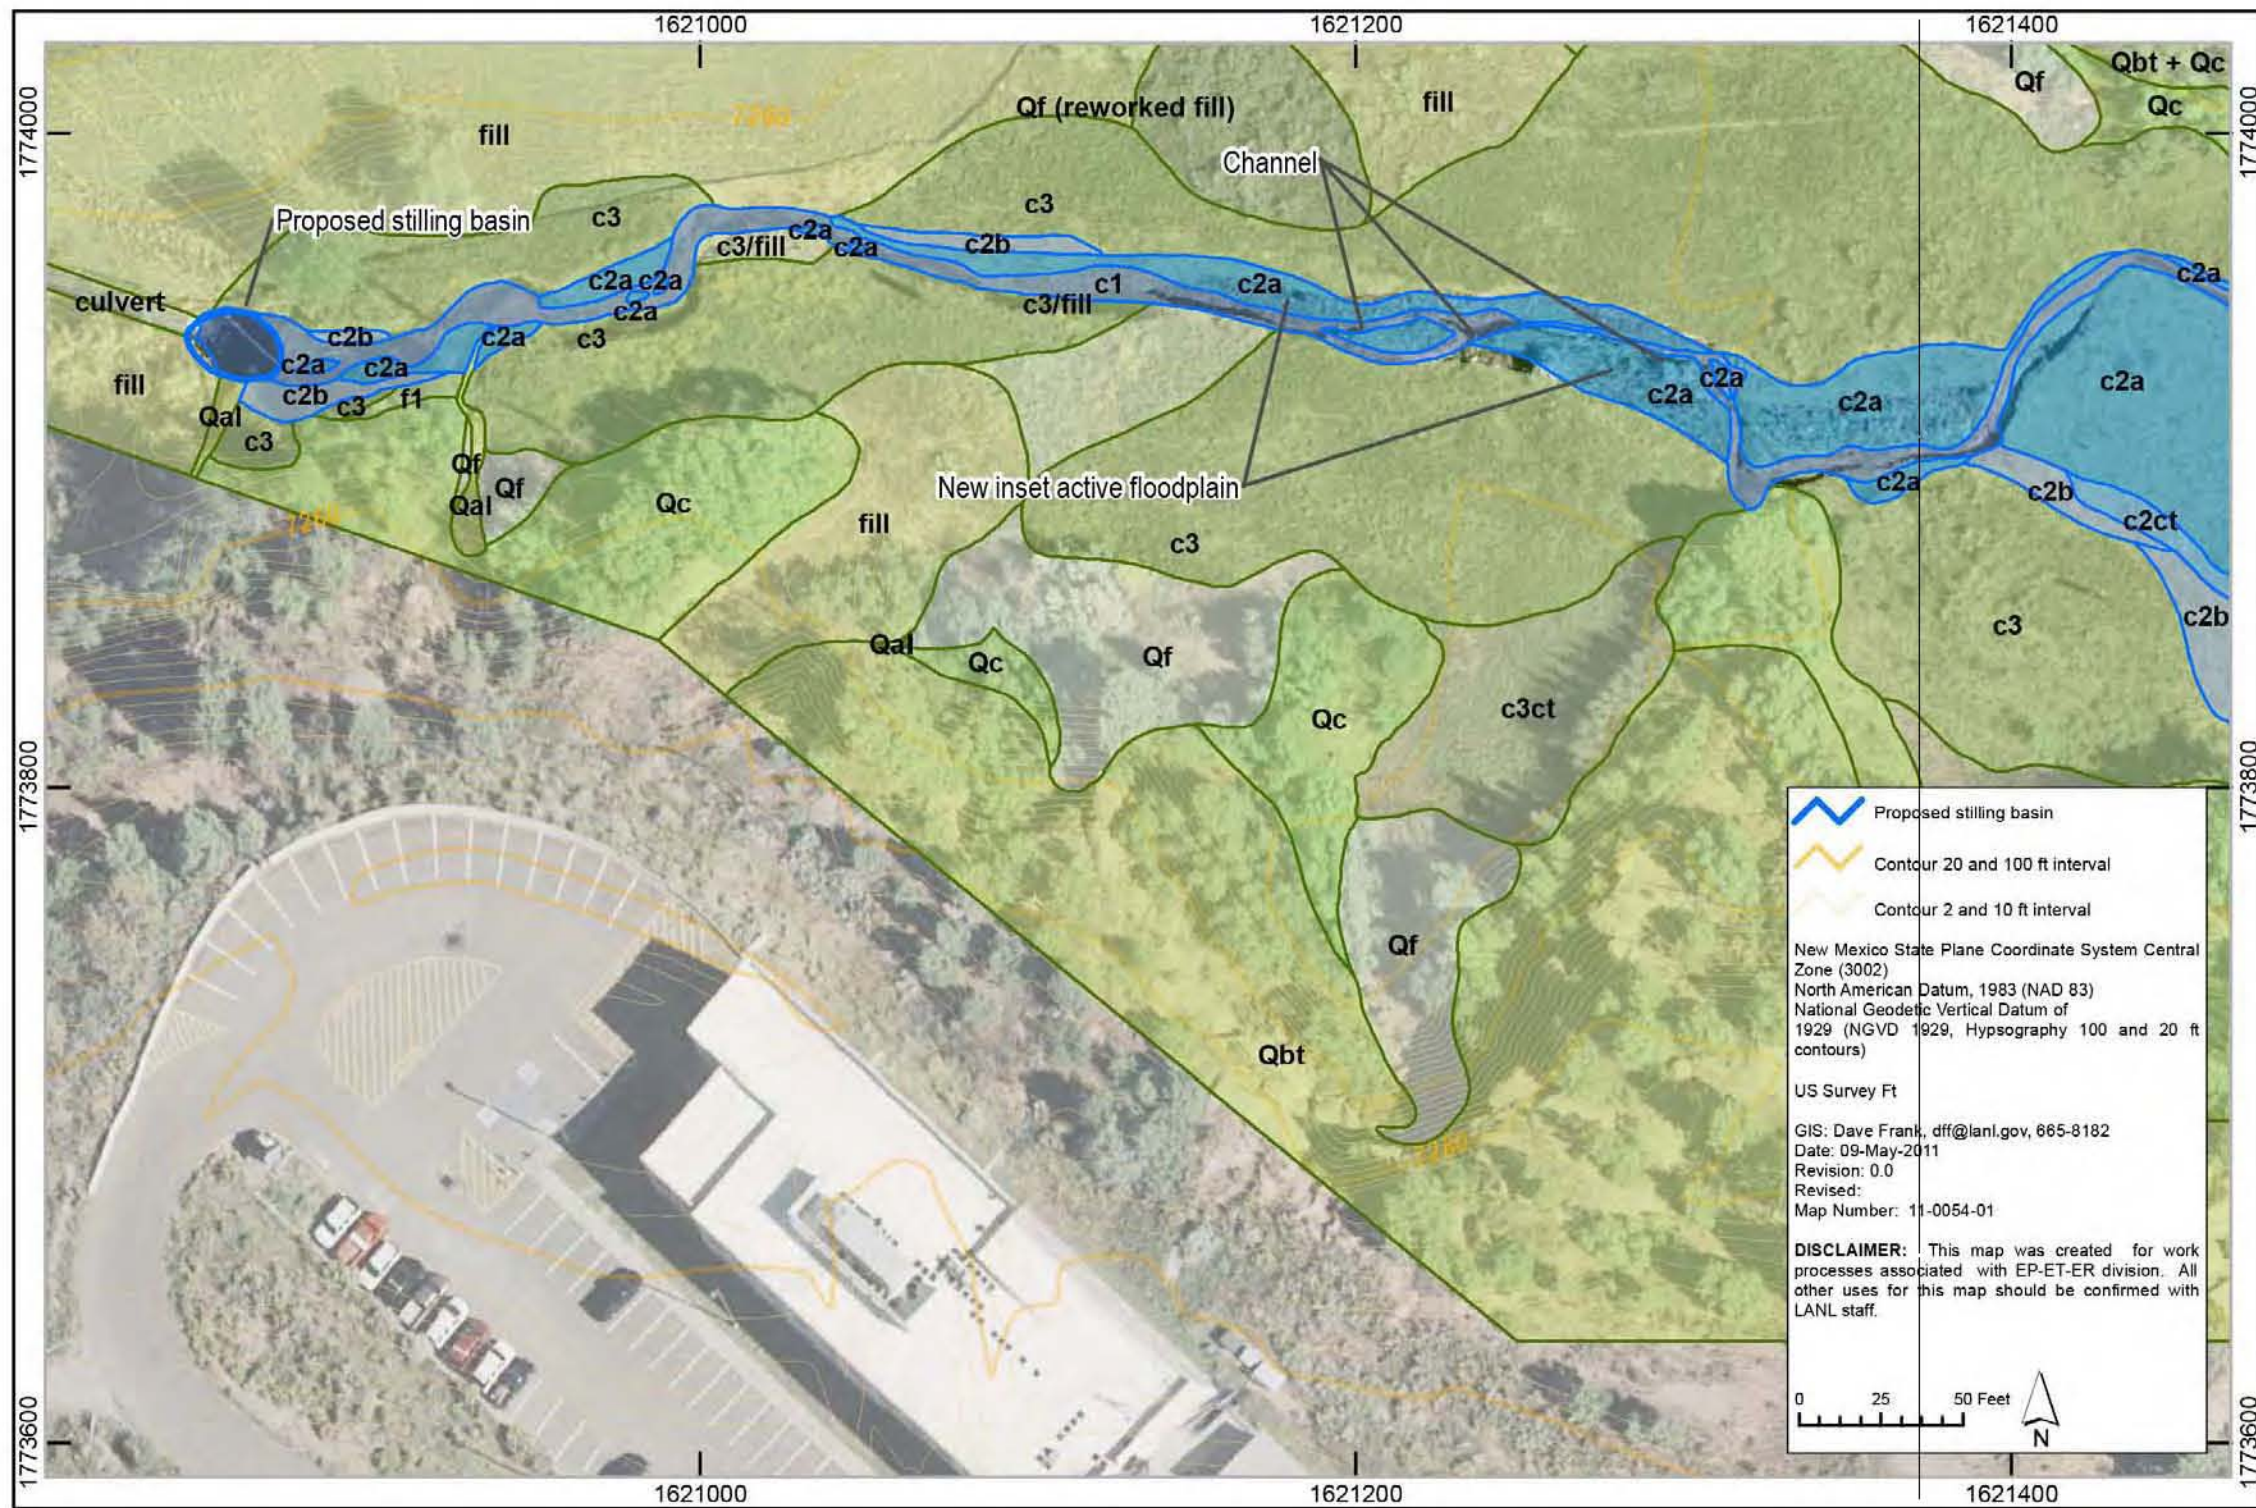
Figure 2.4-1 Upper portion of reach S-2 showing proposed mitigation and location of new inset active floodplains

Before 1998, discharge to upper Sandia Canyon occurred from a hillslope outfall at the head of reach S-2 (Plate 1). This discharge led to alluvial saturation of the southern portion of the upper third of reach S-2. This alluvial saturation resulted in a larger wetland extent than is currently observed. In 1998, the outfall was moved to the south tributary of upper Sandia Canyon. In recent years, the extent of the wetland has decreased because of lowering of the water table in the upper third of reach S-2 when the outfall was rerouted to the upper tributary (Figure 2.4-1).

Currently, the largest contributing drainage area that flows into reach S-2 is conveyed through a 72-in.-diameter corrugated metal pipe (CMP) culvert a short distance upstream of the wetland. Peak stormwater flows have created a scour hole at the culvert outfall into the stream reach. Between the outfall and the upstream extent of the wetland, the stream is unstable and has experienced moderate stream-bank erosion. Along this reach, the stream has become disconnected from its floodplain. Observations in spring 2011 suggest that the channel in the upper third of the reach is approaching stable grade and is beginning to meander and establish an active floodplain surface inset into a higher abandoned terrace (Figure 2.4-1). A narrow, bankfull terrace has begun to form along this reach as the stream seeks equilibrium. In some locations, this bankfull terrace is up to 4 m wide, and wetland vegetation is beginning to opportunistically reestablish and expand upstream on this terrace, creating a more stable environment. These newly vegetated active floodplains are important for managing stormwater runoff by enabling higher discharges to spill out of the channel and by providing roughness and sediment-trapping elements to reduce potential contaminant transport. This natural process of stream widening, therefore, is acting to expand and stabilize the wetland in the upper part of the reach.

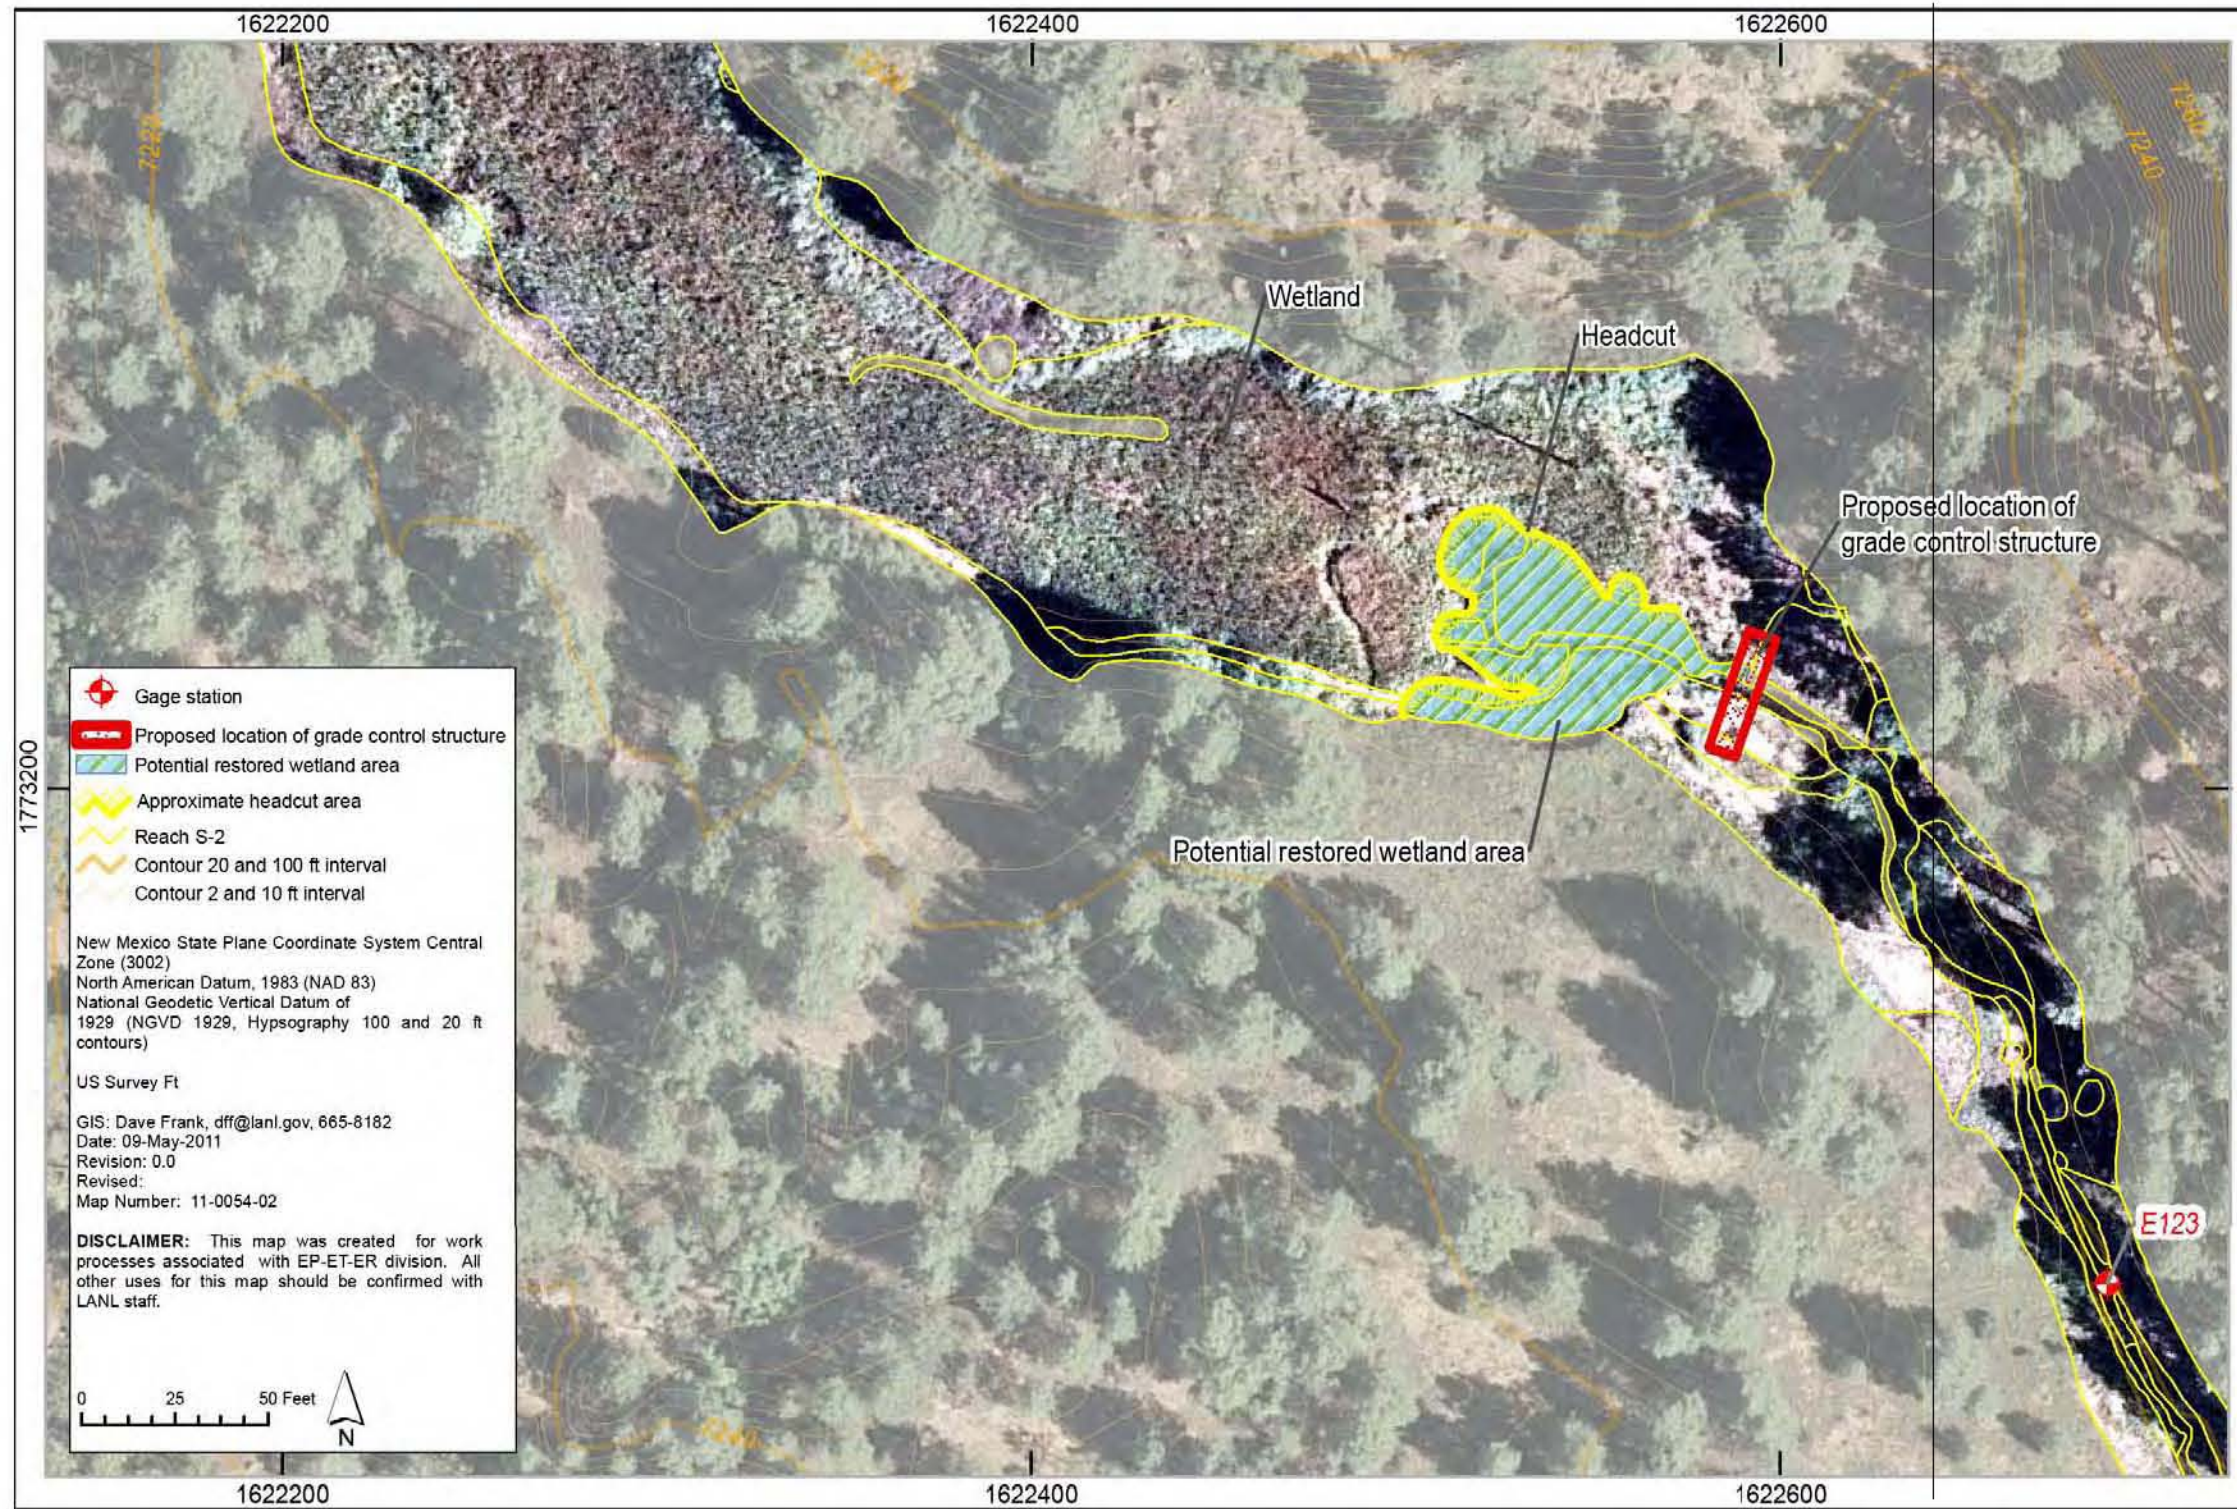
Figure 2.4-2 Lower portion of reach S-2 showing proposed location of grade-control structure

In order to arrest the headcut at the terminus of the wetland in reach S-2, a grade-control structure is proposed approximately 30 m downstream of the current headcut (Figure 2.4-2). The grade-control structure will be designed to create and fix an optimal channel and floodplain grade that will mitigate potential channel incision and continued headcutting. The grade-control structure design will incorporate an impervious or low-permeability material to maintain sufficiently high alluvial groundwater levels to maintain or enhance upcanyon wetland conditions.

The proposed location for the grade-control structure is on competent bedrock just upcanyon from the location of gage station E123. The transition from the wetland above the grade-control structure and the stream channel below the grade-control structure will be designed to prevent erosive flows that could scour and destabilize the stream reach below the structure.

Fill will be placed upstream of the grade-control structure to replace the area of the wetland that has been eroded. This area will be filled to the elevation of the existing wetland area to prevent the formation of a pool behind the grade-control structure and to facilitate rapid reestablishment of the eroded area of the wetland. Native wetland vegetation may be planted on the fill to accelerate the stabilization process.

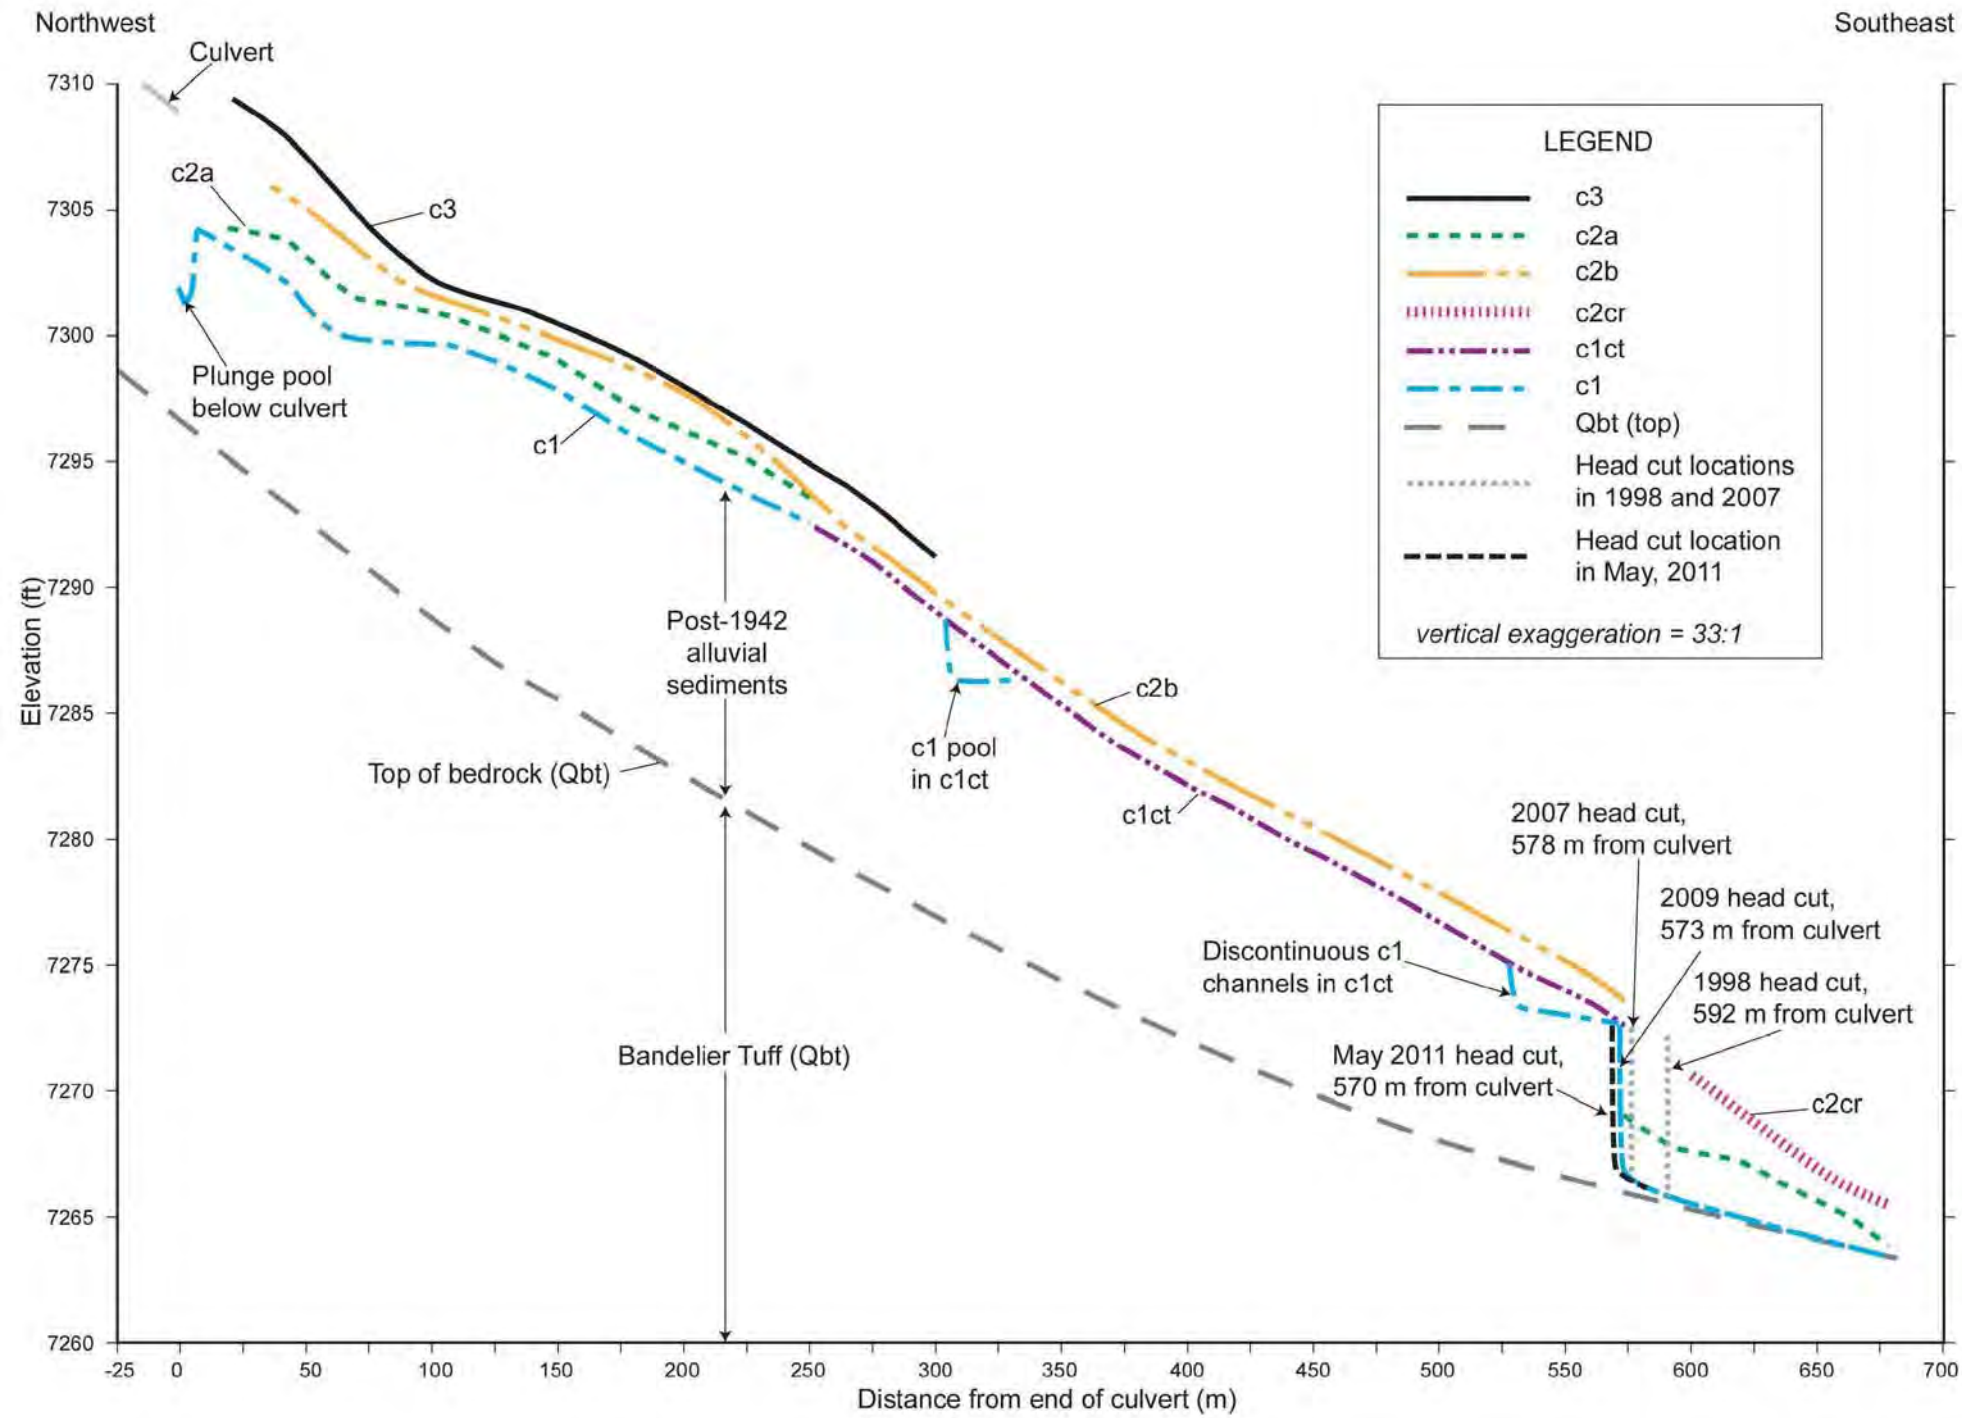
Figure 2.4-3 Longitudinal profile through reach S-2 showing elevations of geomorphic surfaces and depicting time-series of headcut retreat

In the lower two-thirds of the reach, wetland vegetation is well established across the entire floodplain and the stream and wetlands are very stable. In the downstream portion of the wetland, the defined channel is lost and water is conveyed as sheet flow across the width of the wetland. However, as the water leaves the wetland, there is a large headcut (up to 3 m high) traveling upstream through the wetland (Figures 2.4-2 and 2.4-3). Indirect observations are that this headcut advances upstream associated with effects of stormwater runoff. Between 1998 and March 2007, the headcut migrated upcanyon about 14 m. Between March 2007 and August 2009, it migrated approximately 5 m, and since 2009, the headcut advanced an additional 5 m. Dense willow planting at the headcut in 2010 did not arrest the head advancement.
